**Arboricultural Report
Trees at Proposed Site at
Former Filling Station
Nutgrove Avenue
Rathfarnham
Dublin 14
April 2021**

**The Tree File Ltd
Consulting Arborists
Ashgrove House
26 Foxrock Court
Dublin 18
D18 R2K1
086-3819011**

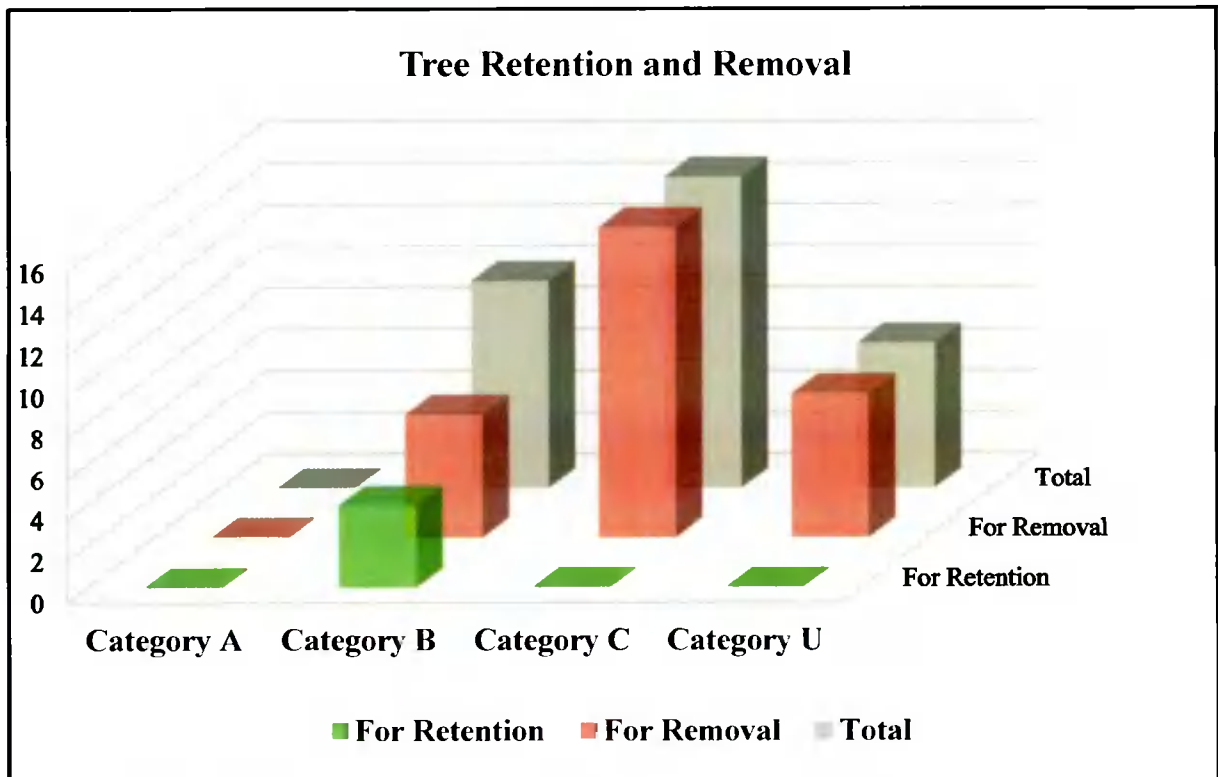
Fig 5 Graphic Representation of Tree Loss/Retention Scenario

- 11.3 Normally, all category “U” trees will be removed (many need removal regardless of development) (8 items cumulative, but one specimen (no.177) is beyond the jurisdiction of the site and removal would be the responsibility of others)
- 11.4 Of the site’s “fair” quality, category “B” trees, the development works will require the removal of tree Nos.178, 179, 180, 183, 188, 197 (6 items cumulative)

- 11.5 Of the site’s category “poor” quality “C” trees, the development works appears to require the removal of Nos.173, 174, 175, 176, 181, 182, 184, 186, 187, 189, 190, 191, 196 and 198. (14 items cumulative).

- 11.6 The tree loss breakdown for the site will be-
- 7 No. Category U trees (1 Additional Off-site tree is recommended for removal)
 - 6 No. Category B trees
 - 14 No. category C trees

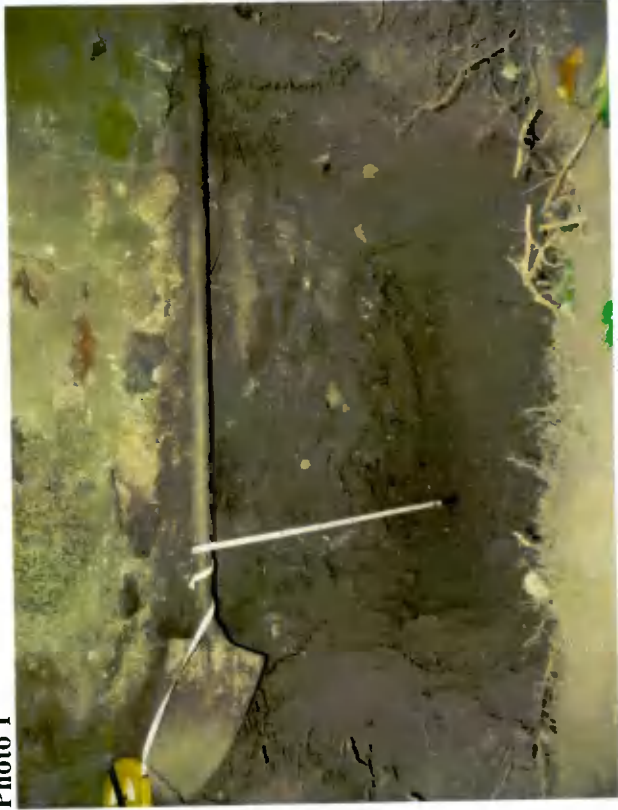
Photo 1

These photographs relate to trial pit excavations at locations depicted upon the Arboricultural drawings and adjoining Norway Maple No.201

Photograph 1 (left) illustrates the broader excavated pit. The shovel level approximately equates to soil levels with the lower end of the tape registering circa 800 mm depth. Attention is drawn to the routes in the foreground relating to on-site scrub development including Bramble and Sycamore saplings.
