**Proposed works to:  
'WHITEHALL' - KATHARINE TYNAN HOUSE  
Kingswood, Dublin 24**

## **ARCHITECTURAL HERITAGE IMPACT ASSESSMENT REPORT**

**May 2021**

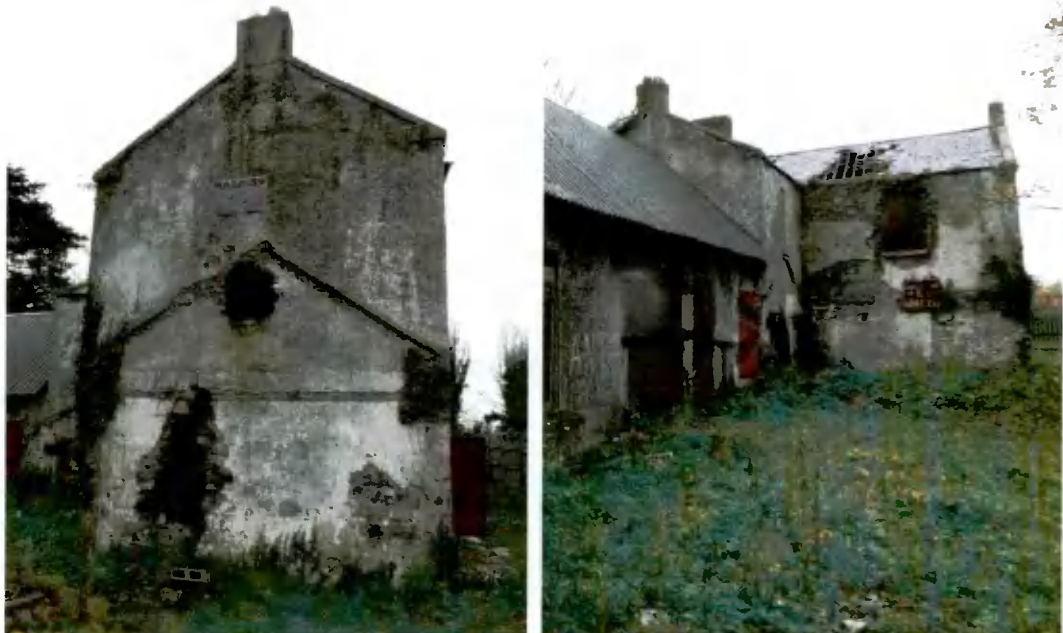
Figure 10: North gable with stone barge copings  
damage to roof

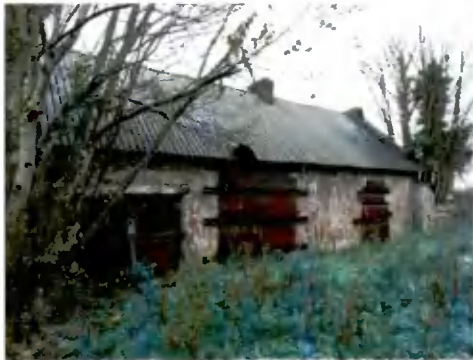
The east-facing pitch of the slate roof has been damaged by a fire with an area having no slates and allowing water ingress. Otherwise slates have slipped and broken in areas throughout the slate roof.

Figure 11: View from east with  
damage to roof

Conservation repair works is to be carried out to the two-storey section of the building supported by the 2021 Built Heritage Investment Scheme, in order to make it water tight. Existing slate is to be retained and completed with natural slate to match. The supporting timbers to the single-storey part of the building are currently protected by a metal sheeting.

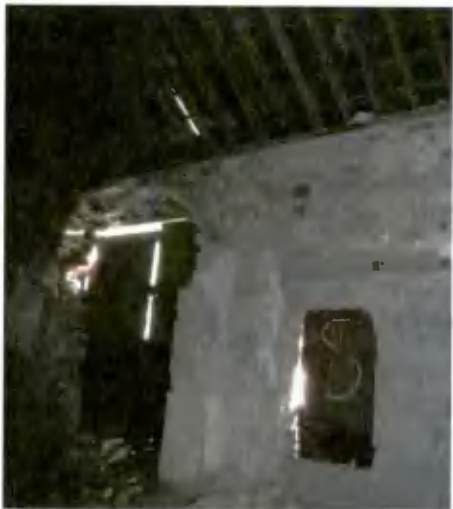
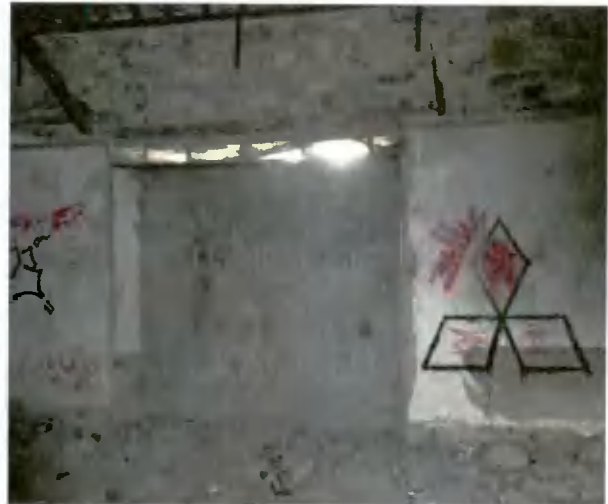
Window and door openings have timber lintels, some with brick relieving arches. The window openings have mix of flush and projecting stone sills. Historic images show a mix of large glazed projecting bay windows to the single-storey part of the structure. These have been removed and some of the openings no longer retain their lintel supports. In some of these, the walls above the openings have collapsed or are sagging.

Figure 25: Missing lintel and weakened timber lintels above openings on north elevation

The walls of the structure shows no major cracking or subsidence. However, timber lintels have been removed to some of the larger exterior ground floor window openings. These will have to be replaced.

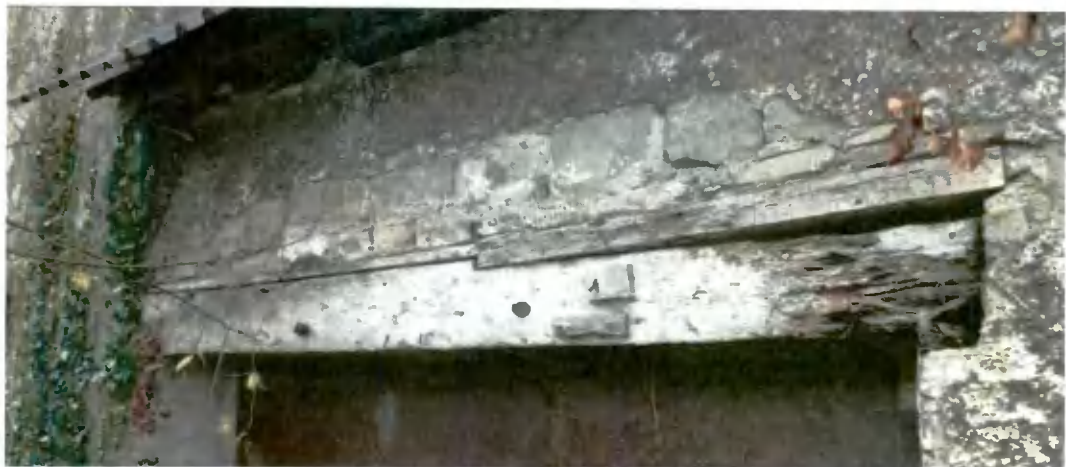
Figure 26: Decay of lintel over large window opening on south elevation

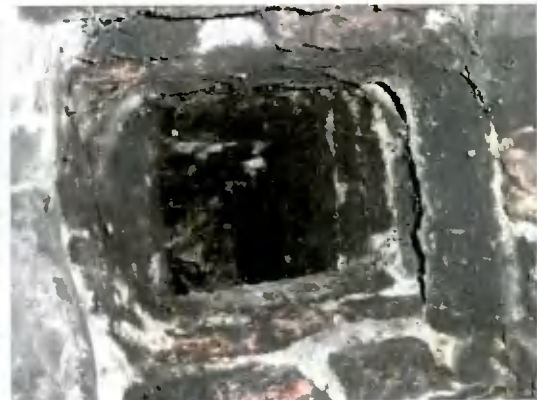
The only flues accessible to inspection were at ground floor in the single-storey part of the house. They are both brick lined with large flues. They appear to be unblocked with no areas of collapse.

Figure 28: Flue in chimney in room G05

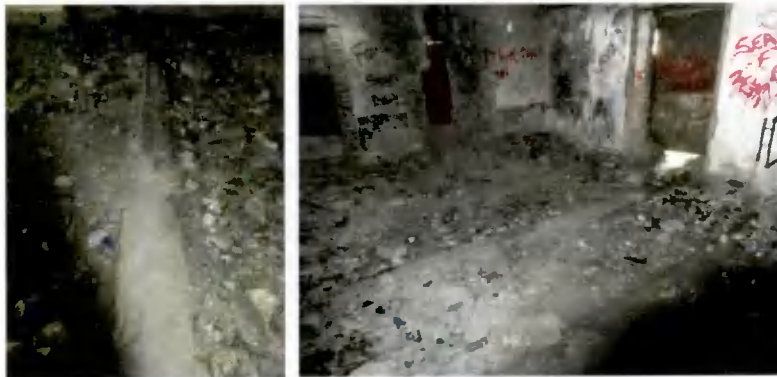
The ground floors were originally raised timber on sleeper walls, no original floorboards or joists remain. Evidence of the sleeper walls is particularly clear in room G05.

Figure 29: Remains of sleeper walls in Room G05

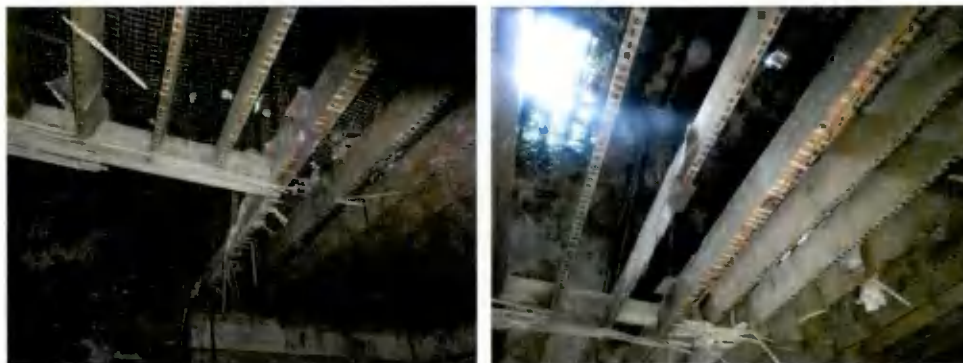
Figure 30: Stairs opening in first floor joists above Room G04 and above Room G01

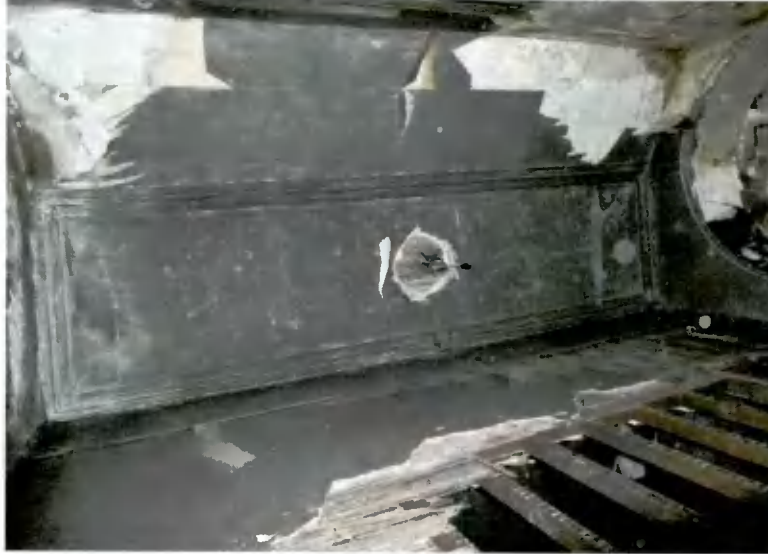
Most ceilings have been entirely removed. There are remains of the lath and plaster ceiling to the first floor rooms. Decorative features remain to the ceiling of the first floor hall corridor. Nail marking remain to the underside of joists indicating the use of lath and plaster to the ceilings of the ground floor (Figure 38).

Figure 38: Ceiling above stair hall at first floor (room 102)

- The first floor decorative ceiling above the stairs is to be retained
- All wall plasters to be repaired/reinstated with traditional lime plaster, non-hydraulic or naturally hydraulic NHL2 lime-sand plaster, to conservation architect's specification.
- Ceilings: Where historic lath and plaster is found to survive, repair like-for-like with traditional lime plaster and riven lath to conservation architect's specification.

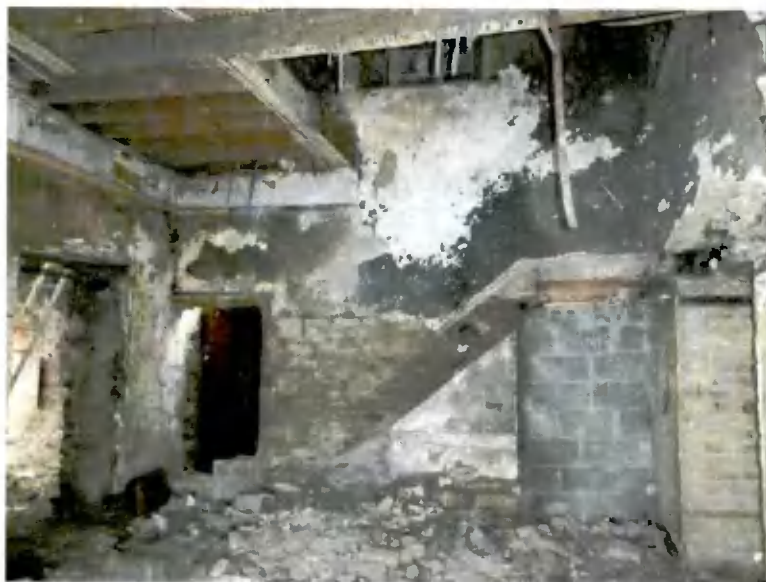
The historic stairs have been removed. The wall in the entrance hall indicates the position of the lower leg of the stairs.

Figure 39: Wall marking of dog-leg stairs in hall (room G03)

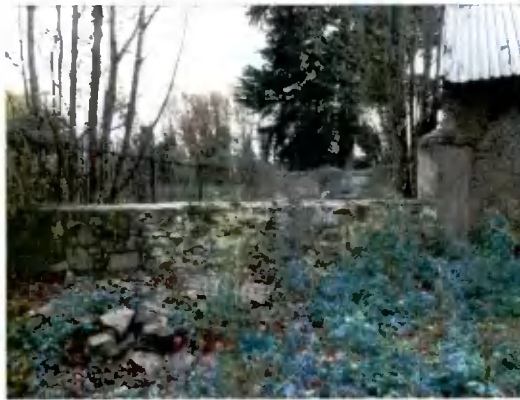
A number of low garden walls remain to the east and south of the house. These connect with tall walls directly to the east which may have been part of a walled garden. They are of rubble stone with some brick dressing. Cappings are of profiled render and slate. Some of the walls have a roughcast render coat. These are damaged and have collapsed in a few areas but are largely intact and stable.

Figure 40: Garden wall at east gable

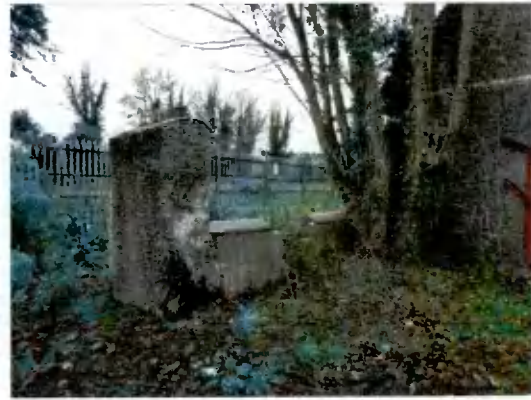
Figure 41: Garden wall at east gable

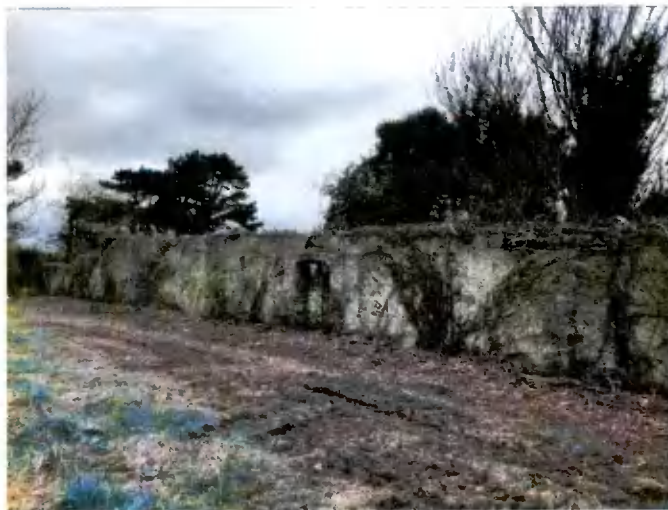
Figure 42: Walled garden east of house
