ARBORICULTURAL INVENTORY AND RECOMMENDED WORKS

Incorporating a
TREE PROTECTION STRATEGY

GROUNDS OF KATHARINE TYNAN HOUSE,
KINGSWOOD, DUBLIN 24.

HIBERNIA REIT

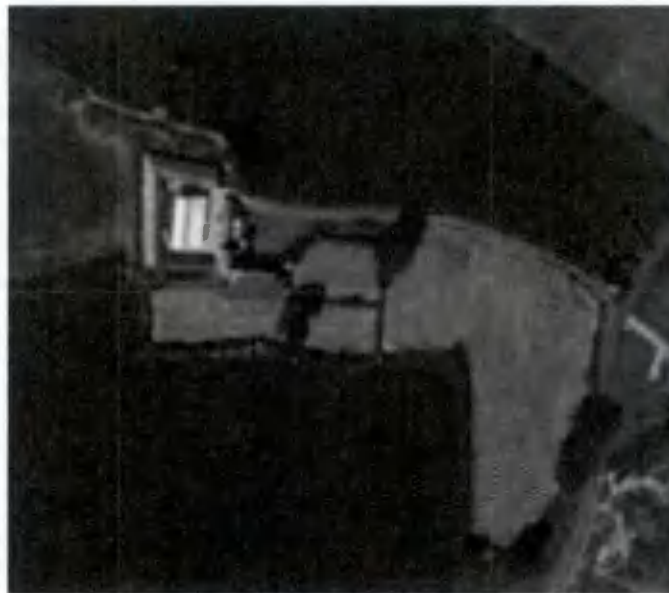
Figure 3 – 1995 Aerial Survey

The trees within the site area are in fair to good condition. Some of the existing trees are seedling Sycamore which have established on the site after 1995 (see the aerial image of the site below from 1995) are causing damage to the structure of the existing house and should be removed.
