**BALLYROAN HOUSE
RATHFARNHAM
DUBLIN 14**

**ARCHITECTURAL HERITAGE
IMPACT ASSESSMENT**

24th June 2021

**Historic Building Consultants
Old Bawn
Old Connaught
Bray**

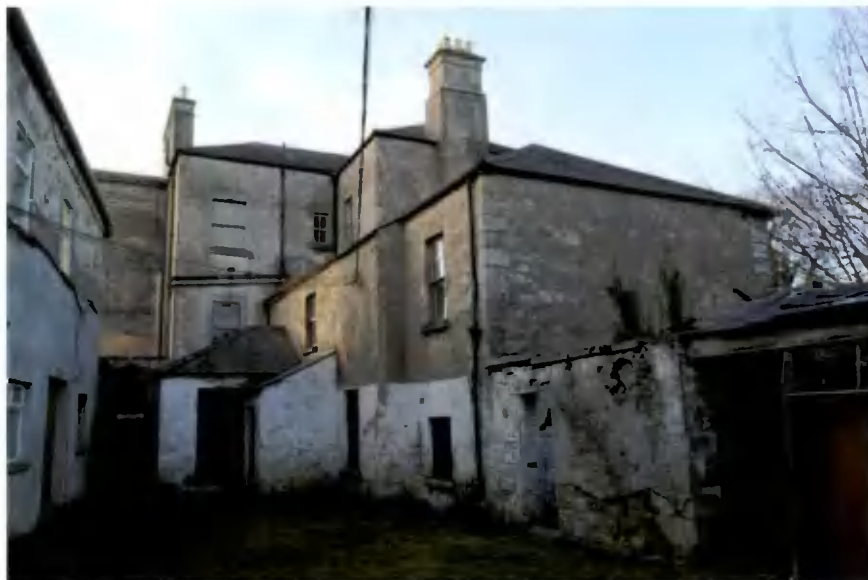
Plate 3: Eastern side of house

The side and rear of the wing are rendered with harling, much of which has failed. This reveals a construction of rubble granite with hammer-dressed granite quoins and with buff-coloured brick surrounds to the windows and doors and at the corner of a small projection to the rear.

The eastern side of the main house is rendered with Roman cement, ruled and lined, and has failed in places to reveal rubble stone with some red brick at the corner and buff-coloured brick at the chimney stack. The windows in this part of the house are a mix of two-over-two sashes and six-over-six sashes in a variety of sizes.

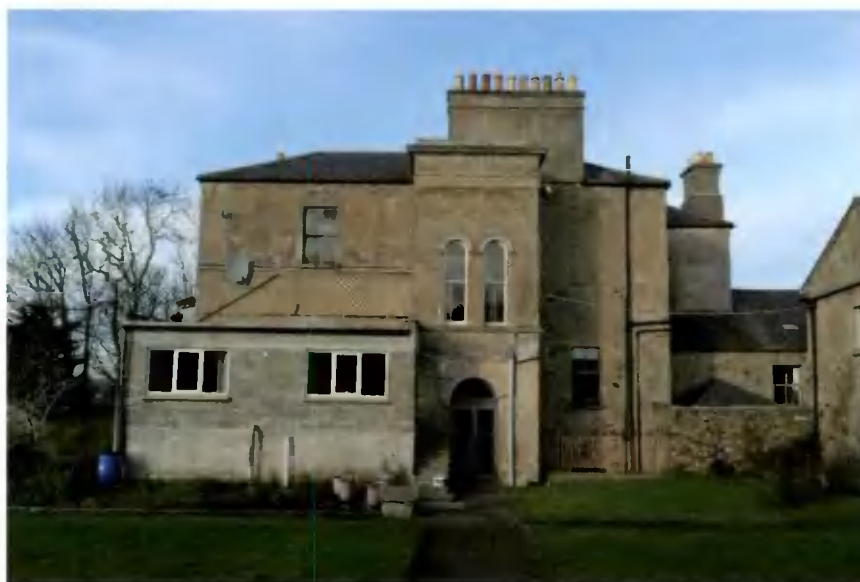
Plate 4: Rear elevation

The rear elevation is rendered, ruled and lined with Roman cement, failing in places. This reveals a construction of rubble stone with brick in places, including the chimney stack. There are only three windows at the rear of the main house, each being a two-over-two sash. A projection to the rear is constructed of brick and topped by a parapet with a cut-granite cornice and blocking course. A pair of round-headed windows on the upper floor of the projection are topped with rendered archivolt, while a single opening on the floor below is round-headed and facilitates a pair of glazed doors. A substantial addition to the side of this projecting section is constructed of concrete blockwork and is not rendered.

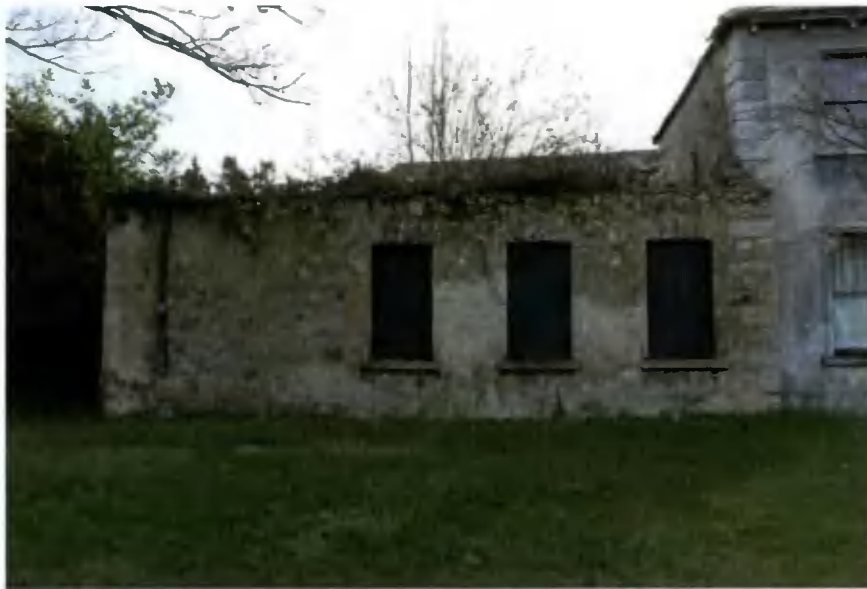
Plate 6: Front of ruined building

To the east of the house, and in line with the front façade of the house, there is a single storey building in ruins. This building has no roof visible at the front. It is a three-bay structure with a stone façade from which the render has mainly failed.

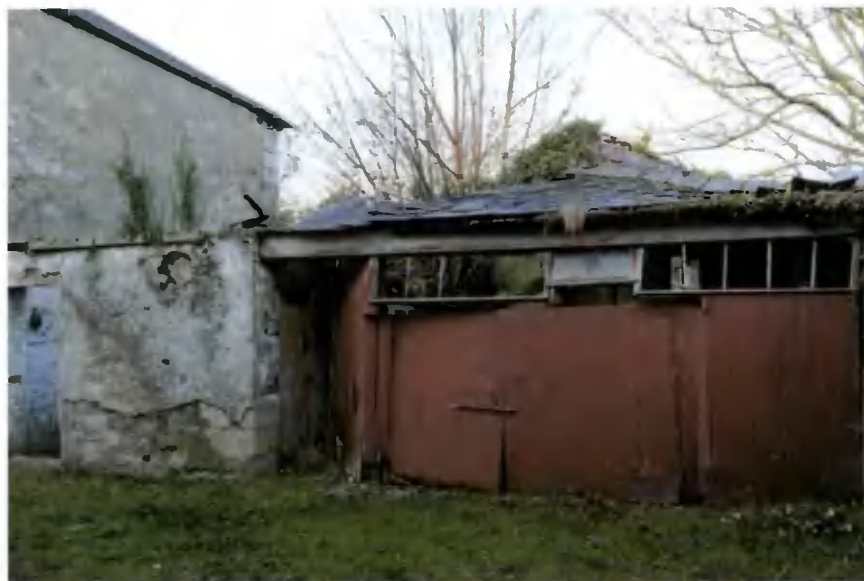
Plate 7: Rear of ruined building

The rear of the building shows that it was altered at some time through the provision of garage doors. The roof is present, but in a state of collapse.

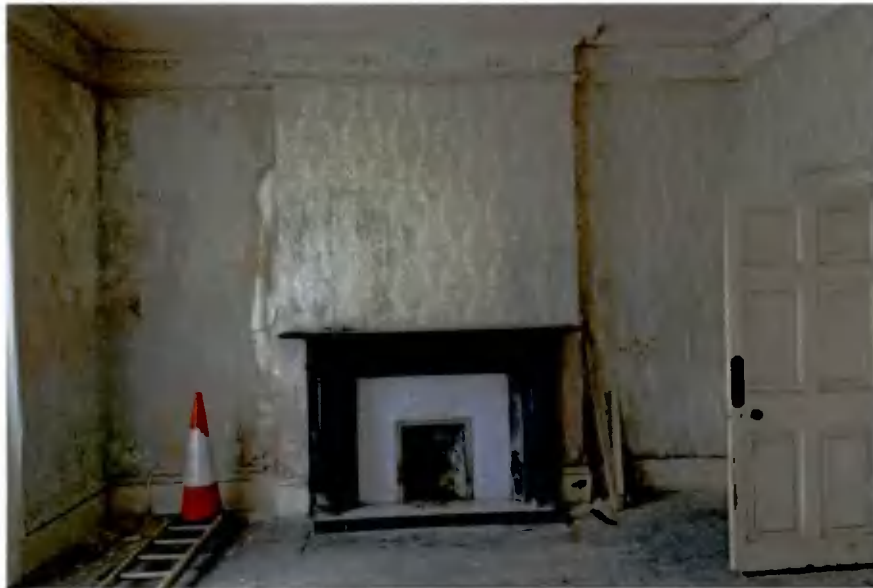
Plate 24: View to the east in room G-11

Room G-11 is a large reception room at the front of the house. A six-panelled door set in a moulded-timber architrave leads off the entrance hall. A second door, also six-panelled and set in a moulded-timber architrave, leads to the corridor at the rear. The room is lit by two windows, each of which is a one-over-one timber sliding sash with concave horns each window is set in a moulded-timber architrave and with panelled shutters. A decorative cornice and frieze run around the room. A black marble chimneypiece at the eastern end of the room has marble columns supporting friezes, which in turn support the mantle shelf. The insert is tiled in mid-twentieth century style. The floor is boarded and in poor condition, part of it having collapsed. The skirting is original and relatively simple.

The subdivision of room G-11 to provide for two bedrooms will be reversible. The works will avoid any damage to the existing cornicing and new cornicing will be provided alongside the new partition wall. It is proposed to keep the height of the en-suite and the storage spaces low so as to minimise the impact on the character of the room.
