North (front) façade of Newbrook House from Taylor's Lane

## INTRODUCTION

This report has been prepared to accompany the planning application for a new care home at Taylor's Lane, Rathfarnham, Dublin 16, Co. Dublin, D16 N9C2, as Newbrook House sits within the site and is a protected structure. The house is recorded as Registration No. 11216028. The rating is "Regional". It is dated in the registration as 1820-1870, although other texts found state an earlier date.

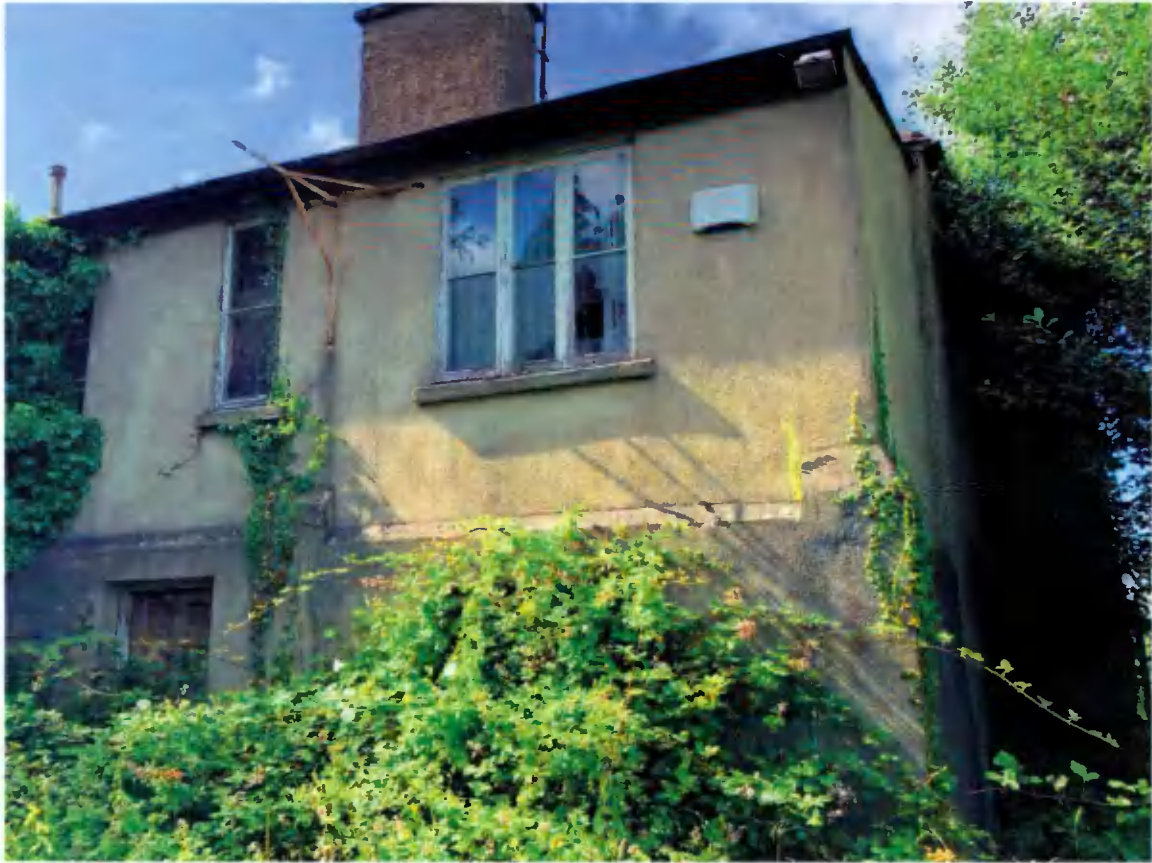
The rear elevation of the house - note projected ground floor wall face.

On the rear elevation there is evidence that a single storey structure existed. This could have been a single storey building or a courtyard wall. The more modern upper storey wall is set back from the ground floor wall and the set back composed of an angled section of render. This render will be vulnerable to water ingress and should be detailed to protect the ground floor structure. An intrusive survey should be instructed to establish the construction of both sections of the building. This survey should establish the original finish condition of the wall with a view to re-establishing this finish if possible.

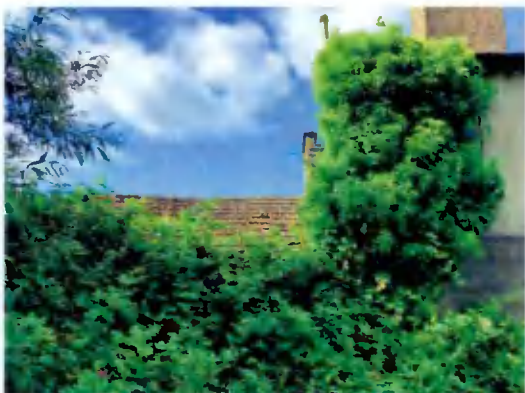
Bowed concrete tile roof.

Roof under concrete tiles appears to be bowed. Carry out structural assessment and repair as necessary.

Strip all roofing back to sarking.

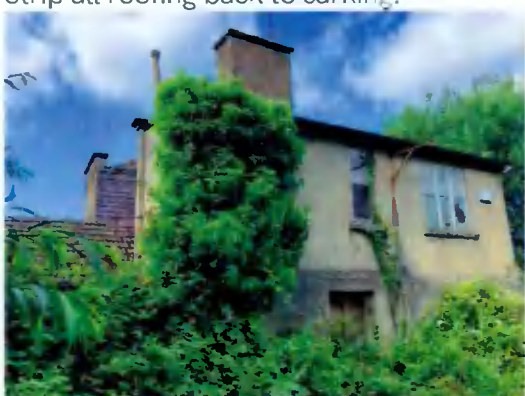
Note patterned slates to rear of main façade.

[Take care to rescue methodically, the shaped slate patterns to the rear of the main upper section.]

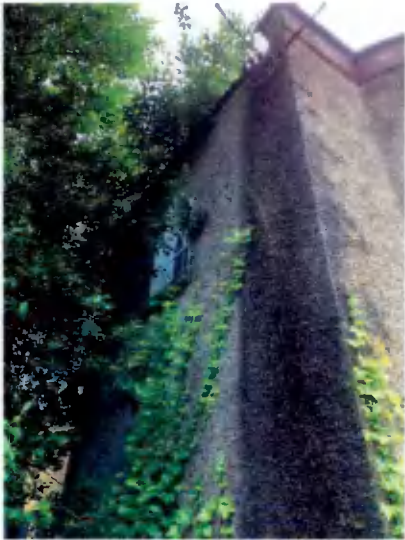
Rainwater staining at north east corner.

There is evidence of water shedding out from behind the front elevation parapet at the east end. This should be inspected and roof alterations considered, or installation of cast iron hopper and downpipe considered at this location.

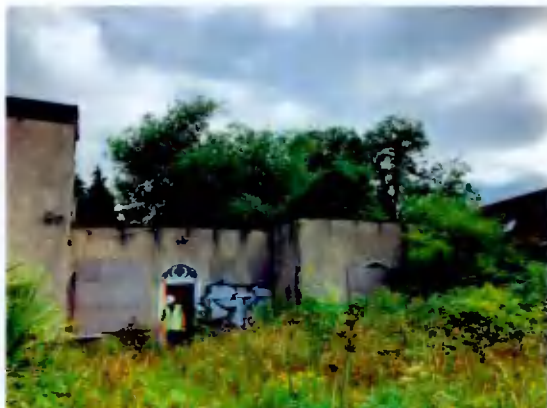
Part of front elevation showing stains at every parapet joint.

Closely inspect and repair/replace as required.  
Install lead flashing cap over parapet stones with drip clear of face.

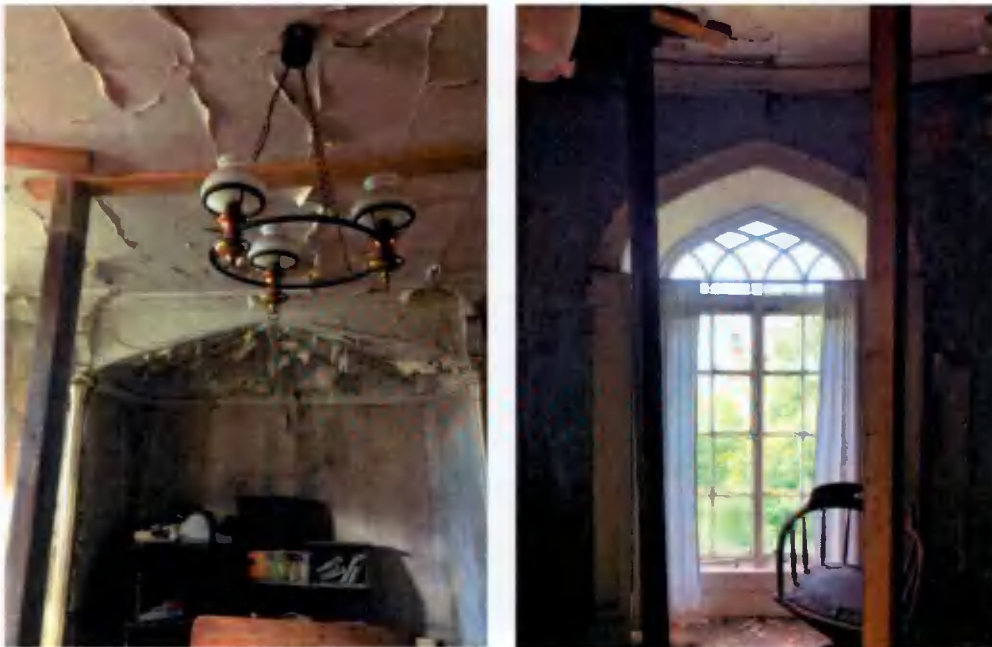
One of the primary room interiors.

There are a few rooms where high-quality finishes (shaped timber, decorative plasterwork) still exist. These rooms should be restored to a higher level with all finishes, made good and decorated.

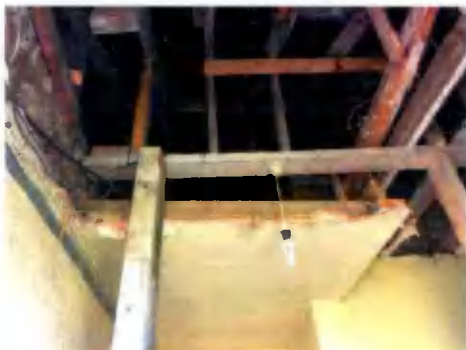
Interior missing/disturbed structural timbers.

Closely inspect for rot and replace defective timbers.  
Allow for repairs to stabilise structure.  
[There is one floor which has collapsed and should be replaced.]

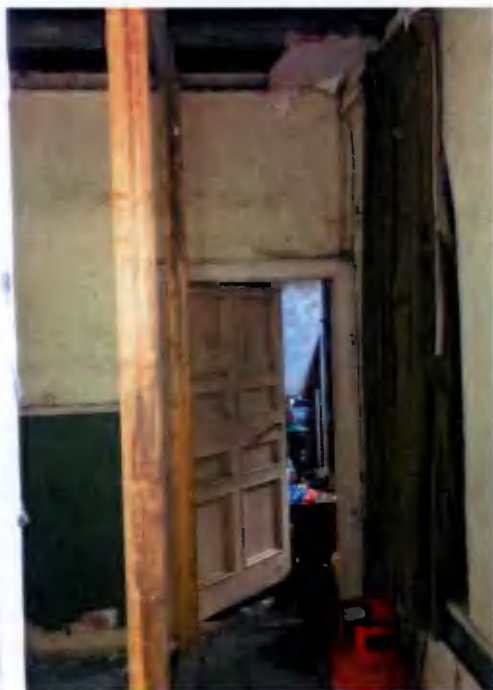
The existing door pattern.

Restore existing doors where suitable for new use.

Decorate.  
Install new doors where required to existing pattern.

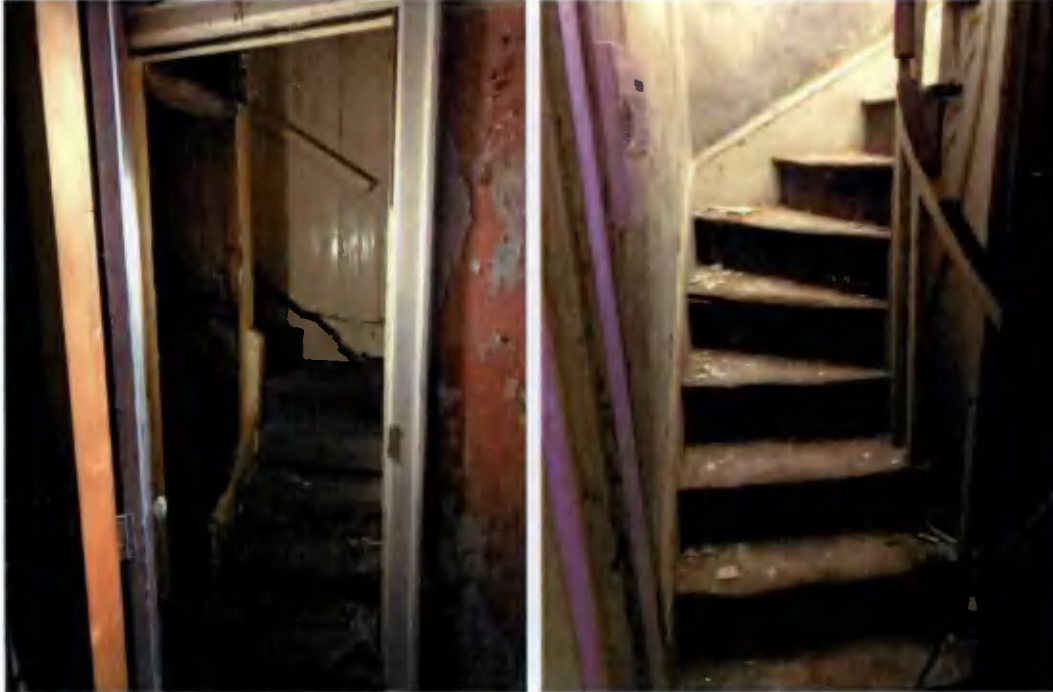
Existing stairs – note sagging tread.

Repair timber stair structure where required.  
Repair finishes timber.  
Decorate.

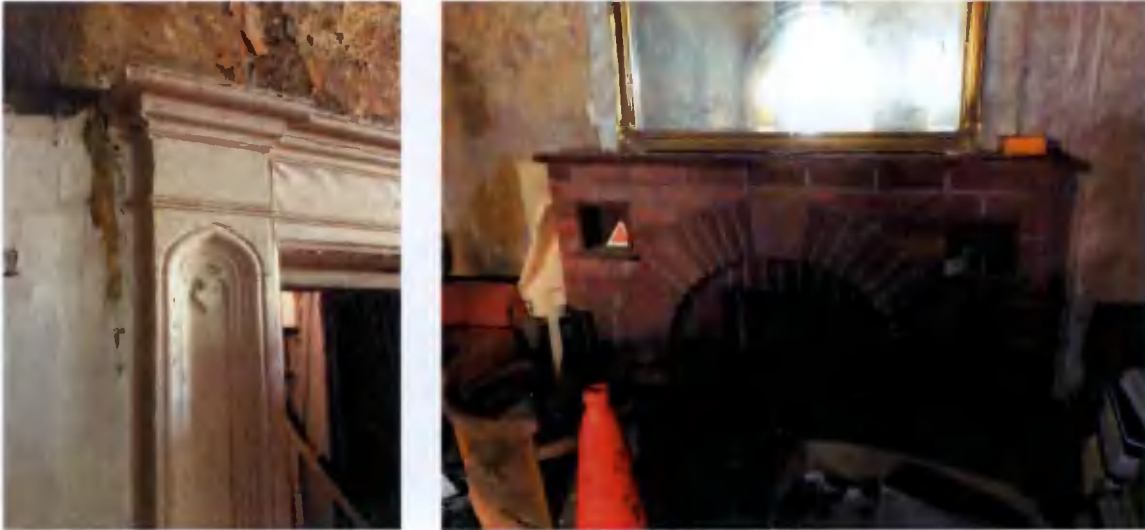
The two fireplaces.

There are several existing fireplaces in the house. One (left above) appears to be original. Others appear to be modern. Without a suitable replacement available and with recognition to the damage to adjacent fabric, it is proposed to retain the modern fireplaces in position.
