Arboricultural Report

**Tree Survey,
Arboricultural Impact Assessment &
Arboricultural Method Statement**

**Palmyra
Whitechurch Road
Rathfarnham
Dublin 16**

September 2020

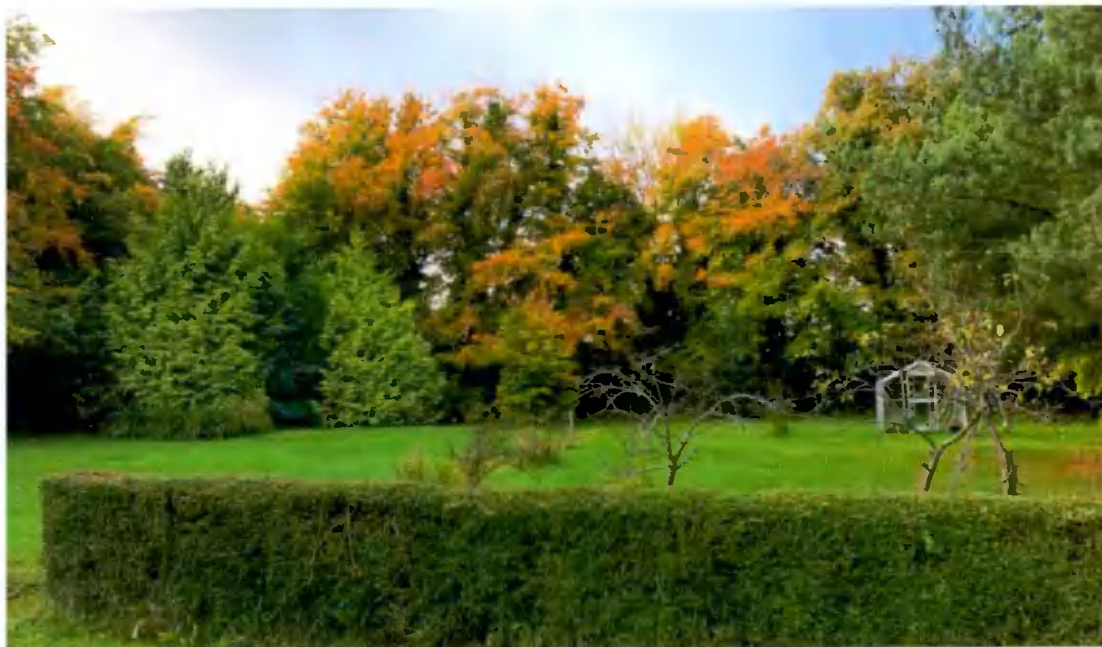
Photo 1: View of the western boundary trees (T653 to T665) from within the main garden of the site.

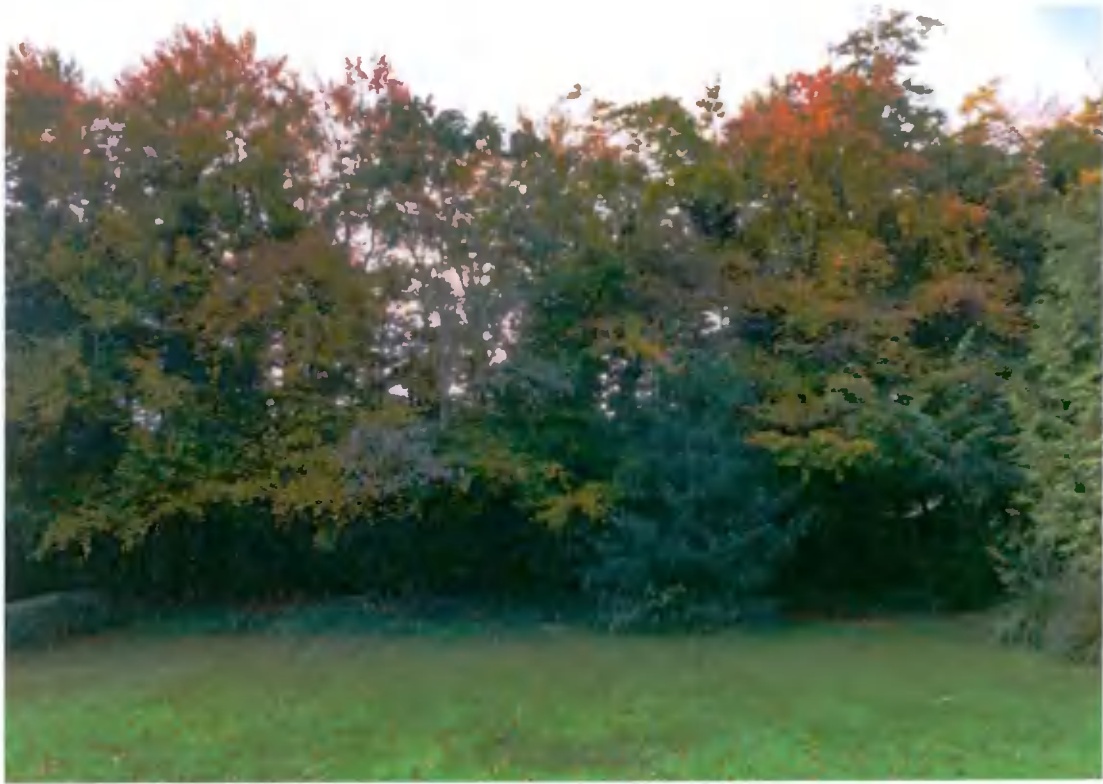
Photo 2: View of the southern boundary beech trees (G626) from within the main garden of the site.

Group G626	28 Fagus sylvatica (Common Beech)	17.0 50 AVE	1	1										Early Mature	Structural condition Fair. Physiological condition Fair. Competition - Adjacent trees. Deadwood - Minor. Fork - Weak with included bark. Hedgerow - Neglected / overgrown. Physiological / cambial damage - Fungal. Physiological / cambial damage - Insect. Pruning wounds - Historic. Height and stem diameter are average for group. Group of trees originally formed a beech hedgerow but have been neglected and are now overgrown. They have congested crown breaks at the point of the previous pruning heights 1-1.5m. Group is a borderline C2 / B3 Category. The majority of trees are infected with Cryptococcus fagisuga and contain cankers typical of beech bark disease.	01/11/2019	113.1	6.0	20-40	B3
Tree T627	1 Malus sp. (Apple sp.)	3.0 10	1	1	1.0	1.5	1.0	1.0	1.0	1.0	1.0	1.0	Semi Mature	Structural condition Fair. Physiological condition Fair. Pruning wounds - Historic.	01/11/2019	4.5	1.2	10-20	C1

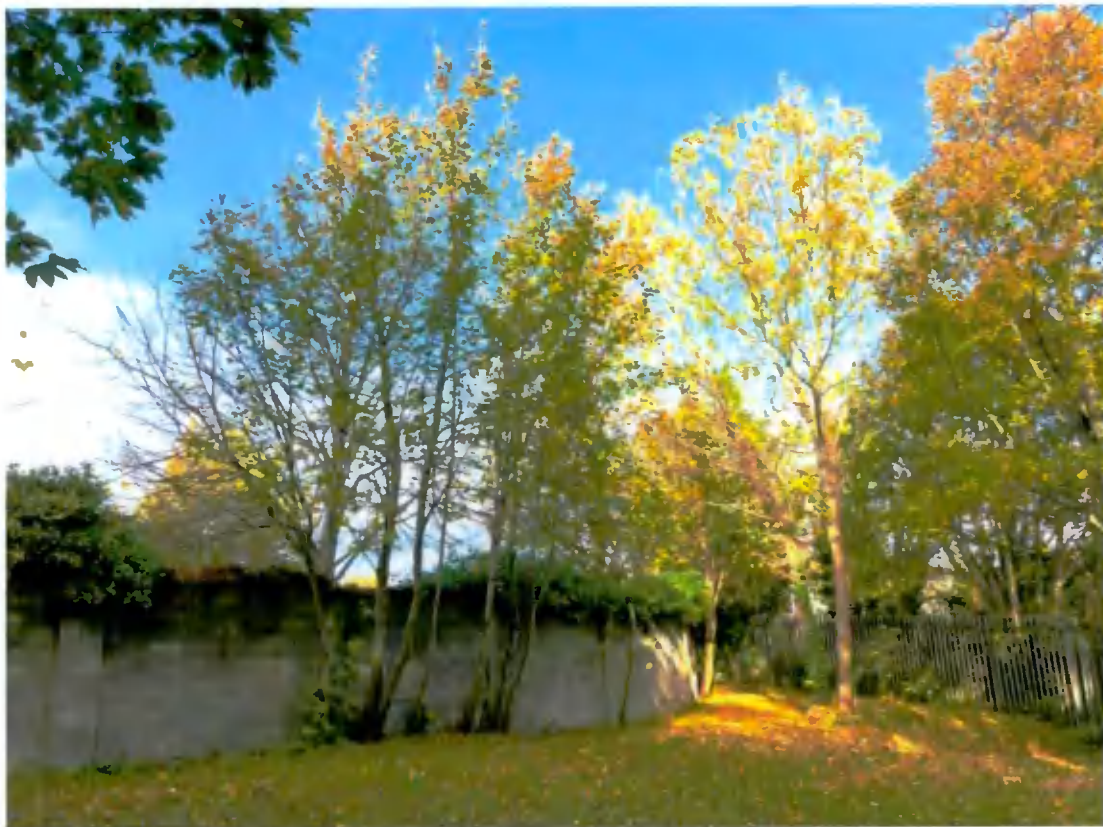
- 3.7 The northern area of the site contains a mixture of ash and sycamore trees. A number of these trees have self-seeded and are located immediately adjacent to the boundary wall.

Photo 3: View of the sycamore and ash trees (T711 to G714) located within the northern corner of the site.

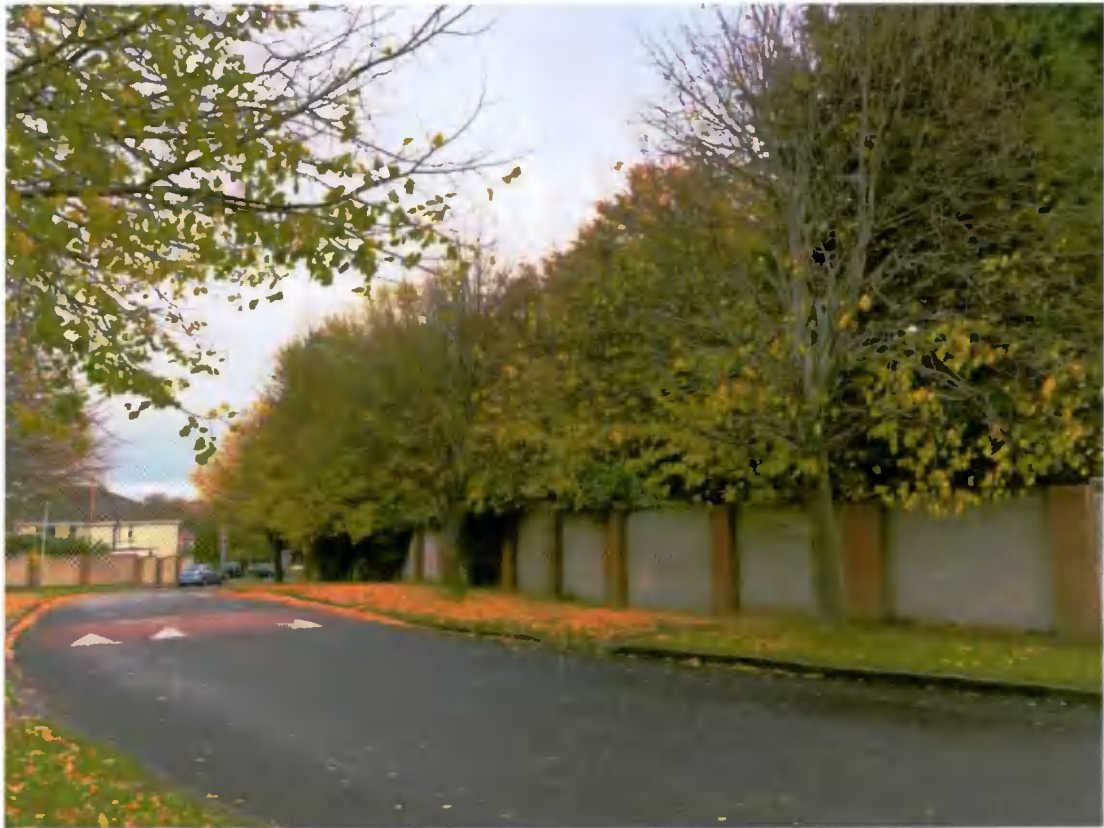
Photo 4: View of lime trees (T749 to T758) located within the grass verge along Grangebrook Avenue.

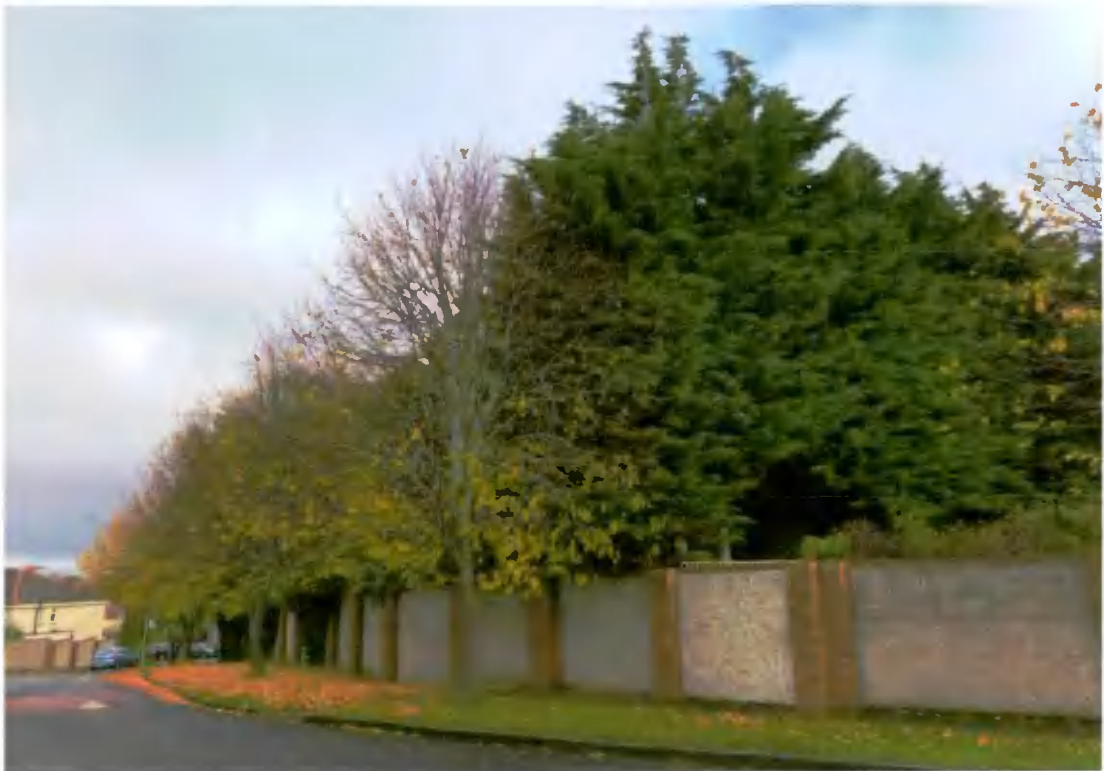
Photo 5: View of the lime trees and Leyland cypress trees (G625) which are located along the southern boundary of the site.
