Oak Lodge, New Road, Clondalkin

Architectural Heritage Impact Assessment

October 2021

ARC Consultants have prepared this Architectural Heritage Impact Assessment on behalf of the applicant in relation to the proposed renovation, refurbishment and extension of Oak Lodge, New Road, Clondalkin, a Protected Structure, RPS No 156

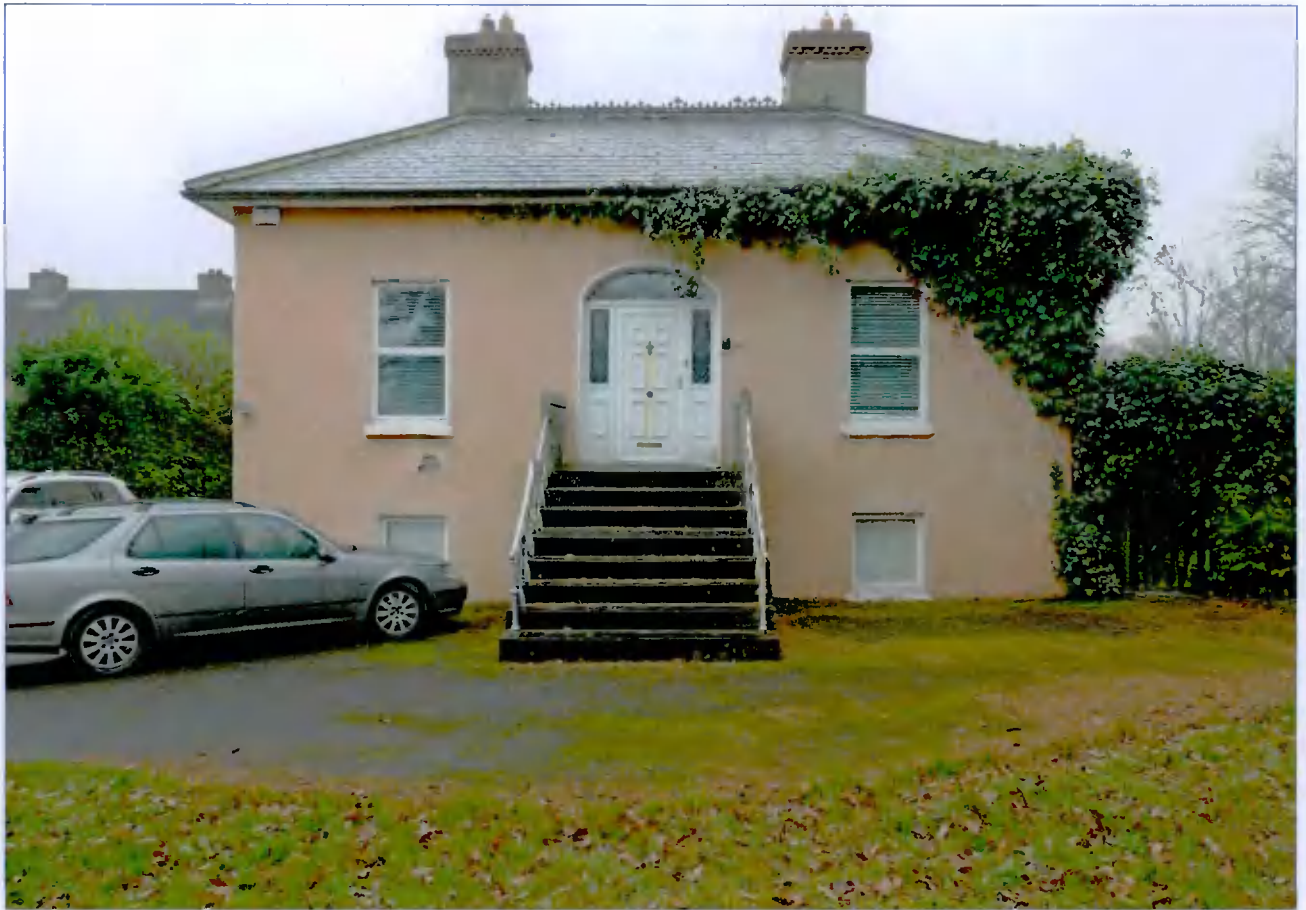
Front (west) facade. It is proposed to replace the existing uPVC windows with timber 1-over-1 up-and-down sash windows detailed appropriately and to replace the modern door and doorcase with a timber door and doorcase of a design and detail appropriate to the period of the house

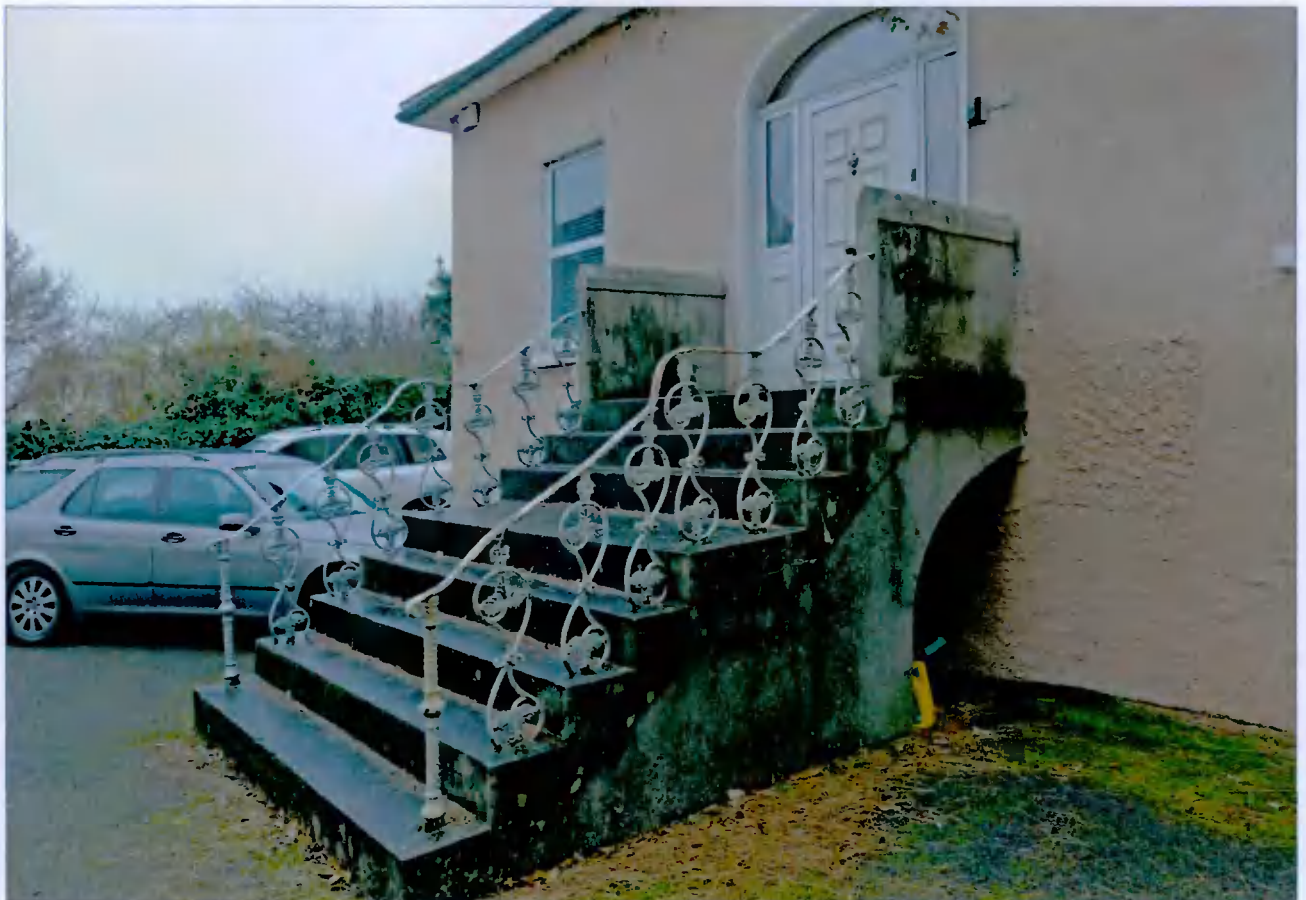
Front Steps. It is proposed to overhaul and repair the front steps where required.

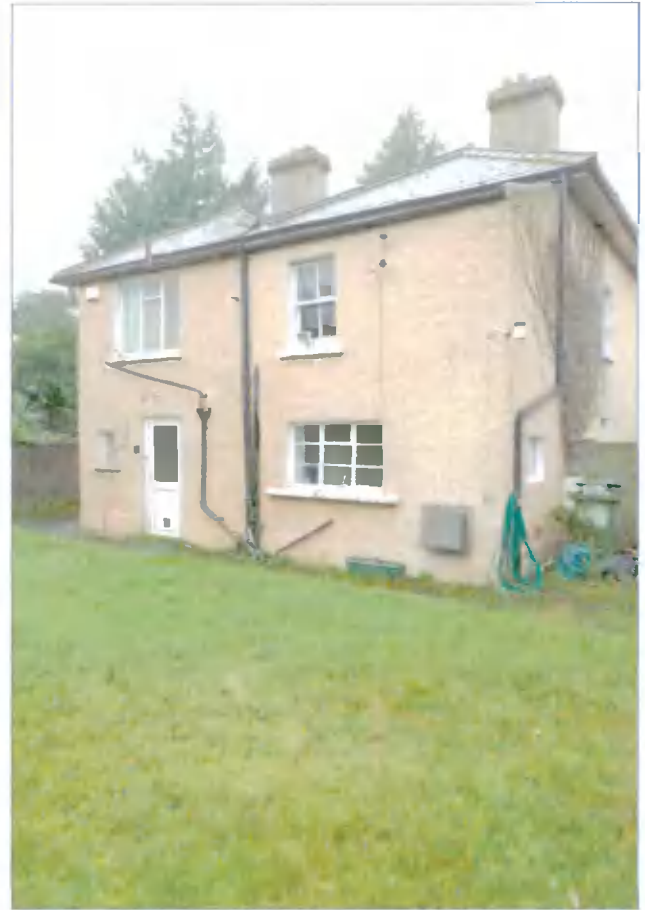
Rear (east side) of house. It is proposed to demolish the modern left half of the return and to refurbish and extend the older section.

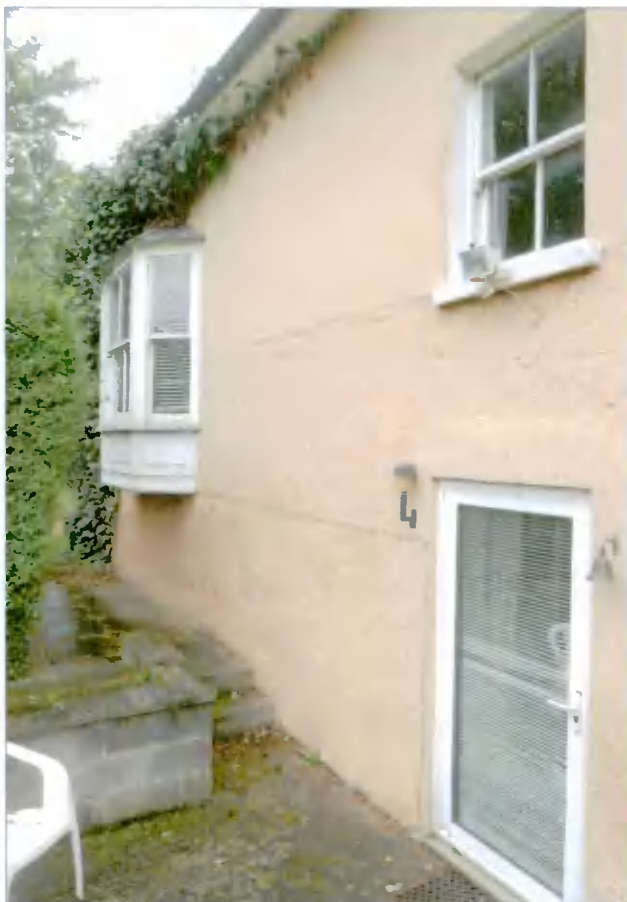
South side of house. A new bay window is proposed at ground level, replacing the door seen on the right.

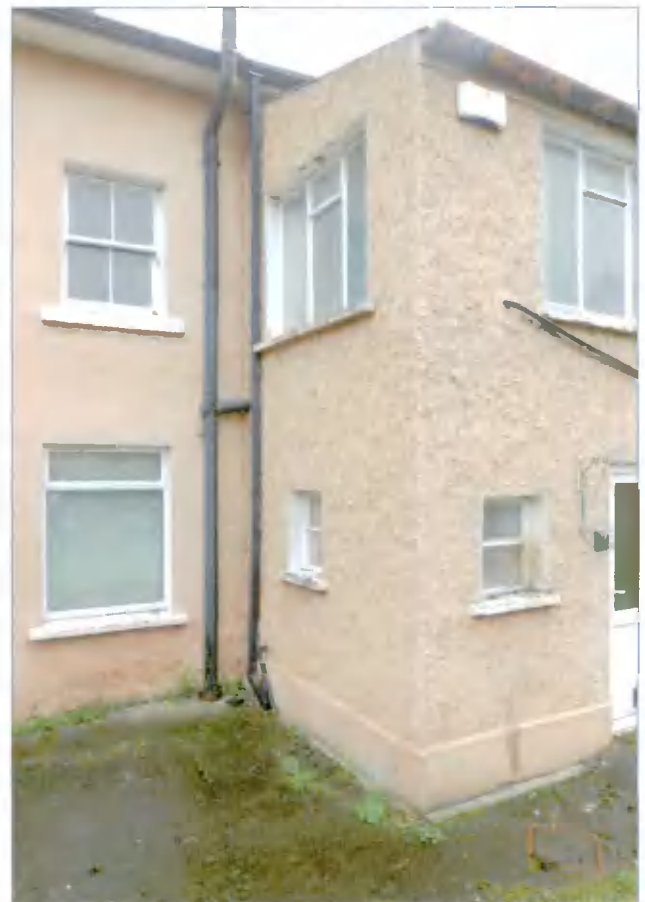
South east corner. A new return is proposed extending across the rear of the house incorporating part of the old.

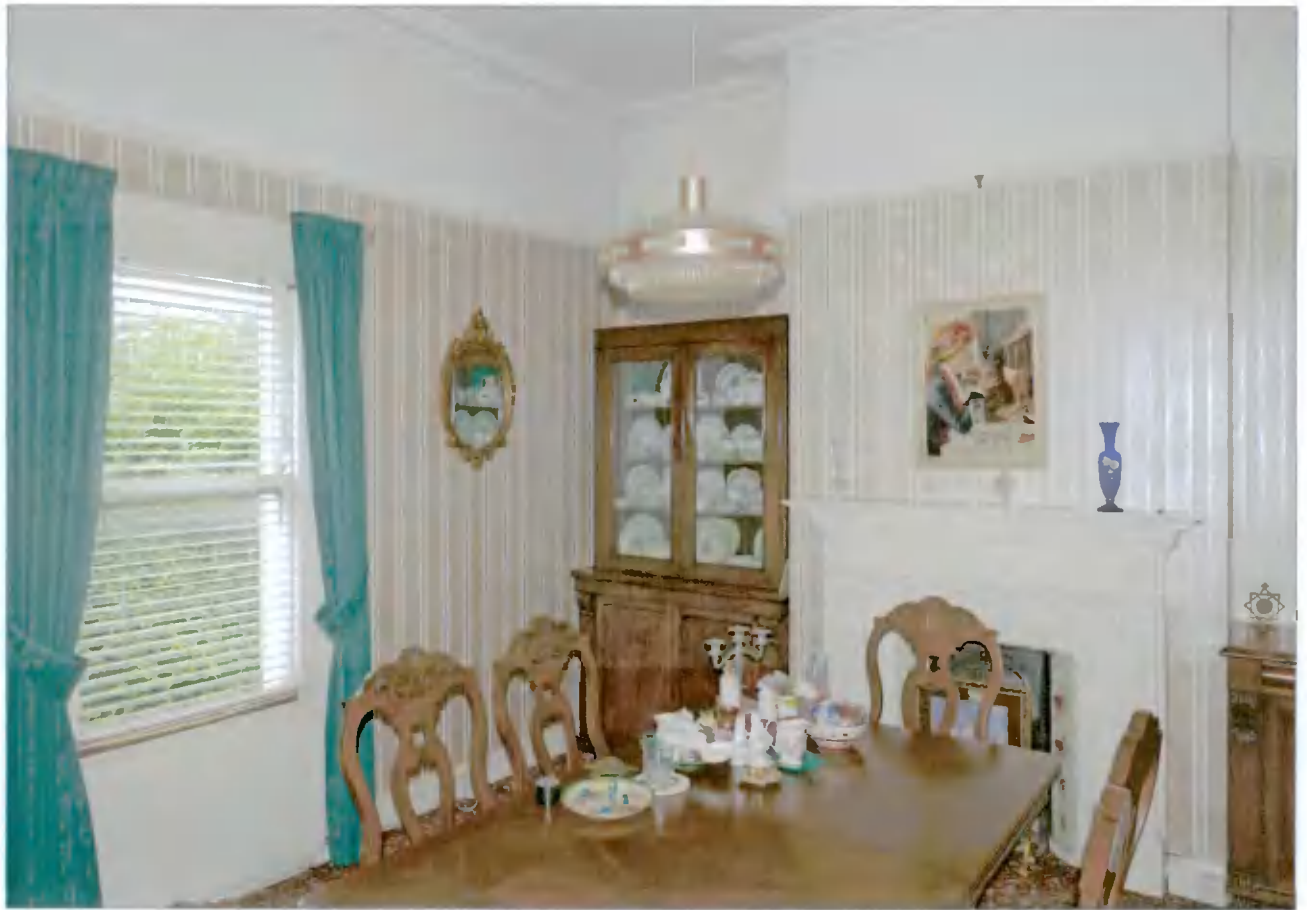
North west upper room looking north east. The 1-over-1 sash window, the cornice and the cast iron fireplace are all consistent with a date in the second half of the 19th century.

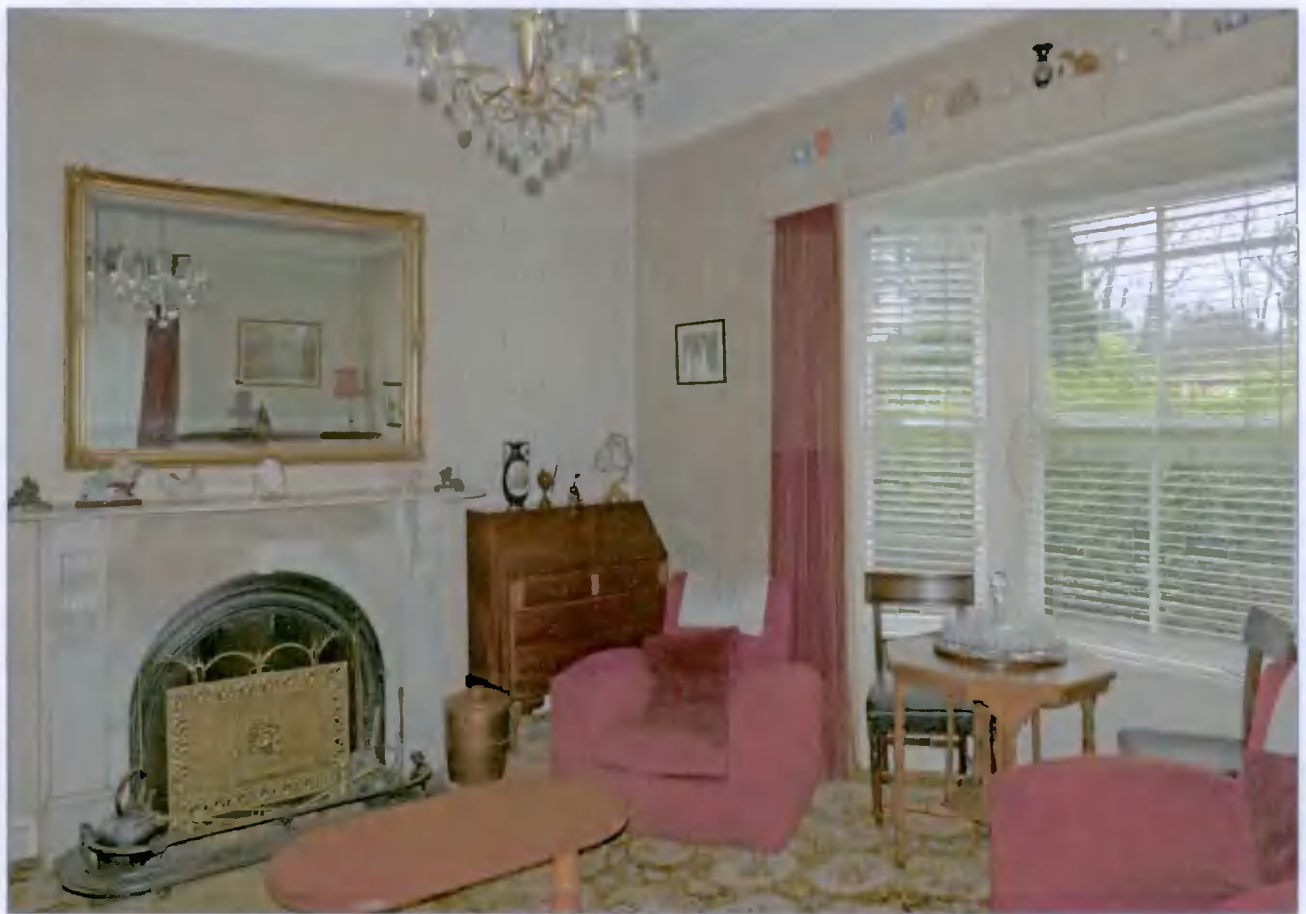
South west upper room looking south east. The marble fireplace, the cast iron insert and the iron fender all appear to be late 19th century. The bay window to the right and the cornice also appear to form the second half of the 19th century

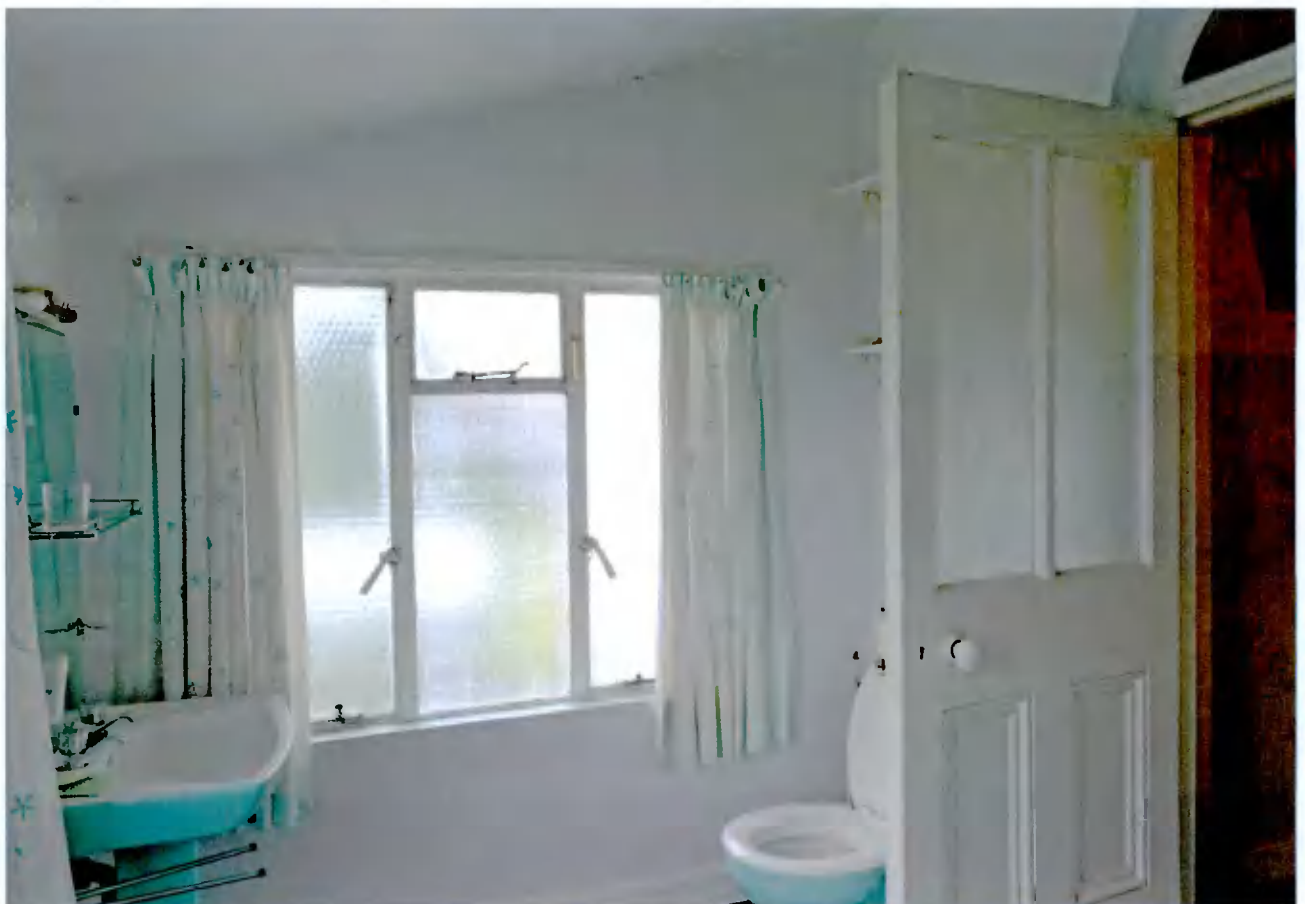
Bathroom at rear of upper hall level in the existing modern return. It is proposed to extend the upper hall into this area as part of a new return to be constructed across the back of the house and partly incorporating the older northern section of the return.

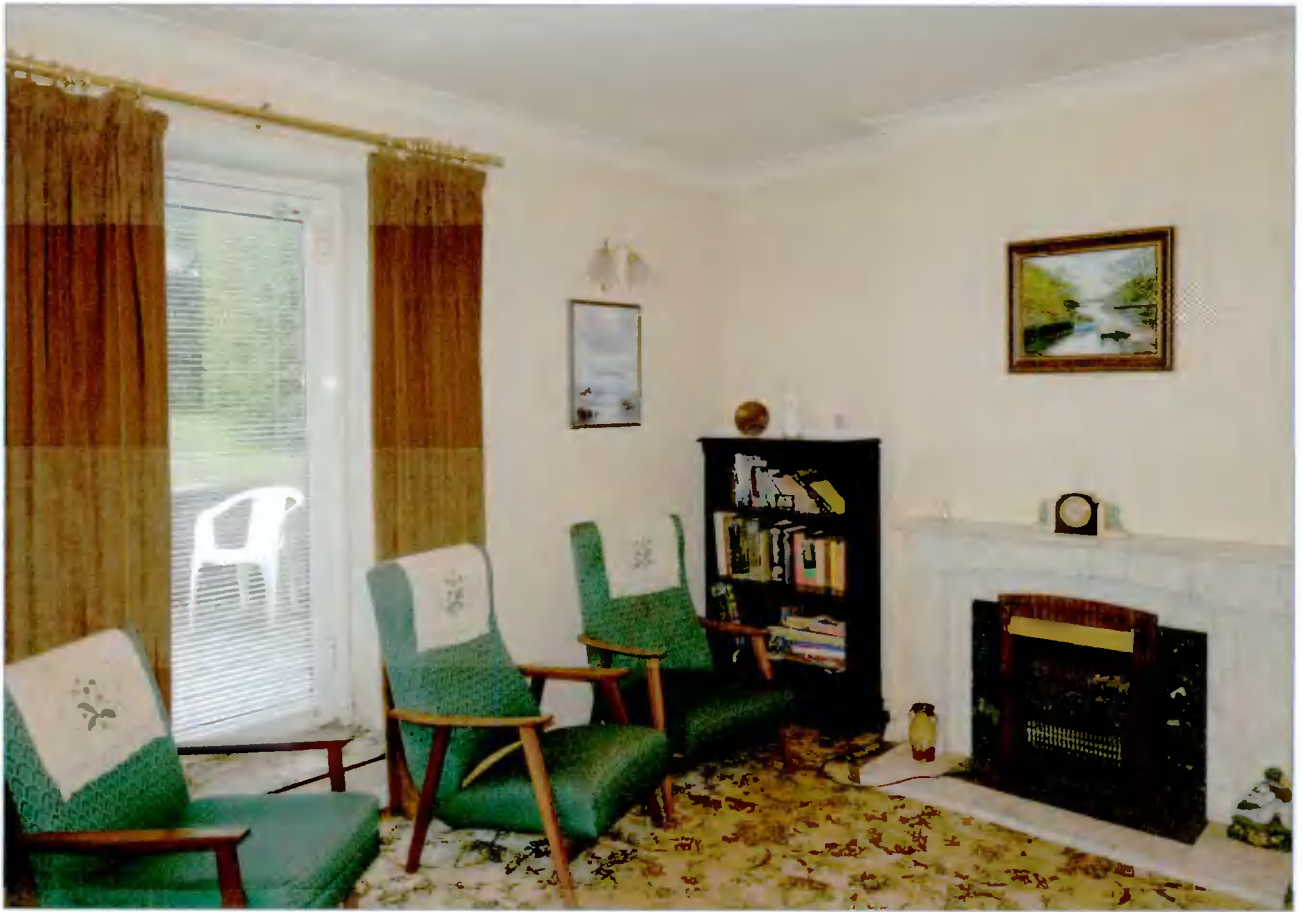
South east room at the lower level looking south west. It is proposed to convert this room into a bedroom, removing the fireplace, and to provide a new bay window on the south side of the room providing access to the southern garden.

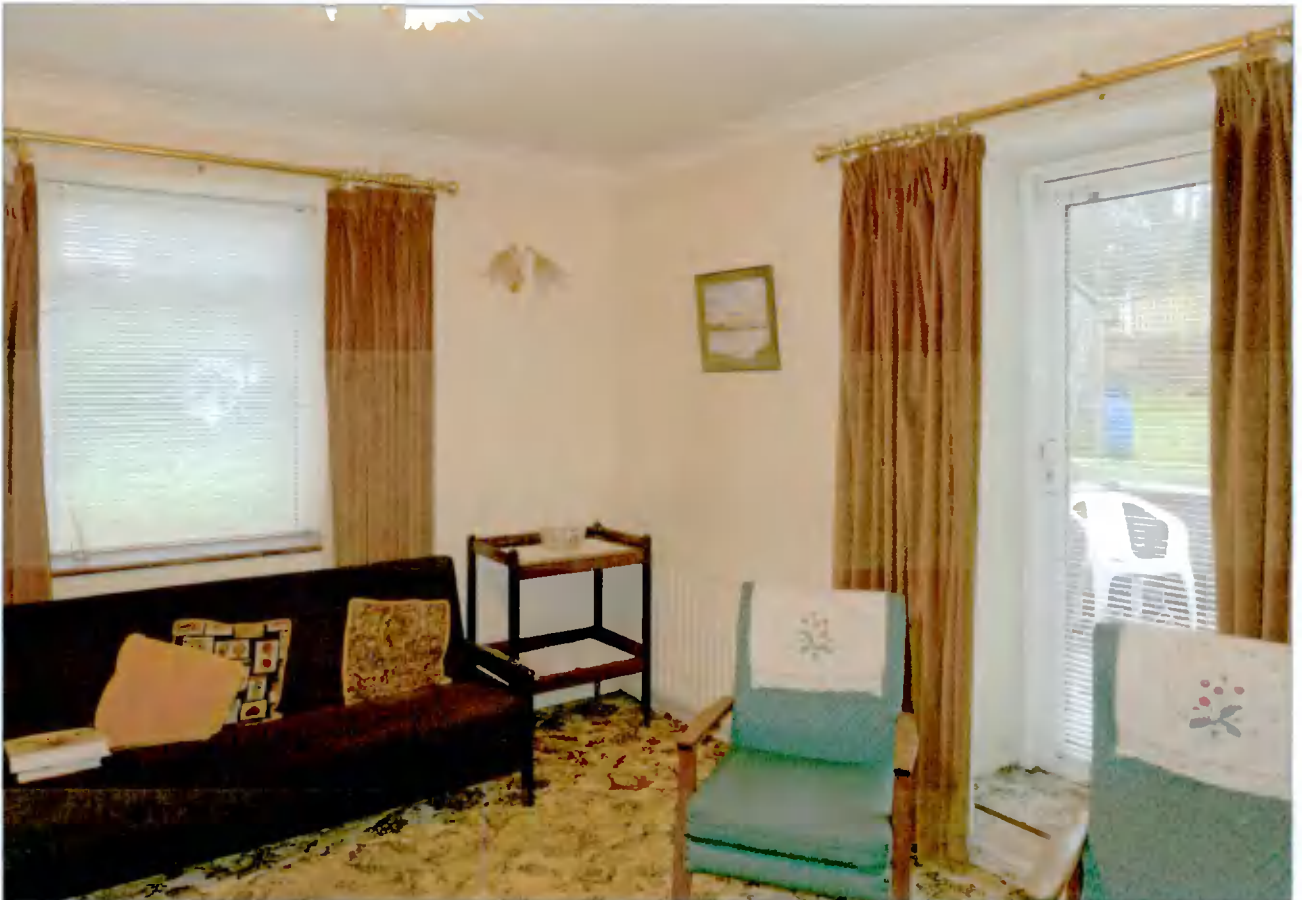
South east room at the lower level looking south east. It is proposed to provide a new en-suite bathroom at the rear, in the ground floor of a new return to be built across the rear of the house

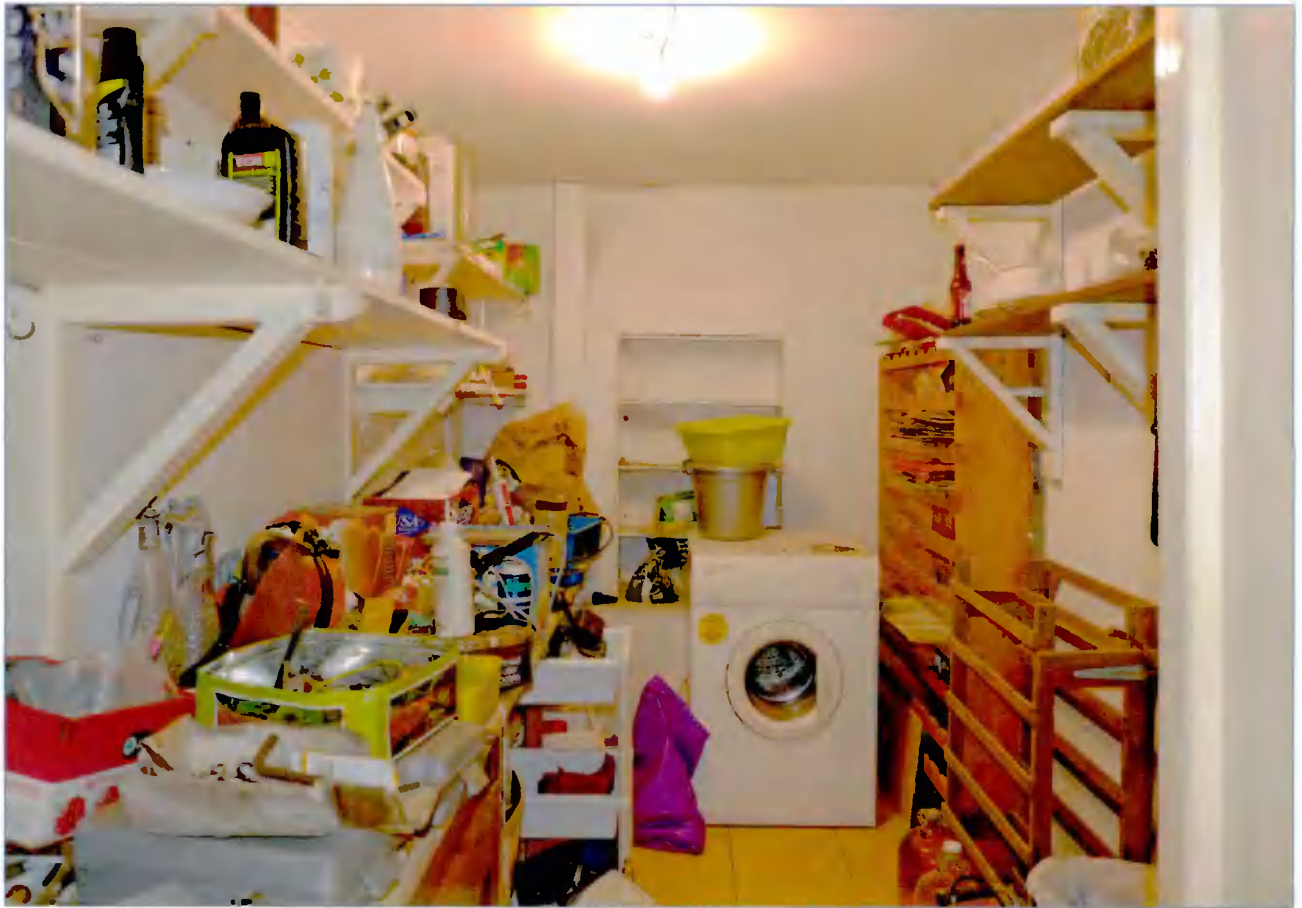
Central room at the west end of the lower level - ie: below the entrance hall. It proposed to convert this room into a bathroom.

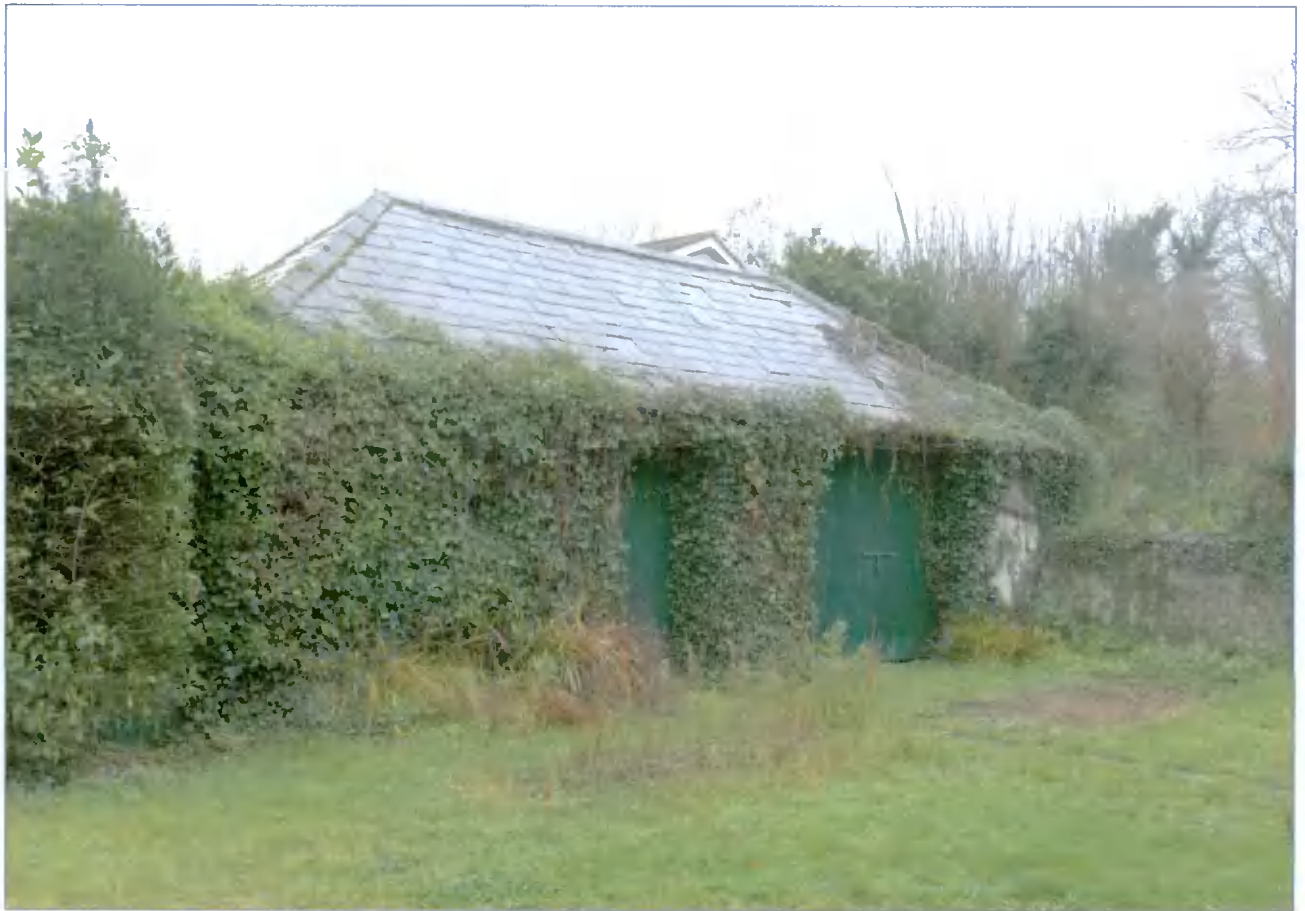
South west outbuilding. It is proposed to overhaul and repair this outbuilding.

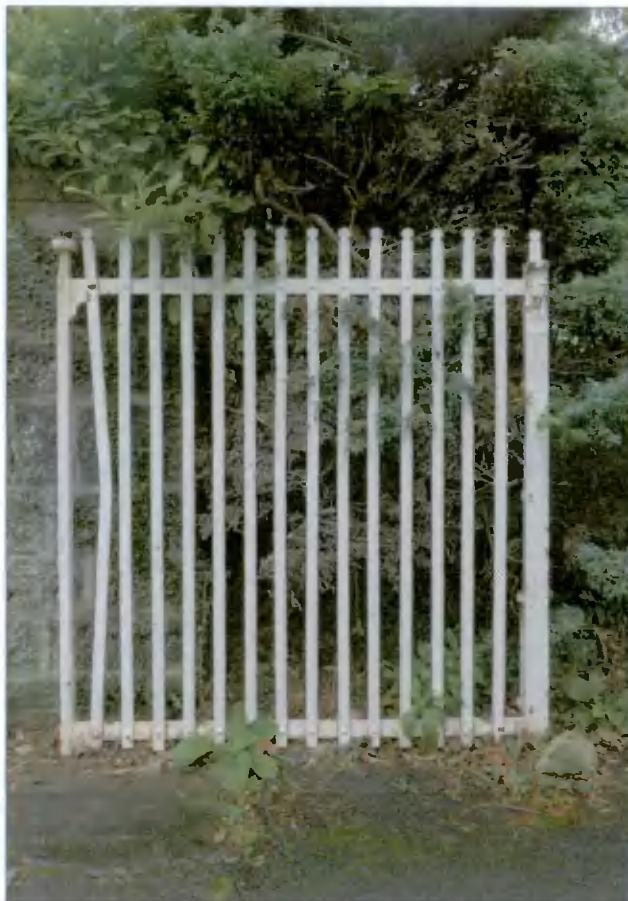
North half of front gate. One of a pair of fine wrought iron gates

There is a large outbuilding at the south east corner of the site. It is proposed to retain, overhaul and repair this outbuilding. The entrance from New Road has two fine stone gate piers and a pair of fine wrought iron gates. It is proposed to retain the gates and gate piers, carrying out minor repairs to the gates.
