# Arboricultural Assessment

Nangor House,  
New Nangor Road,  
Gallanstown,  
Dublin, D12 F726

TDIA002	Diageo	30/09/21	-
---------	--------	----------	---

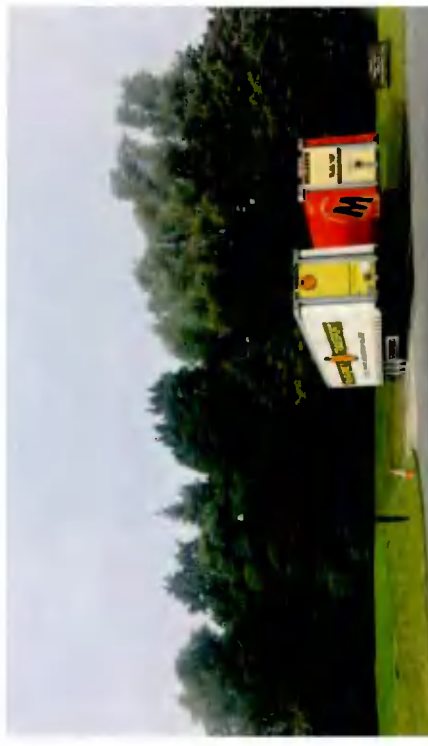
Image 1. Subject trees adjacent to parking bay
