**Proposed works to:  
'WHITEHALL' - KATHARINE TYNAN HOUSE  
Kingswood, Dublin 24**

## **ARCHITECTURAL HERITAGE IMPACT ASSESSMENT REPORT**

**December 2021  
Revision A**

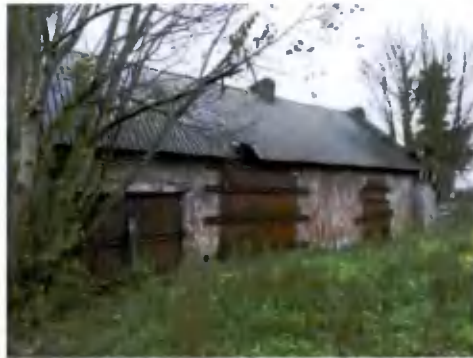
The east-facing pitch of the slate roof has been damaged by a fire with an area having no slates and allowing water ingress. Otherwise slates have slipped and broken in areas throughout the slate roof.

Figure 11: View from east with damage to roof

Conservation repair works were carried out to the two-storey section of the building supported by the 2021 Built Heritage Investment Scheme, in order to make it water tight. Existing slate were retained and completed with natural slate to match. The supporting timbers to the single-storey part of the building are currently protected by a metal sheeting.

Conservation repair works to the damaged roof of the two-storey section of the house

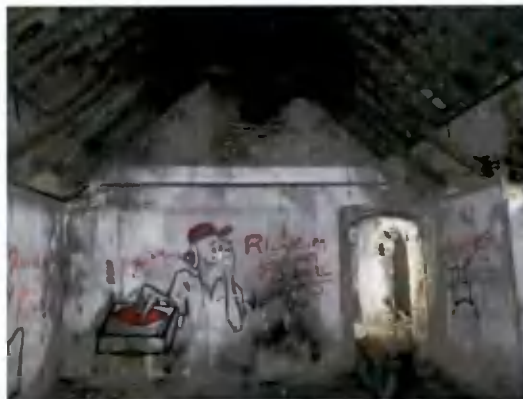
The roof structure is of sawn timbers. Some have been exposed and are decaying. The roof structure remains straight with no evidence of major sagging.

Figure 16: Roof structure (room G04)

Any damaged timbers are to be repaired and if necessary replaced on a like-for-like basis. There are remaining timber eaves boards on the south or garden elevation.

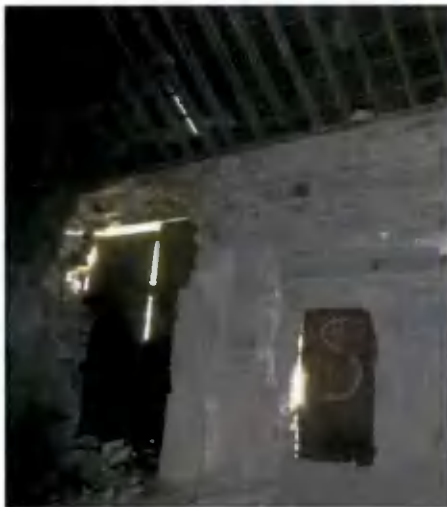
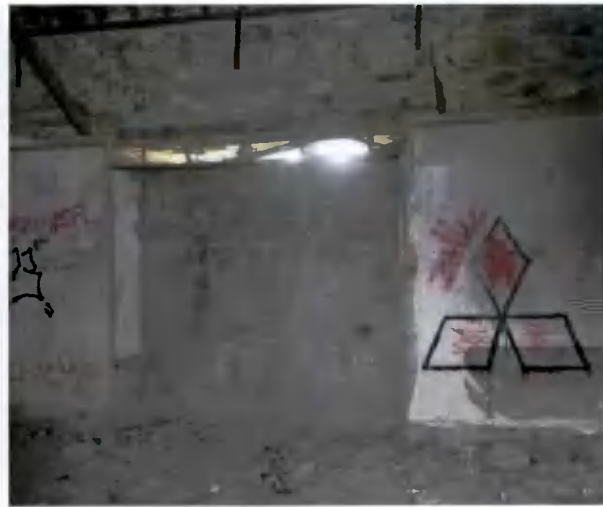
Window and door openings have timber lintels, some with brick relieving arches. The window openings have mix of flush and projecting stone sills. Historic images show a mix of large glazed projecting bay windows to the single-storey part of the structure. These have been removed and some of the openings no longer retain their lintel supports. In some of these, the walls above the openings have collapsed or are sagging.

Figure 25: Missing lintel and weakened timber lintels above openings on north elevation

The walls of the structure shows no major cracking or subsidence. However, timber lintels have been removed to some of the larger exterior ground floor window openings. These will have to be replaced.

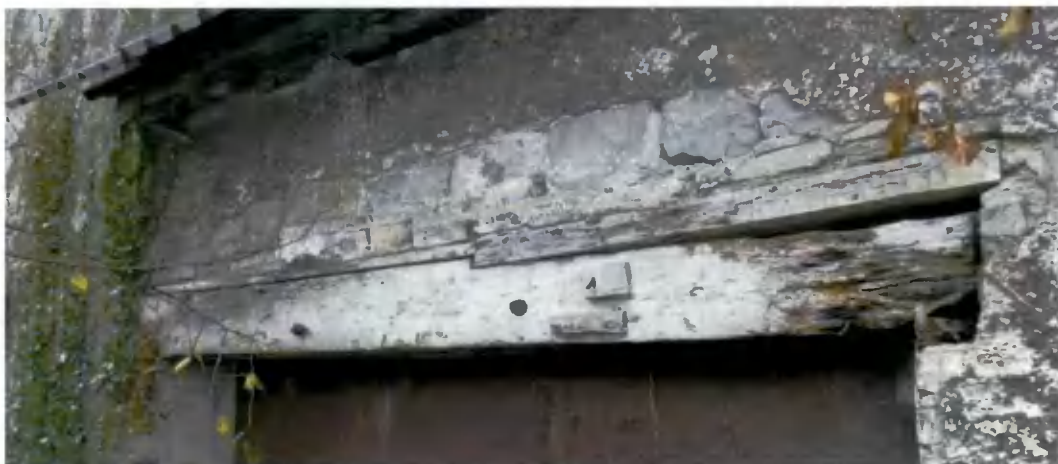
Figure 26: Decay of lintel over large window opening on south elevation

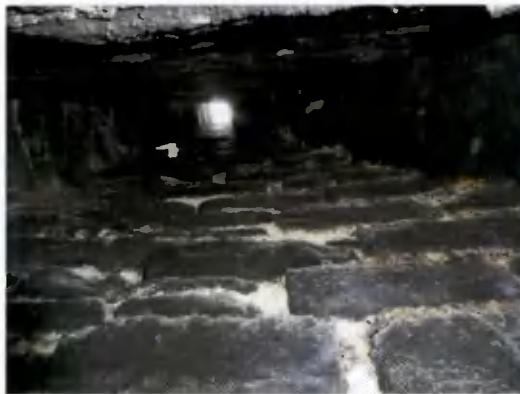
The only flues accessible to inspection were at ground floor in the single-storey part of the house. They are both brick lined with large flues. They appear to be unblocked with no areas of collapse.

Figure 27: Flue in chimney in room G04

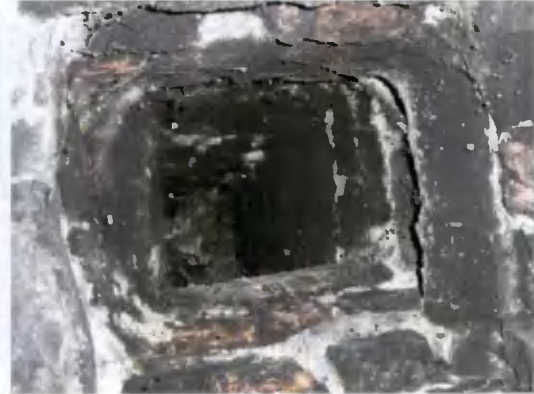
Figure 28: Flue in chimney in room G05

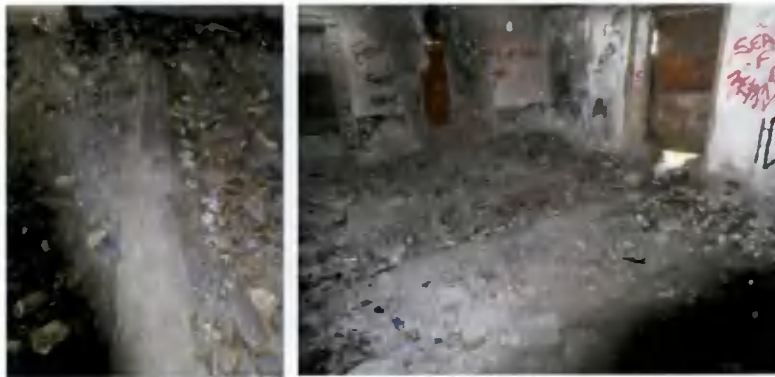
The ground floors were originally raised timber on sleeper walls, no original floorboards or joists remain. Evidence of the sleeper walls is particularly clear in room G05.

The subfloors change in level in the centre of G04. There is also a difference in level between rooms G04 and G05. This will need further investigation to ascertain the original layout.

Figure 29: Remains of sleeper walls in Room G05

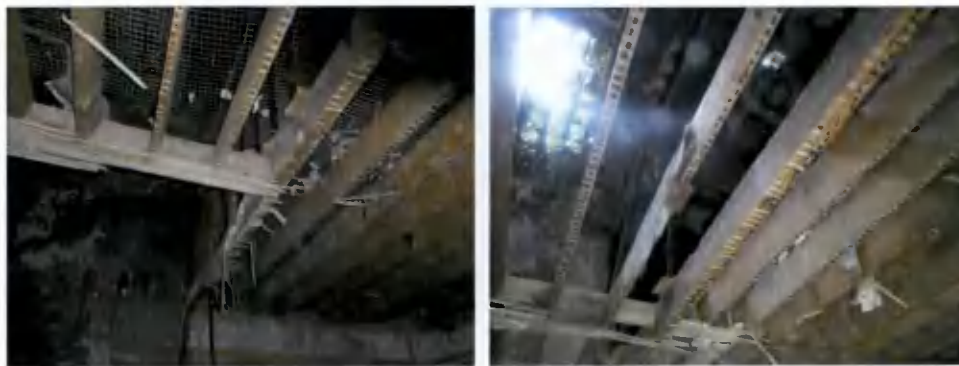
Figure 30: Stairs opening in first floor joists above Room G04 and above Room G01

The first floor structure of cut timber joists, they are largely intact with little evidence of decay. There are no remaining floorboards, these appear to have been systematically removed. In the hall, trimming joists mark an opening for the original dog-leg stairs. The joists show remains of laths to the underside to which the ceiling plaster was once fixed.

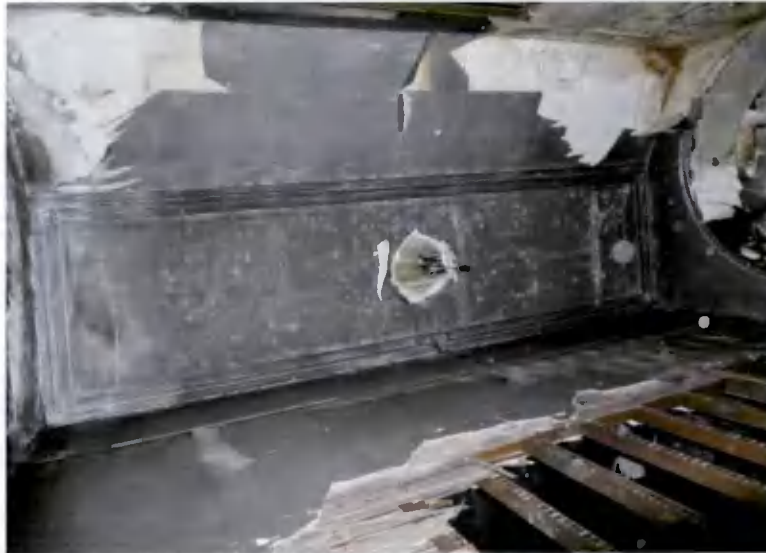
Most ceilings have been entirely removed. There are remains of the lath and plaster ceiling to the first floor rooms. Decorative features remain to the ceiling of the first floor hall corridor. Nail marking remain to the underside of joists indicating the use of lath and plaster to the ceilings of the ground floor (Figure 38).

Figure 38: Ceiling above stair hall at first floor (room 102)

- The first floor decorative ceiling above the stairs is to be retained
- All wall plasters to be repaired/reinstated with traditional lime plaster, non-hydraulic or naturally hydraulic NHL2 lime-sand plaster, to conservation architect's specification.
- Ceilings: Where historic lath and plaster is found to survive, repair like-for-like with traditional lime plaster and riven lath to conservation architect's specification.

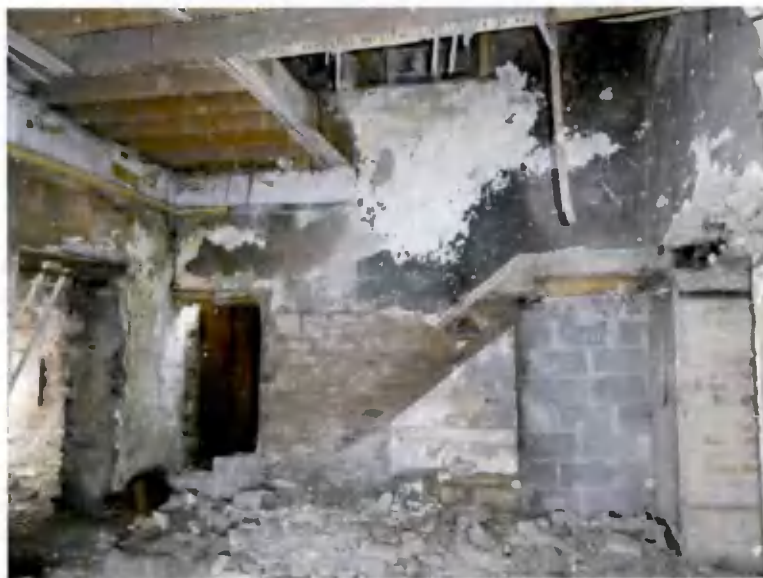
The historic stairs have been removed. The wall in the entrance hall indicates the position of the lower leg of the stairs.

Figure 39: Wall marking of dog-leg stairs in hall (room G03)

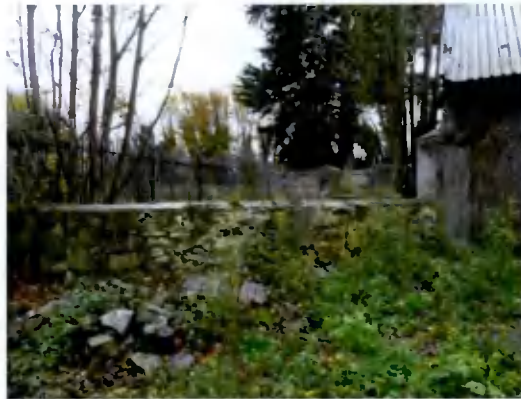
A number of low garden walls remain to the east and south of the house. These connect with tall walls directly to the east which may have been part of a walled garden. They are of rubble stone with some brick dressing. Cappings are of profiled render and slate. Some of the walls have a roughcast render coat. These are damaged and have collapsed in a few areas but are largely intact and stable.

Figure 40: Garden wall at east gable

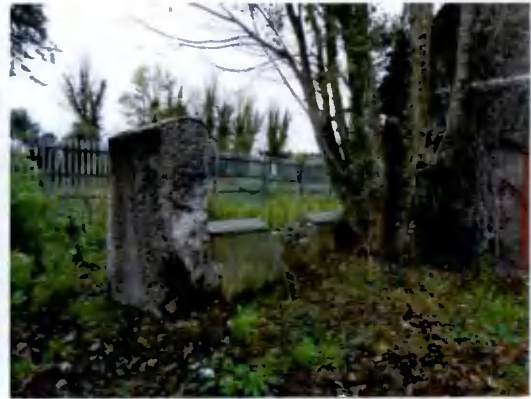
Figure 41: Garden wall at east gable

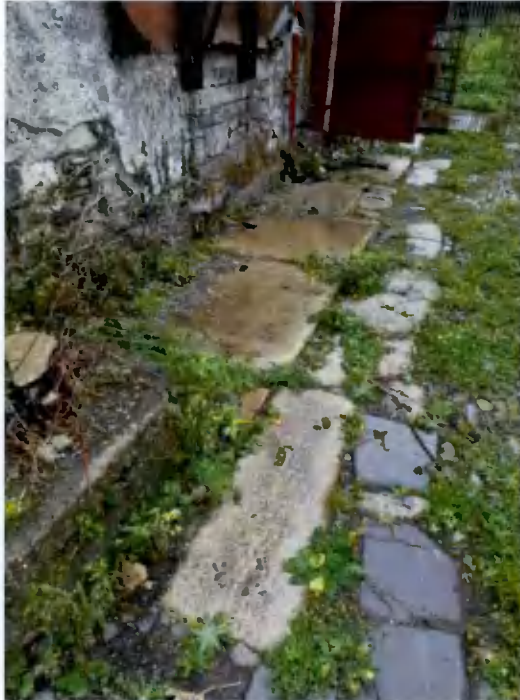
Fine granite and sandstone paving is to be found at the west side of the house. This extends from the house a good distance to the north. Further investigation is required to map the extent of paving in the historic gardens.

*Figure 44: Stone paving at west side of house*

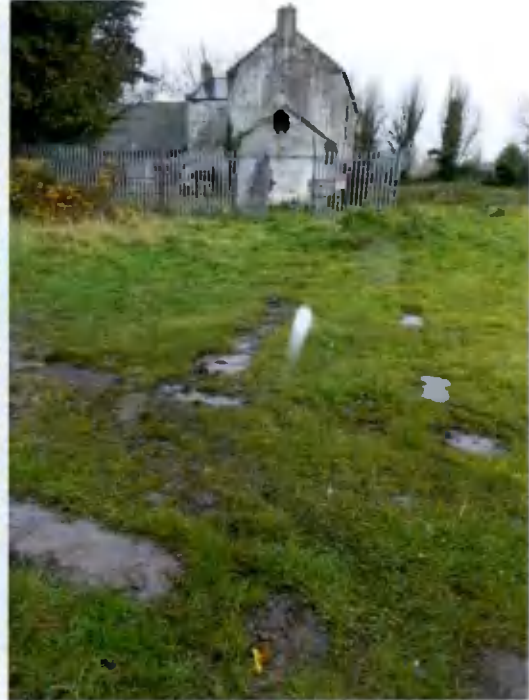
*Figure 45: Paving extending north of house*
