TECHNICAL NOTE

Project EdgeConnex Ireland Limited
Subject Additional Information Response
Item no. 7 & 11

Date 26 November 2021

Ref. LB/20/11901TN02

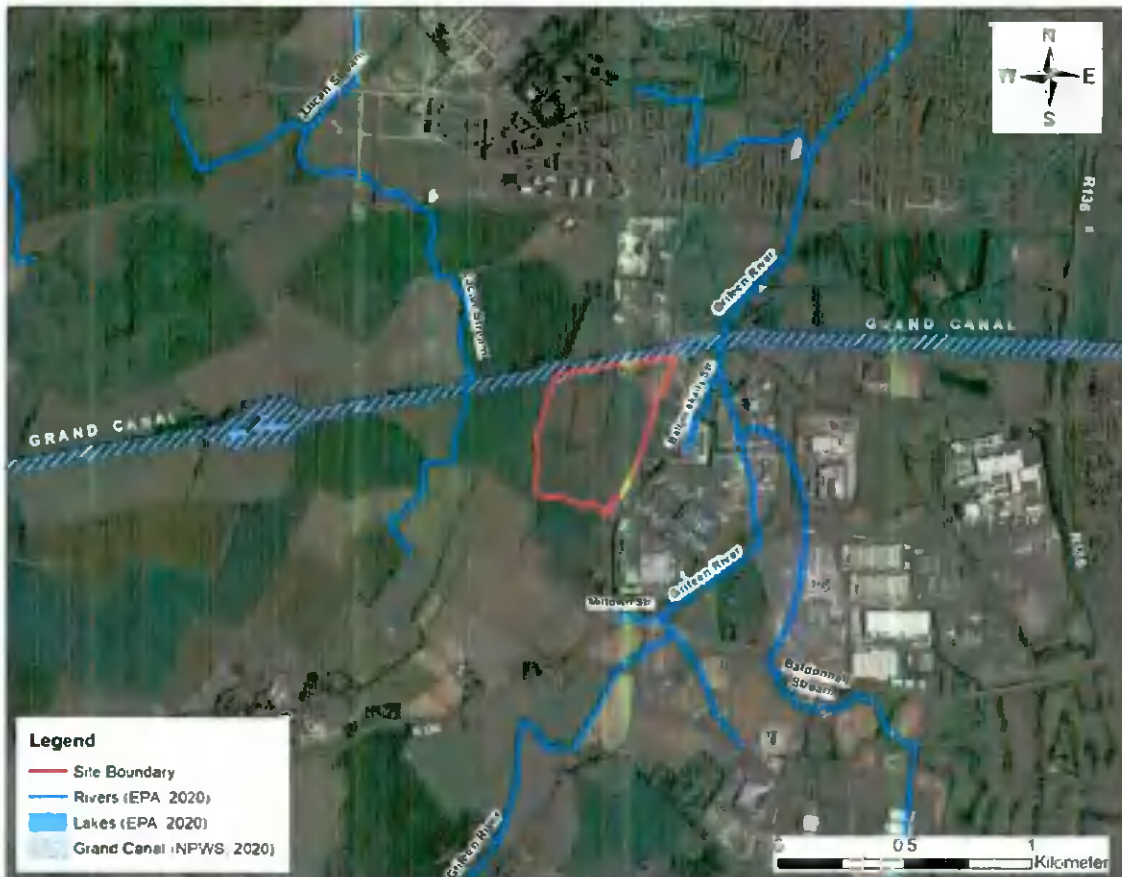
Figure 1 Hydrology (Source: EIAR Chapter 6 Hydrology (AWN, 2021))

There are no mapped surface water courses on or bordering the site as seen in Figure 1 below. below taken from the EIA Hydrology chapter submitted to as part of the EIA.

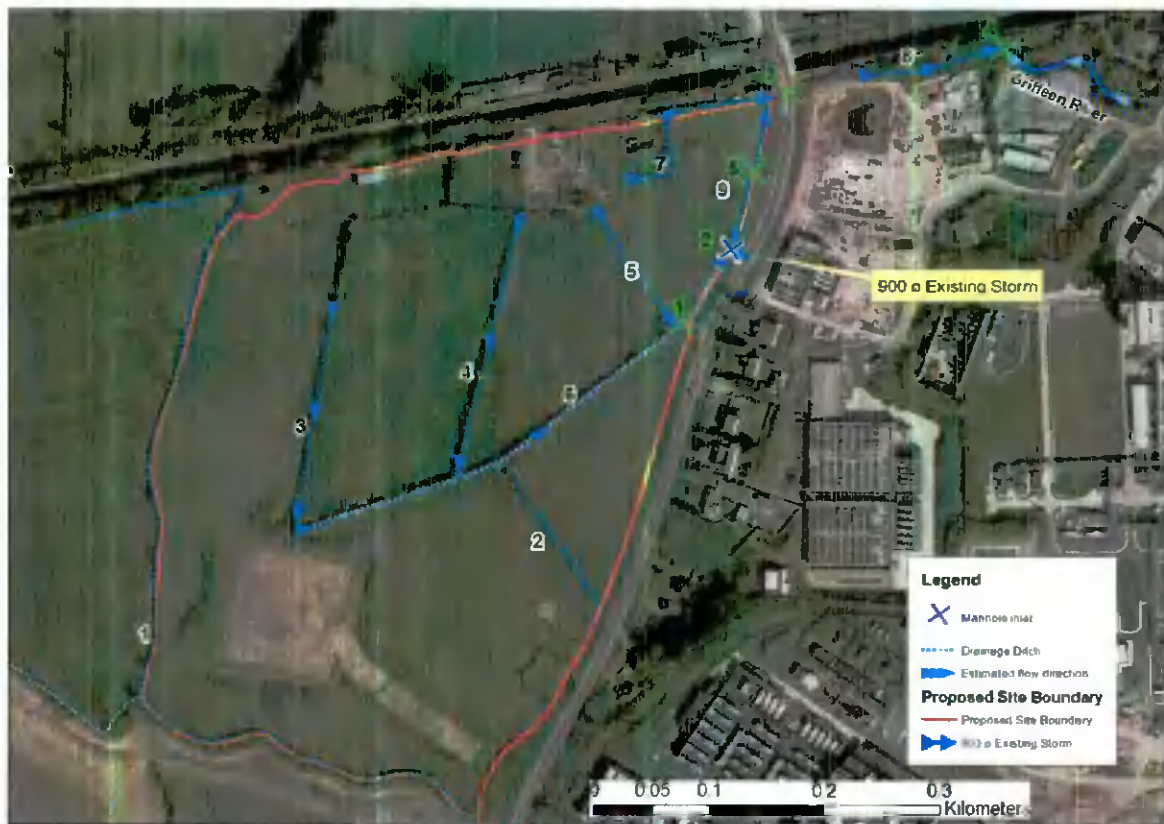
Figure 2 Drainage Layout (updated base imagery)

Field Drain	Flow direction	Condition
1	No apparent flow direction.	Land ditch marking field boundary overgrown with vegetation, shallow banks. Located to the west and South the proposed development site boundary. Overgrown vegetation, no outfall within the proposed development site boundary.
2	No flow direction visible.	Land ditch marking field boundary overgrown with vegetation, shallow banks. No water present at time of visit. Ditch is not connected to any other features, assumed discharge to ground.
3	Contour suggests a southern flow direction and connection to Field drain 6.	Land ditch marking field boundary overgrown with vegetation, shallow banks. No water present at time of visit.
4	Contour suggests a southern flow direction and connection to Field drain 6.	Land ditch marking field boundary overgrown with vegetation, shallow banks. No water present at time of visit.
5	Flow is directed south towards Field Drain 6.	Stagnant water visible. Located alongside an old access to dilapidated buildings.

6	North and North-East to Griffeen River.	No water present in upstream of Culvert 1, with some flowing water visible before Manhole Inlet 2 ; at very low flow rate. Generally overgrown with vegetation. Point of clarification: This ditch discharges to an existing 450 diameter storm inlet that connects to the existing 900 diameter storm drain in the bed of the R120 at the location of Manhole Inlet 2. Clarified by topographical survey of the site as shown in Figure 3 and 4 below

Field Drain	Flow direction	Condition
7	East to Griffeen River.	No water present at time of visit. Shallow dish drain for stormwater collection for dilapidated buildings.
8	East to Griffeen River.	Steep sites, Flowing water visible; very low flow rate.
9	North and North-East to Griffeen River.	Point of clarification: This section of ditch <i>begins</i> at the location of Manhole Inlet 2 with some flowing water visible at very low flow rate. Clarified by topographical survey of the site as shown in Figure 3 and 4 below.

Overall internal ditches shown in Figure 2 are predominantly artificial ephemeral drainage ditches, most of which were dry during the time of the visit so flow direction is assumed. These are manmade ditches to drain the fields and generally marking the field boundaries.

Ditch 1 is not located within the site on the western boundary and is located on the boundary line along the south. It is likely that the ditches (2, 3, 4, 5) primarily drain to ground, or during extended periods of heavy rainfall drain into Field Ditch 6 which flows through the centre of the site and adjacent to the R120 as shown on Figure 2. This ditch, which is outside of the application boundary, discharges to an existing 900 diameter storm drain in the bed of the R120 at the location of Manhole 2, which was constructed under the R120 Upgrade Contract for SDCC. Ditch 7 connects directly with Culvert 4.

The field drains (9 & 7) are hydraulically linked through a series of culverts to drainage Ditch 8 and ultimately the Griffeen River. The storm drain in the bed of the R120 to also connects to the Griffeen River. The Griffeen combines with drainage Ditch 8 at Culvert 4 before flowing north and converging with the River Liffey which then flows east to the Liffey Estuary c. 15 km downstream of the site.

The RFI Response prepared by Pinnacle Consulting Engineers addresses how these ditches will be modified as part of the Proposed Development.

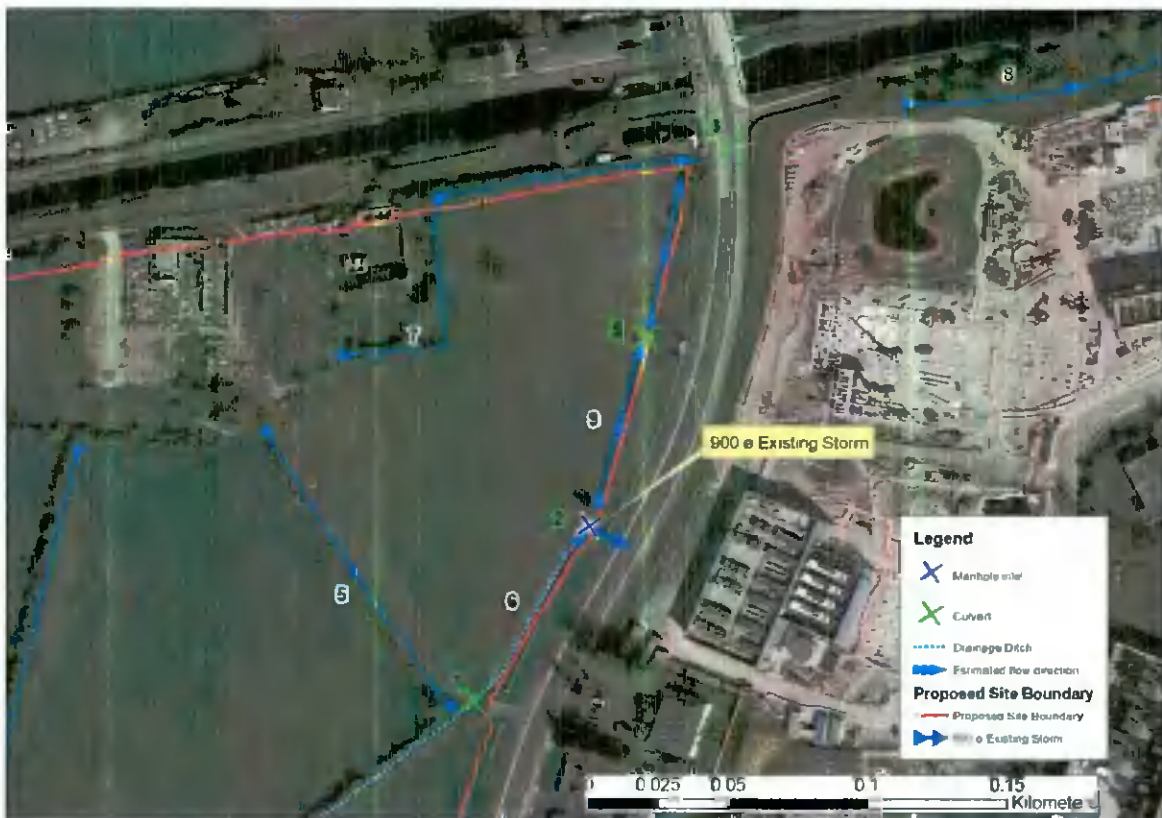
Figure 3 Location of stormwater drain (including renumbering of ditches)

It is acknowledged that the development of this greenfield site will result in the infilling of some pre-existing agricultural drainage ditches that previously drained the site. These ditches facilitate the draining surface waters primarily to ground, or during extended periods of heavy rainfall drain into Field Ditch 6. It has been clarified (as part of this further information response) that this Field Ditch 6 in fact discharges to an existing 450 diameter storm inlet that connects to the existing 900 diameter storm drain in the bed of the R120 at the location of Manhole Inlet 2. This is clarified by topographical survey of the site as clarified in the above discussion and shown in detail on Figure 3 and Figure 4 below.

To clarify in respect of the culverts, the identified Culverts 2, 3, 4, are beyond the site and effectively in 3rd party ownership and it is not proposed to modify or remove these culverts. This has been confirmed by the georeferenced site boundary provided by the project Architect Henry J Lyons and project Civil Engineers Pinnacle Consulting Engineers.

There is only 1 no. culvert (shown as Culvert 1) within the site boundary. The culvert inlet is within the boundary and the outlet located at the boundary. To the north of Culvert 1, the eastern Field Ditch 6 lies outside of the property boundary (redline).

While it is acknowledged that Objective 4 of Policy G3 is to uncover existing culverts and restore the watercourse to acceptable ecological standards and for the passage of fish, where possible. The proposed landscaping berms will be located at Culvert 1, therefore it is not possible to replace this culvert with an open ditch. Culvert 1 will be replaced by an extended culvert suitably sized to current Office of Public Works (OPW) guidance in accordance with Section 50 of the Arterial Drainage Act 1945. The Clarification-RFI Response prepared by Pinnacle Consulting Engineers addresses the detail on the culvert design.
