This report has been prepared to accompany the planning application for a new care home at Taylor's Lane, Rathfarnham, Dublin 16, Co. Dublin, D16 H3V2, as Newbrook House sits within the site and is a protected structure. The house is recorded as Registration No. 11216028. The rating is "Regional". It is dated in the registration as 1820-1870, although other texts found state an earlier date.

Condition Report

Scope of Works

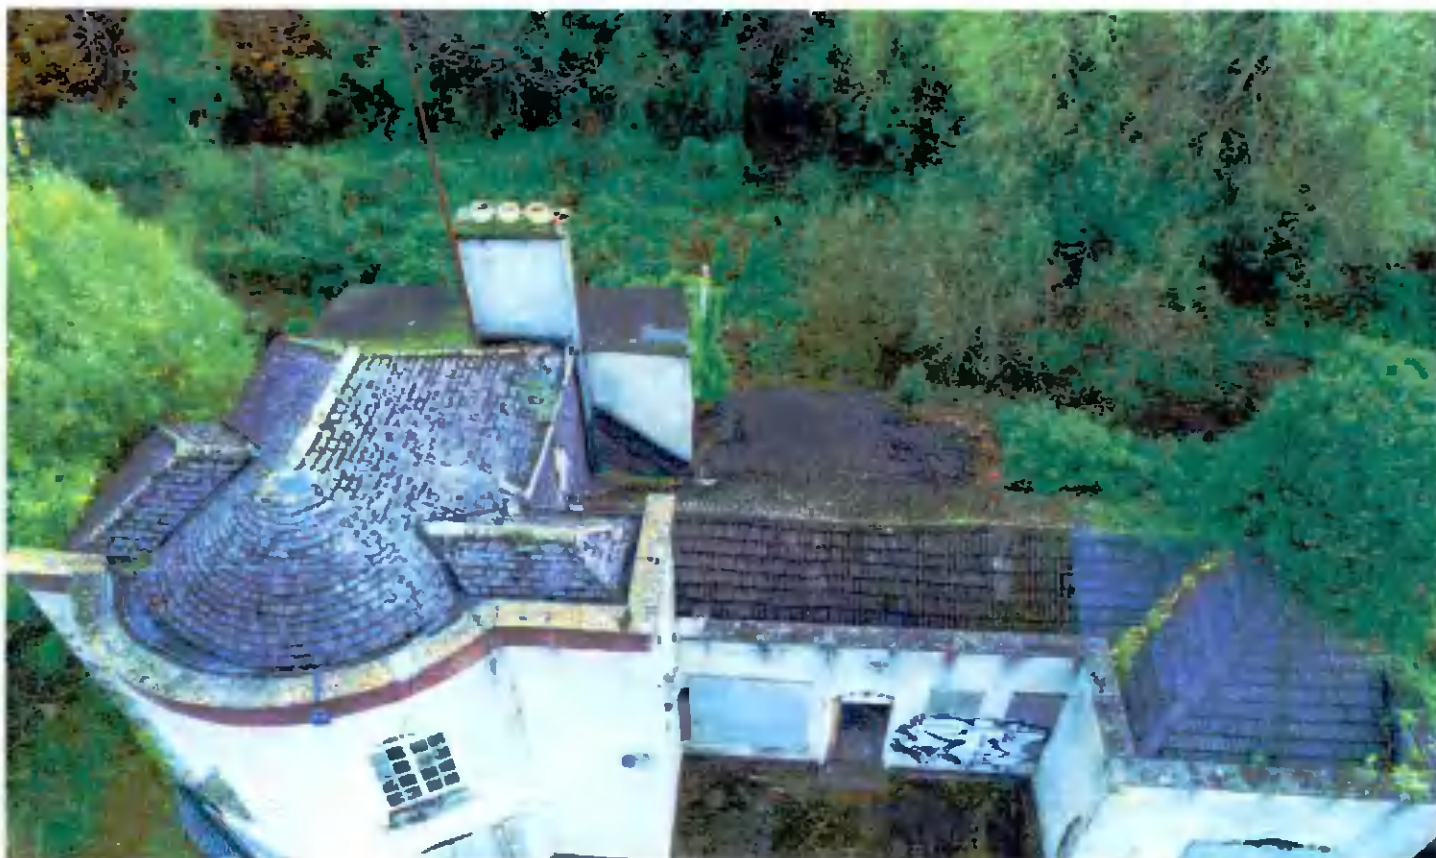
View of Newbrook House looking south

There is a large structural crack in the west side of the bow frontage - just visible above the window in the photo above.

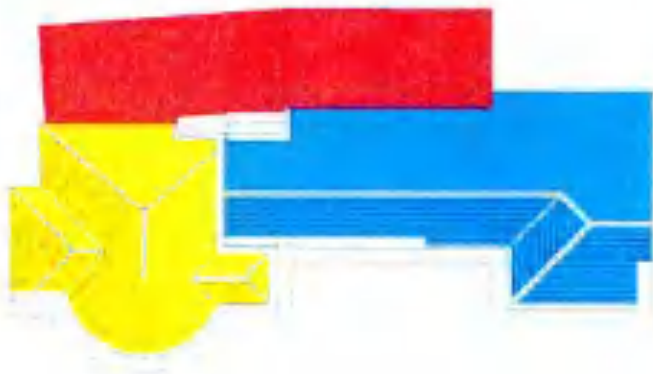
Plan of existing roof
 Yellow indicates slate covering
 Blue indicates concrete tiling
 Red indicates bitumen felt on modern extension

There is significant evidence of water ingress internally. The full roof requires to be stripped and some of the structure will likely require to be replaced according to the structural report. The roof is made up of a number of smaller roofs. See plan adjacent.

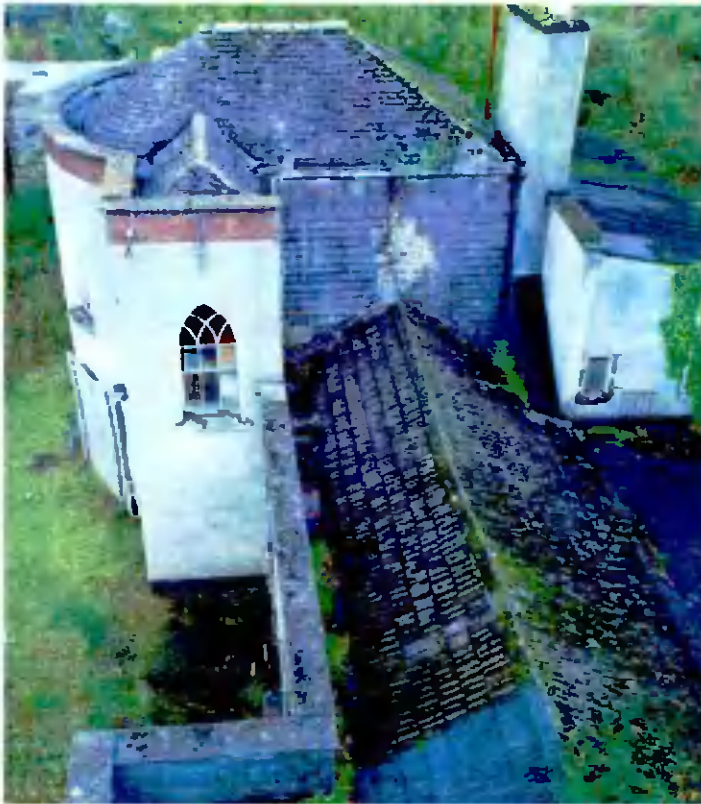
View of bowing tile roof with missing vertical slates beyond

Tiling - The west and central roofs are clad in concrete tiles. These roofs appear to be bowed as can be seen on the adjacent photo. A structural assessment has been carried out and states that the roof is beyond repair and should be removed in its entirety. These tiled roofs also have a parapet gutter at the front, which appears to be in lead but has ponding water indicating that there is a blockage somewhere or the gutter is not falling towards the outlet.

Roof under concrete tiles is bowed. The structural engineer recommends that this roof is completely removed (tiles, flashings, sarking, rafters) and replaced to match the existing geometry.

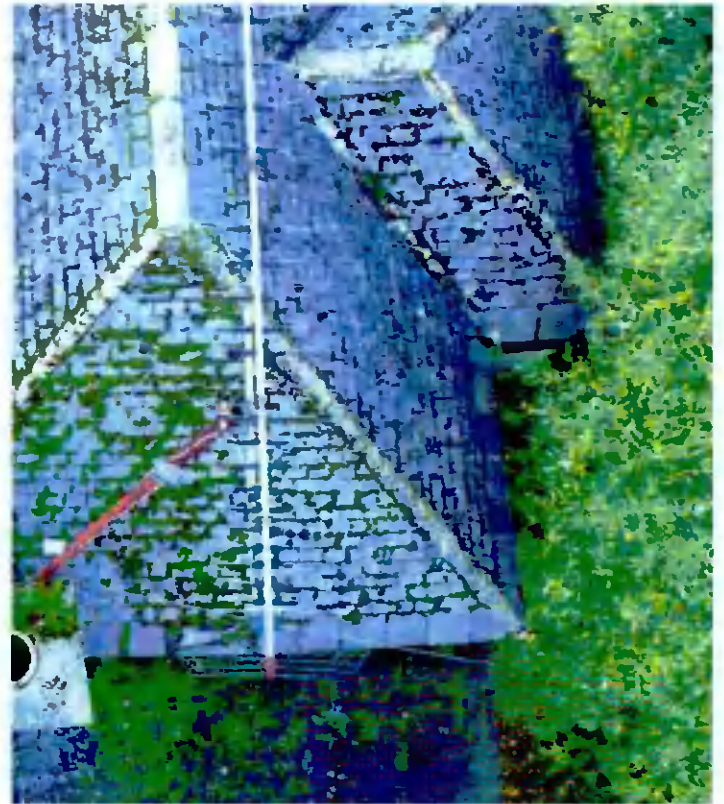
South-east corner of roof showing large slates at base of roof

The mortar is subject to cracking and also does not allow any ventilation at high level. The proposal for this detail will be discussed in Section 4.

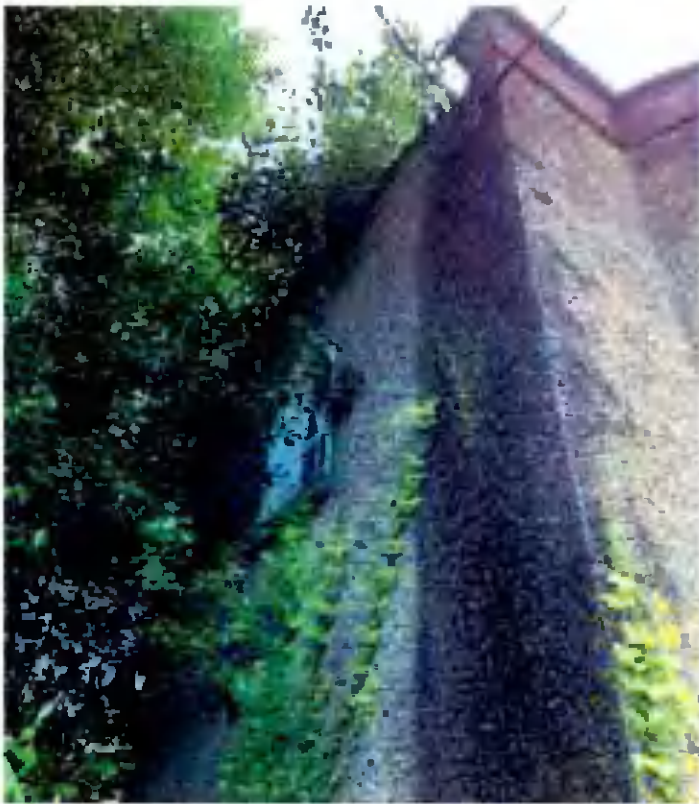
There is a parapet gutter around the perimeter of the roof which appears to be in lead but has been repaired badly in places with flashband. There are no overflow pipes. There is evidence of water shedding out from behind the front elevation parapet at the east end and running down the wall (see photo on p.20). Some of the roof's sarking is missing in the SW corner which is allowing a great deal of water ingress.

View of eastern damp wall where water is running down wall from parapet gutter

New lead parapet gutter to be installed in code 8 lead along the front facade; fix with lead/copper/ stainless steel clips fixed back to timber/stone; all joints to be 50mm step laps (if heights not available lead to be increased to code 9 or 10); Install robust lead grating to outlets.

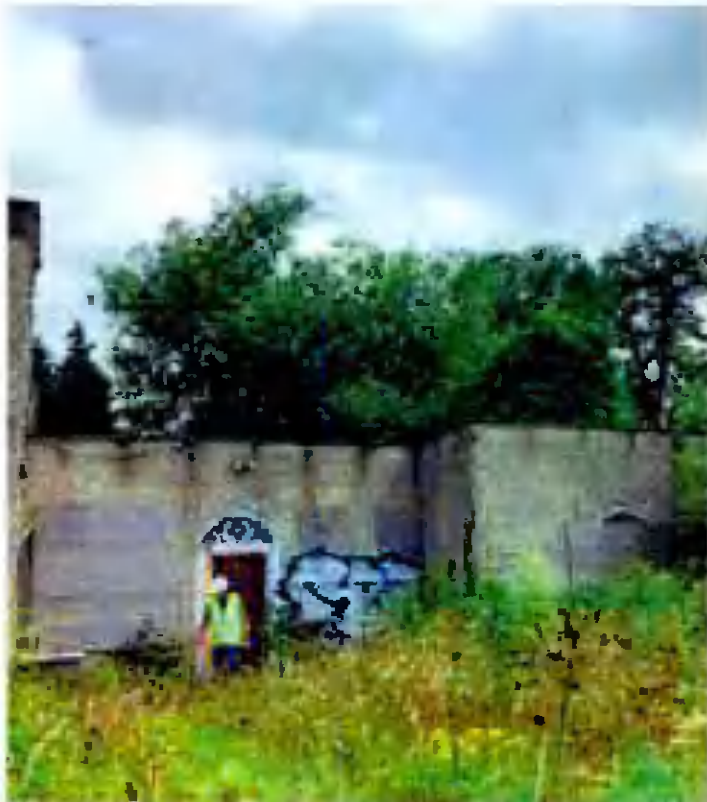
Photo of front of building showing streaks on render below parapet joints

The parapet stones appear to be concrete and do not appear to have any fall. The photograph shows staining on the harling under every cope joint indicating that the joints are full of vegetation rather than mortar. Some of the joints have been covered in flashband or infilled with unsuitable mastic.

- Parapet copes to be replaced with stone copes.
- Existing render to be investigated and replaced and/or repaired as necessary
- Remaining existing ground floor to be removed and new insulated concrete floor to be installed.

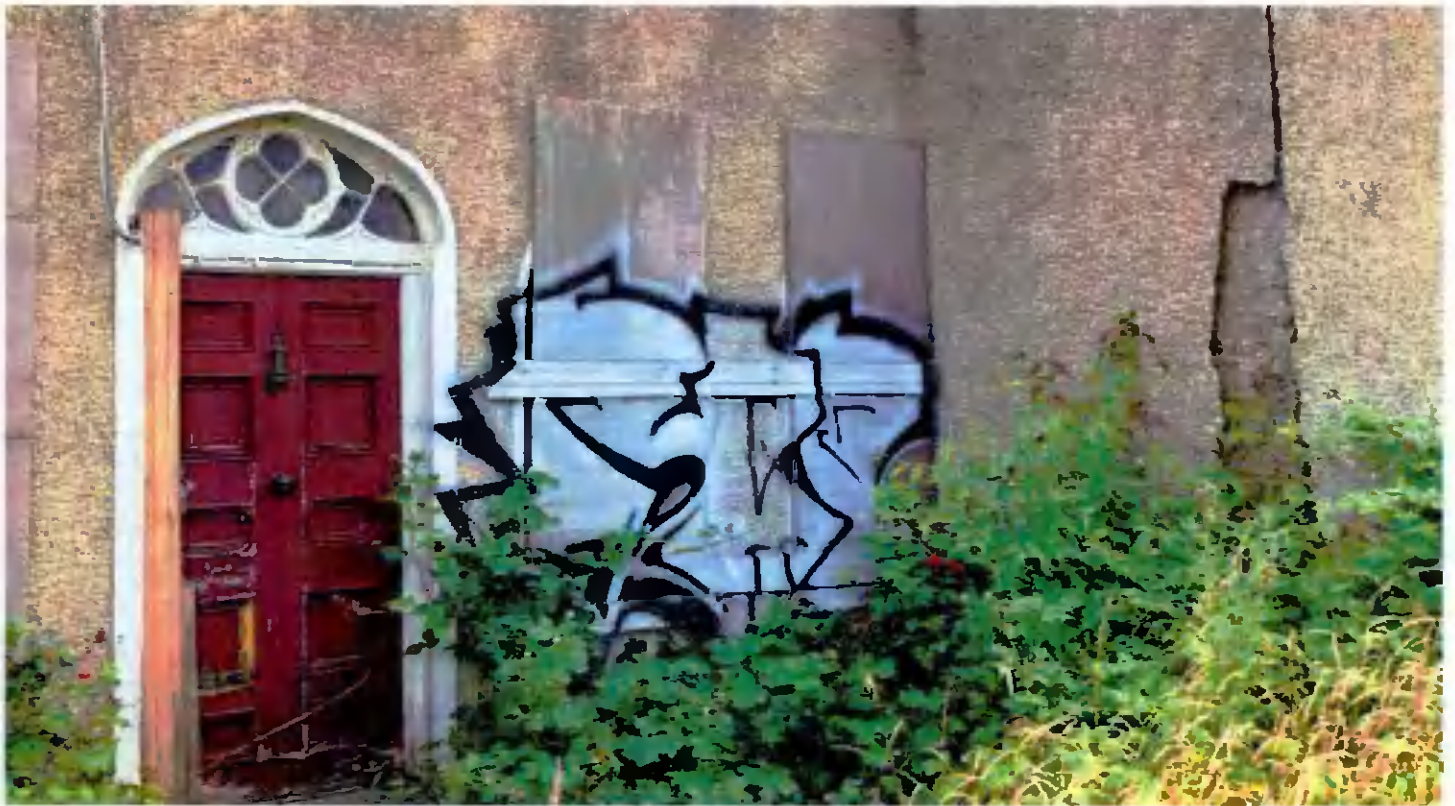
Existing panelled front door and graffiti and bessed render

Some of the harling has graffiti sprayed onto it - see photo above.

Graffiti spray paint to be removed using Tavec 201 biodegradable paint stripper.

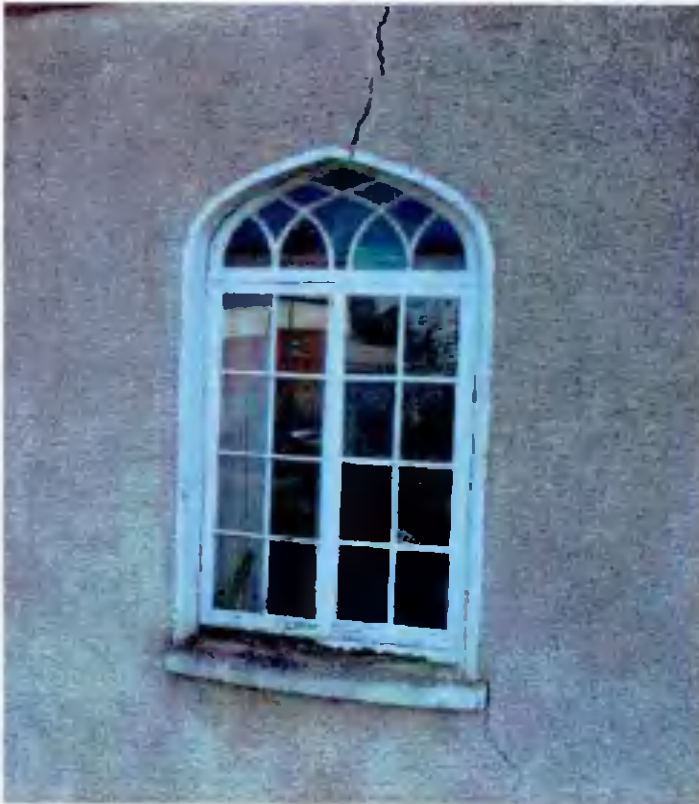
Typical gothic window with Y-tracery Note smooth render surround

Smooth render window surrounds to front elevation are generally in good condition. They have been painted and the paint is starting to flake off. Some small areas of damage to the render is evident. This detail is to be retained.

The rendered window surrounds in front elevation are generally in good condition. Remove loose paint, closely inspect, repair and decorate as above.

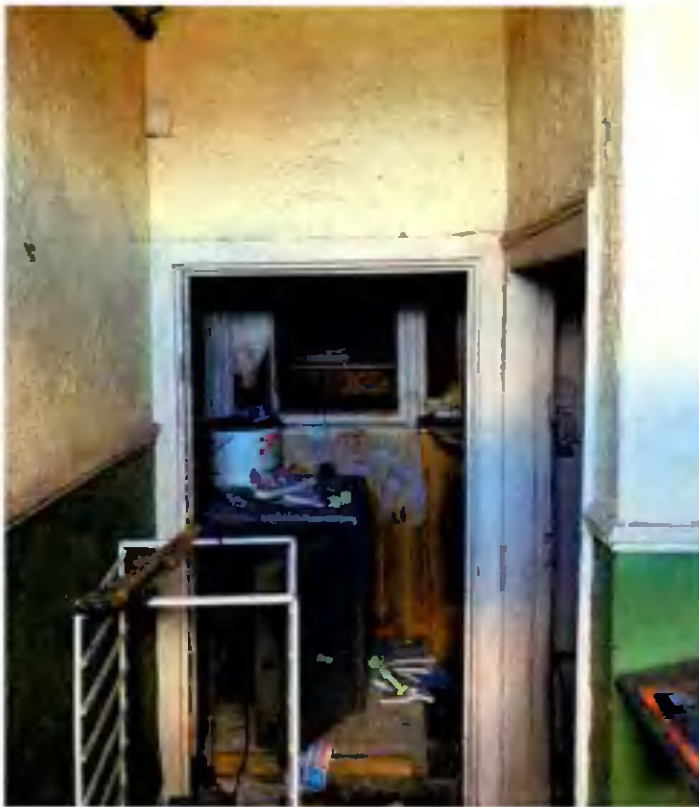
Internal view showing textured plaster at upper levels

The upper sections of some walls are textured (see adjacent photo). This is thought to be modern compared to the original building. This material should be tested for asbestos and then removed back to smooth finish in preparation of repairs.

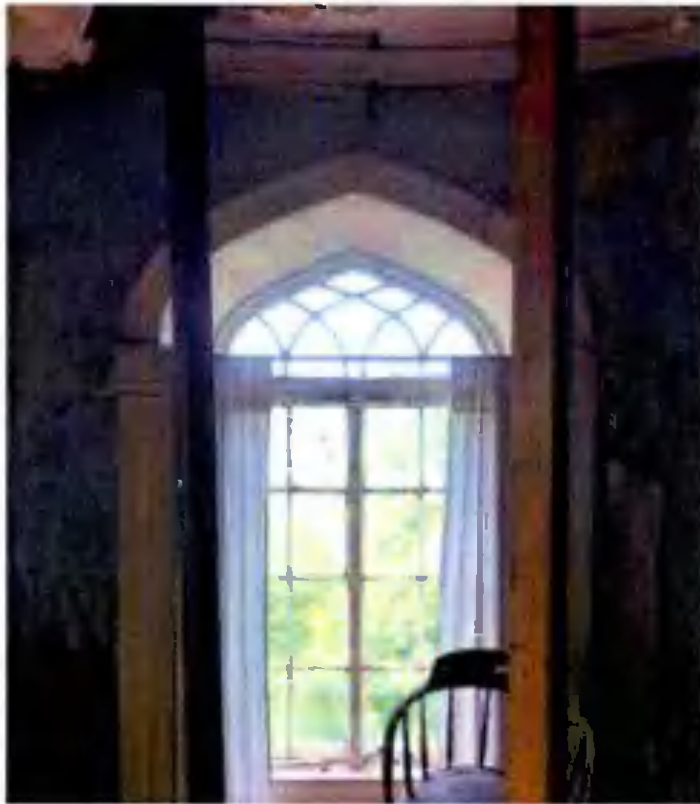
There is a lot of damage to the internal plasterwork. Once the building has been made watertight and all bossed or friable plaster has been removed, a further assessment is to be made on what plaster can remain once it has had time to dry out. All damaged plaster and lathes to be removed and replaced to match existing - see Section 4: Method Statement.

Internal view showing damaged plaster and intact window

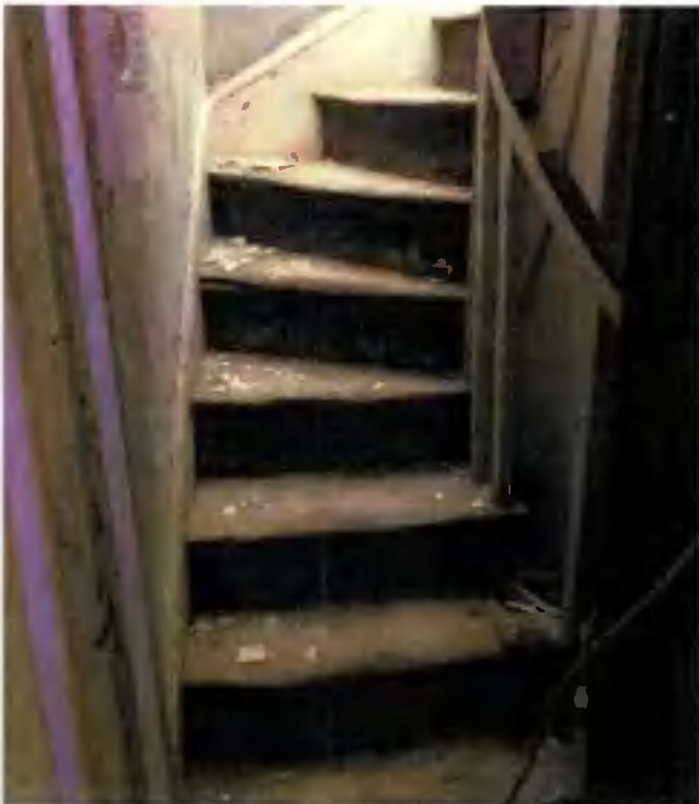
Original winding stair

There is significant damage to the original staircase (see adjacent photo) with some treads being unsalvageable. Any such treads and any rotten timbers to be replaced in a suitable timber of the same profile.
