**COWAL DESIGN**  
**CONSULTANTS LTD**

## Newbrook House, Taylor's Lane Rathfarnham

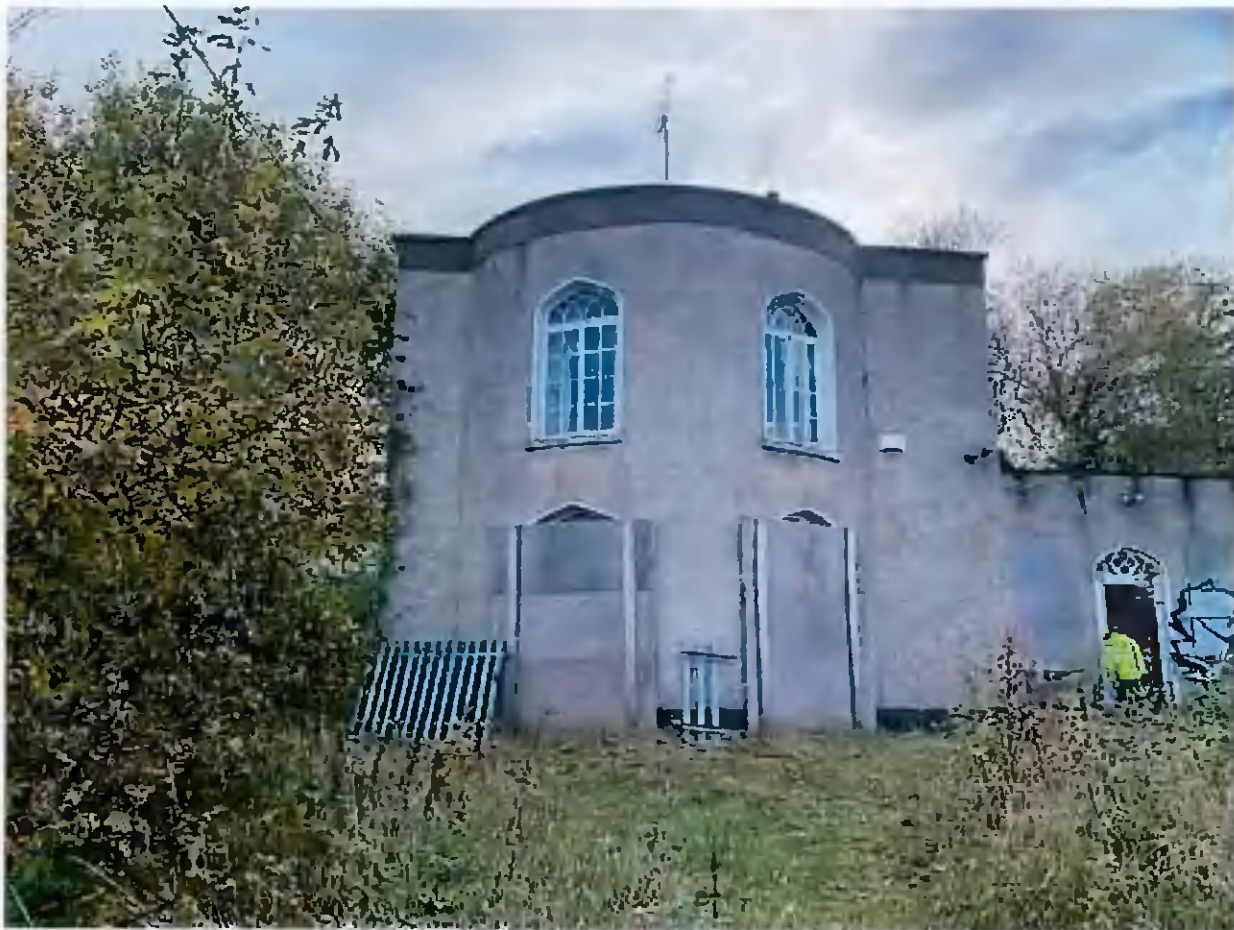
Eastern half of north elevation.  
Note crack running through left hand window on drum.

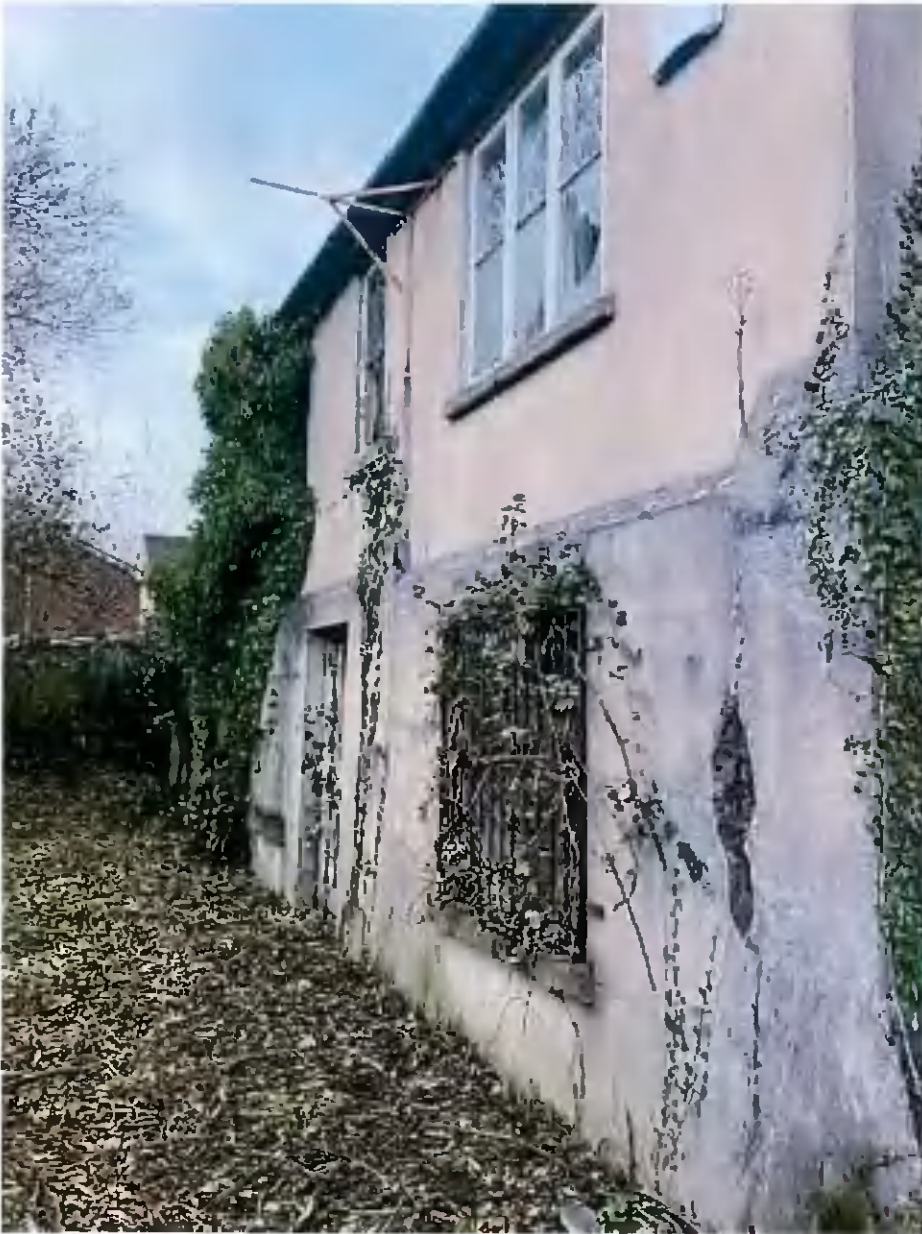
Rear wall looking west.

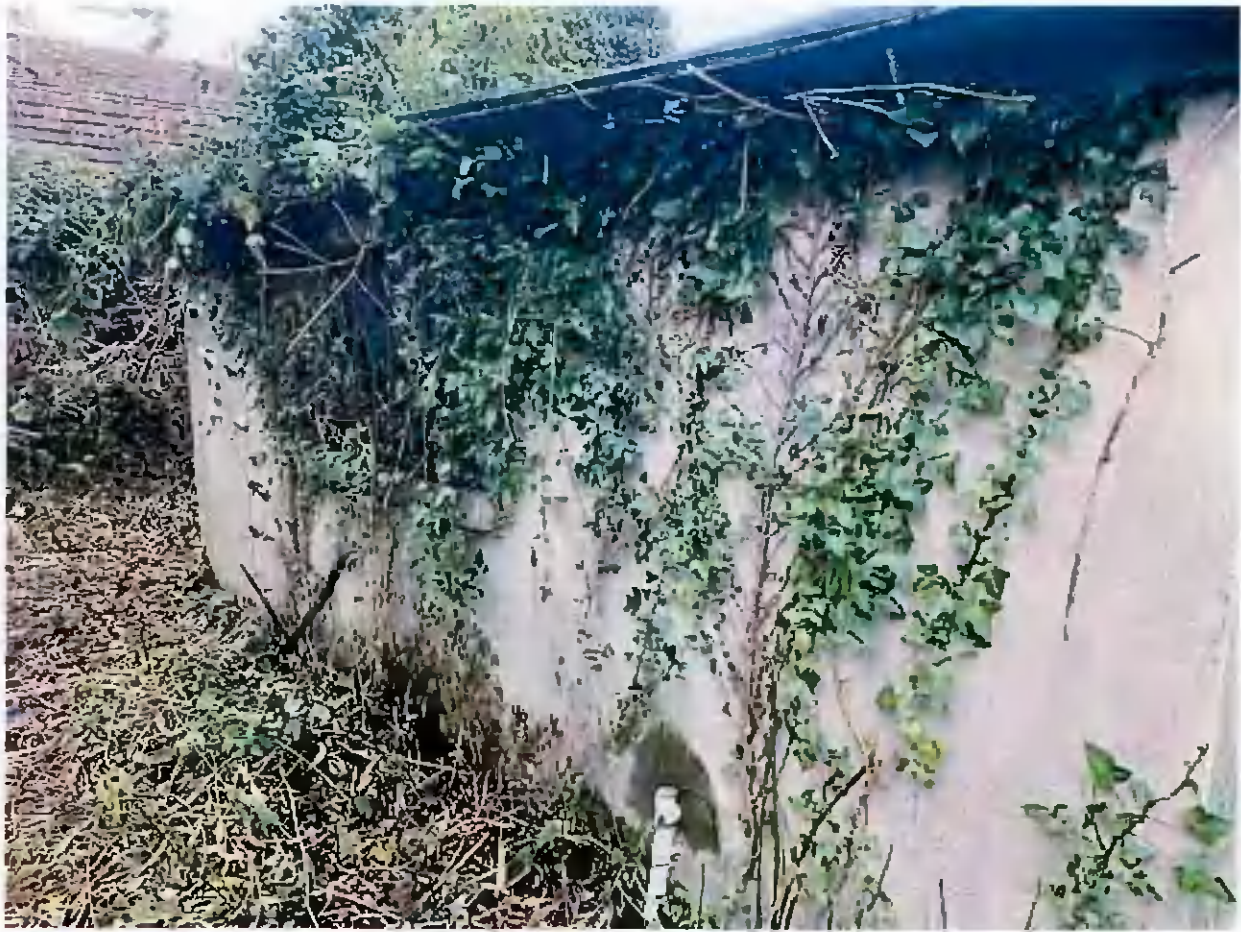
South west corner.  
Significant vegetation damage at roof edge.

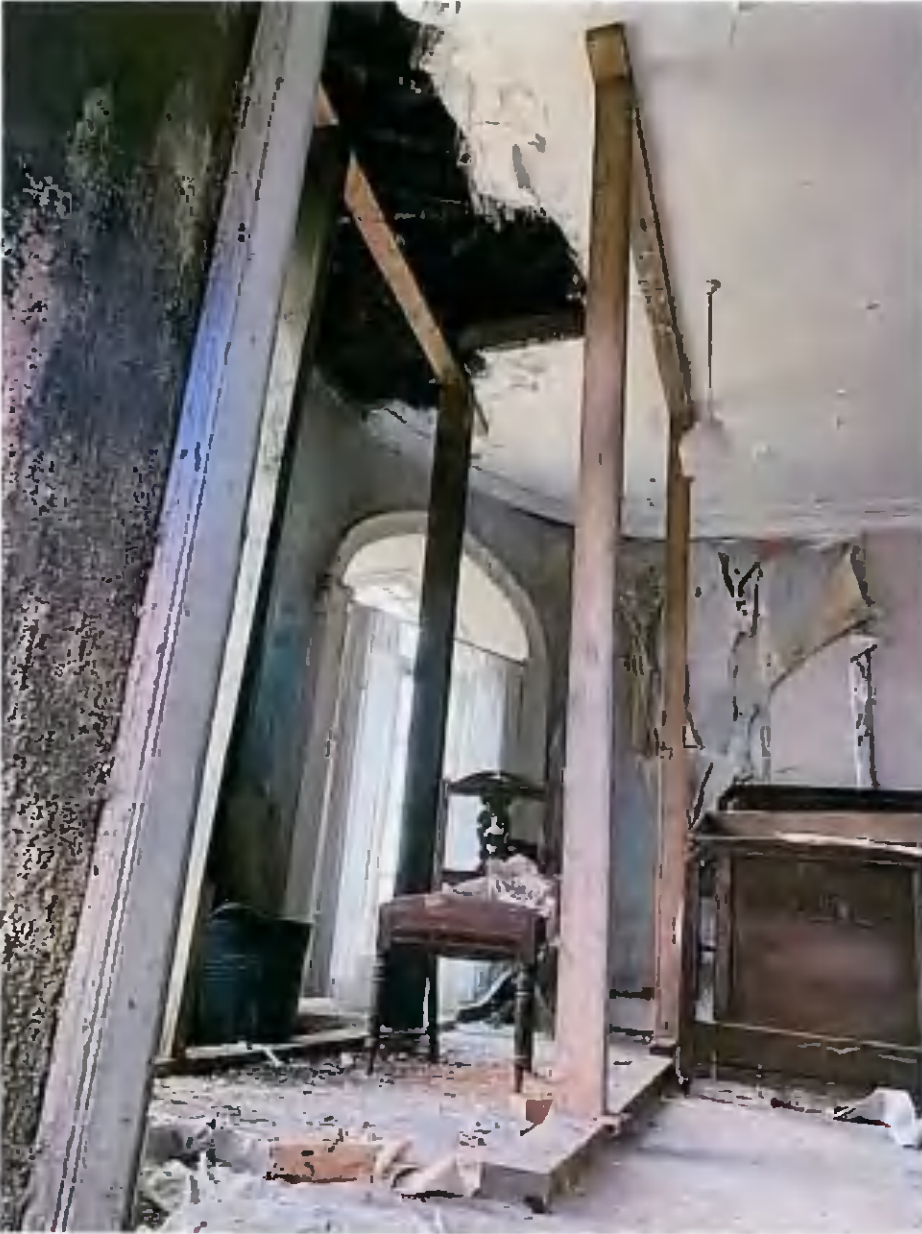
First Floor North Wall Behind Drum
