## ***Tree Management Services***

**Report Title:** Arboricultural Tree Survey Report

**Project Title:** Residential Development at St Edmunds Phase 3

**Client(s):** Moykerr Limited

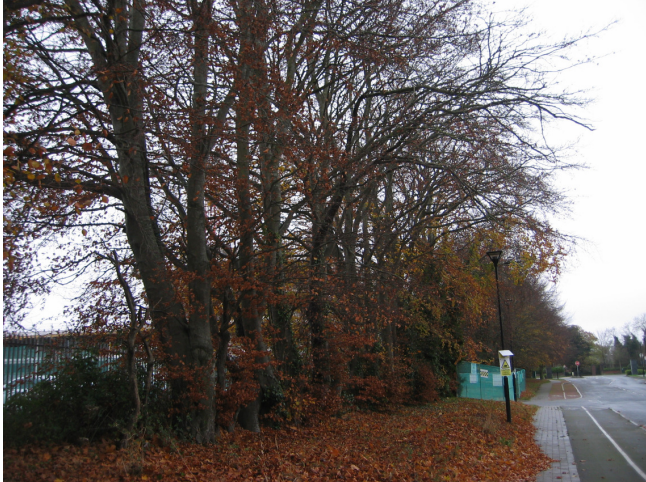
Photo 1: Start of Tree Survey from tree no. 621 looking southwards.

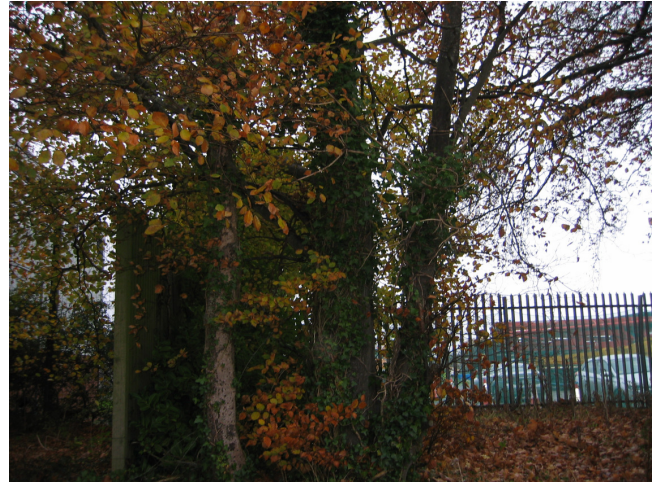
Tree No.	Species Common Name See Appendix 3 for Scientific Name	Ht. Ms. m.	Girth	Branch Spread m.	Age Y-Young M - Middle- aged MA - Mature OM - Over mature	Physiological Condition and Comments <ul style="list-style-type: none"> <li>• Good</li> <li>• Fair</li> <li>• Poor</li> <li>• Dead</li> </ul>	Preliminary Management recommendations	Estimated Remaining Contribution In years. <10 10-20 20-40 >40	Retention Category A - High B - Moderate C - Low U - Remove
621	Common Beech	9.0	20	0N 0S 0E 1W	MA	Dead. Removal recommended.	Fell.	<10	U
622	Common Beech	14.5	46	2N 1S 4E 1W	MA	Fair. Forked at 2m. Ivy growth to 4m. Basal sucker growth present. Forked at 2m. Could develop into a weak stem union in time. Wire attached to main trunk east side.	Remove the tree - see paragraph 4.4	20-40	U
623	Common Beech	10.0	17	0N 0S 0E 1W	MA	Poor. Light ivy growth to 2m. Asymmetrical crown. More crown weight to west. Unbalanced and deformed crown.	Remove the tree - see paragraph 4.4	20-40	U

Photo 2: Views of Beech trees nos. 621, 622 and 623

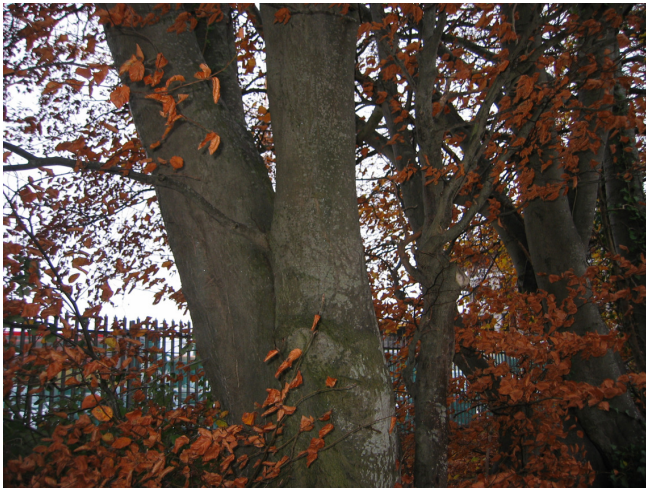
624	Common Beech	19.0	75	4N 0S 5E 3W	MA	Poor. Forked at 1.5m and 2.5m. Weak forking points. Could be prone to stem failure. Co-dominant stem at base - west side. Cavity on main stem on south side at 4m. Fused stems at 6m. Dead stems east side. Wire attached to main trunk east side. More crown weight to east over site. Poor shape and form.	Remove the tree - see paragraph 4.4	20-40	U
625 1262	Common Beech	7.0	17	0N 0S 3E 0W	MA	Poor. Suppressed tree. Crooked main stem. Cavity on main stem to 1m. Wire attached to main trunk east side.	Fell.	10-20	U
626 1263	Common Beech	17.0	45	0N 0S 5E 4W	MA	Poor. Fused tree with no 627. Crooked main stem. Forked at 2m. Over-extended limbs to east. Wire attached to main trunk east side.	Remove the tree - see paragraph 4.4	20-40	U
627	Common Beech	19.0	33	2N 0S 0E 2W	MA	Poor. Fused tree with no 626. Could be a weak point where fused. Wire attached to main trunk east side. Light crown. Suppressed on south side.	Remove the tree - see paragraph 4.4	20-40	U

Photo 3: Views of Beech tree no. 624 with weak forking point.

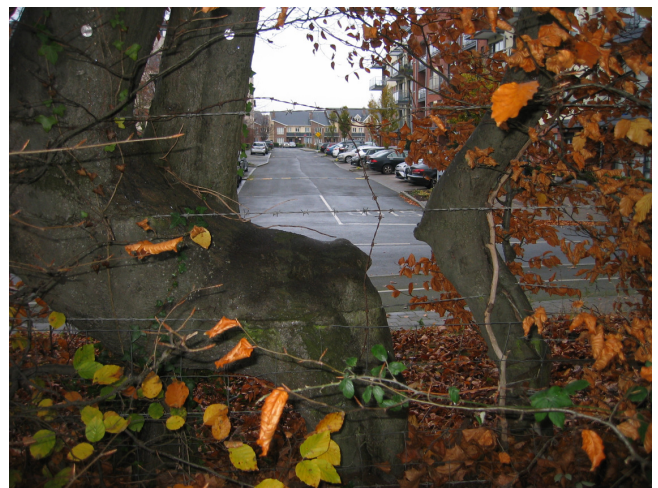
Photo 4: Tree nos. 626 and 627 with fused stems - Poor long-term potential.

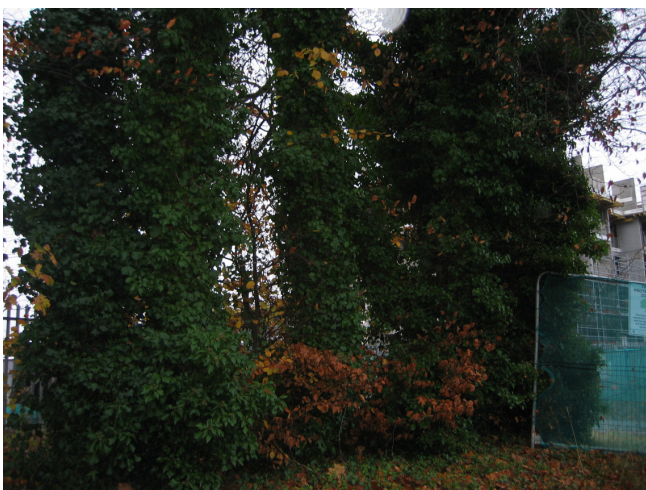
642	Common Beech	16.0	35	1N 0S 0E 4W	MA	Fair. Heavy ivy growth to 6m. Lower stem not assessed. Wire attached to main trunk east side.	Remove the tree - see paragraph 4.4	20-40	U
643	Common Beech	17.0	45	2N 1S 2E 4W	MA	Fair. Crooked stem to 1m. Ivy growth to 6m. Dominant tree. More crown weight to west over footpath and road. Wire attached to main trunk east side.	Remove the tree - see paragraph 4.4	20-40	U
644	Common Beech	12.0	28	0N 0S 3E 0W	MA	Poor. Suppressed on south side. Leaning to northeast. Crooked stem. Cracked stem at 4m. Heavy ivy growth to 3m. Lower stem not assessed. Wire attached to main trunk east side.	Remove the tree - see paragraph 4.4	20-40	U
645	Common Beech	14.5	38E, 30E	1N 0S 4E 4W	MA	Poor. Heavy ivy growth to 7m. Lower stem area not assessed. Forked close to base. Leaning stem to west. Wire attached to main trunk east side.	Remove the tree - see paragraph 4.4	20-40	U
646	Common Beech	14.0	42E	0N 2S 0E 2W	MA	Poor. Heavy ivy growth to 7m. Lower stem not assessed. Close to no. 645. Dead stems on south and west sides.	Remove the tree - see paragraph 4.4	20-40	U

Photo 5: Views of Beech trees 642-646  
- Note heavy ivy growth.

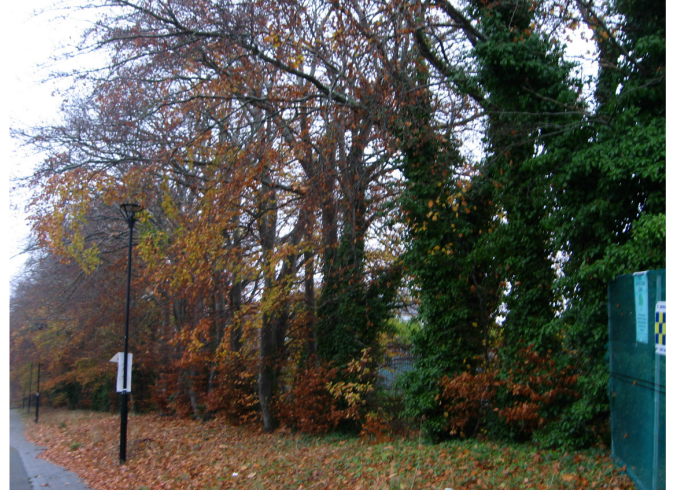
Photo 6: Views of row of Beech trees from entrance road looking north.

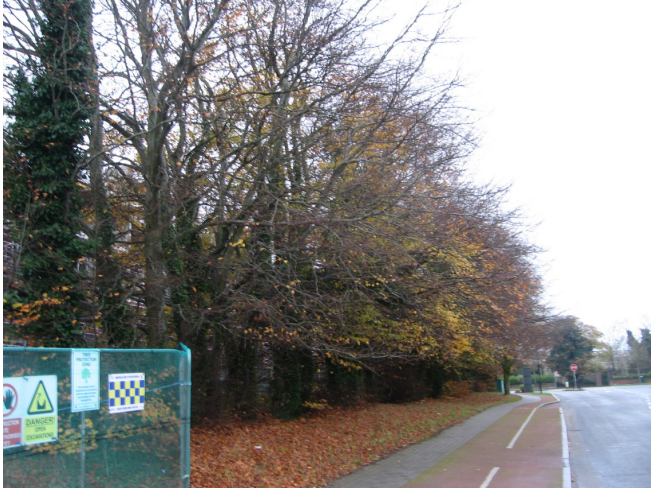
Photo 7: Views of row of Beech trees from entrance road

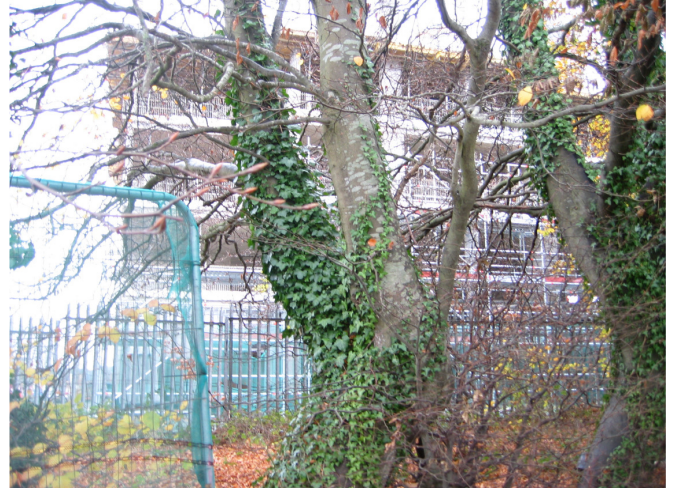
647	Common Beech	13.0	34E	1N 0S 0E 0W	MA	Fair. Heavy ivy growth to 7m. Lower stem not assessed. Suppressed on south side. Wire attached to main trunk east side.	Remove the tree - see paragraph 4.4	20-40	U
648	Common Beech	16.0	76	1N 1S 4E 4W	MA	Poor. Forked at 1m. Weak stem union. Water retention in stem union. Crooked stems. Poor shape and form. Suppressed on south side. Wire attached to main trunk east side.	Remove the tree - see paragraph 4.4	20-40	U
649	Common Beech	15.0	40	1N 0S 3E 1W	MA	Poor. Crooked main stem. Wire attached to main trunk east side. Light ivy growth attached.	Remove the tree - see paragraph 4.4	20-40	U
650	Common Beech	16.0	41, 33	0N 0S 6E 6W	MA	Poor. X 2 stems. Light ivy growth attached. Fused stems at base. Weak stem union. Prone to stem splitting. Limbs overhang footpath to west. Heavy over-extended limbs to east. Wire attached to main trunk east side.	Remove the tree - see paragraph 4.4	20-40	U

Photo 8: Tree no. 648 with weak stem union.

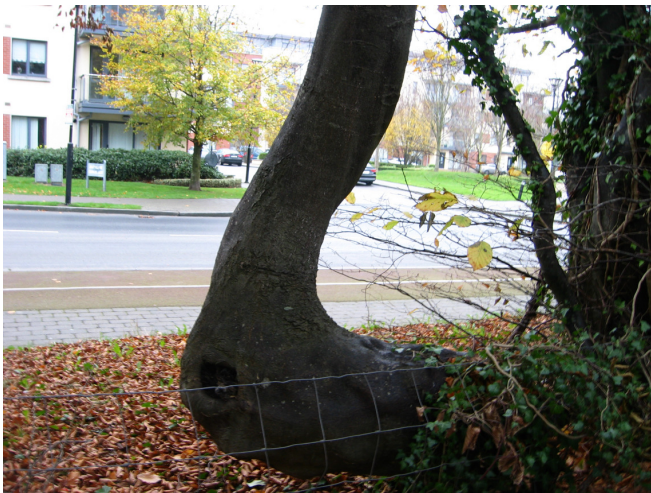
661	Common Beech	15.0	29	0N 0S 5E 0W	MA	Poor. Cavities along trunk. Crooked and deformed main stem. Cavity on main trunk at elbow. Could be prone to stem breakage. Leaning to east. Wire attached to main trunk east side.	Fell.	<10	U
662	Common Beech	16.0	53	1N 0S 3E 5W	MA	Fair. Forked at 1.7m. Wire attached to main trunk east side. Ivy growth to 14m. Leaning stems to west over path and cycle lane. Deformed and unbalanced crown.	Remove the tree - see paragraph 4.4	20-40	U
663	Common Beech	15.0	40	0N 2S 3E 3W	MA	Poor. Light ivy growth to 5m. Multiple forking points from 2m. Old pallet in crown. Wide-spreading crown. Leaning stem to west. Wire attached to main trunk east side.	Remove the tree - see paragraph 4.4	20-40	U
664	Common Beech	17.0	34	1N 0S 2E 1W	MA	Poor. Crooked stem. Self-corrected. Heavy ivy growth to 10m. Wire attached to main trunk east side. High crown.	Remove the tree - see paragraph 4.4	20-40	U

Photo 9: Views of Beech tree (no. 661) with crooked stem and cavity.

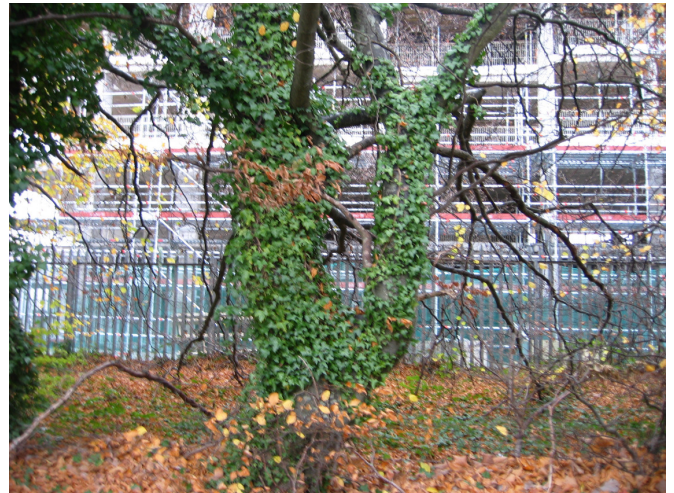
Photo 10: View of Beech tree with poor shape and form.

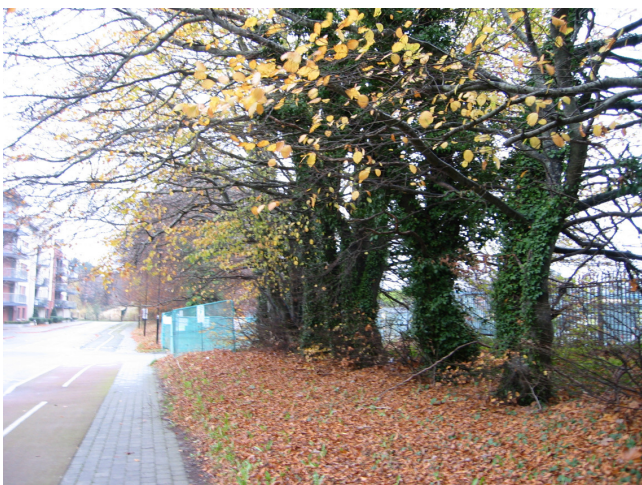
Photo 11: Views of row of Beech trees looking north - Note the overhanging limbs over path and cycle lane

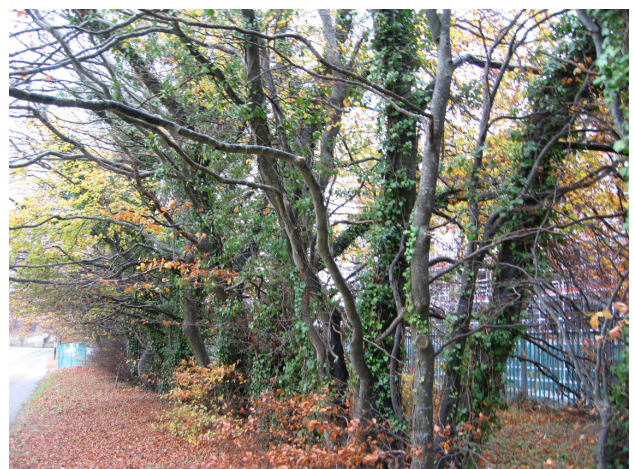
Photo 12: Close up views of Beech trees showing poor formation from overcrowding

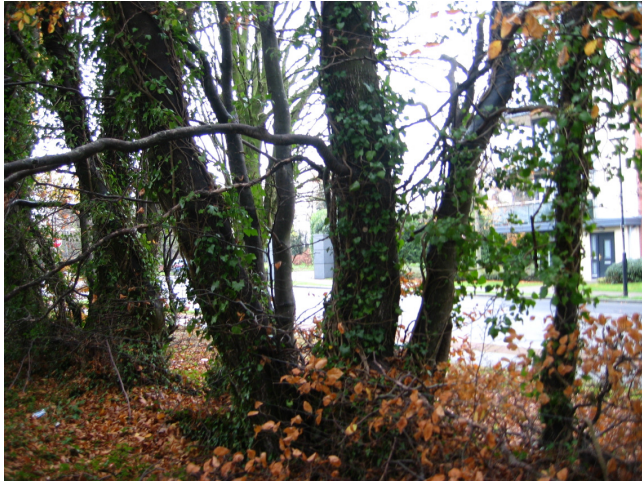
Photo 13: Beech trees with low forking points leading to weak stem unions.

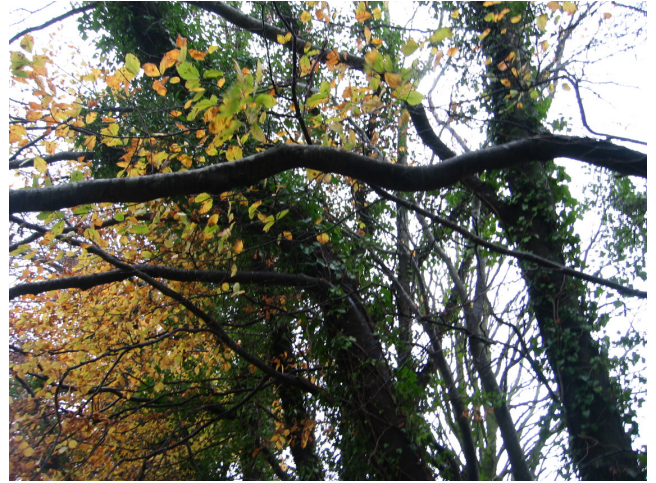
Photo 14: Upper canopy views of Beech tree with leaning stems to east.

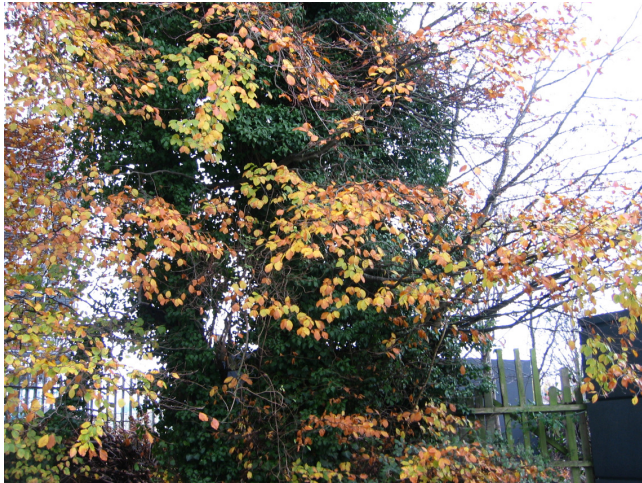
681	Common Beech	15.0	75E	2N 2S 2E 4W	MA	Poor. Forked at 1.2m. Fused stems. Heavy ivy growth to 14m. Lower stem not assessed. Leaning stem over cycle lane and path to west. Deformed crown. Suppressed crown on south side. Wire attached to main trunk east side.	Remove the tree - see paragraph 4.4	20-40	U
682	Common Beech	6.0	16	-N -S -E -W	M	Poor. Suppressed tree. Heavy ivy growth to 4m.	Remove the tree - see paragraph 4.4	20-40	U
683	Common Beech	18.0	38	1N 0S 1E 4W	MA	Poor. Heavy ivy growth to 4m. Wire attached to main trunk west side. High crown	Remove the tree - see paragraph 4.4	20-40	U
684	Common Beech	17.0	54E	0N 0S 4E 1W	MA	Poor. Forked at 1.5m. Decay in forking point. Could be prone to splitting. Heavy ivy growth to 14m. Wire attached to main trunk east side.	Remove the tree - see paragraph 4.4	20-40	U
685	Common Beech	16.0	46E	0N 0S 3E 3W	MA	Fair. Heavy ivy growth to 14m. Lower stem not assessed. Main forking point from 6m. High crown. Wire attached to main trunk. Electrical service unit box on western side.	Remove the tree - see paragraph 4.4	20-40	U

686	Common Beech	16.0	33	0N 0S 2E 0W	MA	Poor. Suppressed by ivy. Suppressed crown. Heavy ivy growth to 14m. Wire attached to main trunk. Electrical service unit box on western side.	Remove the tree - see paragraph 4.4	20-40	U
687	Common Beech	15.0	32, 70E	3N 0S 3E 2W	MA	Fair. Close to entrance. Forked at .5m. Suppressed by ivy. Elder scrub at base. Forked at base. Multiple forking points from 3m. Heavy ivy growth attached to 16m. Lower stem not assessed. Wire attached to main trunk.	Remove the tree - see paragraph 4.4	20-40	U
688	Common Beech	14.0	47E	0N 2S 6E 0W	MA	Fair. Wooden plank attached. Suppressed by ivy. Close to entrance. Heavy basal sucker growth. Major forking point at 7m. More end weight to east. Wire attached to main trunk.	Remove the tree - see paragraph 4.4	20-40	U
689	Whitebeam	4.5	8	0N .5S .5E .5W	Y	Good. Staked and tied. Clear Stem to 2m.	Readjust stake and tie.	>40	C
690	Whitebeam	5.0	11	.5N .5S .5E .5W	Y	Good. Clear stem to 2m. Crown-raised in recent past.	NAR	>40	C

Photo 15: Beech trees nos. 685-688 - note heavy ivy growth.

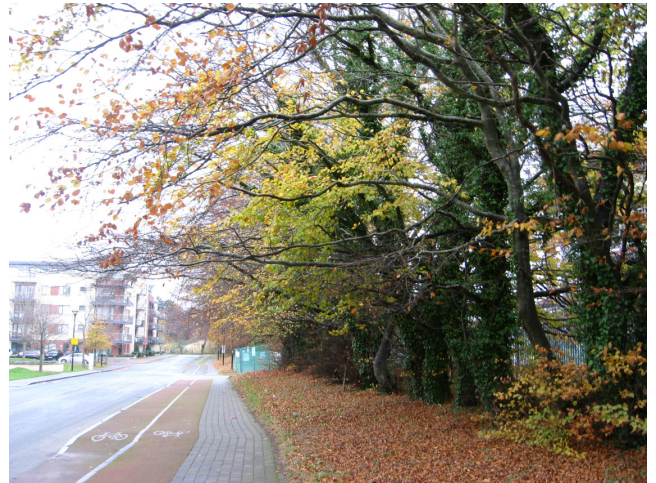
Photo 16: General views of Beech trees looking northwards from entrance.

cyclists, motorists, busy road, cycle lane, footpath and buildings) all combine to provide a high tree hazard evaluation with limited abatement options. Therefore our recommendation is to fell the row of Beech trees and to replant with a more sustainable and suitable species of avenue trees.

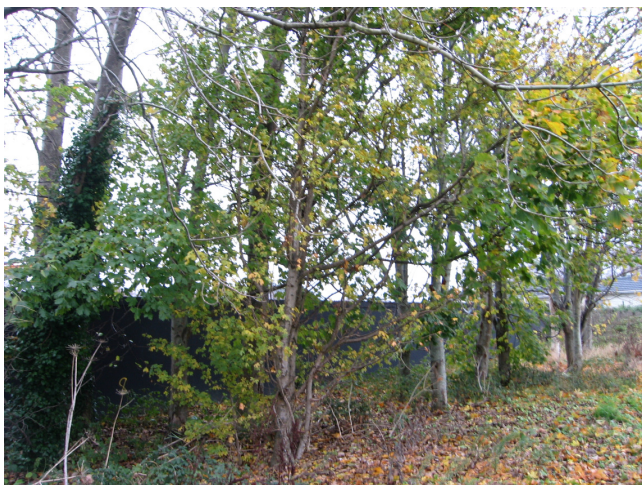
4.5 The group of Poplar and Maple growing on lands to the east of the site in the ownership of South Dublin County Council are in fair to poor condition. The trees are growing in an exposed part of the site. Many of the trees have suffered from storm damage in the past, resulting in broken and storm-damaged crowns. Some trees are displaying signs of storm damage, stem fractures, cavities, decay and broken and hung-up limbs. The tall poplar trees are close to or within falling distance of the adjoining slip road to the N4. In general, Poplar trees show a high propensity to form weak forks, a high propensity for fork failure and a high propensity to fail due to decay. Thus the species are not suitable for long-term retention on public lands close to a busy road. We have prescribed felling a number of the Poplar trees and recommend that consideration be given to the removal of the remaining Poplar trees in this location. Other works for trees to be retained includes crown cleaning, crown pruning and the removal or repair all leaning, storm-damaged and broken limbs.

Photo 17: Views of trees on SDCC Lands - eastern boundary.

5.1 Refer to the Programme of works outlined in the Tree Survey schedule below. Tree Works recommended includes the felling of the row of mature Beech trees on the western boundary and remedial and felling works to those trees growing on SDCC Lands on the eastern boundary. Remedial works include the severance of ivy growth, crown cleaning, deadwood removal, as well as general pruning and reshaping. The works as detailed in the Tree Schedule below shall only be carried out by a competent, professional and fully insured and certified Tree Surgery firm. The Contracting firm shall adhere to the Safety, Health and Welfare at Work Act 2005 and other relevant safety legislation. Works to trees on SDCC Lands shall only be carried out with the prior consent and approval of SDCC.

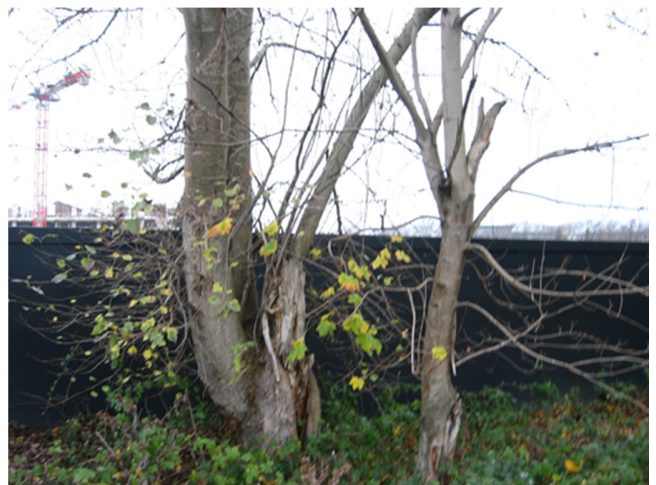
Photo 18: Views of Poplar and Maple trees in poor condition.
