# **Arboricultural Assessment, Arboricultural Impact and Tree Protection Strategy Report**

**Lucan Shopping Centre,  
Lucan,  
Co. Dublin**

<b>Project No.</b>	TLUC001	<b>Date</b>	20/12/21
<b>Project Name</b>	Lucan Shopping Centre	<b>Revision</b>	-

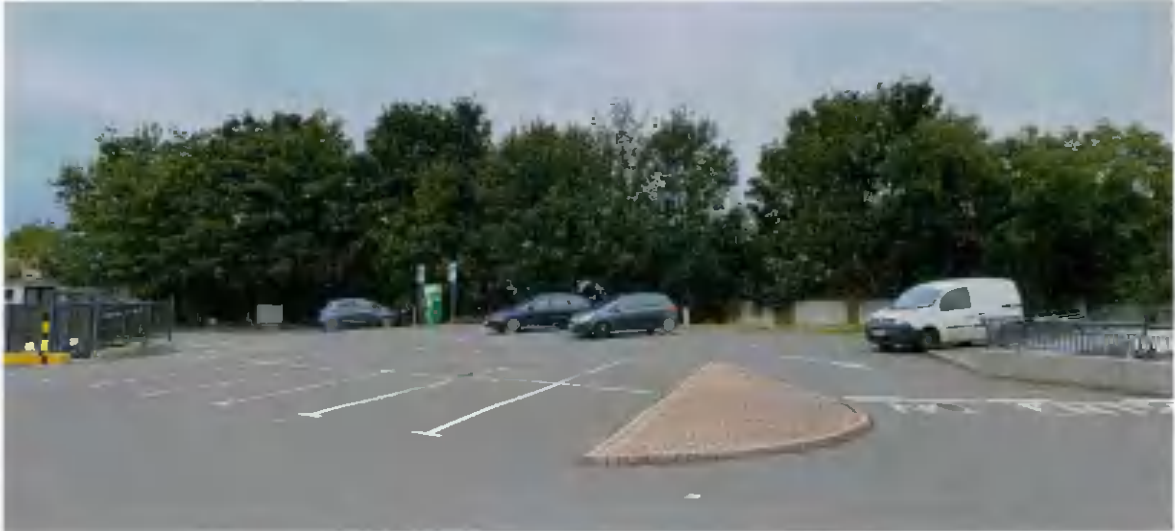
This survey concentrates on the trees either side of the boundary with Hillcrest Grove (images 2-3) on the north west site boundary.

The trees located here are primarily sycamore (*Acer pseudoplatanus*) and ash (*Fraxinus excelsior*), with a single pedunculate oak (*Quercus robur*). The trees on the Hillcrest Grove side predate the concrete boundary wall which was constructed circa 1990. These trees were likely part of a agricultural boundary hedge dating from the early 20th century as seen on 25 inch survey OS maps (ref. pg31).

The overall quality of these trees is moderate to poor (Table 1/#441-449; pg24), having suffered from a lack of appropriate management inputs. A mature sycamore (#445) has failed and is recommended for removal.

Image 2. Sycamore and ash trees on the boundary with Hillcrest Grove, viewed from within Lucan Shopping Centre car park.

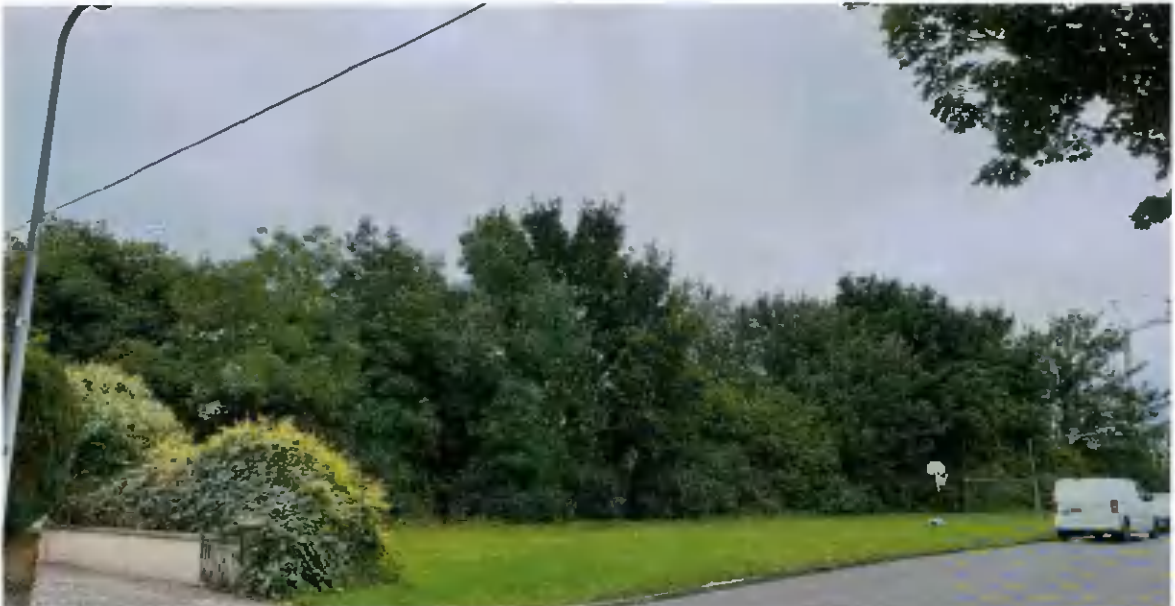
Image 3. Sycamore and ash trees on the boundary with Hillcrest Grove, viewed from Hillcrest Grove.

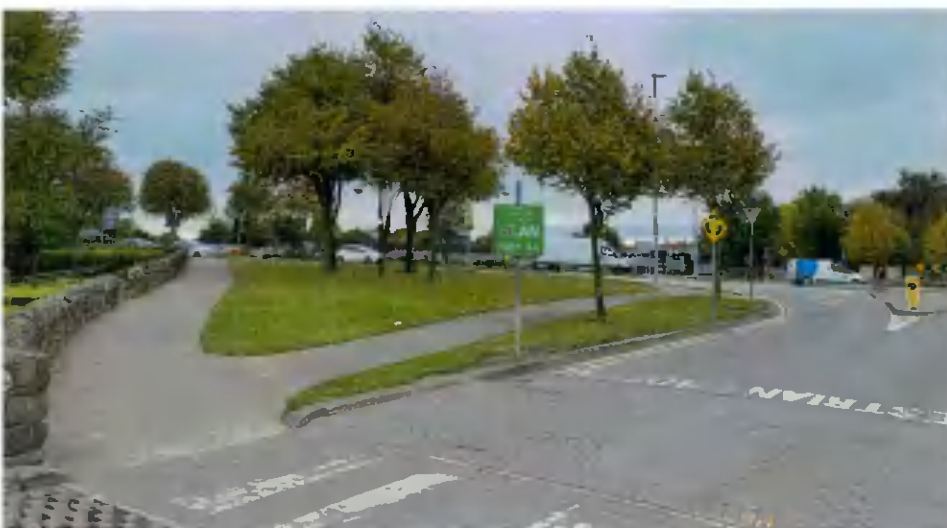
Image 4. Small leaf lime at the north east entrance from Newcastle Road (#450-454).

Tag Number	Species	Vigour	Age class	Category	Comments	Recommendations	Long Term Potential	DBH (mm)	Height (metre)	Clear Stem (metre)	Crown spread NESW (metre)
453	Small leaf lime ( <i>Tilia cordata</i> )	Good	Early mature	B	Located within an open grass area at the main traffic entrance to Lucan shopping centre. Contains several wide diameter (15mm) pruning cuts at 1.5 east with no associated decay. Minor bark damage to exposed roots east with no associated decay.	No action necessary	20-30	290	8	5n	4;3;2;3
454	Small leaf lime ( <i>Tilia cordata</i> )	Fair	Early mature	C	Located within an open grass area at the main traffic entrance to Lucan shopping centre. Contains several small diameter (10mm) pruning cuts at 1.5 south with no associated decay. No visible defects.	No action necessary	15-20	230	6	3s	3;2.5;3;2.5
455	Small leaf lime ( <i>Tilia cordata</i> )	Good	Young	C	Located within an open grass area at the main traffic entrance to Lucan shopping centre. Young with good management inputs. No visible defects.	No action necessary	15-20	150	5	2.25s	1;1.5;1;1.5

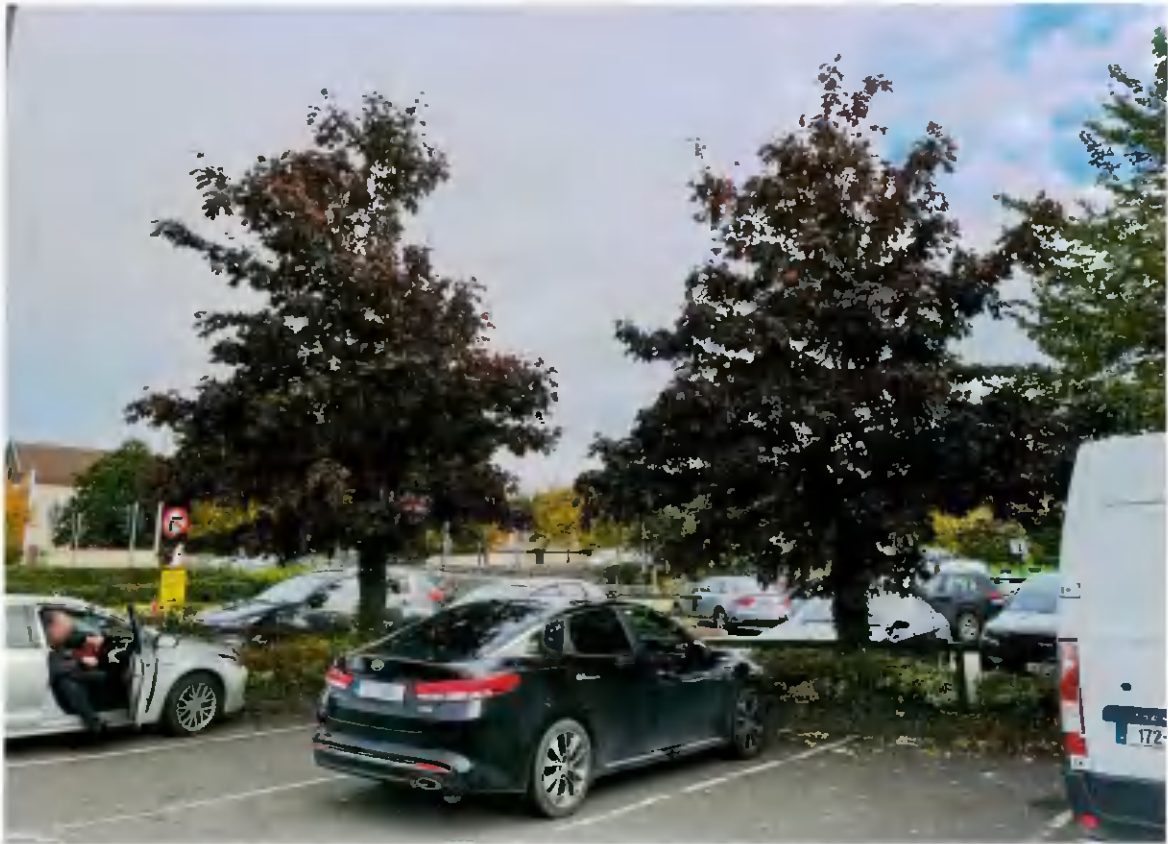
Image 5. Norway maple within a central area of the Lucan Shopping Centre car park.

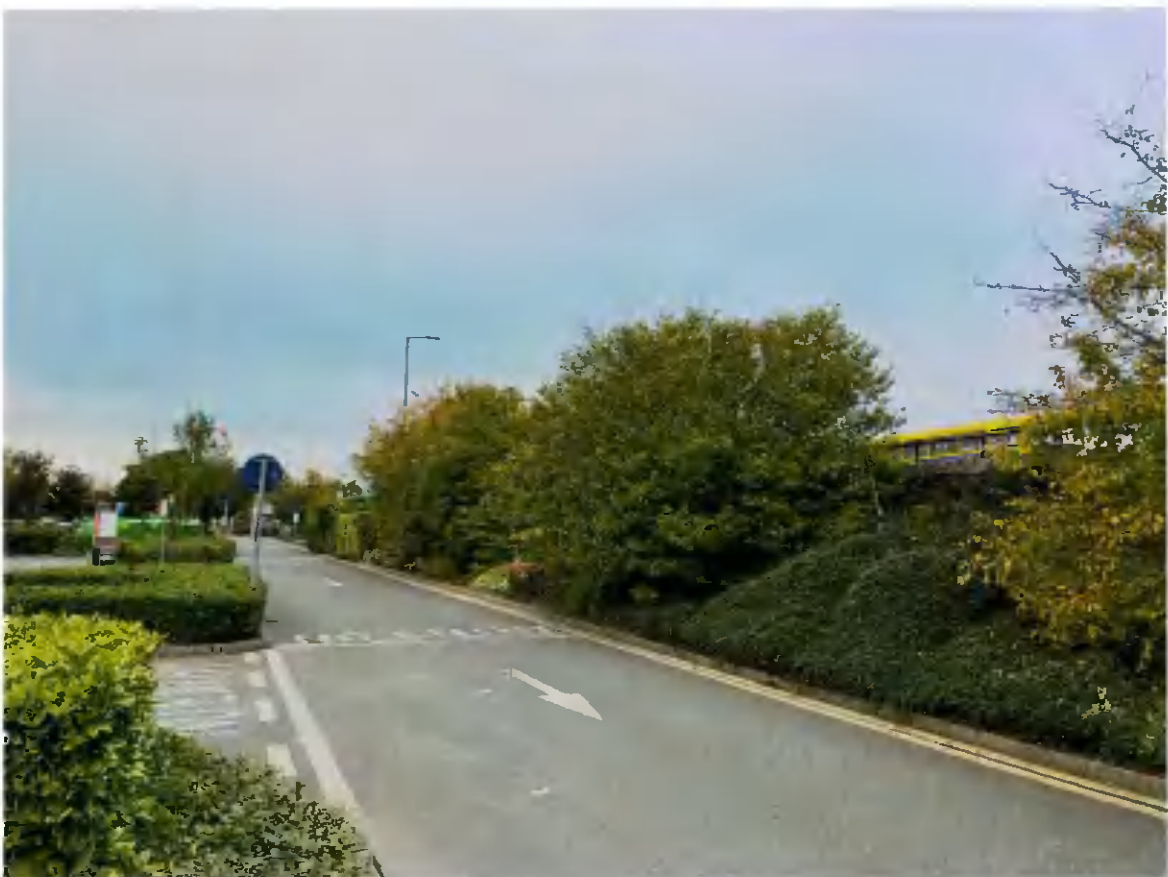
Image 6. Seven early mature hornbeams that form a gappy hedge parallel with Newcastle road (Group #501).

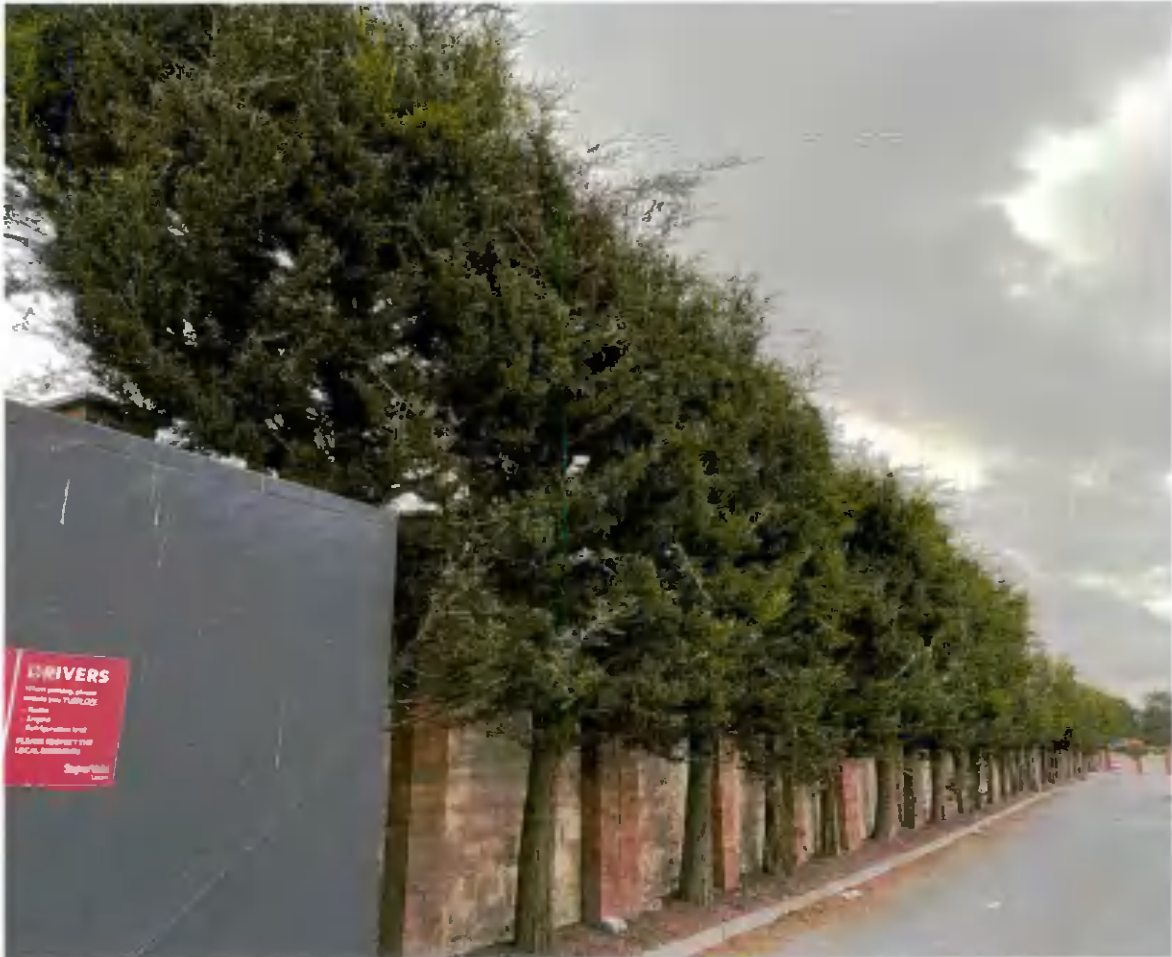
Image 7. Row of leyland cypress on the southern boundary with Westbury Drive (Group #502).

502	Leyland cypress ( <i>Cupressus × leylandii</i> )	Fair	Early mature	C	A group of 31 Leylands on the surveyed sites southern boundary that form a hedge with the Westbury housing estate. Appear to be suffering drainage issues.	Review drainage	10-20	190 (avg.)	4	N/A	0.5;0.5;0.5;0.5
503	Ash ( <i>Fraxinus excelsior</i> )	Fair	Young	C	Minor bark damage west with no associated decay.	No action necessary	10-15	200	7	2e	1;1.5;1;1
504	Small leaf lime ( <i>Tilia cordata</i> )	Good	Early mature	B	Well developed with no visible defects.	No action necessary	20-30	190	7	3w	2;3;2;2
505	Small leaf lime ( <i>Tilia cordata</i> )	Good	Early mature	B	Well developed with no visible defects.	No action necessary	20-31	180	7	3.25e	2;2;1;1
506	Small leaf lime ( <i>Tilia cordata</i> )	Good	Early mature	B	Well developed with no visible defects.	No action necessary	20-32	160	6	3.5e	2;2;1;1

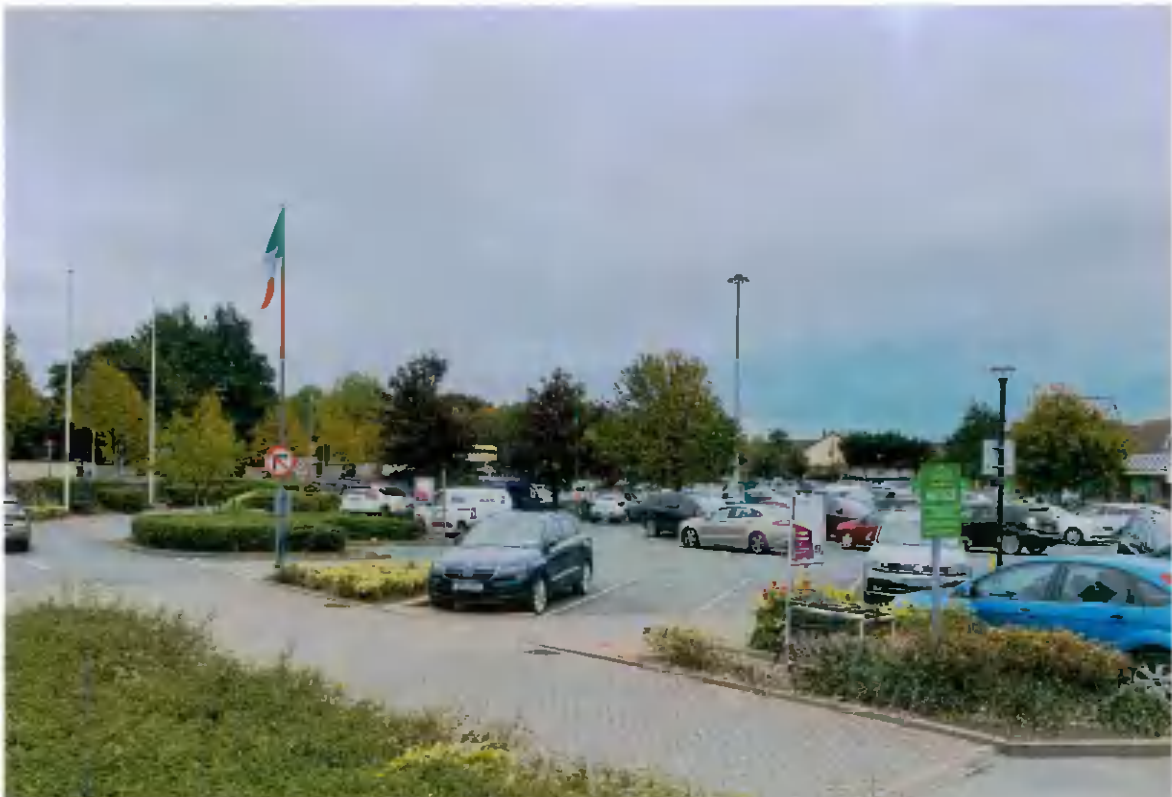
Image 8. Centre of car park with Norway maple and small leaf lime centre (Group #479-481).

480	Norway maple ( <i>Acer platanoides</i> ) crimson king CV	Good	Early mature	B	Located within a raised planting area 1m wide between two lengths of parking bays. Ivy extended into lower canopy. No visible defects.	No action necessary	20-30	260	8	2n	3;3;3;3
481	Small leaf lime ( <i>Tilia cordata</i> )	Good	Early mature	B	Located within a raised planting area 1m wide between two lengths of parking bays. Ivy extended into lower canopy. No visible defects.	Raise lower canopy over carpark spaces.	20-30	310	9	2n	3;4;3;3
482	Norway maple ( <i>Acer platanoides</i> )	Good	Early mature	B	Located within a raised planting area 1m wide between two lengths of parking bays. Minor included bark at stem union at 2m which is not significant at present. No visible defects.	No action necessary	20-30	240	10	2n	4;3;3;4

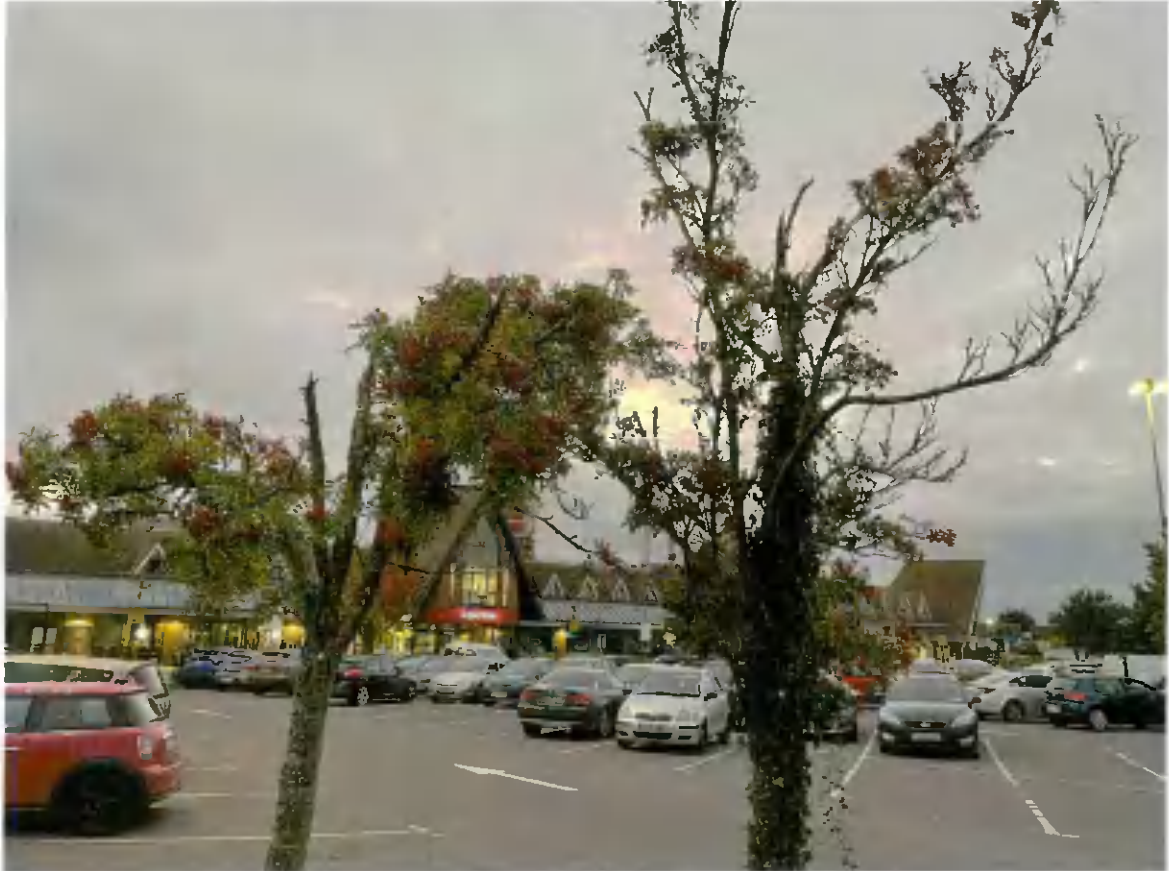
These trees are of is moderate to poor quality. With the mountain ash and purple leaf plum having failed in many cases (images 9-10).

Image 9. Mountain ash (#486 & #487) in a state of decline due to pruning activity.

487	Mountain ash ( <i>Sorbus aucuparia</i> )	Poor	Early mature	C	Located within raised planting area at the end of a parking bay. Damage to central stem, though vigour present in lower canopy.	No action necessary	10-20	190	4.5	1.75s	1;1;1;1
488	Sycamore ( <i>Acer pseudoplatanus</i> )	Fair	Early mature	C	Located adjacent to a low stone wall that borders the Newcastle road. Has been topped to allow line of sight for security camera. No visible defects at present.	No action necessary	10-20	240	5	1s	2;2.5;2;2
489	Norway maple ( <i>Acer platanoides</i> )	Fair	Early mature	U	Located within raised planting area at the end of a parking bay. Tree failed due to bark damage and decay.	Remove	0	220	5	2e	2;2;2;2
490	Purple Leaf Plum ( <i>Prunus Cerasifera Nigra</i> )	Fair	Early mature	U	Located within raised planting area at the end of a parking bay. Tree failed due to bark damage and decay.	Remove	0	190	6	2e	0;2;2;0

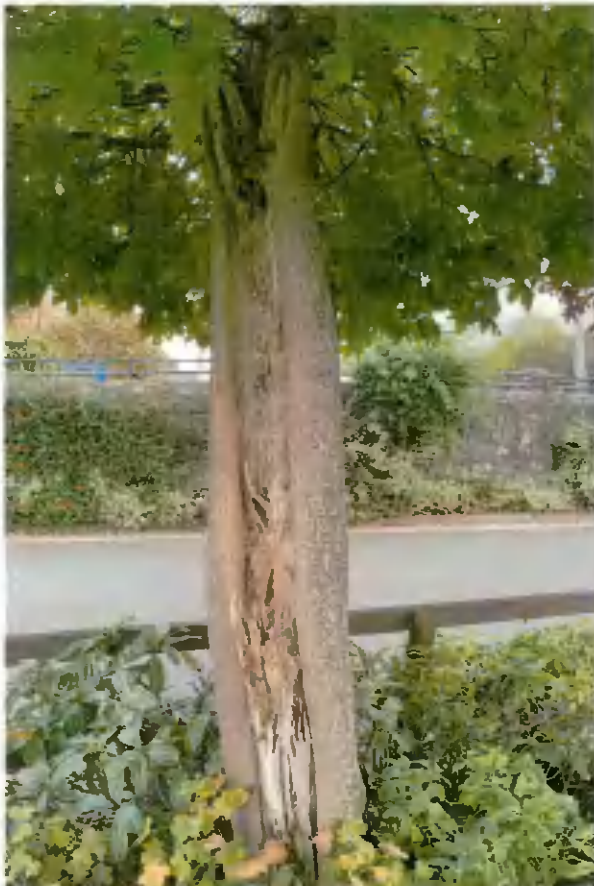
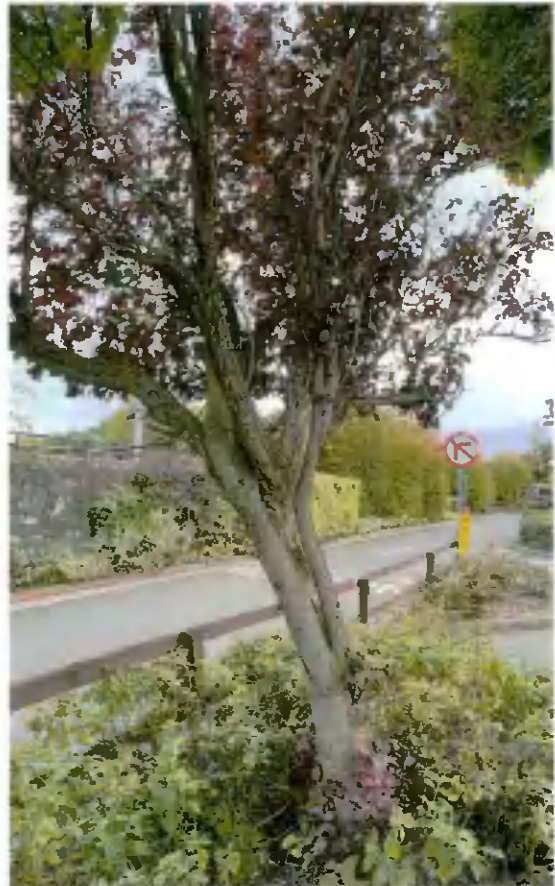
Image 10. Norway maple (#489) and Purple Leaf Plum (#490) which have failed.
