**Arboricultural Report  
Trees at Proposed Site at  
Boden Villas  
Taylors Lane  
Ballyboden  
Dublin 16  
January 2022**

**The Tree File Ltd  
Consulting Arborists  
Ashgrove House  
Kill Avenue  
Dun Laoghaire  
Co Dublin  
01-2804839**

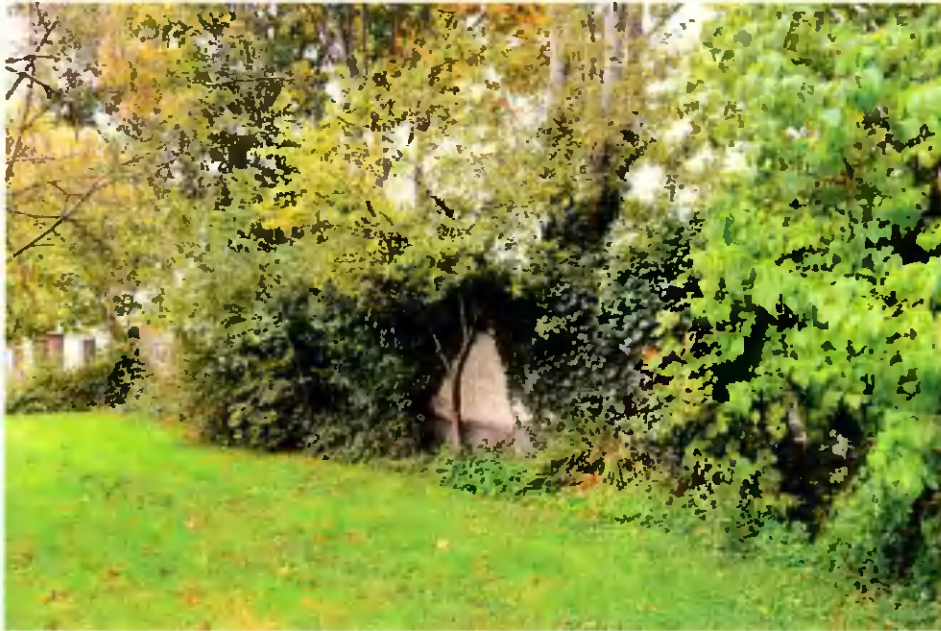
**Fig 1**

The excavation was undertaken at a position inside the site but perpendicular the tree no.3 The small Plum was removed to facilitate the dig.

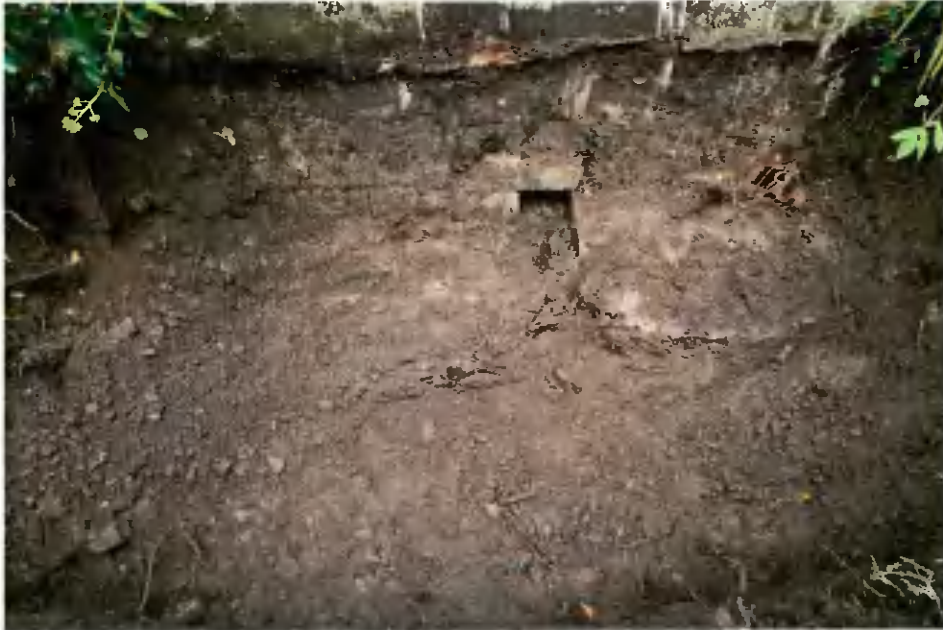
**Fig 2**

- 4.6 The excavation illustrated that with one exception, the wall structure had prevented tree root access. This related primarily to the depth to which the wall and its foundation extended. The only exception to this related to one root that had penetrated the mortar joint between the wall and the foundation.

The excavation extended to circa 650mm below garden levels and more than 1 metre below roadside verge levels. The excavation found and extended below wall foundation levels, so as to identify any root material as might pass beneath the wall footing.

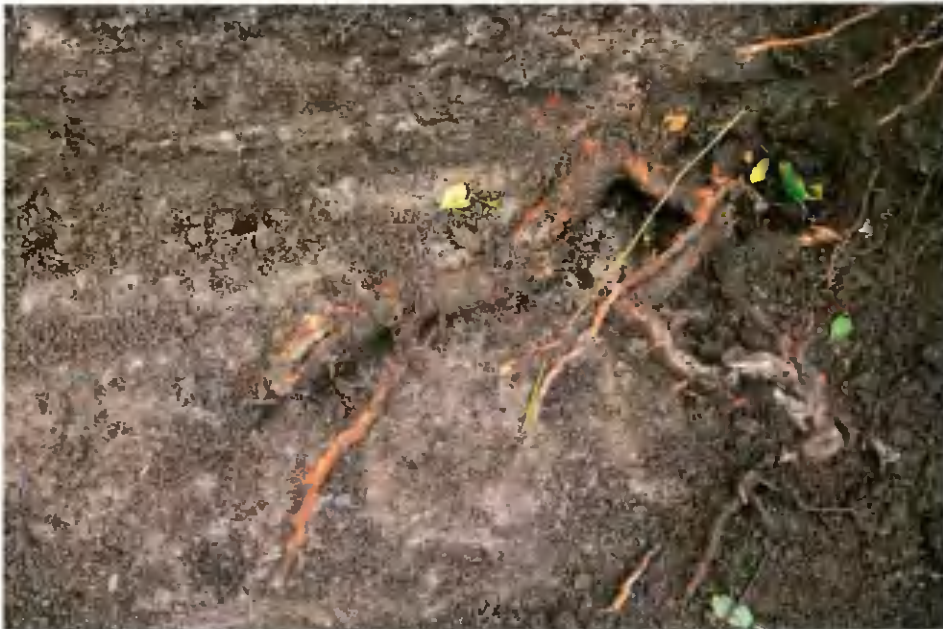
**Fig 3**

The only root material entering from outside of the site, had passed through the mortar at the joint between the wall base and the wall foundation. This suggests poor workmanship as well as a likely cause of wall damage over time.

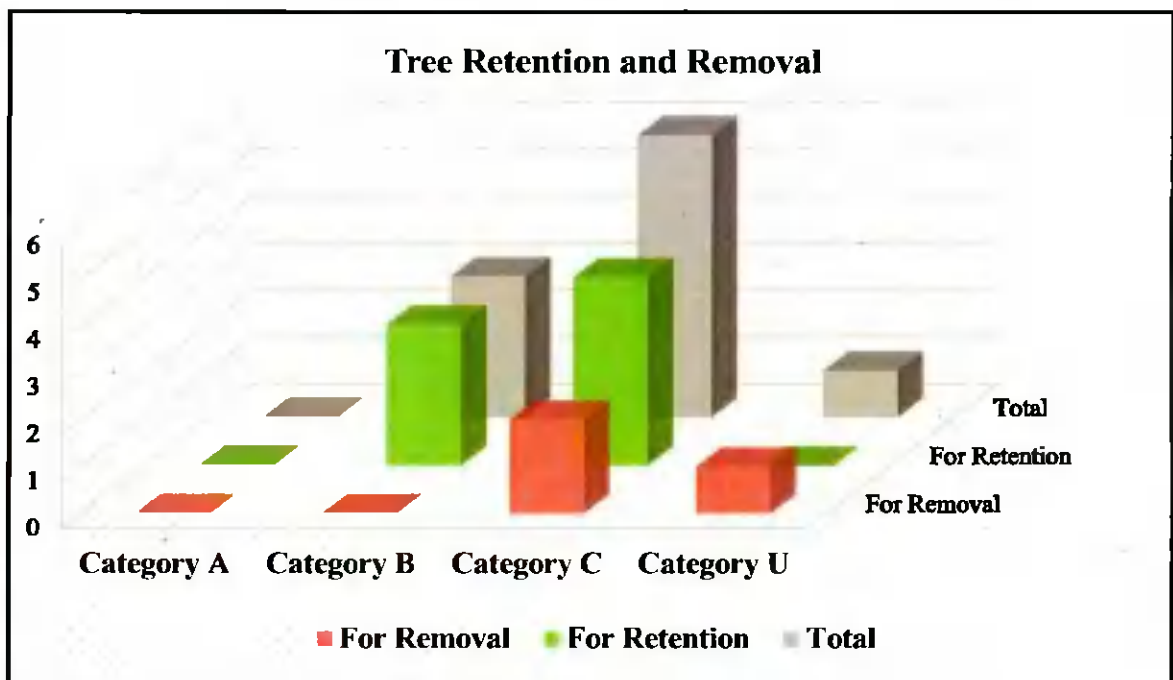
Fig 5 Graphic Representation of Tree Loss/Retention Scenario

10.5 Of the site's ostensibly retainable trees, the proposed works would require the removal of 2no. Category "C" trees.

10.6 Notwithstanding the above, it must be noted that each of the 6no. roadside Maples are of dubious sustainability. They stand outside of the site's jurisdiction and therefore cannot be removed. Nonetheless, the issues noted in this report would suggest that they are not suitable for retention, and that removal and replacement with a more suitable alternative would offer a better and more sustainable approach.
