Arborist Associates Ltd.

An Arboricultural Assessment on the Site Area for the 'Edmondstown SHD Application', Whitechurch Road, Rathfarnham, Dublin 16.

Prepared for: BCDK Holdings Ltd. & Coill Avon Ltd.

Date: 10th December 2021

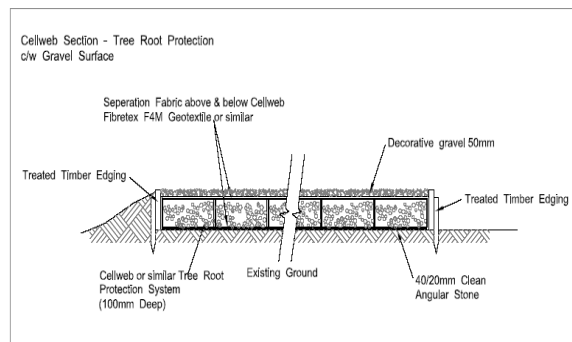
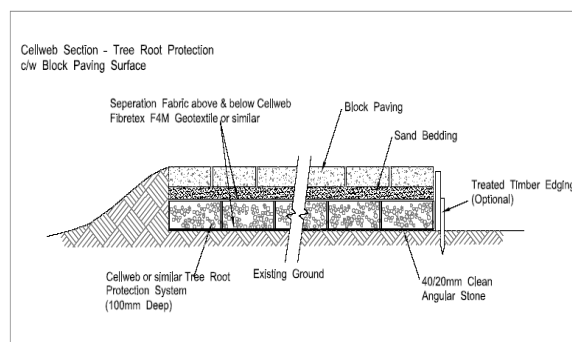
Pictures show the Cell Web being installed on the ground.
The below diagram shows how the Cellular confinement system should be installed.

Step 5 – Place the infill material of a 20-40mm clean sharp stone in the open cells of the Cell Web pushing the infill ahead of you so that the machinery is driving on the filled Cell Web. Compact the infill material to the desired density.

Step 6 – Slightly surcharge the Cell Web product with 25mm of 40/20mm clean angular stone.
