**ARBORICULTURAL ASSESSMENT
&
IMPACT REPORT**

EDMONDSTOWN SHD

KILMASHOGUE

Project No.	Project name	Date	Revision
TEDM001	Edmonstown SHD	09/03/22	-

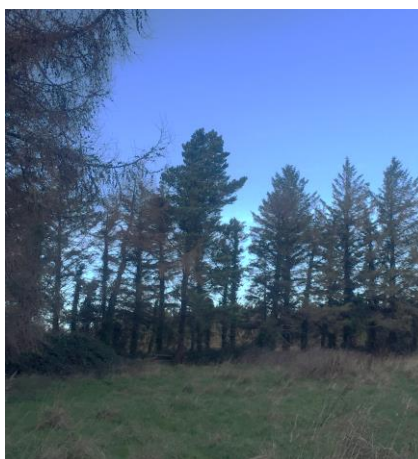
The main group of trees are those on the southern and western boundaries (images 2 & 3). These are screen / shelter-belt plantings mainly composed of coniferous species including Douglas fir (*Pseudotsuga menziesii*), Larch (*Larix decidua*), Sitka spruce (*Picea sitchensis*). There are also occasional poplar (*Populus* spp) with a now mostly dead or poorly developed element of birch (*Betula pendula*) within the mix. Monterey cypress (*Cupressus macrocarpa*) is also represented within the shelter-belt planting and as individual trees and small groups in various locations. There has been no effective management of these trees with the result that their condition is mixed with competition causing the poor development of some specimens (image 4). The planting provides screening, shelter and acts as a noise buffer so is a valuable resource overall. However it requires appropriate management to improve its quality and effectiveness.

Image 2. Section of shelter-belt on southern boundary

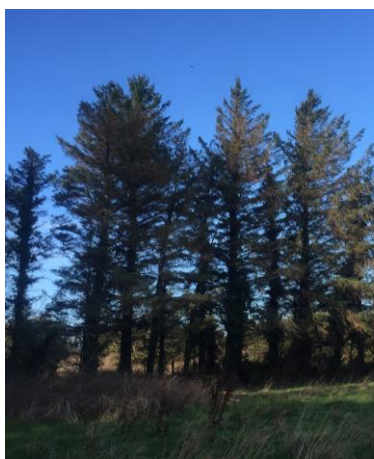
Image 3. Section of shelter-belt on western boundary

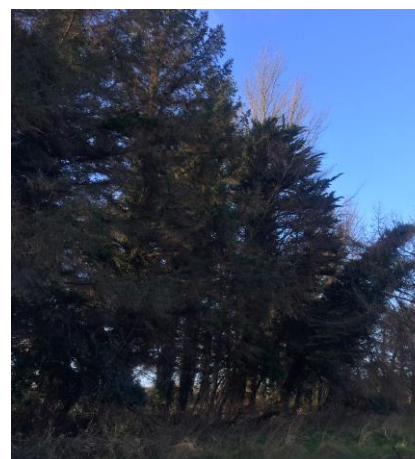
Image 4. Southern and western sections of shelter-belt. Note larch in a state of collapse

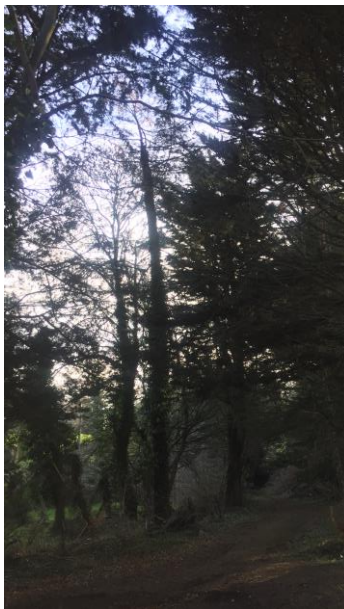
Monterey cypress form the main species along the upper section of the southern edge of the access road (image 5). Again, these trees provide a valuable resource in terms of screening and shelter but due to the dense nature of the planting are in need of management to thin out poorer specimens. This species is also noted for limb failure during storm events therefore appropriate management is crucial for their long-term potential.

Image 5. Monterey cypress along the southern edge of access road

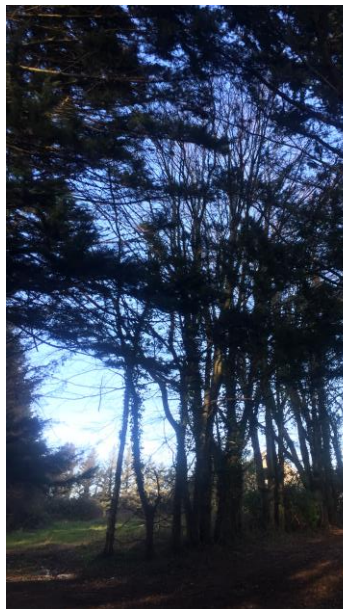
A beech hedge at the entrance to the house has long been allowed to develop without appropriate management with the result that the individual trees are generally drawn and poorly formed due to competition between specimens (image 6). To the east of the house a planting of Leyland cypress (*Cuprocyparis leylandii*) appears to have been planted as a screen (image 7). It is composed of 4 specimens which are developing into trees. None are of particular merit with one specimen in decline.

Image 6. Beech 'hedge' near house. Note competition induced form.

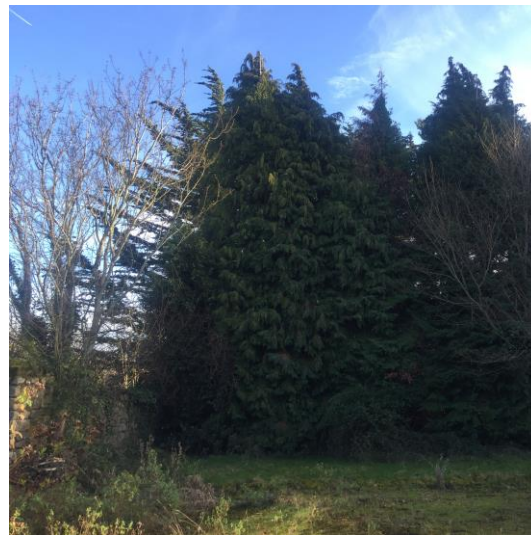
Image 7. Leyland cypress within garden area

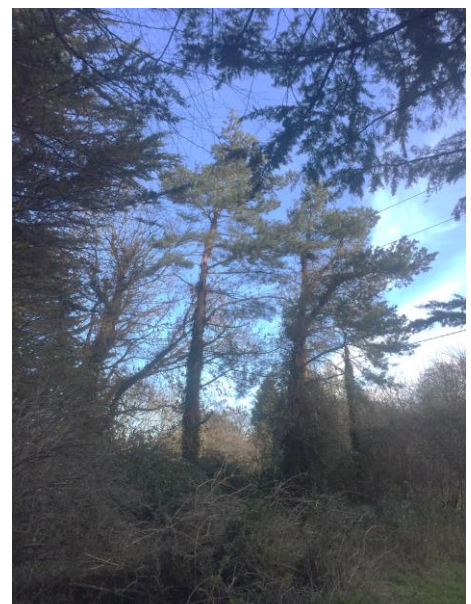
Two Scots pine (*Pinus sylvestris*) are located on sloping ground to the east of the site. These trees have landscape value within an appropriate setting and are in keeping with the upland nature of the site (image 8).

Image 8. Scots pine #2065 & 2066

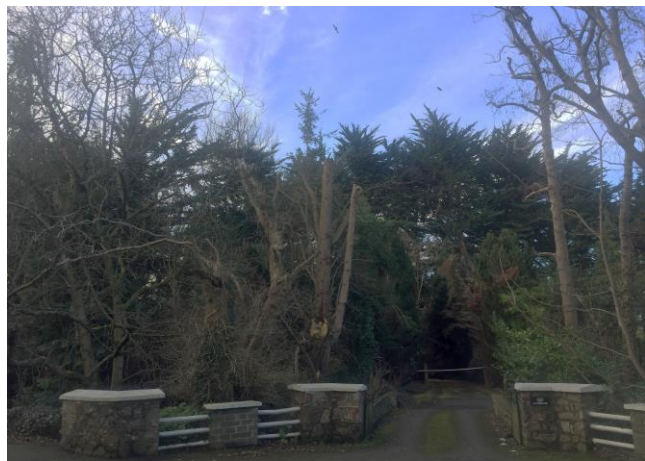
There are a number of trees on the section of the site the borders Whitechurch Road. These are a mixture of native / naturalised self-seeded deciduous species and a section of the screen / shelter-belt coniferous planting. The quality of the trees is generally poor with the deciduous trees #2045 & 2046 low value (category C) with structural issues and elements of decay which limit their long-term potential. The section of coniferous planting in this area is in very poor condition and mostly in a state of collapse or decline due to lack of management (category U).

Image 9. Entrance to site. Note poor quality of blue moss cypress trees #2049 and storm damage to Monterey cypress #2046
