The scope of this CCTV Survey / Investigation to determine no Surface Water enters the existing 900mm diameter Culvert with the demise of the site development denoted as Point E below from the existing Old Mill Drainage Channel flowing from west to east through Points A, B and E:-

Project Name: douglas and stewart con23198

Project Date: 4/19/2022

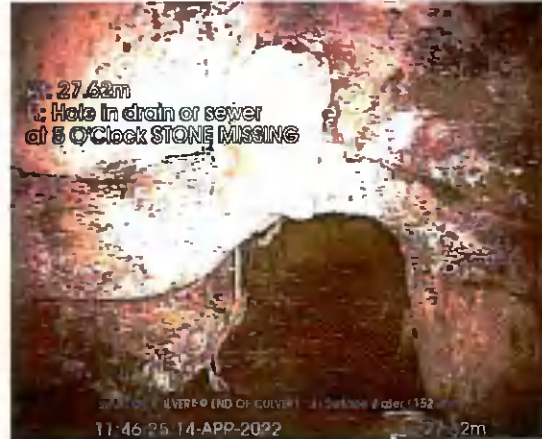
START OF CULVERT US TO END_27-62m_114555.jpg,
00:08:44, 27.62 m
Hole in drain or sewer at 3 o'clock, STONE MISSING

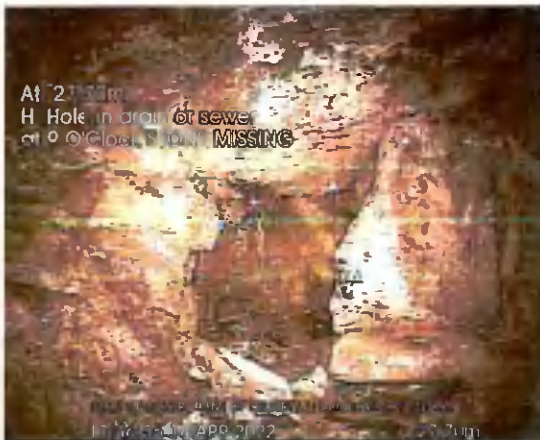
START OF CULVERT US TO END_27-62m_114625.jpg,
00:08:49, 27.62 m
Hole in drain or sewer at 5 o'clock, STONE MISSING

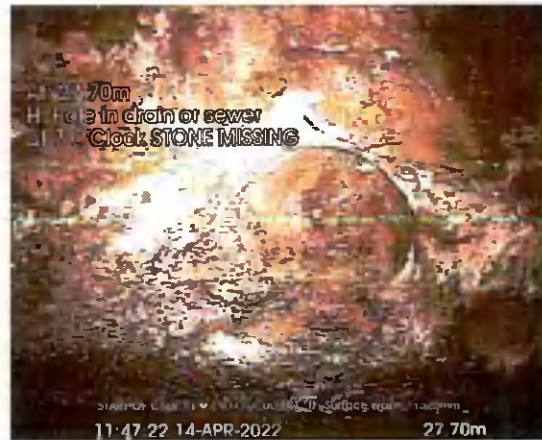
START OF CULVERT US TO END_27-70m_114655.jpg,
00:09:01, 27.70 m
Hole in drain or sewer at 9 o'clock, STONE MISSING

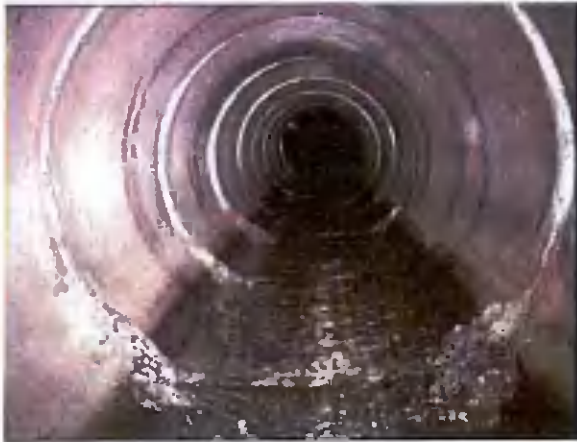
CULVERTX_48eba245-cec1-4feb-a1db-320766e1c5b2_2022
 0329_104036_757.jpg, 00:00:42, 0.97 m
 Settled deposits, hard or compacted at joint, 5%
 cross-sectional area loss, start

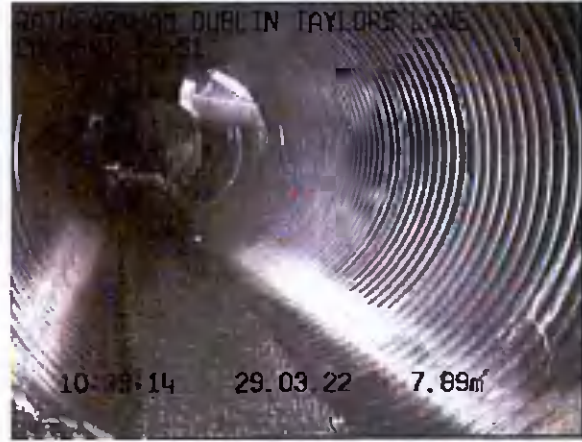
CULVERTX_6f57a131-da16-41a9-9b17-a8bc14d7d968_2022
 0329_104149_390.jpg, 00:01:19, 7.89 m
 Pipe material changes to polypropylene at this point

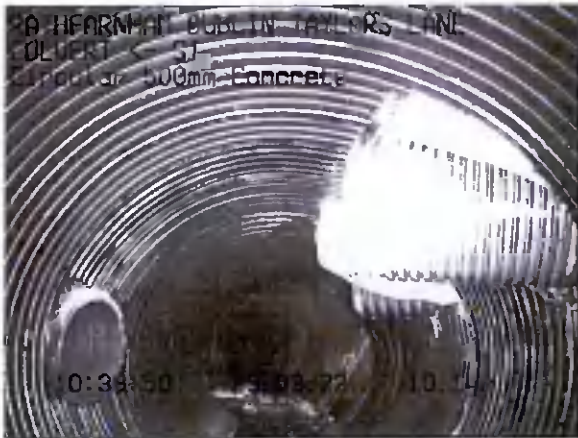
CULVERTX_a9b2f890-dc0d-4c0c-8ca4-898a1a8e911e_20220
 329_104225_728.jpg, 00:01:39, 10.14 m
 Connection defective, connecting pipe is intruding at 2 o'clock,
 225mm dia, intrusion: 15%

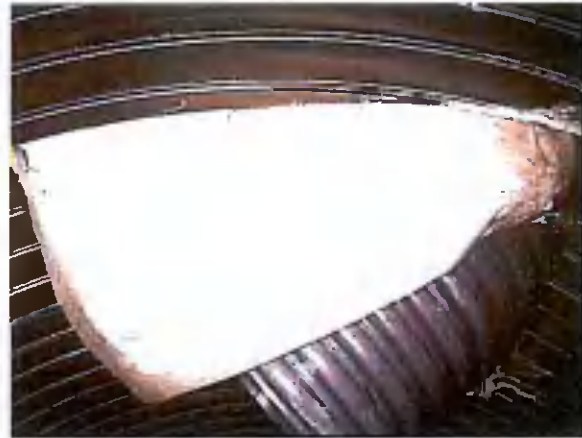
CULVERTX_e39f477b-5958-4e6a-b631-86e679e6465d_2022
 0329_104457_213.jpg, 00:02:30, 11.48 m
 General remark, ROCK INTRUDING INTO PIPE

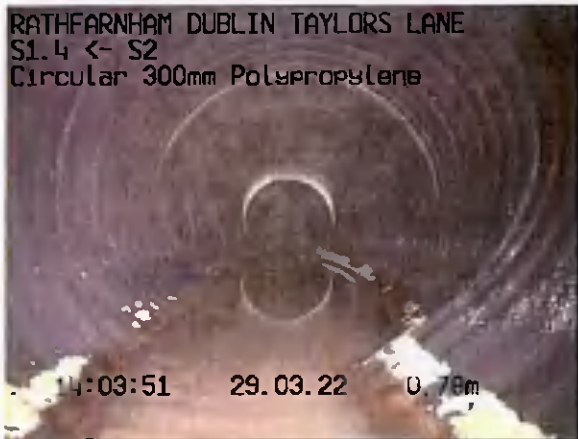
S1.4X_d2016815-55fb-4ec1-a17c-6af5c72a6526_20220329_1
 40627_546.jpg, 00:00:21, 0.78 m
 Deformed sewer or drain, 5%

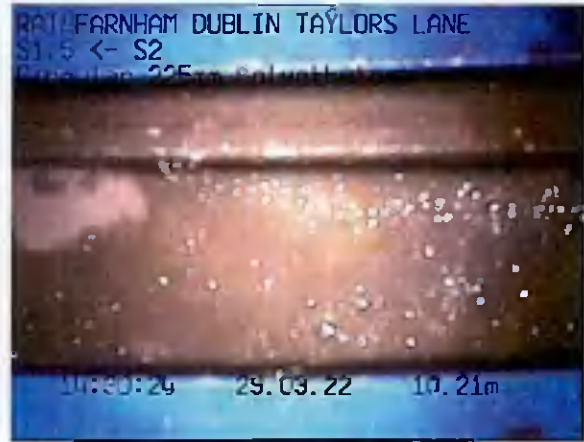
S1.5X_e49f8bd9-b689-4d84-8727-58ddcba34920_20220329_143300_016.jpg, 00:01:55, 10.21 m
 Open joint, medium

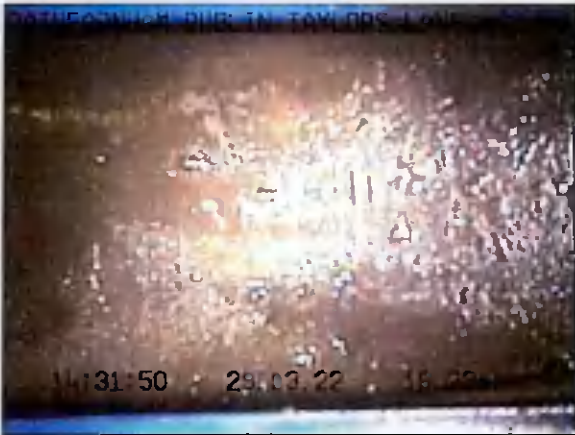
S1.5X_50f16f44-8b2b-41d9-bf27-89650614e110_20220329_143426_104.jpg, 00:02:54, 16.23 m
 Open joint, large

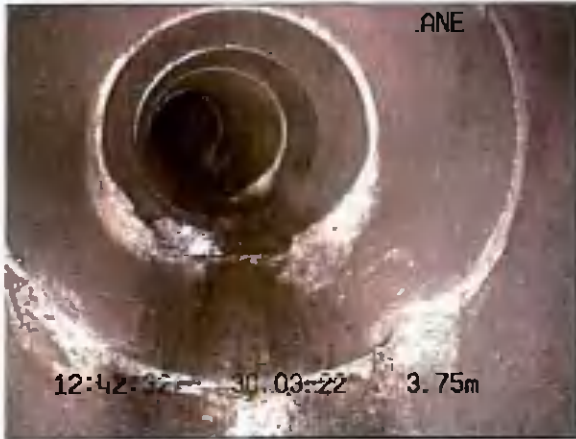
S6X_2c89ba3a-d39c-4a24-869f-47e9db03a731_20220330_1
24509_496.jpg, 00:00:53, 3.75 m
Settled deposits, hard or compacted at joint, 5%
cross-sectional area loss, start

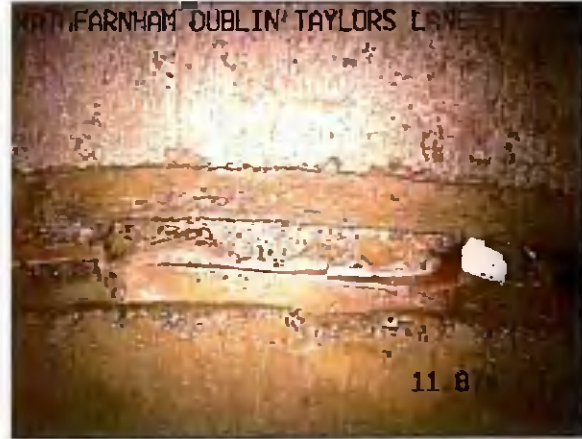
S6X_e184c169-363a-4da8-88e6-14cf39badc3a_20220330_12
4638_960.jpg, 00:02:19, 11.87 m
Open joint, large

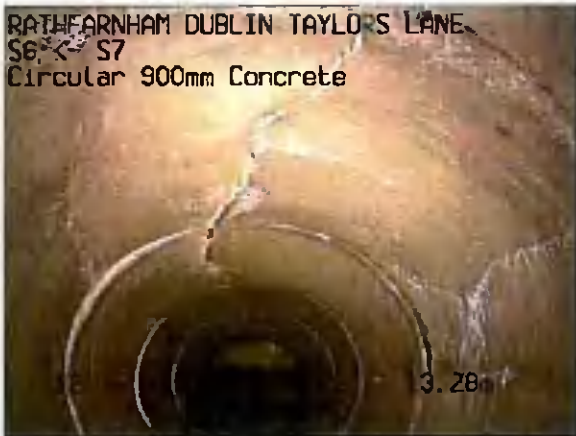
RATHFARNHAM DUBLIN TAYLORS LANE
S6X S7
Circular 900mm Concrete
S6X_7f8de206-7f78-4a4a-8268-73c4d8761dac_20220330_12
4723_357.jpg, 00:02:42, 13.28 m
Crack, longitudinal at 10 o'clock

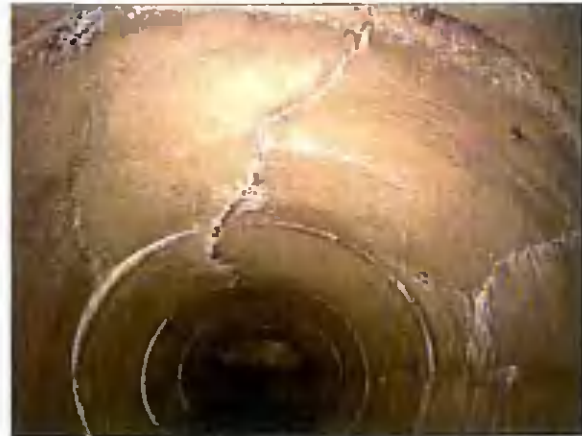
S6X_bc99ee6a-22e3-4f6c-b082-614ea2d5b775_20220330_1
24738_566.jpg, 00:02:45, 13.28 m
Crack, longitudinal at 3 o'clock

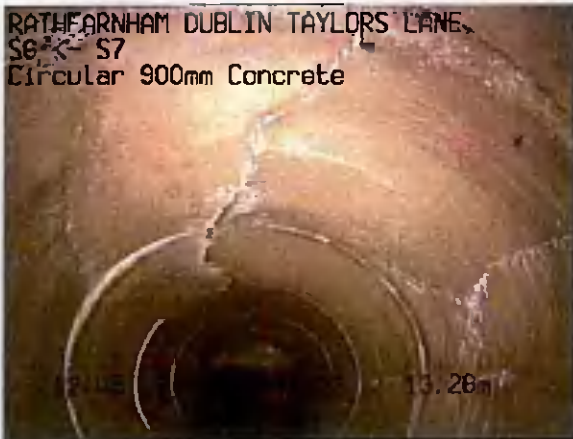
S6X_5c0d0b39-e48c-4253-82f3-0e5c4f26af42_20220330_124752_449.jpg, 00:02:49, 13.28 m
 Crack, longitudinal at 4 o'clock

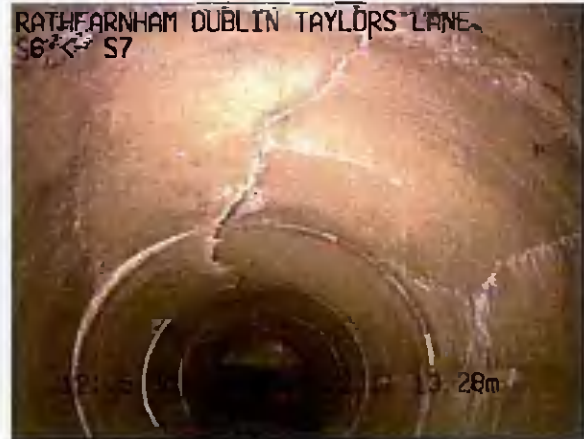
S6X_7eb2e6a5-88f2-4002-b479-51d6eb647213_20220330_124806_940.jpg, 00:02:53, 13.28 m
 Crack, longitudinal at 12 o'clock, start

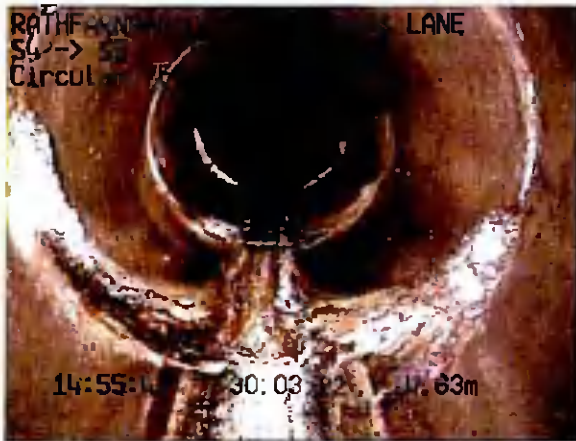
S4X_25e9246a-2b80-4a34-a92a-f87247c0ce68_20220330_1
 45824_162.jpg, 00:00:35, 4.63 m
 Settled deposits, hard or compacted at joint, 5%
 cross-sectional area loss

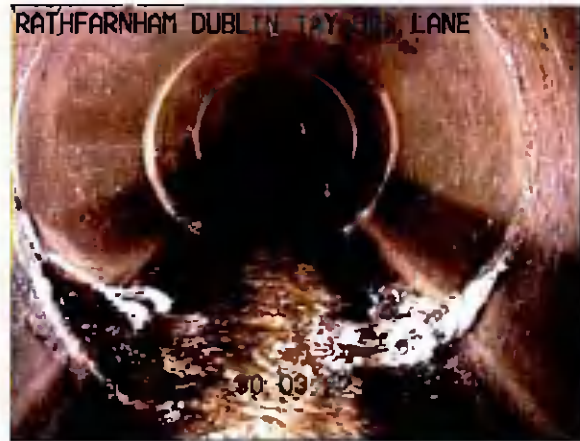
S4X_cbc53040-6ae0-42cf-a44c-890966af4f43_20220330_145
 850_844.jpg, 00:00:57, 8.11 m
 Settled deposits, hard or compacted at joint, 5%
 cross-sectional area loss

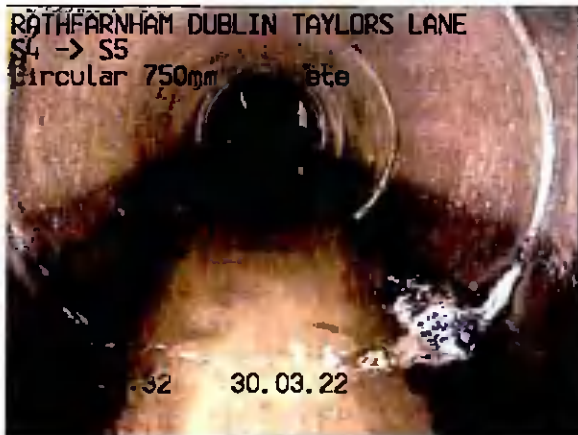
S4X_8730c800-cb5c-41e8-b48b-5606efc9a2ca_20220330_14
 5908_327.jpg, 00:01:09, 9.84 m
 Settled deposits, hard or compacted at joint, 5%
 cross-sectional area loss

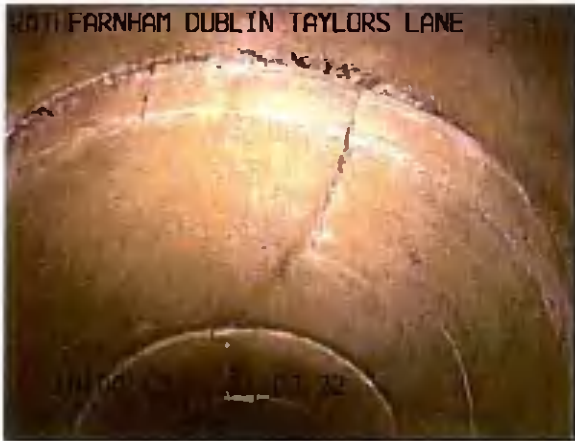
S5X_183cbfbc-eafe-4075-8f26-a2a1f653bb64_20220331_100250_351.jpg, 00:01:28, 4.39 m
 Fracture, longitudinal at 12 o'clock, start

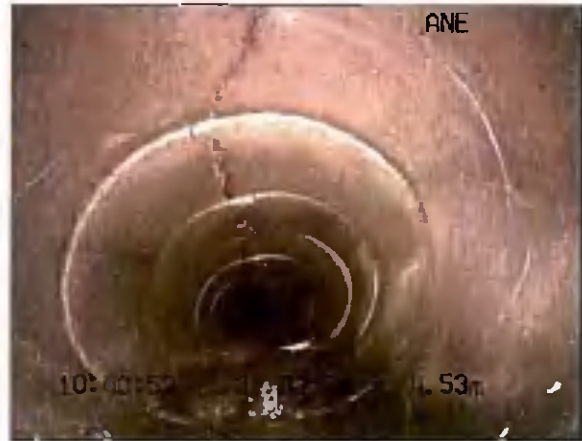
S5X_7dd5fbb8-d536-49ae-93d3-42e36104fe12_20220331_100329_720.jpg, 00:01:53, 4.53 m
 Crack, circumferential from 9 o'clock to 11 o'clock

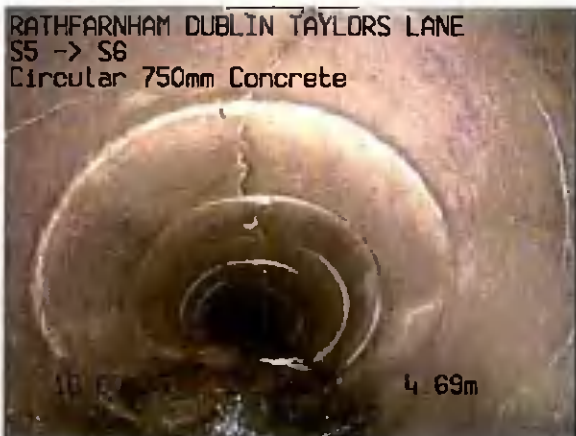
S5X_70bcc9d2-7e16-46d6-ac68-2d55e5bc361e_20220331_100312_436.jpg, 00:01:42, 4.69 m
 Crack, circumferential from 2 o'clock to 4 o'clock

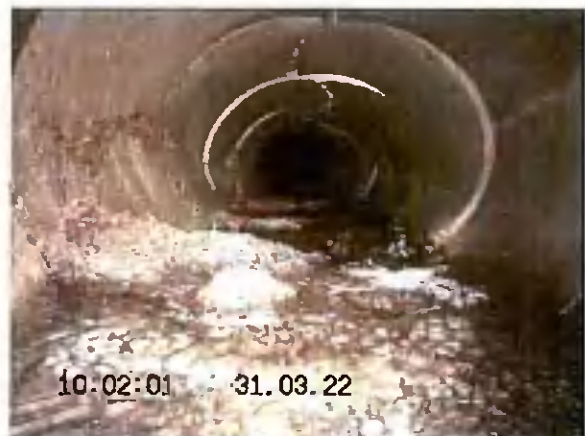
S5X_a89bf5fe-b788-48ab-b650-d55207f2059_20220331_100438_511.jpg, 00:02:25, 6.15 m
 Roots, mass, 25% cross-sectional area loss, start, ROOTS

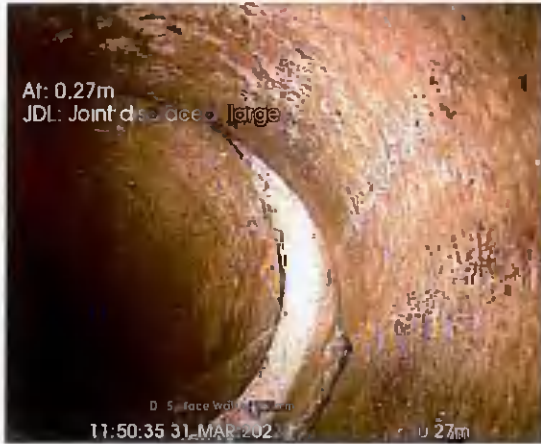
G1 DS S4_0-27m_115035.jpg, 00:00:07, 0.27 m
 Joint displaced, large

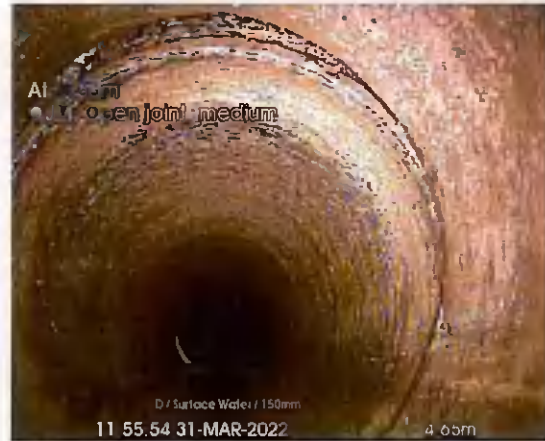
G2 DS S4_4-65m_115554.jpg, 00:00:26, 4.65 m
 Open joint, medium

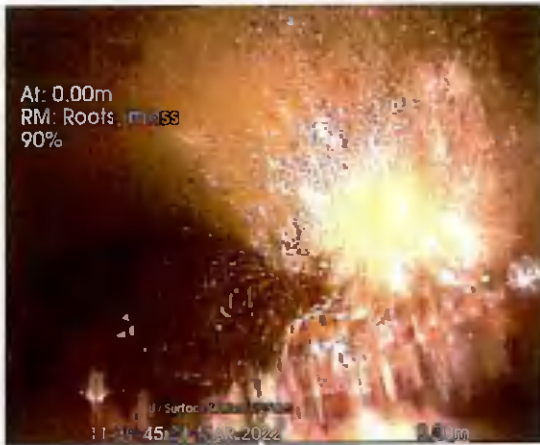
S5 US LINE2_0-00m_113945.jpg, 00:00:02, 0.00 m
 Roots, mass, 90% cross-sectional area loss
