**An Arboricultural Assessment of the Site Area at Adamstown Boulevard,  
Adamstown, Co Dublin (Phase 1)**

**Prepared for: Adamstown Station & Boulevard Limited (The applicant)**

**Prepared by: Noel Lane, Certified Arborist, MSIF National Dip in Science  
(Forestry)**

**Date: 16/02/2022**

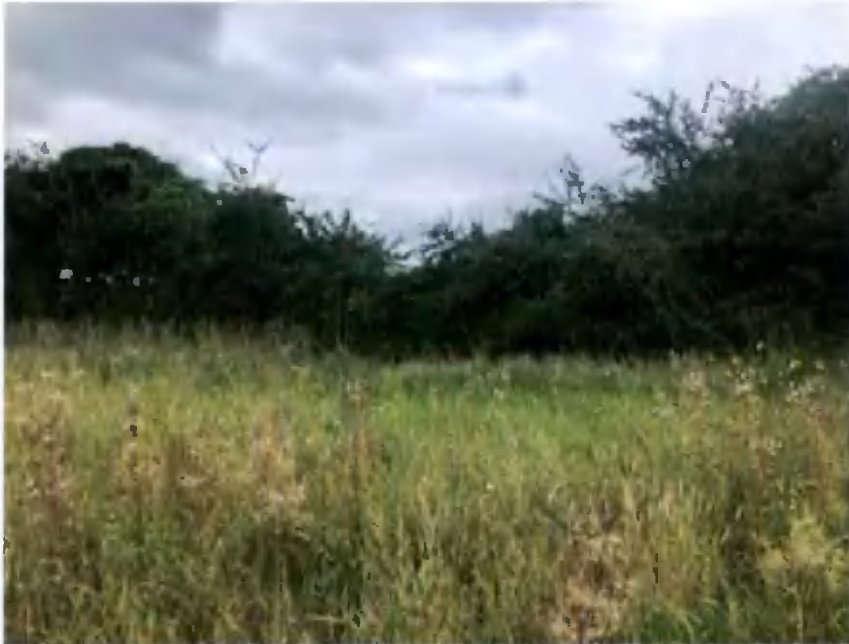
Hedgerow - H1

Section of Hedgerow H1 with blackthorn, ivy, and bramble

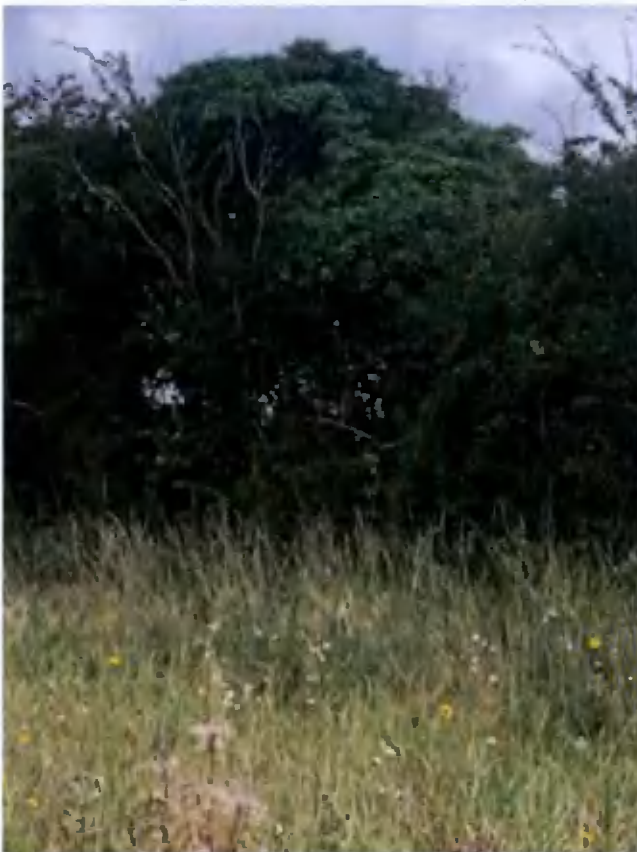
Some hawthorn trees heavily laden with ivy

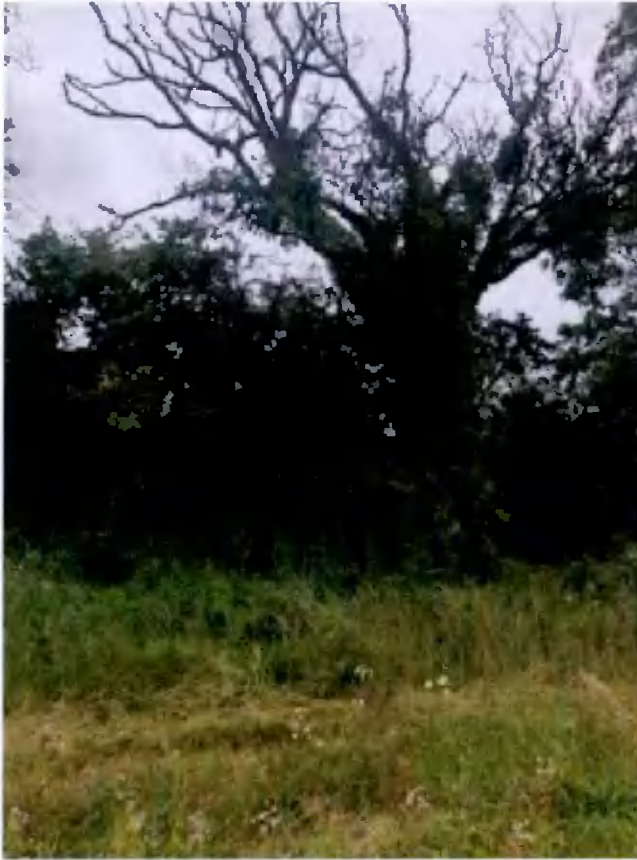
The ash trees have ash dieback disease and in decline. It is inevitable that those ash will continue to deteriorate and eventually die completely within a few years.

Ash trees along H1 with ash dieback disease are in decline and dying

It is recommended to remove the remaining ash trees due to ash dieback disease including 1514, 1515, 1516, 1517, 1518, 1519 and 1520

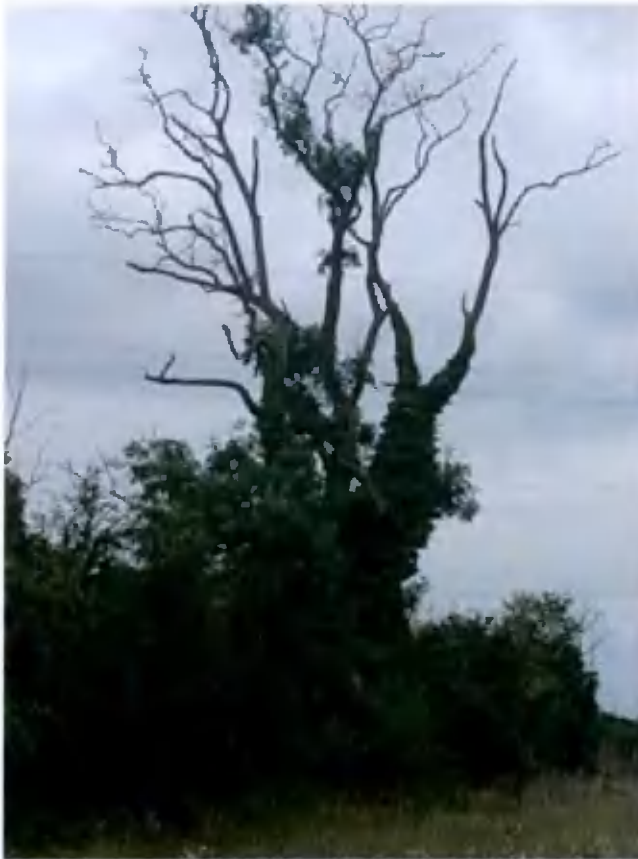
Typical ash tree with ash dieback disease and laden with ivy

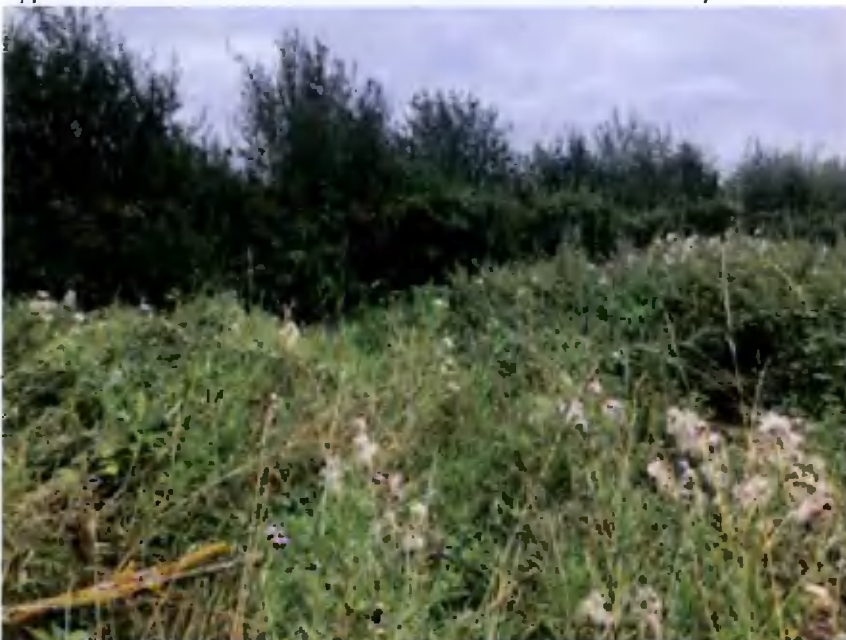
Group of black poplar trees along H1

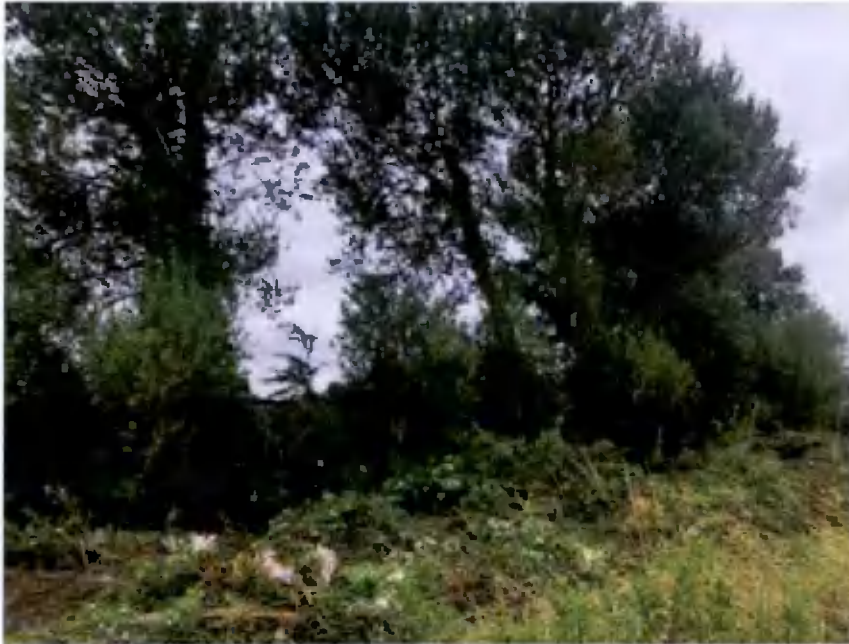
A small number of black poplar trees are present in fair condition but are extremely exposed with fair stability and a moderate lifespan remaining. Several of those black poplar trees were topped and lowered in the past with new coppice growth ongoing.

Black poplar trees in fair condition

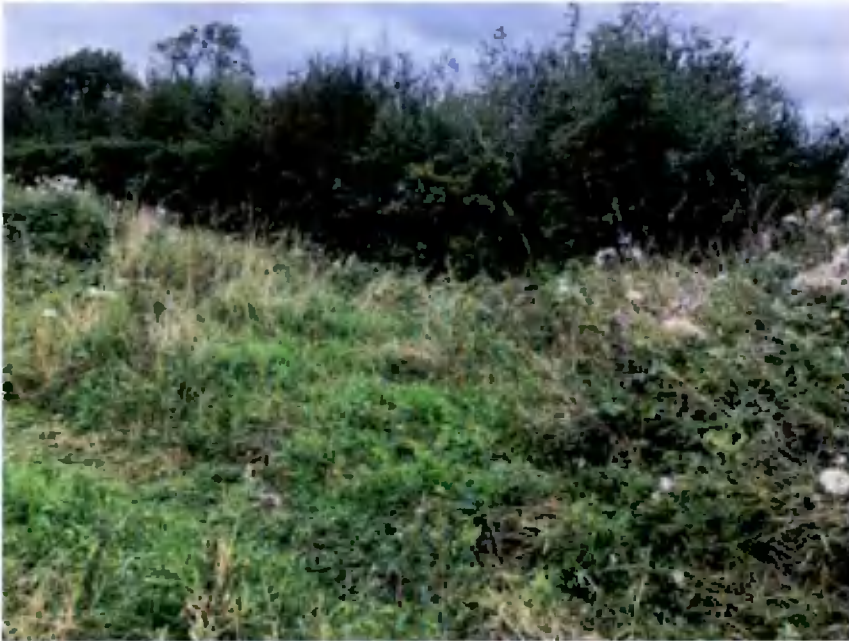
Section of Hi with blackthorn and bramble

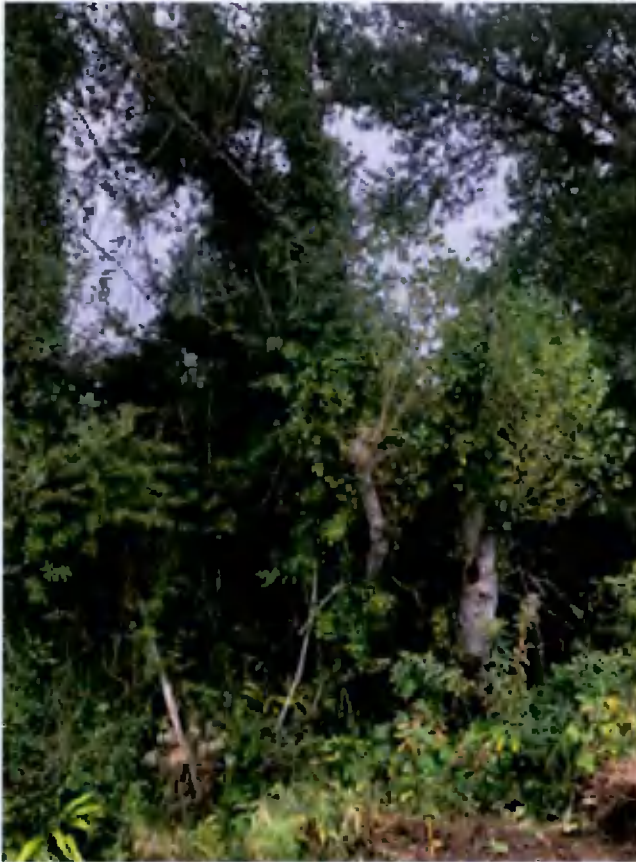
Black polar trees with stems topped and lowered in the past

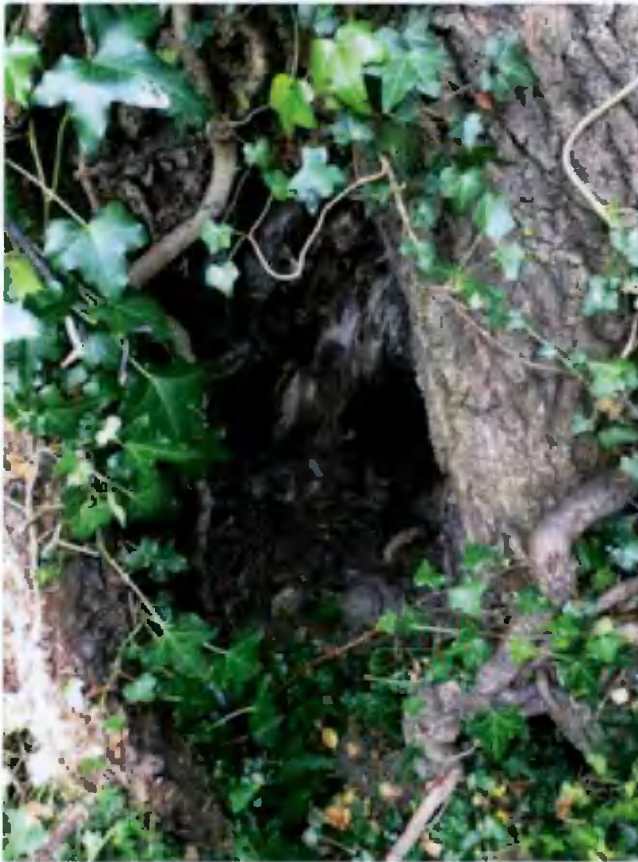
Label 1527 – Black poplar tree with cavity and decay at base of main stem - typical of poplar trees at this location

- 4.4 Saplings of the black poplar trees (Trees 1522 – 1528) will be translocated to a new hedgerow as appropriate. The reader should refer to the accompanying Ecological Impact Assessment Report and the Landscape package for further details.

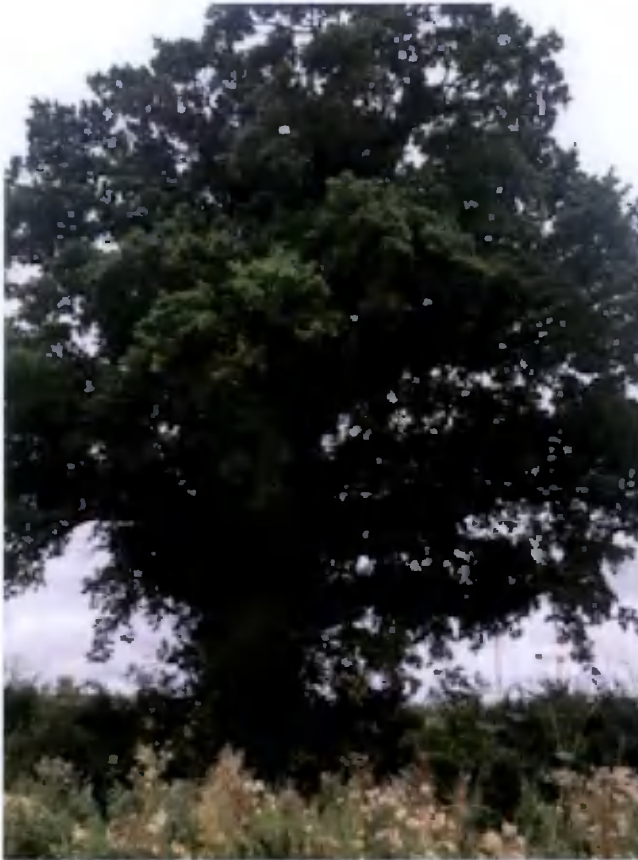
One good quality high amenity and landscape value oak tree – label number 1529 - will be retained.

Label 1529 – Oak tree in fair condition – some minor roots damaged during previous ground clearance operations but should be retained and protected as per attached method statement.

The RPA of label number 1529 must be fully adhered to as specified above.
