Stormwater Soakaway Report

**45 Homelawn Road
Tallaght
Dublin 24**

21/06/2022

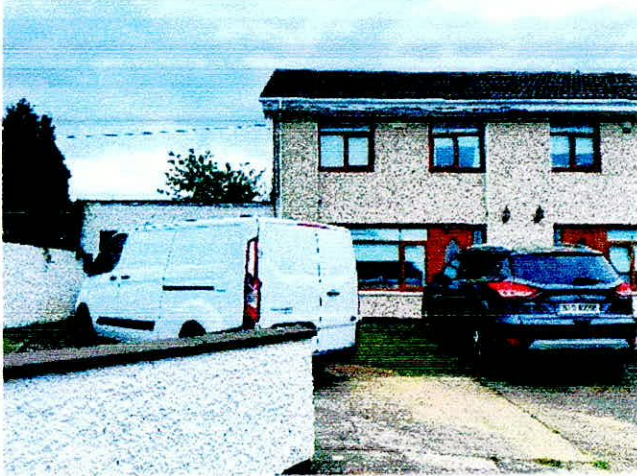
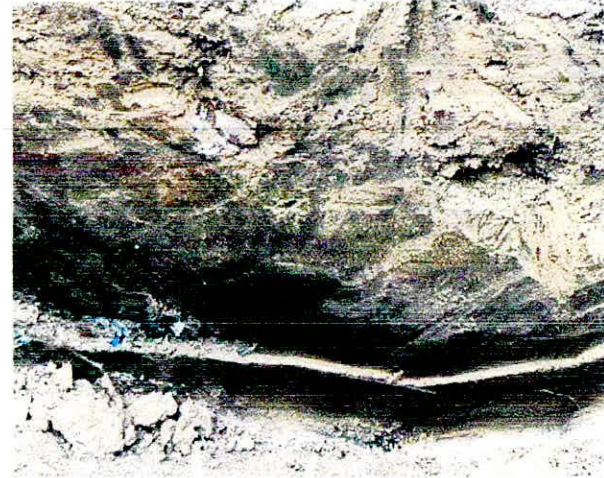
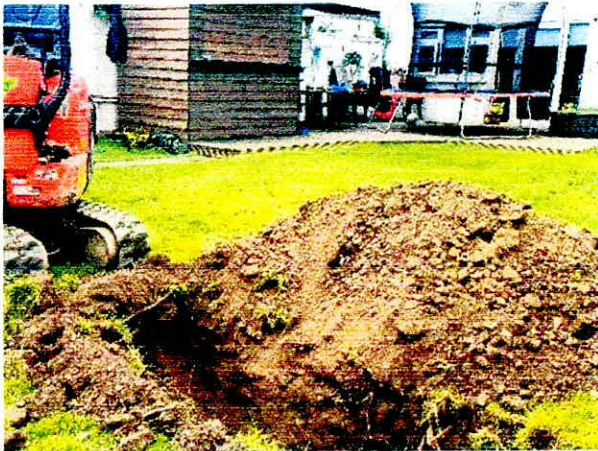
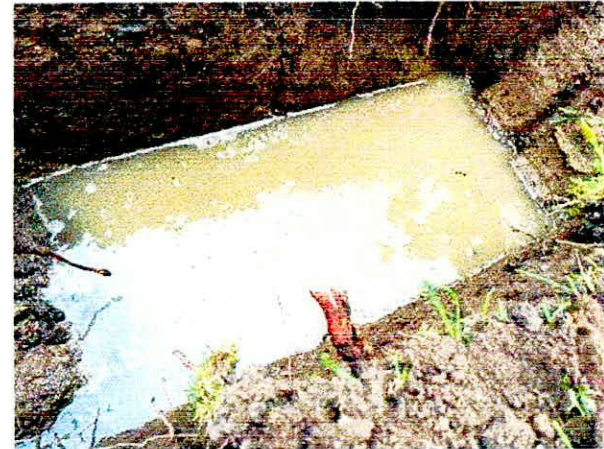
Site Pictures

A test pit was excavated on the site measuring 0.8m wide X 1.4m long X 1.2m deep which revealed a top layer of firm brown slightly gravelly CLAY to a depth of 0.4m which in turn overlies a soil stratum of brown very firm compact slightly gravelly CLAY with occasional cobbles to a depth of 1.2m.

The soil types encountered are likely to have a very low permeable rate due to the very firm compact nature of the soils.

The test hole was saturated to a depth of 0.5m below ground level and monitored for one hour during which time there was no notable drop in the water level.

The soils encountered from ground level to the base of the excavated pit at 1.2m are considered to have very low permeable characteristics and due to the limited available space on the existing site the site is considered unsuitable for a storm water soak-a-way system.

The storm water generated from the proposed extension will need to discharge into the main system along with the existing house.

Permeable paving and drive way is recommended to reduce the hard surface area on the site.

An attenuation tank may be considered if deemed necessary. This would allow for the storm water to be collected in a tank on the site with a controlled discharge to the mains line over a period of time.
