- 3.1 The site was visited by Charles McCorkell on 27 April 2022. The purpose of the visit was to survey trees located on and adjacent to the site which may be of significance to the proposed development. The survey was carried out in accordance with BS 5837:2012 and from ground level only.

190215 - Prospect House

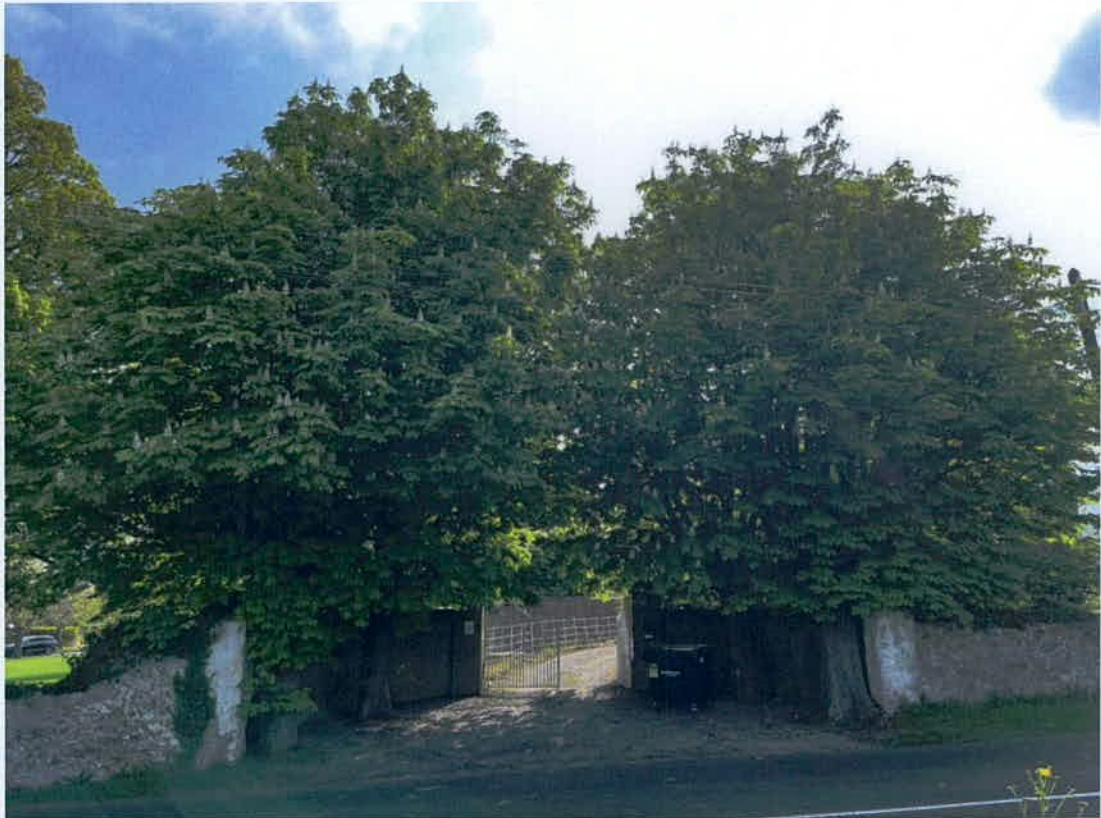
Photo 1: View of the four mature horse chestnut trees (T80-T83) located at the main site entrance.

Tree T80	1 Aesculus hippocastanum (Horse Chestnut)	13.0	60	1	4.0	5.0	5.0	2.0				2.0		Mature	Structural condition Fair. Physiological condition Fair. Competition - Adjacent trees. Pollard - Lapsed / Mature stems. Pruning wounds - Decayed. Root environment - Compacted. Root environment - Restricted. Root damage - Suspected. Suppressed crown - Minor. Unbalanced crown - Minor. Weak live growth.	27/04/2022	162.9	7.2	20-40	C2

Tree T83	1 Aesculus hippocastanum (Horse Chestnut)	13.0	57	1	5.5		3.0		3.0		6.5		2.0		Mature	Structural condition Fair. Physiological condition Fair. Bark exudation. Bark wound - Minor. Competition - Adjacent trees. Crown conflict - Structure / boundary / wire / tree. Pollard - Lapsed / Mature stems. Pruning wounds - Decayed. Root environment - Compacted. Root environment - Restricted. Root damage - Suspected. Structural impact - Potential. Weak live growth. Bark exudations - Bleeding canker of horse chestnut present. Main stem adjacent to wall.	27/04/2022	147.0	6.8	10-20	C2
Tree T84	1 Cordyline australis	4.0	15	1	1.0		1.0		1.0		1.0		2.5		Early Mature	Structural condition Fair. Physiological condition Fair. No significant faults observed.	27/04/2022	10.2	1.8	10-20	C1
Tree T85	1 Malus sp. (Apple sp.)	3.0	21 COM	2	2.0		3.0		2.5		3.0		1.5		Early Mature	Structural condition Poor. Physiological condition Fair. Decay / structural defect - Principal stems. Fungal fruiting body - structural decay suspected. Pruning wounds - Historic.	27/04/2022	20.4	2.5	10-20	C1

- 6.8 For arboricultural reasons, the mature sycamore and horse chestnut trees are required to be crown reduced. These works are to reduce the level of risk associated with the mature regrowth that has been produced following the historical topping and pollarding works that were carried out on these trees. The mature regrown branches are considered to be weakly attached. Reducing their length will alleviate the amount of loading on the point of attachment.

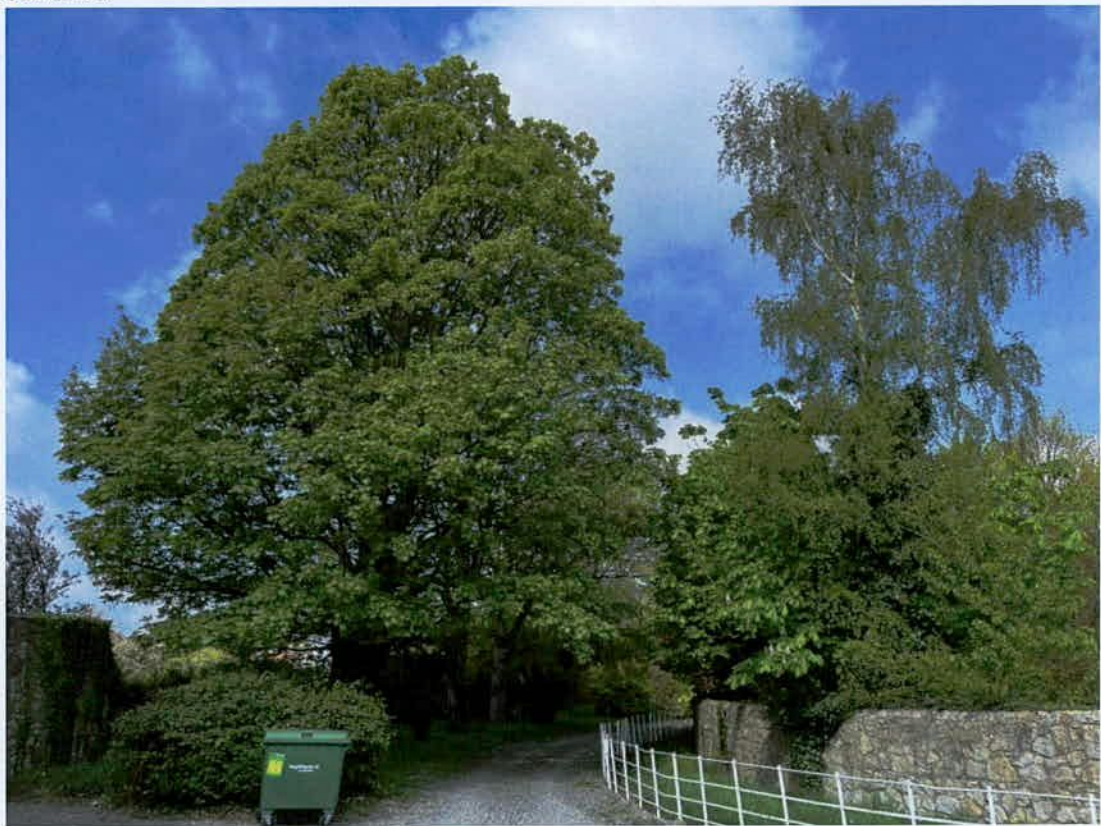
Photo 2: View of the mature sycamore trees (T69-T73) located along the main driveway.

- 6.7 To facilitate the development, the lower canopies of the trees located along the existing driveway are required to be pruned. These works will include crown lifting the laterals overhanging the driveway to 4m above ground level to provide sufficient clearance for construction vehicles accessing the site.

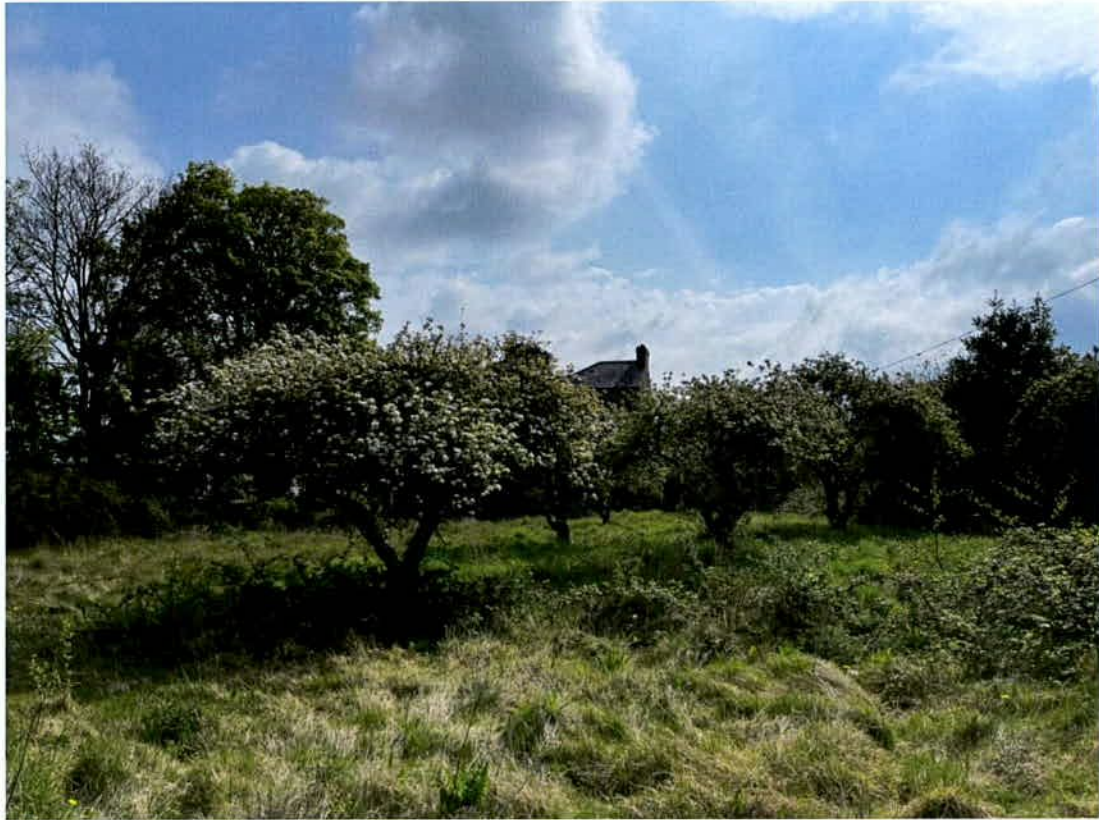
Photo 3: *View of the apple trees within the walled garden.*

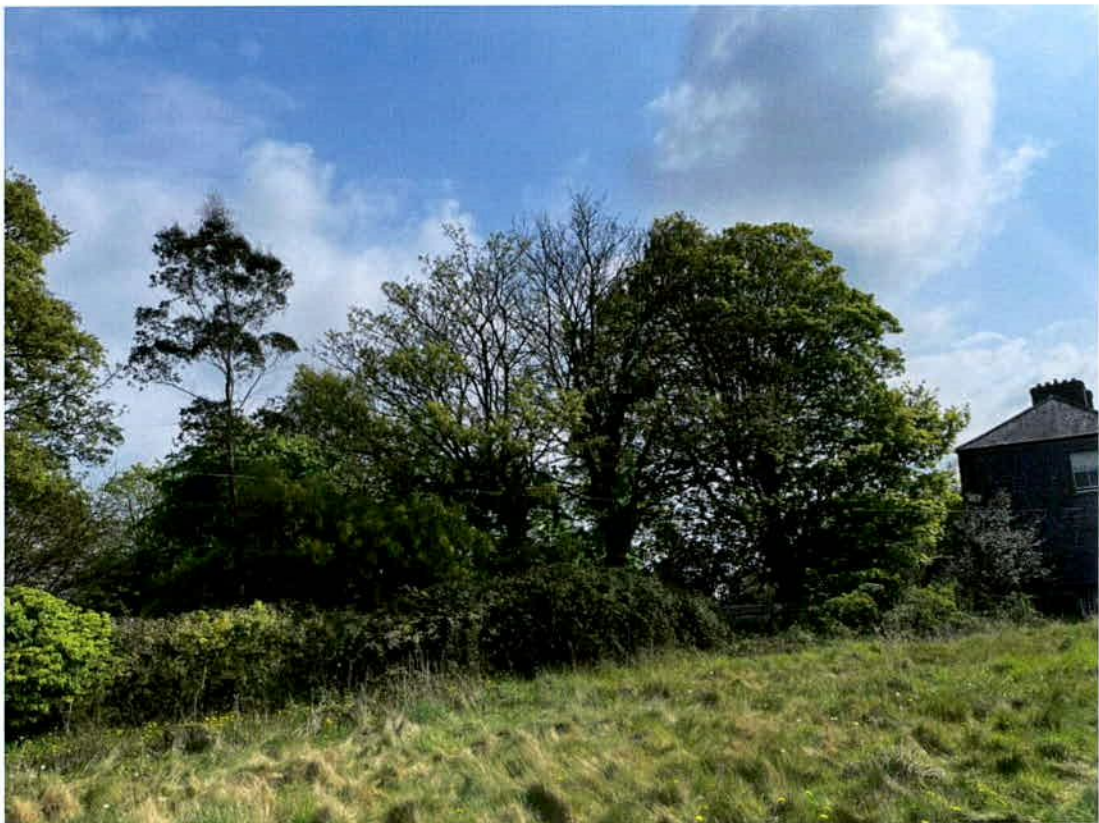
Photo 4: *View of the mature sycamore trees (T69-T72) from within the walled garden.*
