**Quality Audit Response Document**  
**Proposed Mixed-Use Development**  
**Belgard Square East, Belgard Road**  
**and Blessington Road, Dublin 24**

## QUALITY AUDIT RESPONSE DOCUMENT

### PROPOSED MIXED-USE DEVELOPMENT, BELGARD SQUARE EAST, BELGARD ROAD AND BLESSINGTON ROAD, DUBLIN 24

#### **Appendix A: Quality Audit by PMCE**

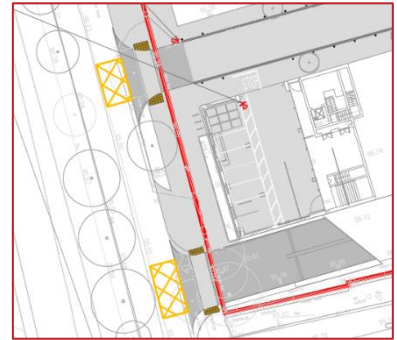
*Summary:* Junction control, or priority, has not been indicated at the accesses to the proposed development.

Two accesses have been indicated to the proposed development from Belgard Square East. The junction control (stop, yield etc.), and thus priority, at both of the development accesses has not been indicated. The absence of adequate road markings and signage, advising drivers of priority/control, may lead to driver confusion and hesitation resulting in drivers misinterpreting priority at the junction and entering the junction at the same time as opposing vehicles where there is an increased risk of side-on collisions.

'STOP' signs and road markings included to indicate priority at development access. Refer to drawing **Q003-CSC-ZZ-XX-DR-C-0022** for further details.

Ensure the junction control, and priority, at the proposed development accesses is clear via signage and road markings.

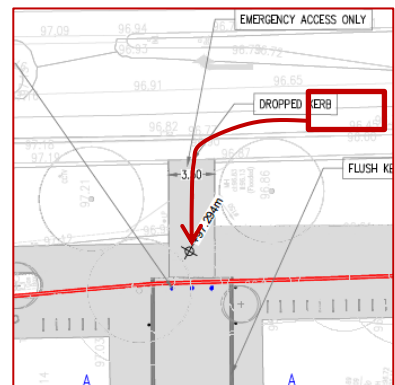
*Summary:* It is unclear if emergency, or larger, vehicles will be able to access the development.

An Emergency Access has been indicated at the rear of the proposed development on Belgard Road, where a collapsible/demountable bollard will be located to deter unauthorised vehicular entry. Information regarding the swept path analysis of vehicles entering and exiting the development's emergency access has not been provided and it is therefore unclear if a fire tender or ambulance will be able to safely enter and exit the emergency access, and subsequently turn around when within the development.

A swept path analysis of emergency vehicles and fire tender has been undertaken to demonstrate that vehicles shall be able to access the development. Please refer to CS Consulting drawing no **Q003-CSC-ZZ-XX-DR-C-0009** for further details

Ensure that emergency vehicles can safely enter, turn, and exit the development.

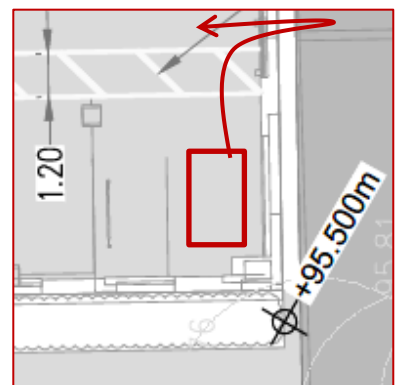
*Summary:* It is unclear if there is sufficient space for drivers to safely enter/exit all parking spaces within the development's surface carpark.

A small surface carpark has been indicated within the proposed development. It is unclear if there will be sufficient space available for drivers to enter and exit all parking spaces within this carpark, particularly those at the end of the aisle and adjacent columns. Should there be insufficient space to safely enter and exit all parking spaces there is an increased risk of low-speed material damage collisions with other parked

vehicles, building boundaries or columns within the carpark.

A swept path analysis has been undertaken to ensure safe entry/exit of vehicles to/from all car parking spaces. Please refer to CS Consulting Drawing no. **Q003-CSC-ZZ-XX-C-0010** for further details.

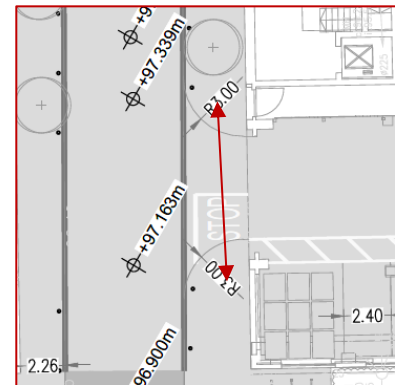
The carriageway and footway within the proposed development is indicated as being flush, however it is unclear if this also includes the access to the surface level carpark. An uncontrolled pedestrian crossing has not been indicated at this location and it is also unclear if the footway is intended to be continuous across the access, as the location of the Stop road markings suggests not.

The lack of an appropriate crossing for pedestrians, including dropped kerbs and tactile paving, or a continuous footway, may increase the risk of slips, trips, and falls, particularly for mobility impaired pedestrians, or to visually impaired pedestrians being insufficiently aware that they have entered a carriageway where they are at risk of being struck by a vehicle.

The proposed access has been revised to clearly indicate the continuation of the pedestrian footpath across the proposed junction. The proposed 'STOP' marking have been removed. Please refer to CS Consulting drawing no. **Q003-CSC-ZZ-XX-DR-C-0022** for further details.

If the footway on either side of the carpark access is not flush with the access carriageway an uncontrolled pedestrian crossing, including dropped kerbs and tactile paving, should be provided.

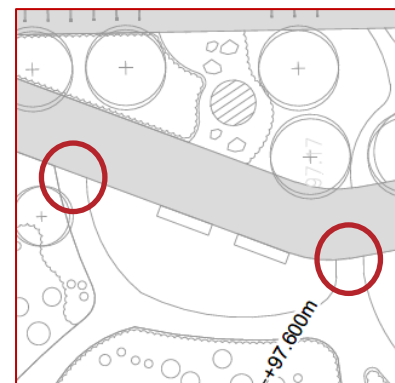
A public leisure area has been indicated within the proposed development. A shared pedestrian and cyclist surface has been indicated from Belgard Square East and extending through this public space, where a trail within the public space intersects the shared area at a number of locations.

The Audit Team are concerned that the trail within the public space may not be wide enough to sufficiently cater for both pedestrians and cyclists, and measures (i.e. tactile paving) have not been indicated at the interfaces between the shared area and trail. This could lead to a visually impaired pedestrian being insufficiently aware that they have entered the shared surface where there is an increased risk of conflicts with cyclists.

It is proposed that cyclist will be routed to the east of the proposed public space. A minimum shared width of 3.5m has been provided. This has been

accepted by the audit team. Refer to drawing **Q003-CSC-ZZ-XX-DR-C-0022** for further details.

Measures, such as tactile paving or sufficient colour/material contrast between the shared surface and adjacent trail, should be provided to advise visually impaired pedestrians of the change in surface.

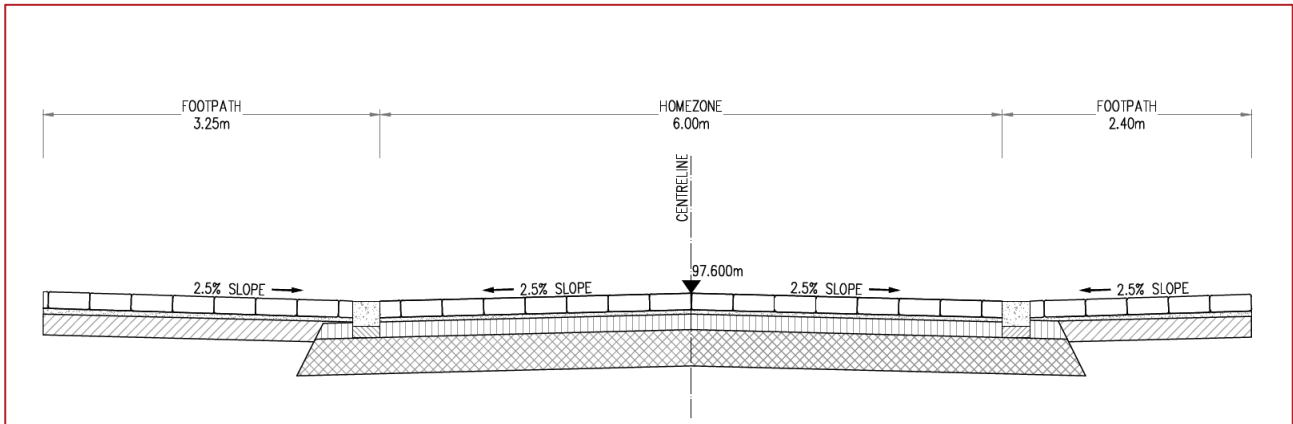
Drawing: Drawing no. Q003-CSC-ZZ-XX-DR-C-0021 (Rev. -)

Summary: Visually impaired pedestrians may inadvertently enter the development's internal carriageway where they are at an increased risk of being struck by a vehicle.

The development's internal carriageway is indicated as being flush with the footway throughout the development, with both surfaces being delineated by a kerb strip only. Measures have not been indicated to advise visually impaired pedestrians of the potential hazard and this may therefore lead to them inadvertently entering the carriageway from the footway where they are at an increased risk of being struck by a vehicle.

A tactile strip shall be provided adjacent to the proposed flush kerb to advise visually impaired users of the carriageway. Please refer to CS Consulting drawing no. **Q003-CSC-ZZ-XX-DR-C-0022** for details.

A tactile strip should be provided within the footway adjacent the kerb strip throughout the development to advise visually impaired pedestrians of the carriageway hazard, and to define the 'safe zone' for them.

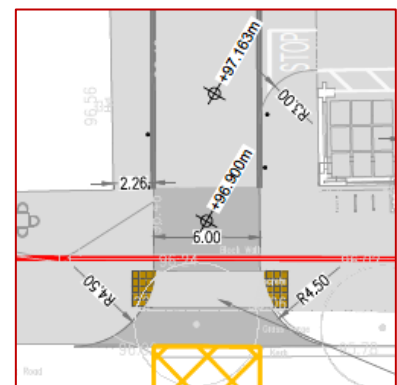
Raised tables have been indicated at both development access junctions on Belgard Square East. It is unclear if the top of these raised tables will be flush with the adjacent footway or if a level difference will be provided between the edge of the footway and the raised table, away from where tactile paving has been indicated.

If a sufficient level difference between the footway and raised table is not provided, outside the extents of the tactile paving at the pedestrian crossing, a visually impaired pedestrian may be unable to detect the edge of the footway resulting in them inadvertently entering the carriageway where they are at an increased risk of being struck by a vehicle.

A tactile strip has been provided adjacent to where tactile paving is not being provided to advise visual impaired users of the carriageway hazard. This measure has been accepted by the audit team.

A level difference of 25mm minimum should be provided between the edge of the footway and the raised table at locations where tactile paving will not be provided such that the carriageway edge can be detected by a visually impaired pedestrian.

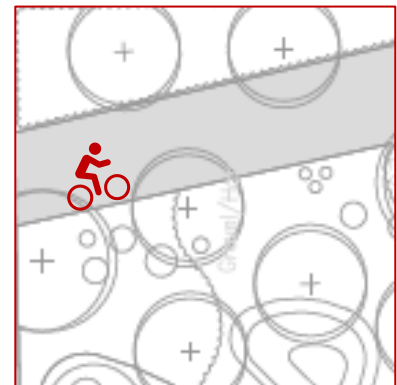
*Summary:* Low hanging tree canopies may obstruct vulnerable road users (VRUs) along pedestrian/cycle routes.

Trees have been indicated within footways throughout the proposed development, particularly at the landscaped areas adjacent routes through the development's public space. The height of the canopy of the proposed trees relative to the footway is unclear. If there is insufficient clearance beneath the tree canopy, there is a risk that tree branches may present a hazard to VRUs resulting in personal injuries.

Ensure sufficient vertical clearance for cyclists and pedestrians is provided beneath tree canopies within the development.

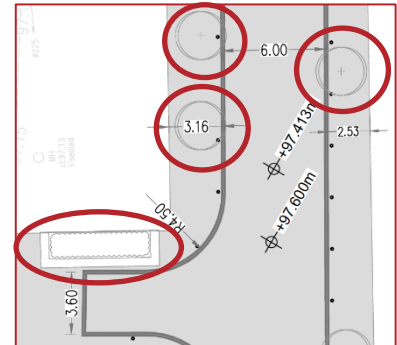
*Summary: The effective width of footways at a number of locations within the proposed development appears narrow as physical obstacles, such as trees and bollards, reduce the effective width of the footway.*

Items of street furniture, such as trees, bollards, and planters, have been indicated within the footway throughout the development and these may reduce the effective width of the footway. Should the effective width of the footways within the development be too narrow pedestrians, particularly wheelchair users, may be required to enter the carriageway to avoid obstacles, or opposing pedestrians, where there is an increased risk of being struck by a vehicle.

Ensure the footways within the development provide an unobstructed width of at least 1.2m minimum.

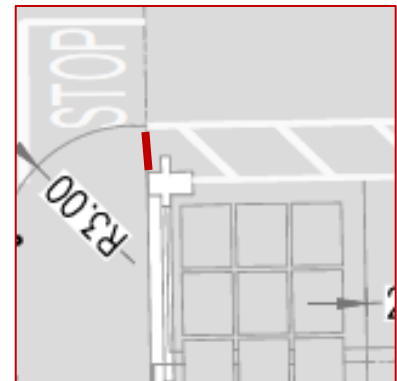
*Summary: Pedestrians may be required to mount/dismount a full height kerb when accessing the footway adjacent to the carpark.*

A small surface level carpark has been indicated within the proposed development. A dedicated pedestrian walkway has been indicated through the carpark transitioning to the footway at the carpark access. The carriageway and footway within the proposed development is indicated as being flush, however it is unclear if this also includes the carpark carriageway and adjacent footway. If the carpark carriageway, and subsequently the dedicated pedestrian walkway, is not flush with the adjacent footway pedestrians may be required to mount a full height kerb to access the footway from the carpark. This may lead to trips and falls for pedestrians resulting in personal injury collisions, or to mobility impaired pedestrians, particularly wheelchair users, having to continue within the carriageway to a suitable access location where there is an increased risk of being struck by a vehicle.

If the carpark carriageway and adjacent footway is not flush, a dropped kerb, and tactile paving, should be provided where the pedestrian walkway transitions to the footway.

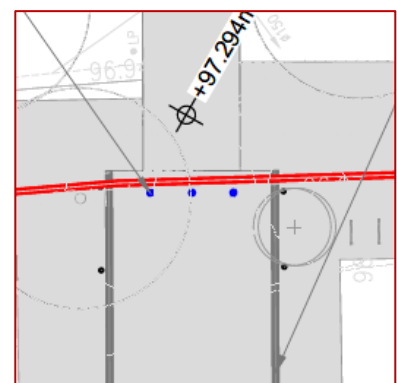
*Summary: Unclear if bollards within the development will be sufficiently visible during the hours of darkness.*

Bollards have been indicated within the development adjacent the set down area/loading bay and mobility impaired parking space and at the emergency access to the rear of the development. The type of bollards proposed has not been indicated and it is therefore unclear if they will be sufficiently visible during the hours of darkness.

If the bollards are not sufficiently visible to road users during the hours of darkness there is a risk of pedestrians and cyclists colliding with the bollards and suffering personal injury, or drivers striking the bollards resulting in material damage.

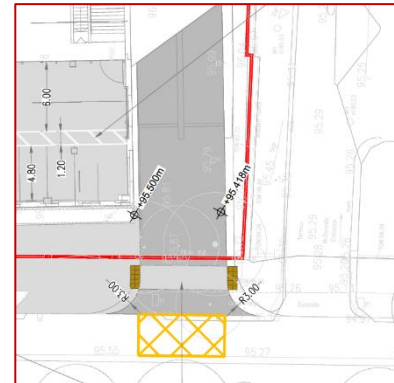
*Summary: The gradient of the access ramp to the basement carpark has not been indicated.*

The gradient of the access ramp to the basement carpark has not been indicated and it is therefore unclear if it will be sufficient for drivers and cyclists to traverse safely. If the gradient of the ramp is steeper than 1:20 there is a risk that cyclists may experience discomfort when using the ramp leading to loss of control type collisions. A steep gradient may also lead to high speeds as vehicles and cyclists descend the ramp and enter the carpark resulting in the potential for loss of control type incidents and collisions with opposing, or parked, vehicles.

Ensure the gradient of the ramp to the basement carpark is sufficient to permit the safe access and egress for drivers and cyclists.

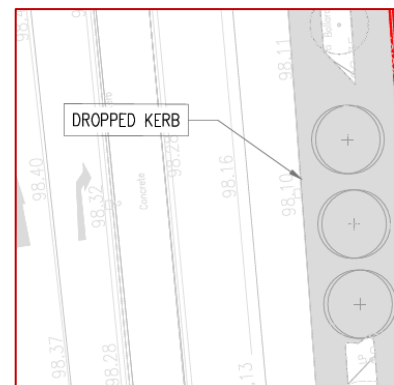
*Summary: Risk of visually impaired pedestrians descending the existing dropped kerb on Blessington Road and entering the carriageway, where there is an increased risk of being struck by a vehicle.*

There is an existing dropped kerb on the southern side of Blessington Road to the north of the proposed development, where an existing vehicular access to the site is provided. This location coincides with the proposed pedestrian and cycle access to the development which is indicated as tying into the existing footway at this location. The dropped kerb is indicated as being retained, however it is unclear if vehicular access to the development will be necessary, or possible, from this location. There is a risk of a visually impaired pedestrian inadvertently entering the Blessington Road carriageway via the dropped kerb where there is an increased risk of being struck by a vehicle.

If vehicular access is not required from this location, the dropped kerb should be replaced with a full height kerb.

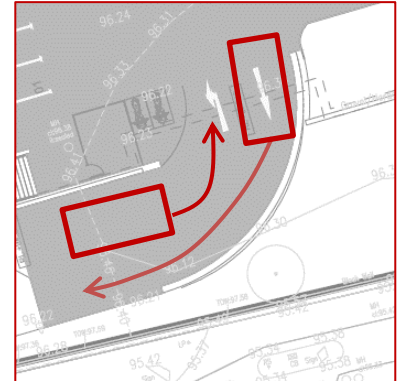
*Summary:* Unclear if two opposing vehicles can safely pass each other on the basement carpark access ramp.

The basement carpark access ramp includes a tight horizontal radius, and it is unclear if two opposing vehicles can pass each other safely on the ramp, particularly when entering/exiting at the bottom of the ramp. If sufficient space is not available on the ramp for two opposing vehicles to pass there is an increased risk of side swipe collisions.

Confirm, via swept path analysis, that opposing vehicles can safely traverse the basement carpark access ramp. If necessary, revise the layout of the ramp to accommodate two-way traffic.

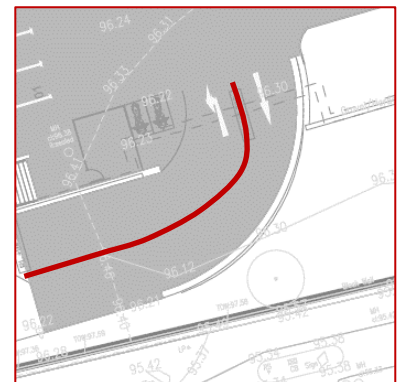
*Summary:* Risk of low speed head-on or side swipe collisions on the basement carpark access ramp.

Two lanes, one entry and one exit, have been indicated on the development's basement carpark access ramp, however measures to delineate the opposing lanes have not been indicated. It is likely that the boundary walls and alignment of the ramp will reduce forward visibility for drivers, and a failure to provide measures to delineate the opposing lanes may lead to drivers unintentionally straying into the opposing lane resulting in low speed head-on, or side swipe, collisions.

Delineation measures should be provided between the opposing traffic lanes on the basement carpark access ramp.

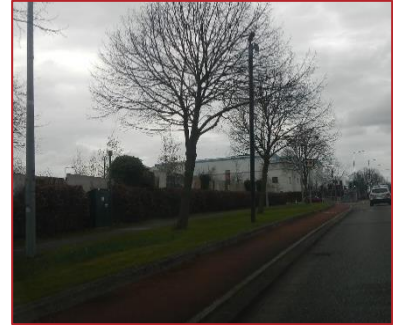
If a sufficient vehicular access is not provided across the cycle track at the location of the proposed emergency access, emergency vehicles will be required to mount the cycle track kerb which may impede access, slow response times or damage the cycle track.

The existing cycle track on Belgard Road at the proposed emergency access should be amended to ensure easy, and quick, access for emergency vehicles.

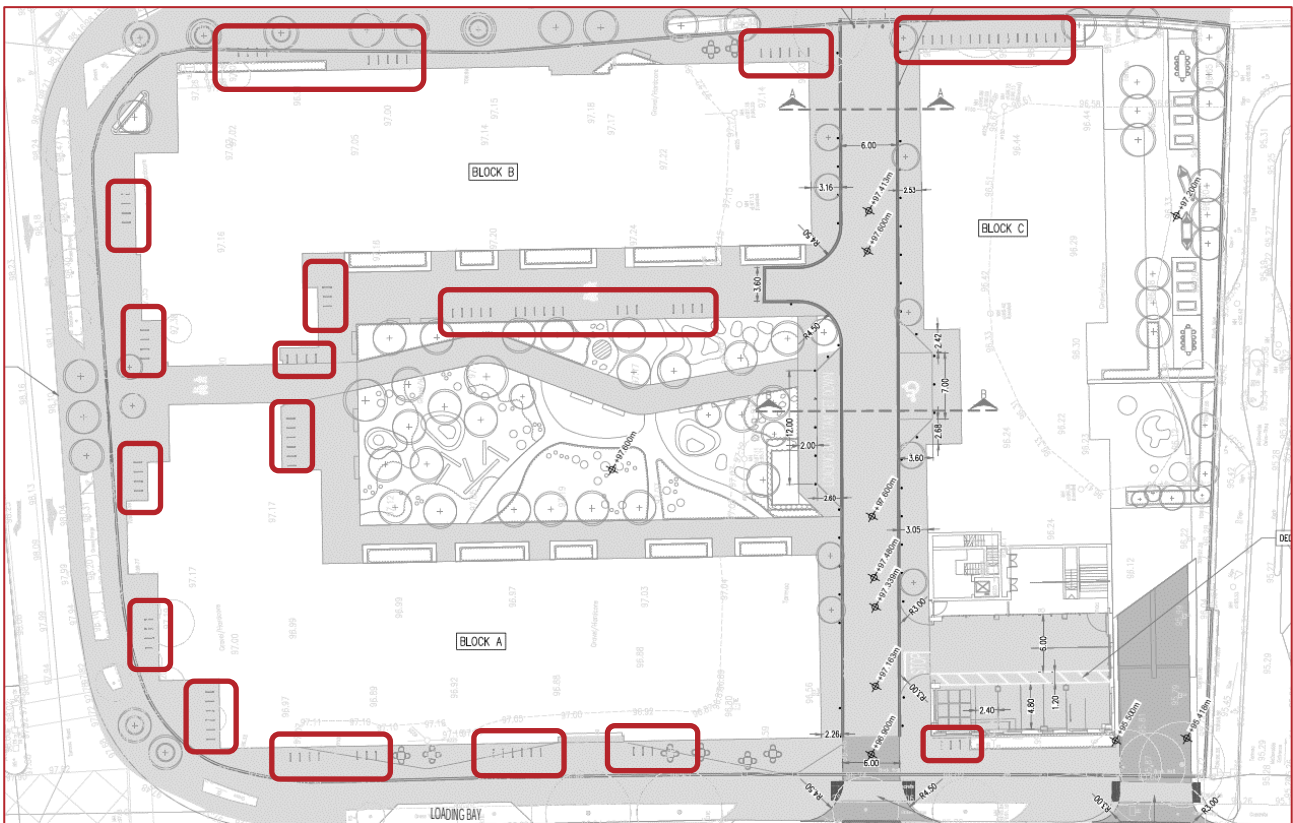
## 5.2.1 Issue

It is unclear if the proposed cycle parking stands within the development and on the amended footways on Belgard Square East, Belgard Road and Old Blessington Road will be sheltered. Users may be discouraged from using cycle stands if they believe the locations are unsafe, or if their bicycle will be exposed to the weather. This may encourage informal parking on footways or at property accesses within the proposed development, thereby restricting pedestrian access.
