GIRAFFE CHILDCARE, LORETO ABBEY, RATHFARNHAM CO. DUBLIN

CONSERVATION STATEMENT

Date of report: 1 July 2022

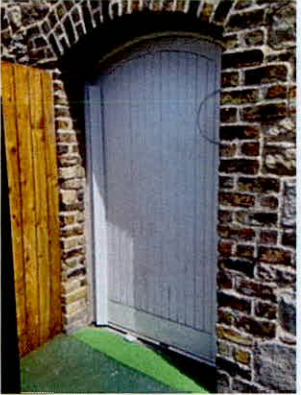
7.	Entrance door thresholds to be altered to level access and sealed to stop water ingress	Existing threshold detail allows water ingress. The threshold is not of significance and door joinery is of modern origin.	<p>New threshold shall be formed with a sloped mortar benching to weather the threshold adequately. The works will not impact on existing brick masonry reveals.</p>

<p><i>Image of door threshold to be modified</i></p>	
8.	Existing plastered reveal to the west elevation to receive lead flashing over	<p>Existing reveal around modern large opening intervention is leaking (Appendix A photos 2 & 5).</p> <p>As the reveal detail is of modern origin, its alteration will not affect the character of the building.</p>	<p>Raking out of joints in existing masonry shall be carried out along an existing joint in the stonework with the modern plaster band lowered if necessary – the existing stone facings shall not be cut above the level of the cement plaster band to chase in the lead flashing.</p> <p>All leadwork shall be neatly trimmed and executed in Code 6 lead, laid and fixed in accordance with the Lead Sheet Association Handbook recommendations.</p>

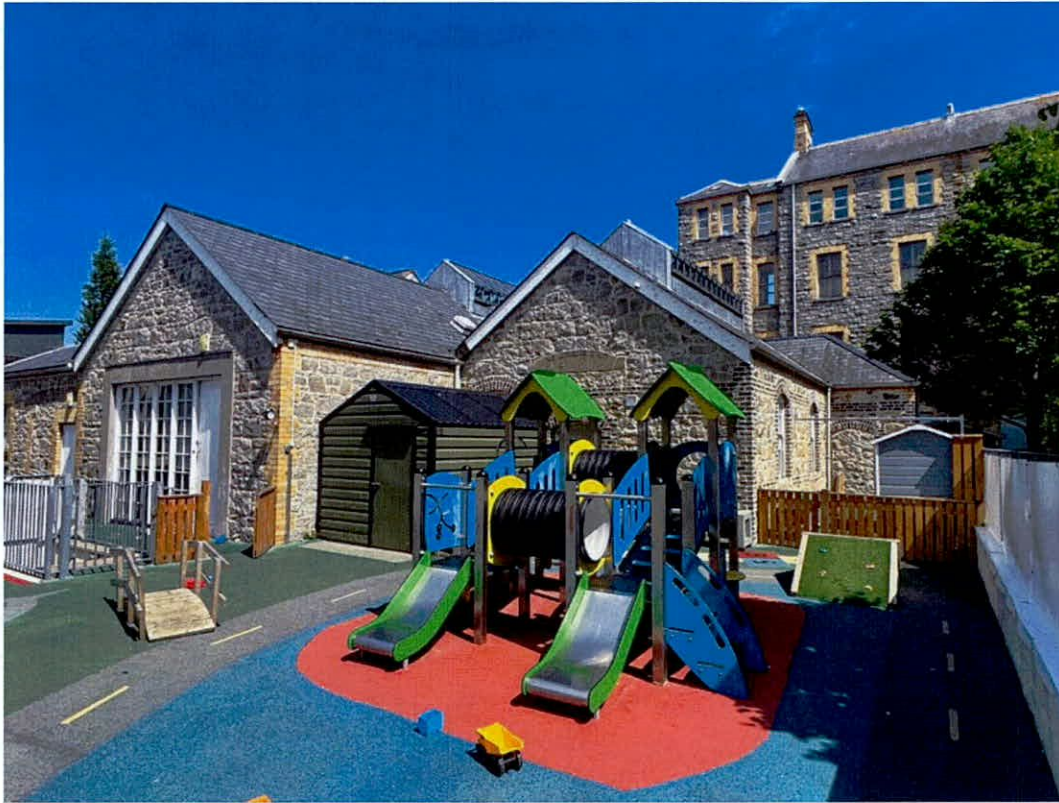
9.	Existing timber soffit and fascia removed and fully replaced to match existing	<p>Localised decay of the fascia boarding and narrow soffit was noted. The boarding appears to be of modern origin given its condition, profile (Appendix A photos 1, 2, 5, 6, 7 & 14) and evidence that the original fascia featured a tie detail as per the 1956 Morgan Aerial Photographic Collection above.</p>	<p>Although existing fascia barges and soffits do not appear to be original will be repaired only where decay is evident with pressure treated timber to match existing profiles.</p>

Photo 1: West elevation view from playground

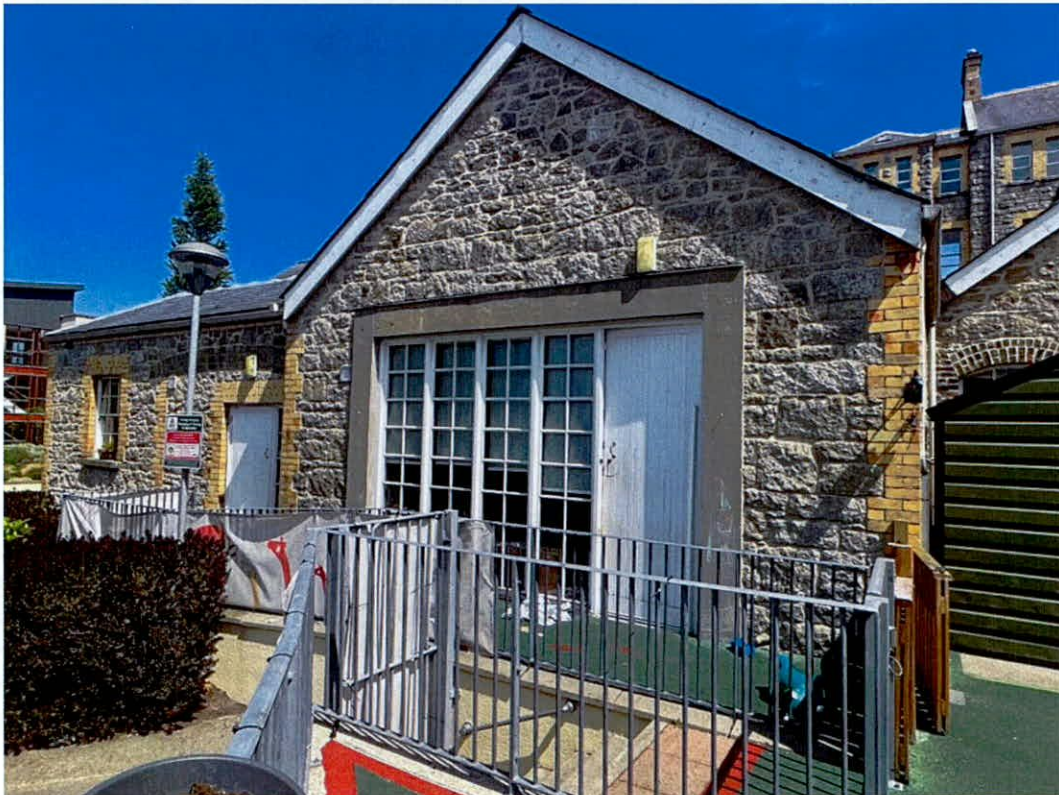
Photo 2: Detail of existing ope to west elevation

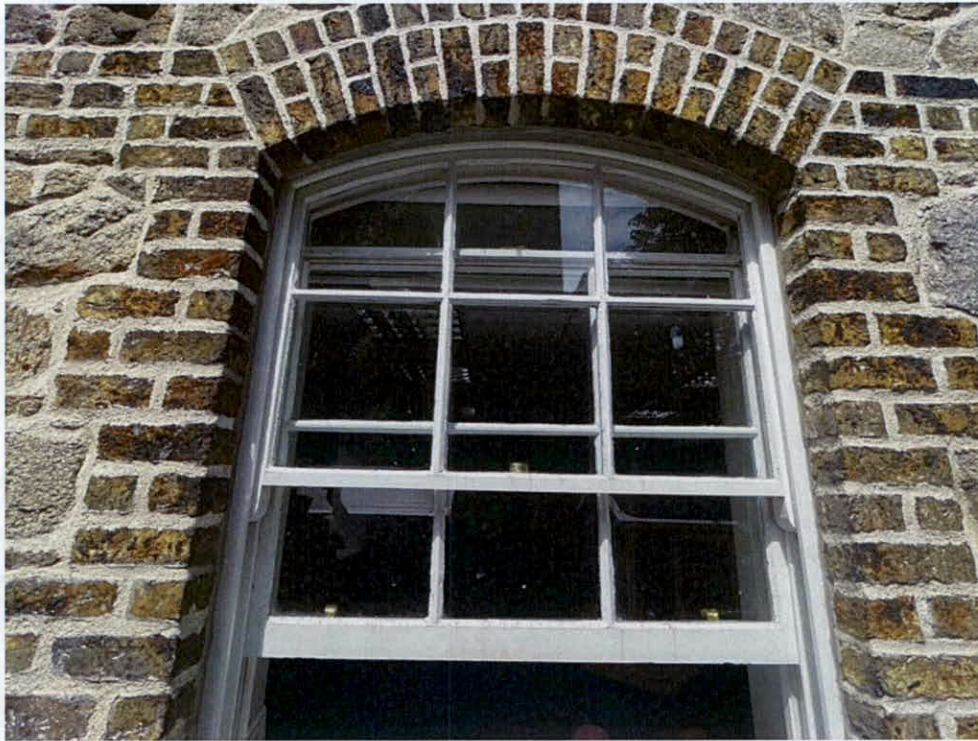
5.	Replacement of existing window sashes with double-glazed sashes.	<p>We are satisfied from site inspection that no historic window joinery is extant given the detail of glazing bars, horns & beadings of the windows which appear to be modern historic replicas. The window detail is consistent throughout the whole building which would indicate that the windows were replaced throughout the whole building presumably during the early 2000s phase of works (Appendix A photos 3, 4, 19 & 20).</p> <p>The replacement of the sashes with more accurately detailed replacements to the 1870 period could enhance the character of the building while incorporating a slim double-glazed unit to provide a greater degree of thermal comfort and energy efficiency for the building.</p>	<p>The replacement sashes shall be fabricated by a conservation joiner experienced in traditional window fabrication to appropriate late 19th century profiles. The configuration of the existing windows will be retained, given that the existing windows appear to match the configuration of the 1956 reference photographs above. It is suggested that the replacement sashes can be double-glazed with slim double glazing or thermal performance glass to improve the thermal performance of the roof without loss of character to the building as per the sample glazing bar images below.</p> <div data-bbox="824 691 1680 1007" data-label="Image"> </div> <p><i>Sample image of 19th century glazing bars incorporating slim double glazing</i></p>

Photo 3: Sample external detail of typical reproduction sash window joinery

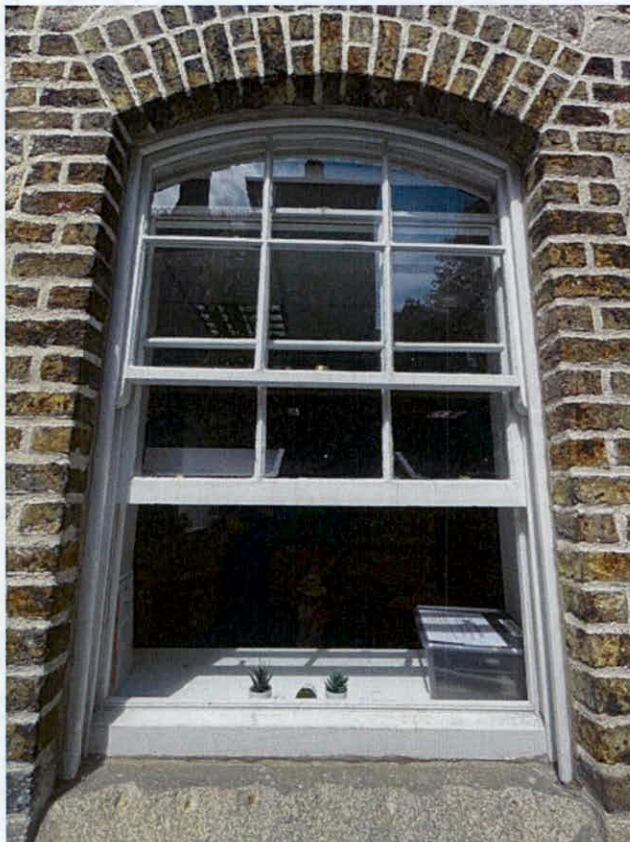
Photo 4: Sample external detail of typical reproduction sash window

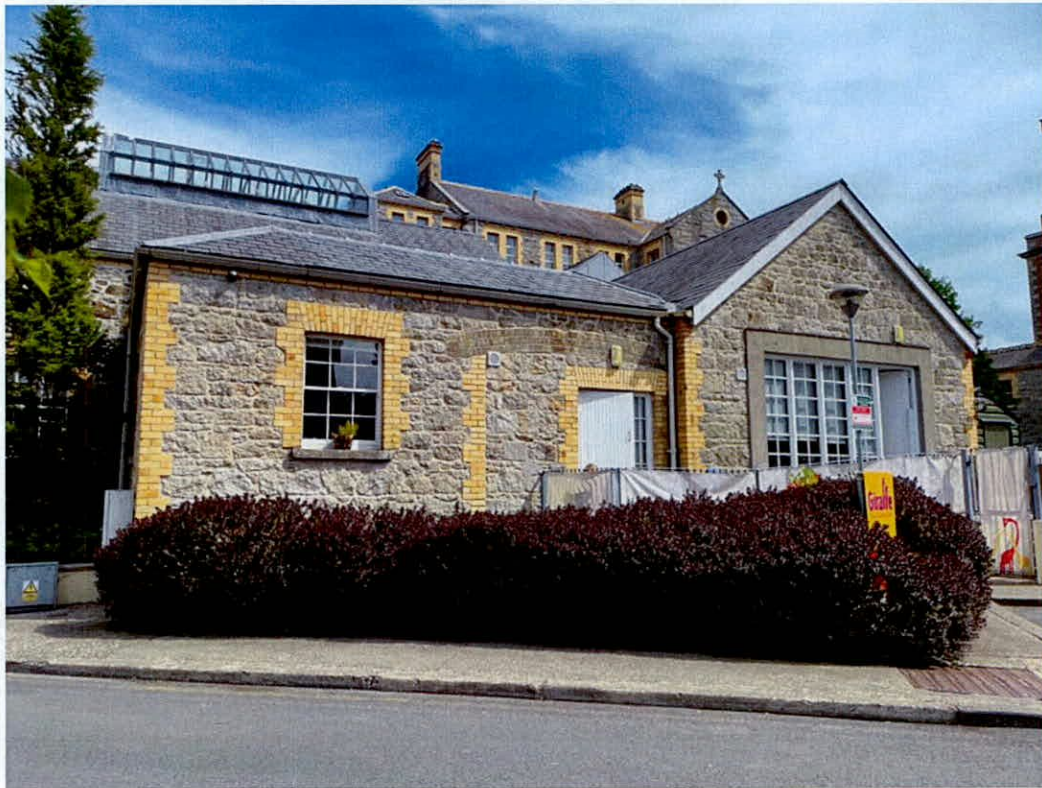
Photo 5: West elevation view from roadway

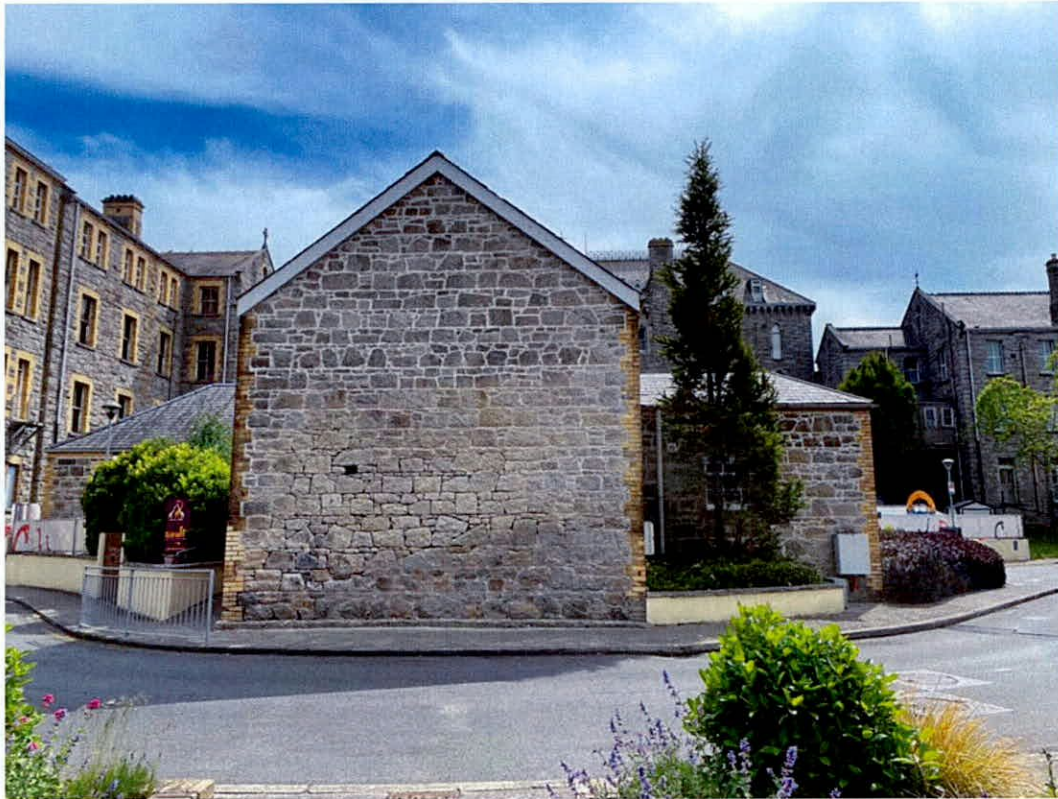
5.	Raking out and re-pointing of stonework to northern gable of building	The jointing to an area of the stonework to the north gable is heavily eroded (Appendix A photos 7 & 8) The cause if same is unclear but required re-pointing to weather this exposed area of wall.	All works involving the use of lime based mortars shall be undertaken with due regard for the weather conditions. No work shall be undertaken when the temperature drops below 7°C on a falling thermometer or until it rises above 5°C on a rising thermometer set in a shaded position. Close to these temperatures, all materials shall be checked to ensure they are not frozen or that any icy particles are present within the materials. Any mortars or renders that exhibit defects due to freezing shall be removed and replaced, including all consequent demolition and re-building and the consequential provision of any new masonry units necessary entirely at the Contractor or Sub-Contractor's expense.

Photo 7: North elevation gable

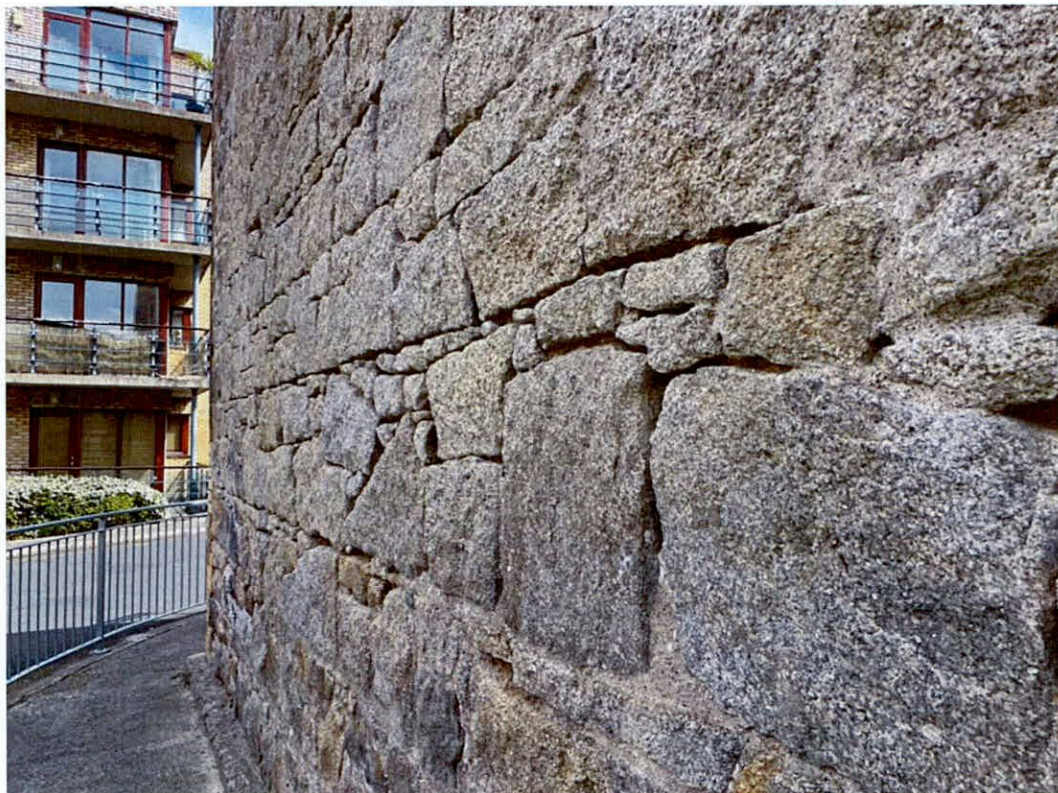
Photo 8: Detail of eroded joints to stonework to north gable

<p>Only personnel competent and experienced in similar masonry work shall be engaged for the execution of the works. The contractor will be required to demonstrate the qualifications and / or experience of any workmen on site / proposed specialist subcontractors / suppliers including references for recently completed conservation work of a similar scope and nature of the proposed project together with details of the subcontractor individuals and supervisory staff intended to work on the proposed project.</p> <p>Raking out shall be carried out using chisels or other appropriate hand held tools / implements. Mechanical raking out using reciprocating saws or revolving discs is not permitted, unless with the prior approval of the Architect / Surveyor. Rake out to a depth equal to 2½ times the width of the joint, the back of the joint finished with a squared seating. The utmost care shall be taken to ensure that the stone arrises are not damaged.</p> <p>Lime shall conform to BS EN 459-1:2015 for the purpose required and shall be Otterbein or St. Astier natural hydraulic lime (NHL). Only hydraulic lime from an approved source will be permitted and the contractor will be required to submit certificates confirming that no cement has been used or added to the powder. Hydraulic lime shall be delivered in bags bearing the manufacturers name, the contents and the use by date clearly marked on the outside. It shall be stored under similar conditions as for cement. All mixes incorporating hydraulic lime shall be placed within the time scale.</p> <p>Sand shall be clean, coarse, well-graded sharp sand, with particle sizes ranging from 5mm to fine dust. The sand colour will be important in achieving a good visual match to the existing mortar and shall only be sourced from a reputable supplier with full and demonstrable provenance. The Conservation Consultant reserves the right to request documentation evidence confirming the source and provenance of the sand used in the works.</p> <p>Mix proportions for re-laying and / or re-pointing may need to vary but shall be in the range: 1 part NHL 3.5 to 2.0 - 2.5 parts graded sharp sand and grit.</p> <p>Repointing shall be undertaken from the top down, the joints having being first wetted and proceed in on continuous operation, all mortar being carefully rammed well home into the joints to ensure no voids remain. The finishing of the pointing shall be as directed by the Architect / Surveyor which for the purposes of tendering can be priced as a flush and lightly brushed finish.</p> <p>The contractor shall include for preparing at least three sample panels of the pointing under the Architect / Surveyor direction using a variety of sand sizes and combinations. When the Architect / Surveyor is satisfied there is a suitable sample panel for the type of pointing desired, he will identify this panel as the exemplar standard panel, at which time all other sample panels shall be raked out and removed to avoid any possible confusion. The chosen sample panel shall remain until such time as the Architect / Surveyor has identified a section of completed work, at which time, the exemplar standard panel shall be raked out and removed. All pointing work which fails to match the standard required</p>

<p>shall be raked out and repointed to match the standard at no extra expense to the employer and the decision of the Architect / Surveyor shall be final and binding in such matters.</p> <p>All areas of pointing shall be fully protected from the effects of the weather including any extremes of sun, wind, rain or temperature, etc. to ensure the mortar, dries, cures and carbonates properly. The fresh mortar needs shall be protected by dry hessian sheeting hung approximately 300mm from the wall face which shall be fitted in such a way that it cannot come free and rub against the wall face, which would cause damage to the fresh mortar. Lime works are best carried out on dry moderate days with a high level of relative humidity. Excessive wind, rain or sun can all effect the quality of the work and if these conditions prevail the working areas must be kept moist by spraying and adequately protected as specified above or equivalent.</p> <p>New stone, brick etc where required, shall match the existing as regards type, colour, texture, porosity, crushing strength and appearance etc. Samples of such stone and brick shall be delivered to the Architect / Surveyor for his approval.</p>

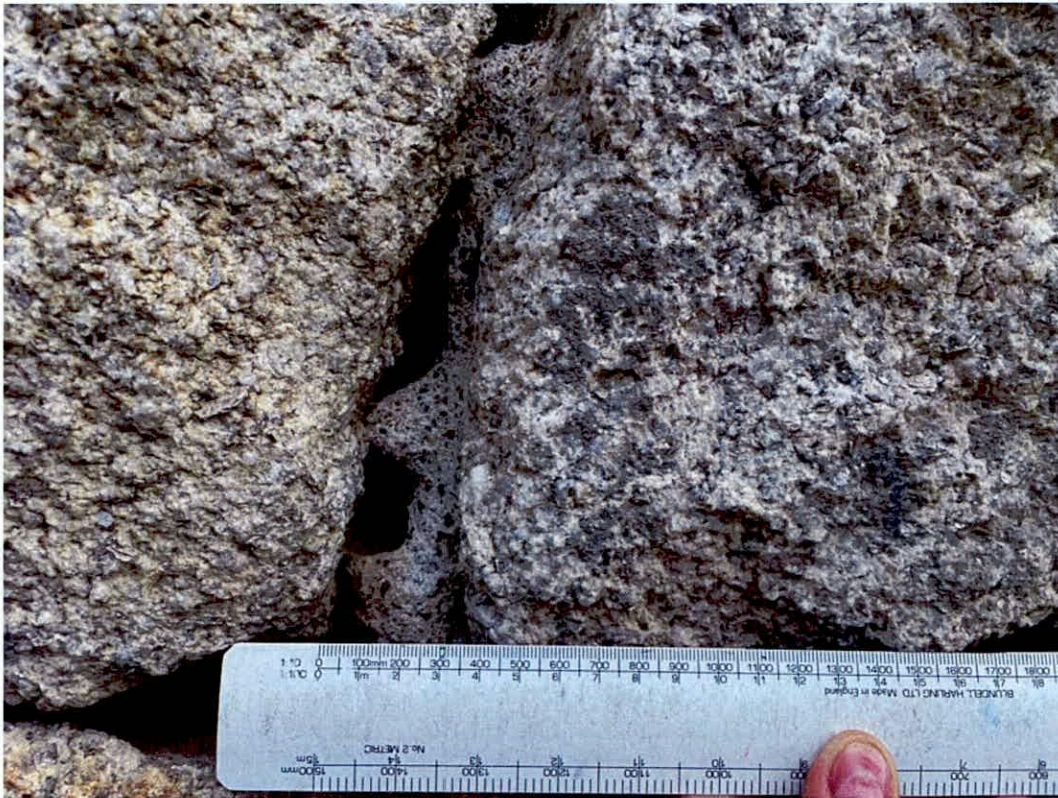
Photo 9: Detail of extant historic mortar to bedding joint to north elevation

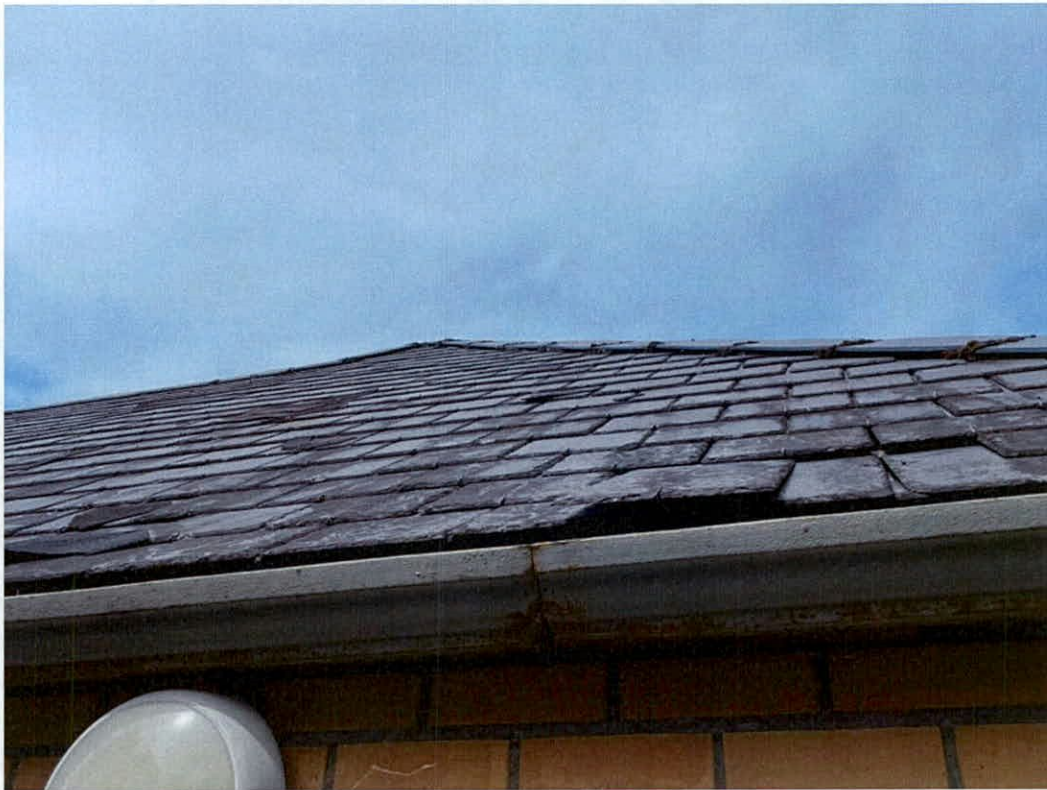
4.	Repair and/or replacement of rainwater goods.	The rainwater goods are of matching ogee-section cast iron throughout (which may indicate that the gutters were replaced completely in the early 2000s). The gutters are corroding in areas (Appendix A photo 13, 17 & 18).	<p>The condition and provenance of the guttering should be established when access is available.</p> <p>Existing cast iron rainwater goods will be carefully removed and assessed as to whether they are suitable for repair. Rainwater goods to be re-used shall be stripped of all paint and rust layers and re-painted with two layers of oil-based paint on a zinc-rich primer. Where it is necessary to replace existing gutters, downpipes, etc. they shall be of matching detail to the existing supplied by Longbottom Foundry, Apex Heritage or similar approved supplier. Samples of same shall be provided for approval of the conservation architect. Gutters sections shall be jointed with rubberized bitumen gutter mastic.</p>

Photo 13: Detail of roof condition, south elevation

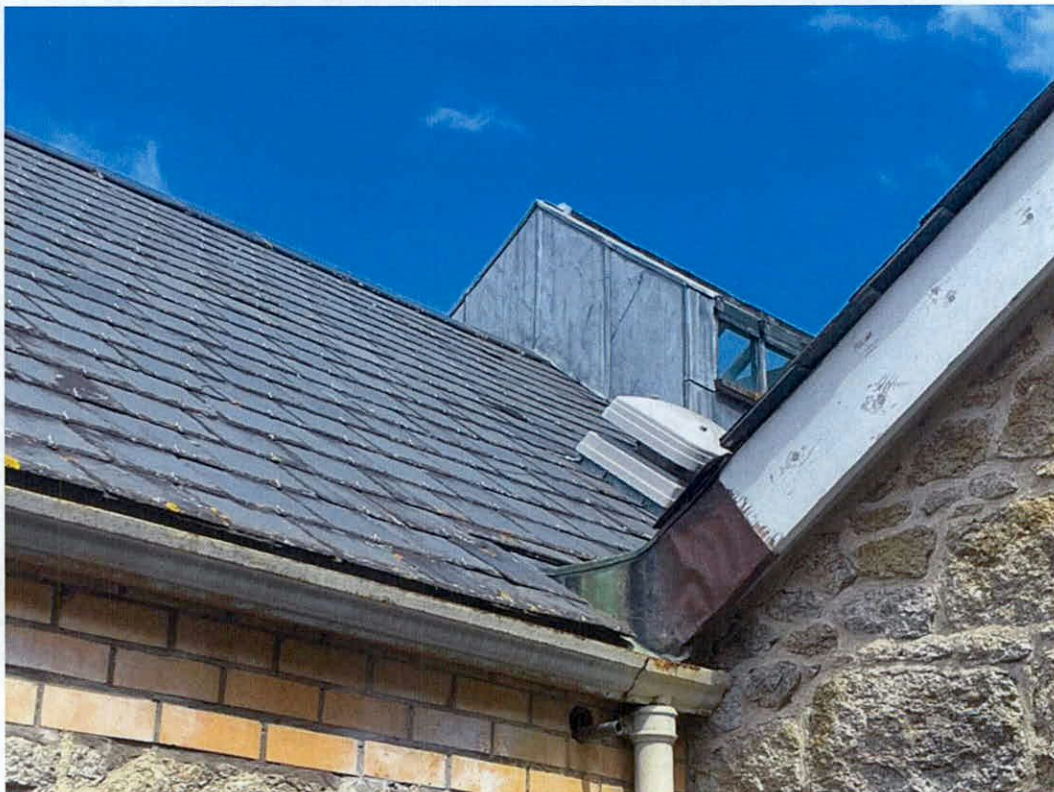
3.	Replacement of lead linings to roof valleys and flashings as part of roof works	<p>The central valleys were inaccessible but appear to be finished with copper (Appendix A photo 14).</p> <p>Nevertheless even from Google satellite evidence, the existing valleys do not appear to feature appropriate steps, bays, etc. (see Appendix A photo key). It would be considered normal to replace the valley linings with lead or copper as part of the re-roofing works.</p>	<p>COPPERWORK Note: leadwork may be replaced with copperwork to equivalent standard following if following detailed survey of the gutters that there is insufficient heights/falls available for leadwork.</p> <p>Lead flashings, counter flashings, cover flashings, gutters, etc. shall comply in all respects with the requirements of CP143 and the Lead Sheet Association guidelines. Replacement parapet & valley gutters shall incorporate falls at 1:80 to individual bays and 60mm steps, etc. appropriate to the gauge of lead used. Where lead is built into masonry as a DPC, it shall be coated with bitumen paint or similar to prevent reaction between lime mortar and lead.</p> <p>MATERIALS Milled sheet lead shall comply with BS 1178 and shall be minimum Code 6. Solder shall comply with BS 219. Copper Clips shall comply with BS 2870 and be minimum 0.6mm thick. Screws shall be brass to BS 1202 with large flat heads Underlay shall be inodorous sheathing felt to BS 747.</p> <p>Flashings All major flat surfaces in excess of 200 mm wide shall be flashed with minimum Code 7 lead laid and fixed in accordance with the Lead Sheet Association guidelines. It shall be dressed to form a minimum 150 mm upstand against all abutting surfaces with a cover flashing and rain-hook detail fixed into a groove with lead wedges.</p> <p>Existing Flashings, All existing flashings to the gutters, parapets, abutments, shall be completely removed and areas prepared to the installation of new flashings.</p> <p>New Flashings Abutment and ridge flashings, shall, if necessary, be executed in Code 6 lead, laid and fixed in accordance with the Lead Sheet Association Handbook recommendations. Soakers where required shall be accurately cut to match the slate size. Existing recesses to abutment walls shall be reused insofar as possible to avoid incremental damage to the existing walls.</p> <p>Underlay The underlay shall be a Grade 1 building paper or geotextile underlay laid on 25mm softwood boarding securely fixed to the substrate. The underlay shall be laid with butt joints on flat surfaces and with a 50mm overlap on inclined surfaces. It is imperative that the underlay is kept dry at all times and no more than can be covered with lead the same day shall be laid at a time.</p> <p>Cutting The lead shall be prepared for cutting by rolling out on a clean, level, smooth surface. It shall not be marked with sharp tools.</p>

Photo 14: Detail of roof condition, internal valley

<p>Laying The lead shall be set out in the appropriate bays sizes within the bay size limitations designated in the Lead Sheet Association Handbook and shall be laid in close contact with the underlay to ensure that not pockets of air, debris etc. are trapped between the various layers.</p> <p>Dressing The lead shall be dressed to the necessary profiles and the drip formed without reducing the thickness of the lead. At welted joints, the drip shall be carefully formed to ensure a neat, weathertight joint. All welts shall be so formed that they do not restrict the thermal movement of the sheets etc. All drips shall be formed by turning up the cut end of the lead. On no account shall cut ends be visible.</p> <p>Fixings The lead shall be securely fixed using clips turned into the welted joints at minimum centres as recommended in the Lead Sheet Association guidelines. In general, 2 clips should be provided in each joint, but more may be necessary at corners, large flat areas etc. The maximum centres for clips shall be 400mm. The welt shall be finished by lightly dressing flat. Cover flashings shall be fixed into a groove or raked out joint by means of folded strip lead wedges or brass screws at maximum 500 mm centres.</p> <p>Angles Angles shall be formed by cutting and folding where the angle cannot be dressed. It shall be finished to form a neat weathertight joint.</p> <p>Finishing The lead shall be cleaned and Patination Oil applied in strict accordance with the Manufacturer's recommendations.</p> <p>Isolation All lead shall be electrically isolated from other metals that would cause electrolytic action using bitumen or other approved isolating membranes. The lead shall also be protected from any risk of corrosion from contact with soluble salts in masonry, renders etc. and from acid attack from timbers or any preservatives applied to the timbers.</p> <p>Completion The completed leadwork shall provide a neat, weather-tight finish to the Architects satisfaction.</p> <p>Works noted above to be carried out in accordance with Department of the Arts, Heritage and the Gaeltacht's Architectural Heritage Protection Guidelines for Planning Authorities, 2004 and the Department of the Arts, Heritage and the Gaeltacht's Advice Series on 'Roofs - A Guide to the Repair of Historic Roofs'.</p>

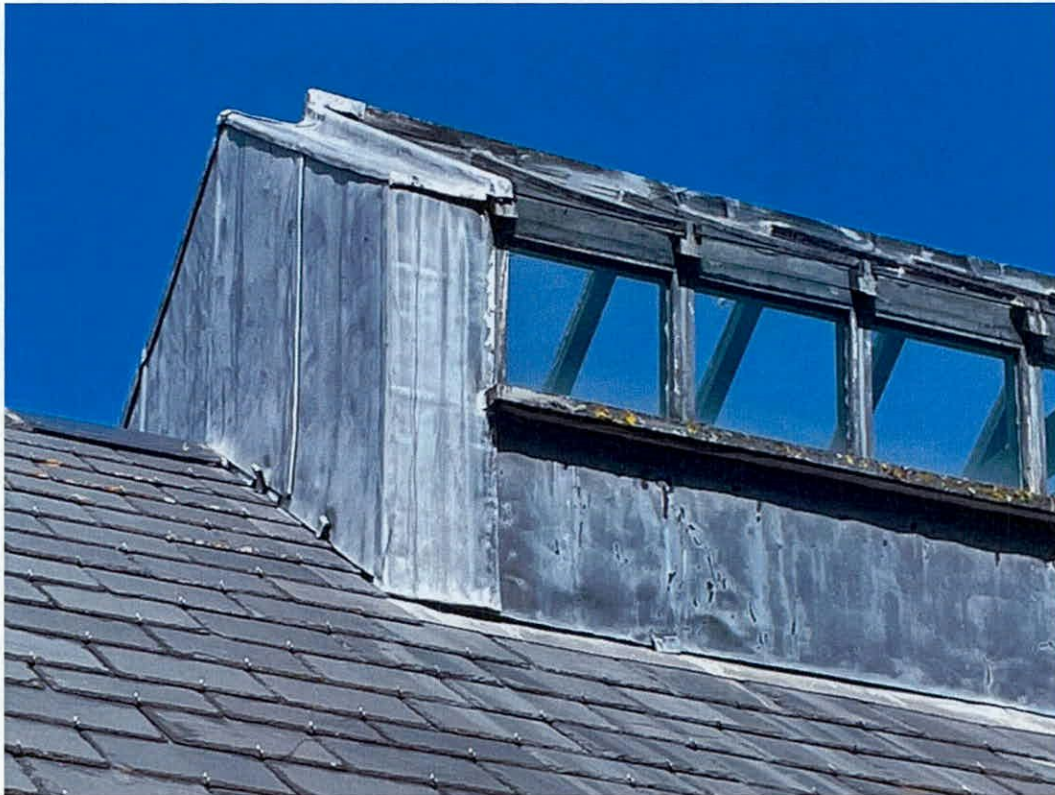
2.	Replacement of existing lanterns	<p>Substantial areas of water ingress are evident to internal ceilings (Appendix A photo 22). This is attributable in a large part to the lanterns where appear to be poorly detailed (Appendix A photo 15) with decayed sections of timber ridges evident (Appendix A photo 16)</p> <p>It is considered that the existing lanterns area not original but formed part of the early 2000s work noted above as there is evidence that the structure below the lanterns was replaced.</p> <p>Furthermore, the three roof lanterns are of identical detail but the lantern to the northern block featured a slated roof and solid siding and was not glazed in the 1956 Morgan Aerial Photographic Collection Figs. 1 & 2 above.</p>	<p>The 1956 Morgan Aerial Photographic Collection above indicate that two of the stepped glazed lanterns with lead-clad end panels were a historic feature of the building. The third featured a slated roof and solid sections to the side panels.</p> <p>Although the extant lanterns are likely recent reproductions, they appear to retain some indication of the earlier configuration of the lanterns including pitch, centres of glazing bars and height of lead upstand walls.</p> <p>The rooflights shall be repaired or replaced with a hardwood frame to match the original in terms of profile, design and material. The framing of the glazed lanterns should be re-formed in more robust hardwood sections fabricated by a conservation joiner experienced in traditional window fabrication. It is suggested that the replacement glazing can be double-glazed to improve the thermal performance of the roof without loss of character to the building.</p> <p>The detail of the lantern glazing bars appears to be poorly weathered with exposed upper edges of the ridge board and rafters being very vulnerable to decay and water ingress given the difficulty of providing maintenance access to the lanterns. The final detail for the lantern will be confirmed when scaffold access is available but it is intended to finish the rafter sections with a hardwood capping and lead capping to the more exposed ridge beam based on traditional details (exemplars below from Macy's Building Construction).</p> <div style="display: flex; justify-content: space-around; align-items: flex-end;"> <div data-bbox="819 794 1220 1018" style="text-align: center;">

Photo 15: Detail of typical condition of roof lanterns

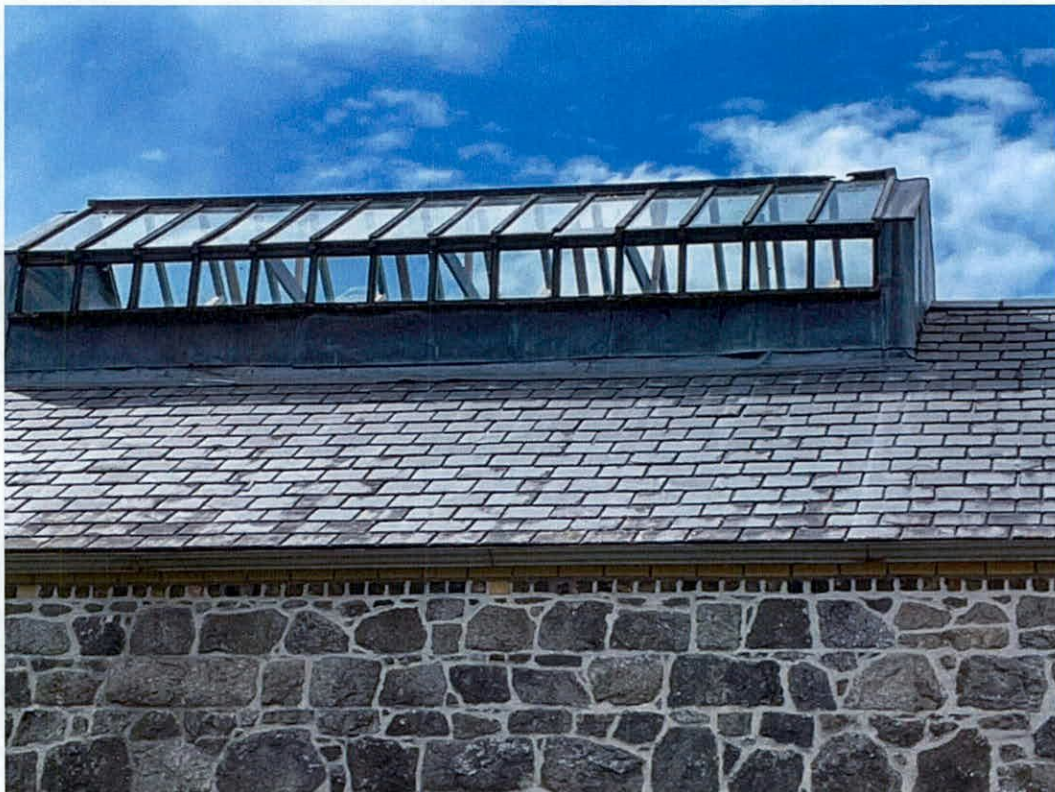
Photo 16: Detail of condition of roof lantern, west elevation

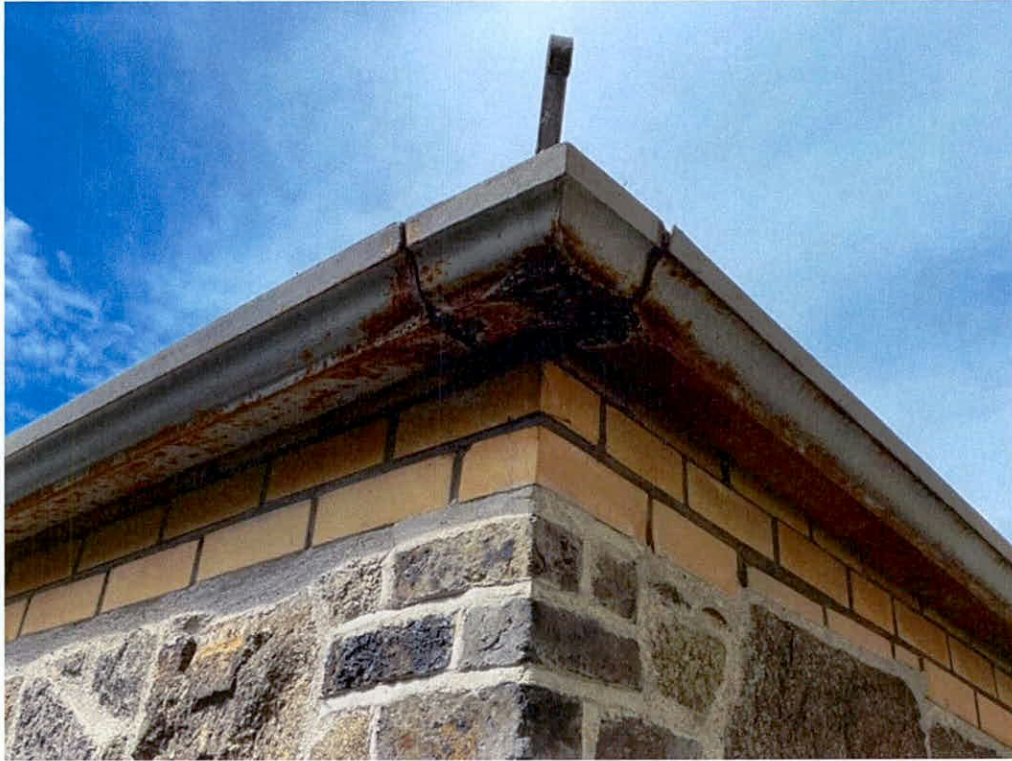
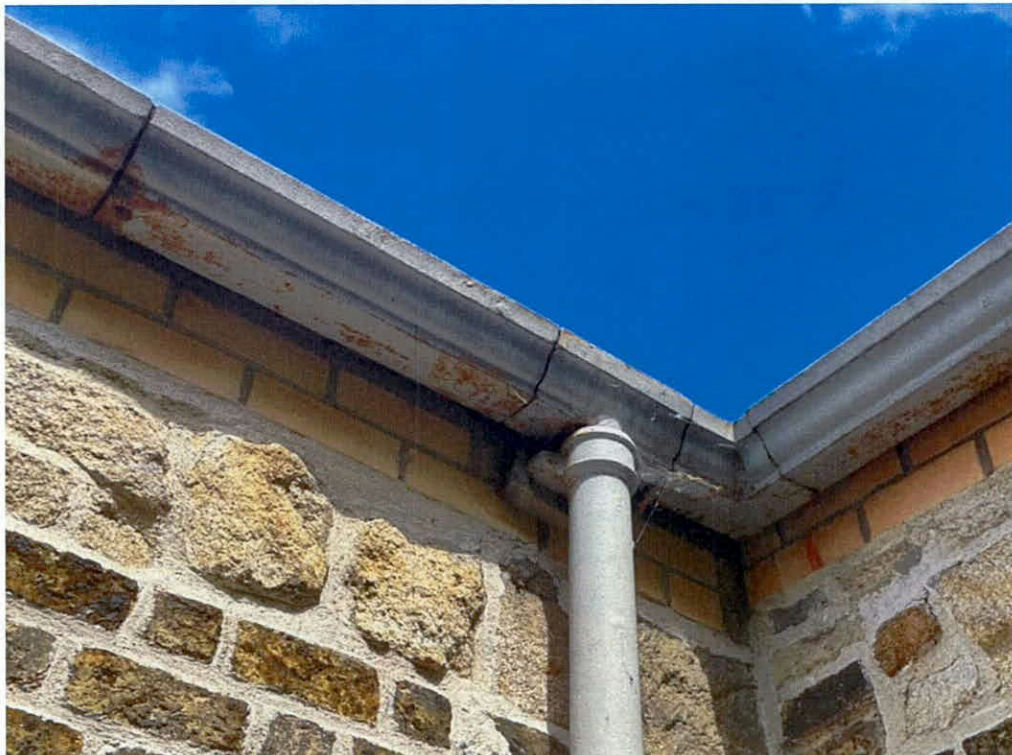
Photo 17: Detail of condition of cast iron guttering

Photo 18: Detail of condition of cast iron guttering

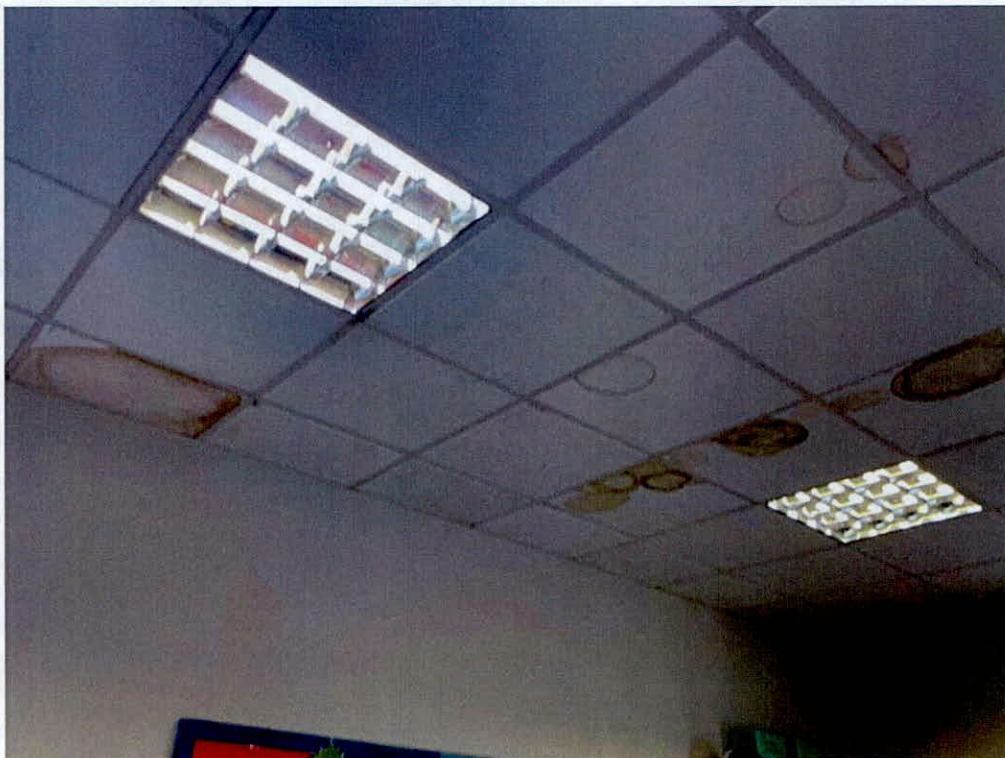
Photo 22: Suspended ceilings and evidence of water ingress
