## INSPECTION REPORT FOR PROPERTY D24X275

A visual inspection was carried out on a property located in Mountpelier in Dublin 24 on 26-6-22 by Michael Moore, Chartered Engineer.

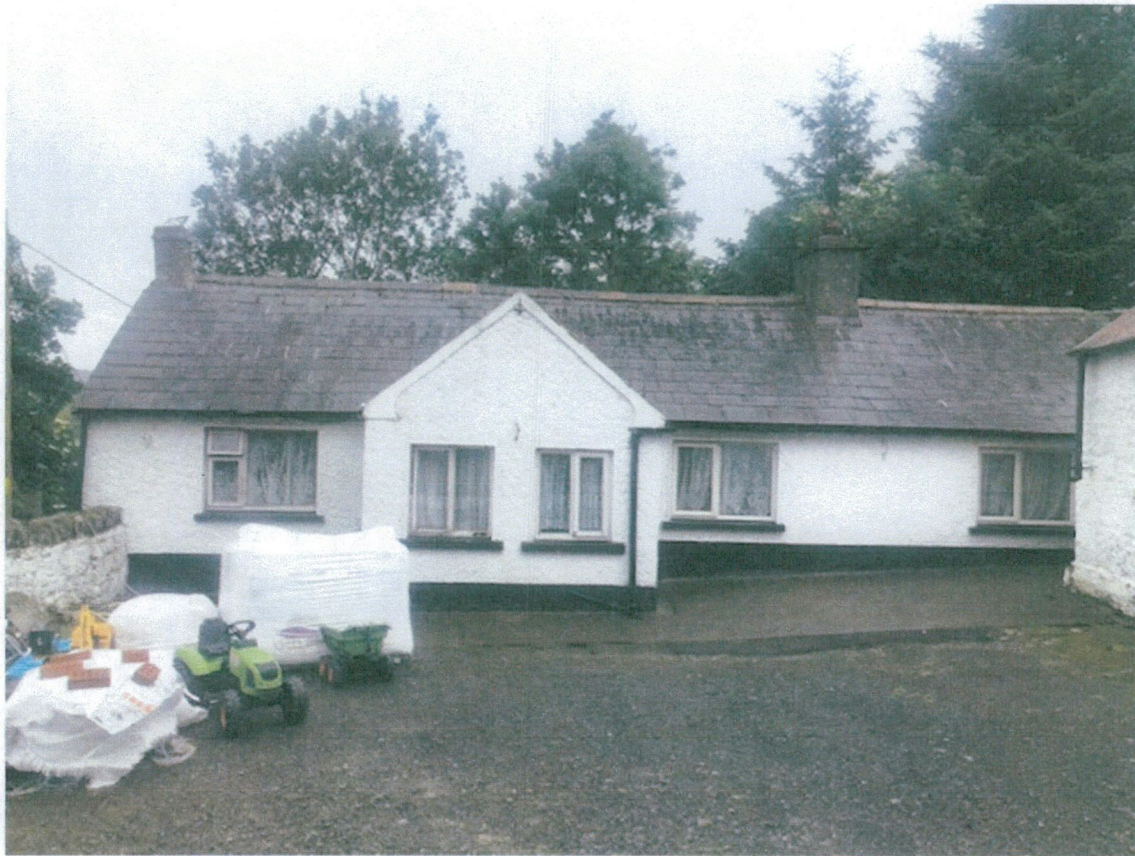
Photo 01 - Front elevation of property

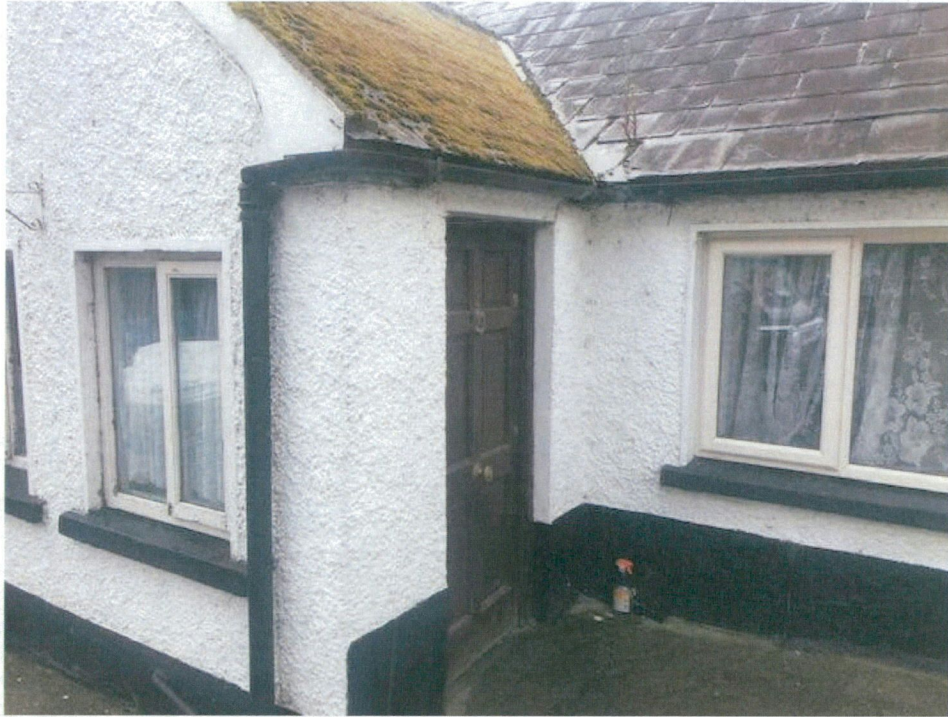
Photo 02 – Front entrance

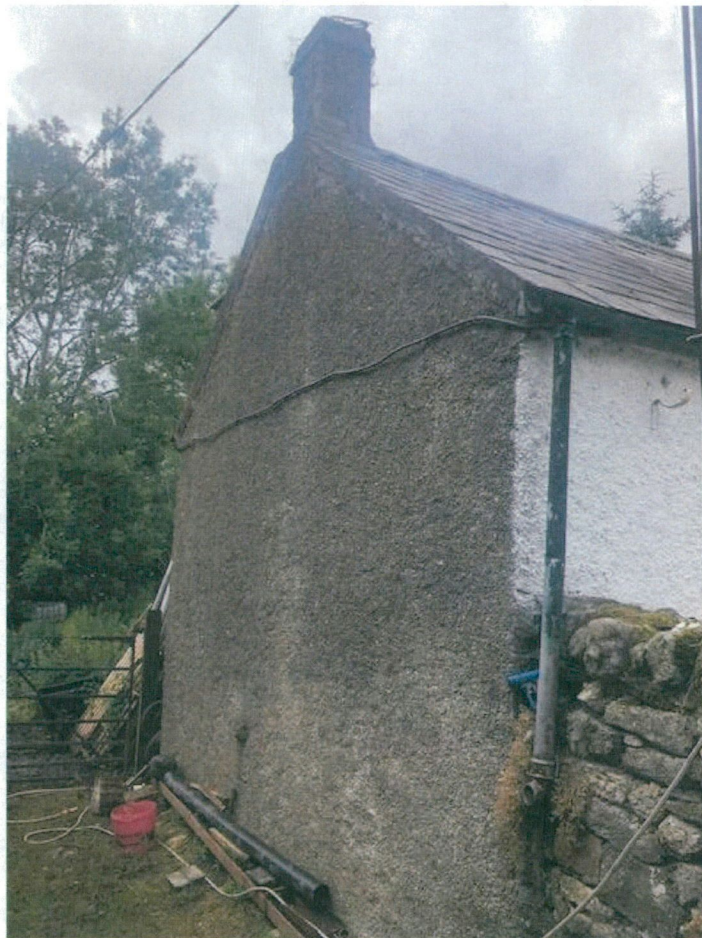
The external ground level is above the internal floor level in the south of the property which is not uncommon in a property of this vintage but can contribute to internal damp.

Photo 03 – South gable and chimney

The property is an honest example of a traditional farm cottage that would greatly benefit from some sympathetic modernisation of the original cottage and bringing the extension up to modern standards. Excavating back the soil or installing a French drain around the south end of the original cottage would isolate the external walls from possible damp ingress.

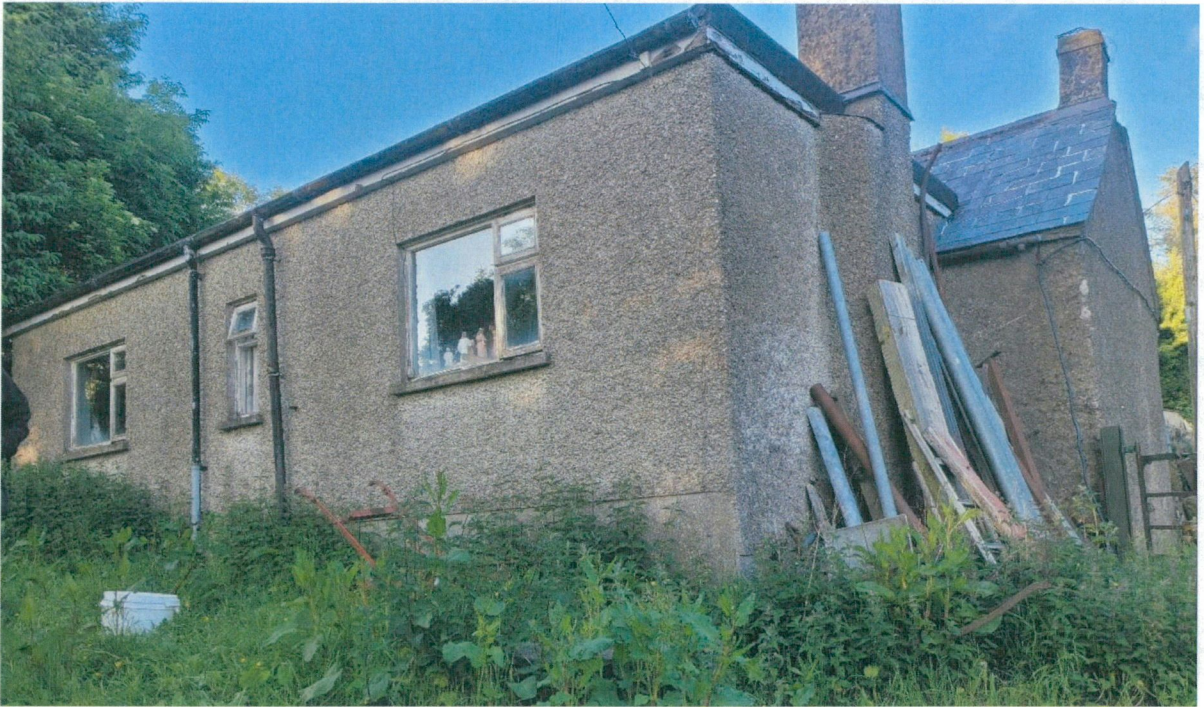
Photo 04 – Rear extension

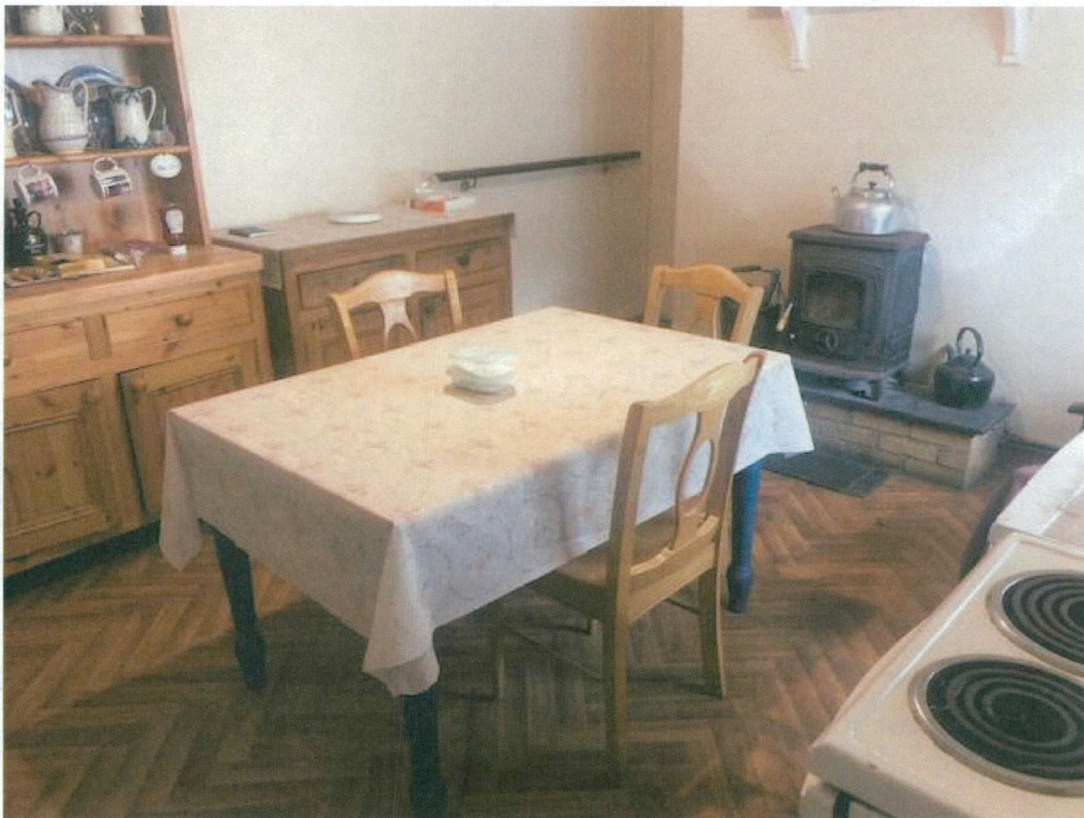
Photo 05 – Kitchen / dining room

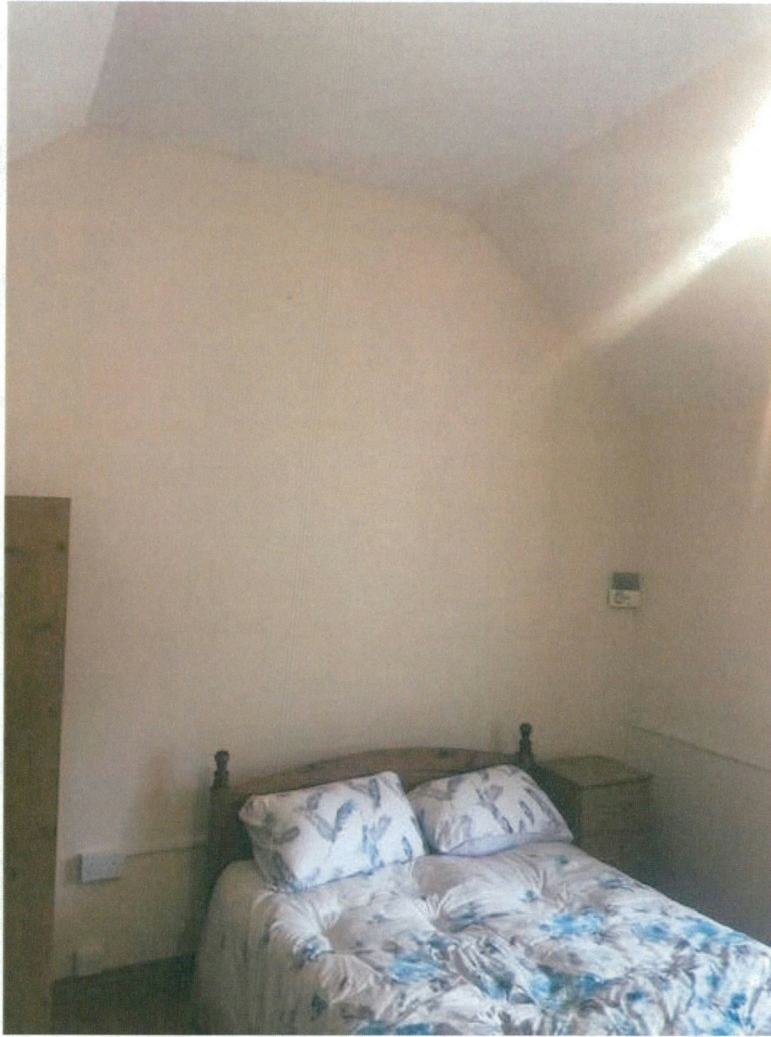
Photo 06 - Bedroom off kitchen with pitched ceiling

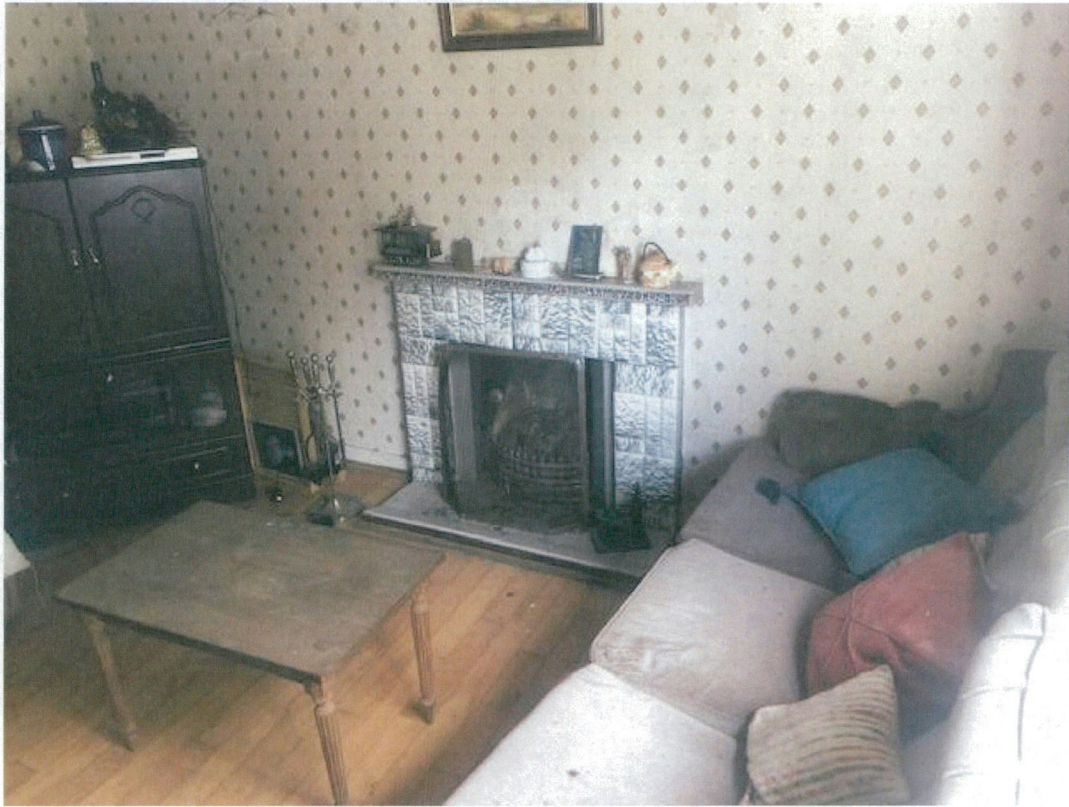
Photo 07 - Living room

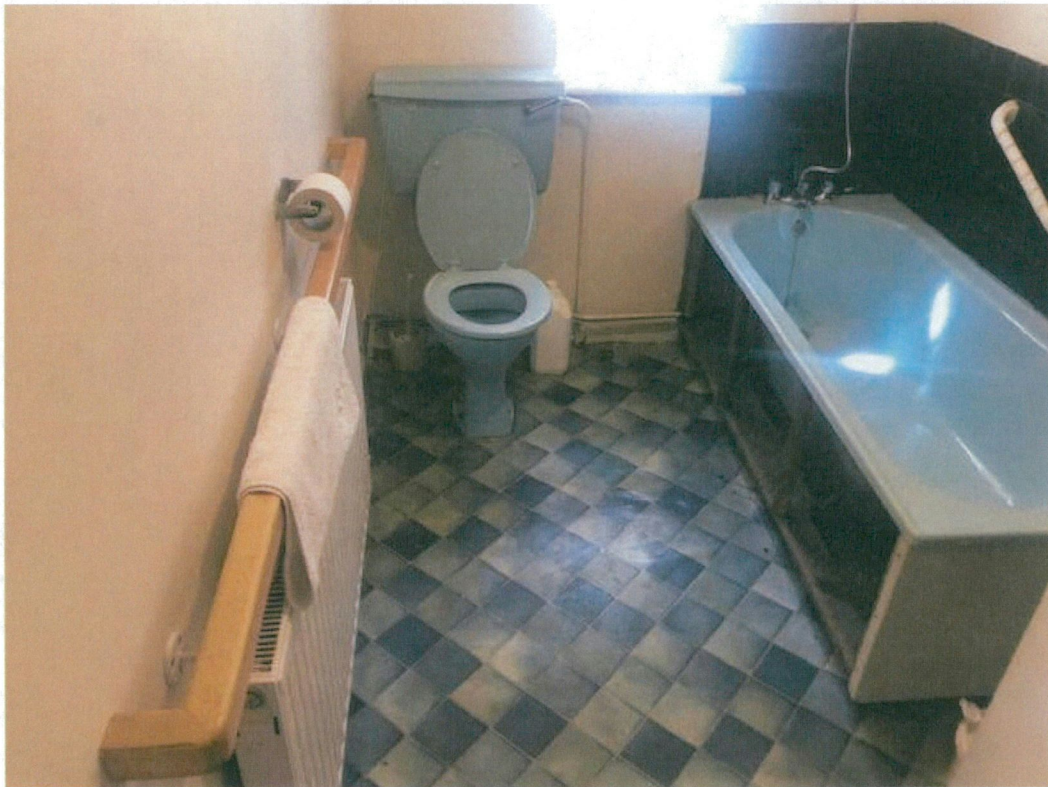
Photo 08 - Bathroom

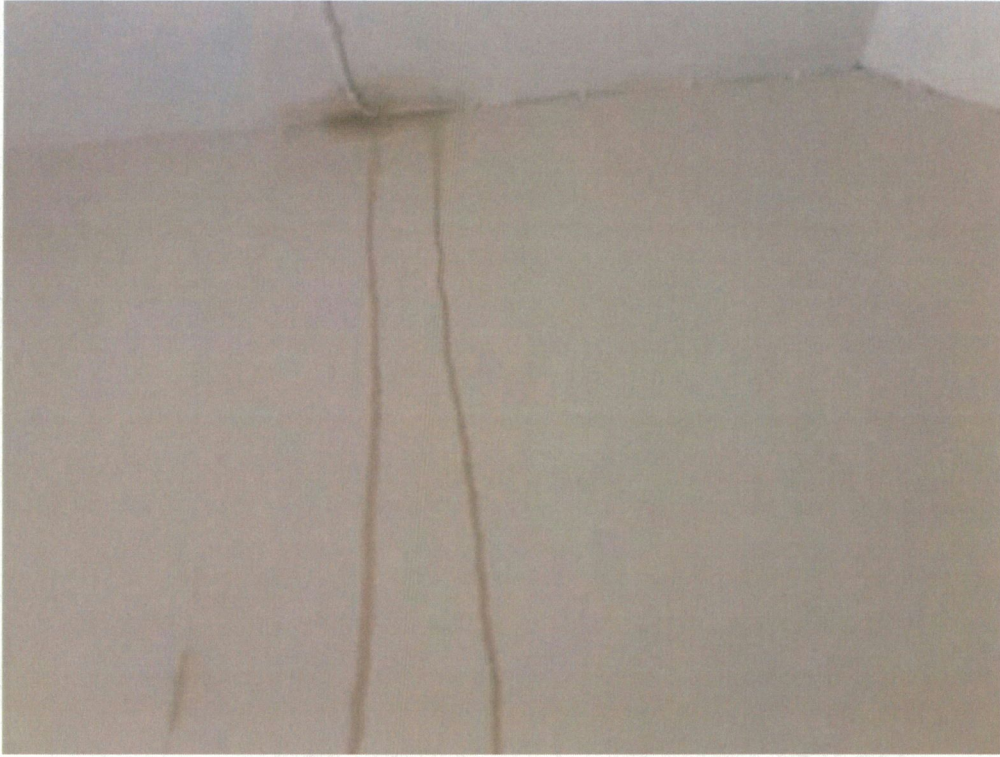
There is a sign of slight water ingress at the central chimney, and this is likely because of damage to the flashing

Photo 09 – Water ingress at chimney

Some further inspections of the chimney would be recommenced if the drylining is removed.

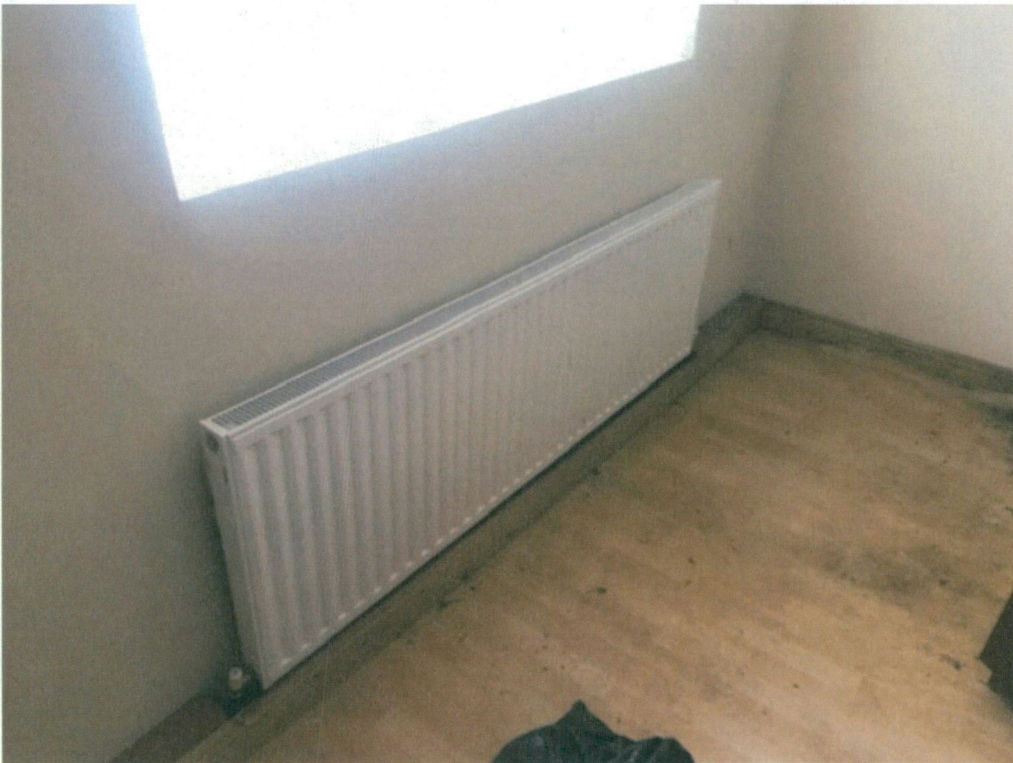
Photo 10 – Central heating in the second bedroom

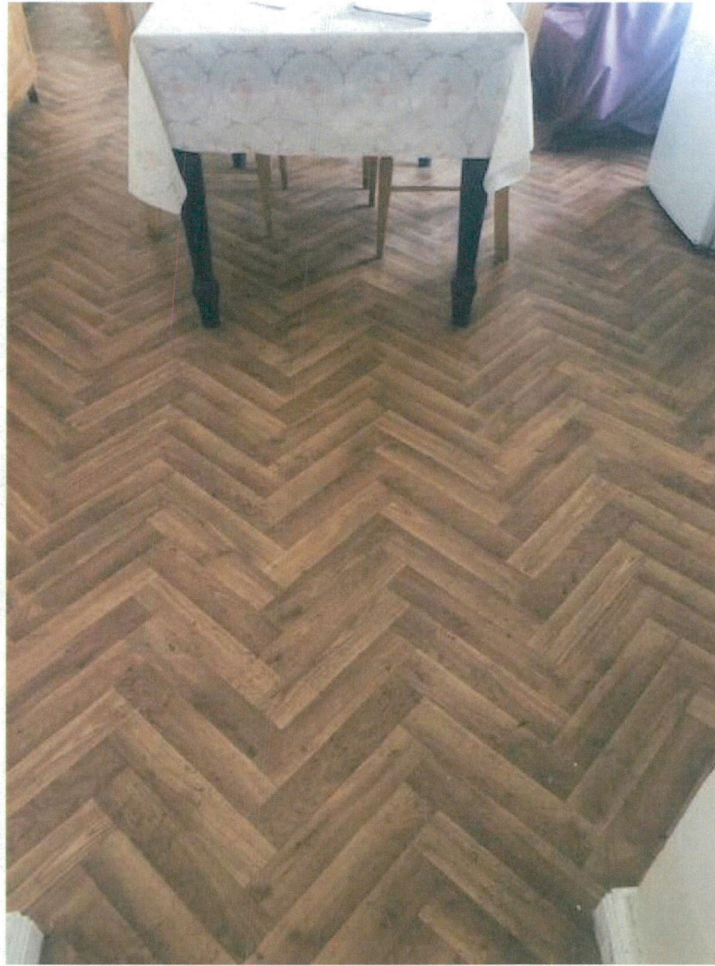
The house has electricity, water and heating and the floors don't show any signs of movement.

Photo 11 – Floors to kitchen
