Title: **Stage 1 Road Safety Audit**

**Link Road to Clonlara Road, Baldonnell Business Park,
Dublin 22.**

Client: **PUNCH Consulting Engineers**

Report reference: **1462R01**

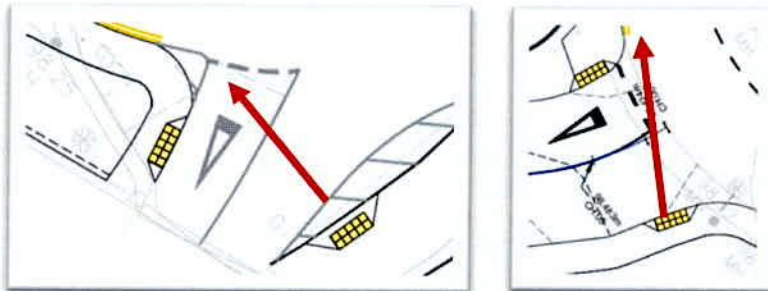
3.2 Problem

The tactile paving at the uncontrolled crossings do not align on either side of the carriageways. This could lead to blind or partially sighted pedestrians being directed incorrectly as they attempt to cross the carriageway. This could lead to collisions with passing vehicles.

RECOMMENDATION

It is recommended that the tactile paving be aligned.

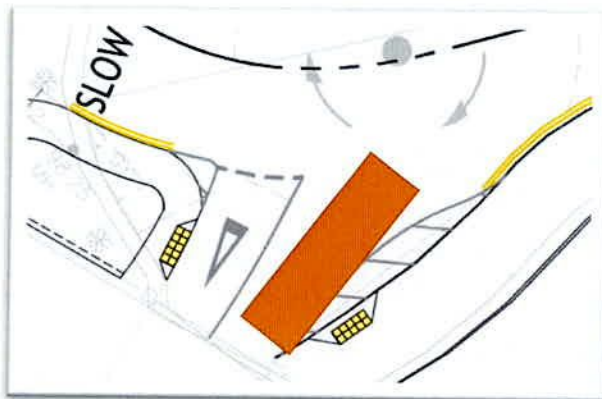
3.4 Problem

It is unclear if a HGV can park outside the Caulfield Transport gated entrance without overhanging the through road. If the trailer overhangs this could lead to side-swipe or rear-end collisions.

RECOMMENDATION

It is recommended that the gate be far enough back so that a HGV driver can pull clear of the carriageway when looking to speak through the intercom to gain access.
