## Construction Environmental Management Plan / Landscape Ecological Management Plan

### Inspection Report

Site: Hinch Site and River Carmac

COFFEY CONSTRUCTION LTD – SAGGART HINCH  
CEMP/LEMP INSPECTION REPORT

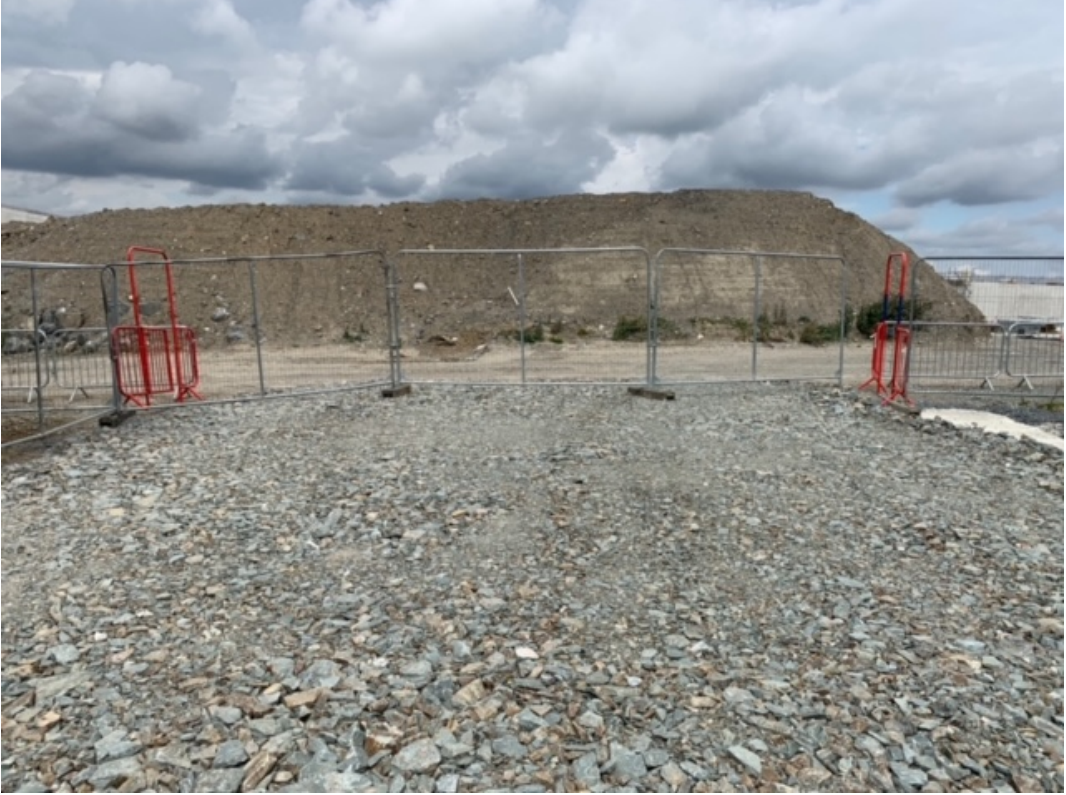
Photo	Note
1

<p data-bbox="312 1077 1382 1137">Site entrance, Fully enclosed as site closed. Fencing throughout – separate segregated footpath outside tree and hedgerow area.</p>
2

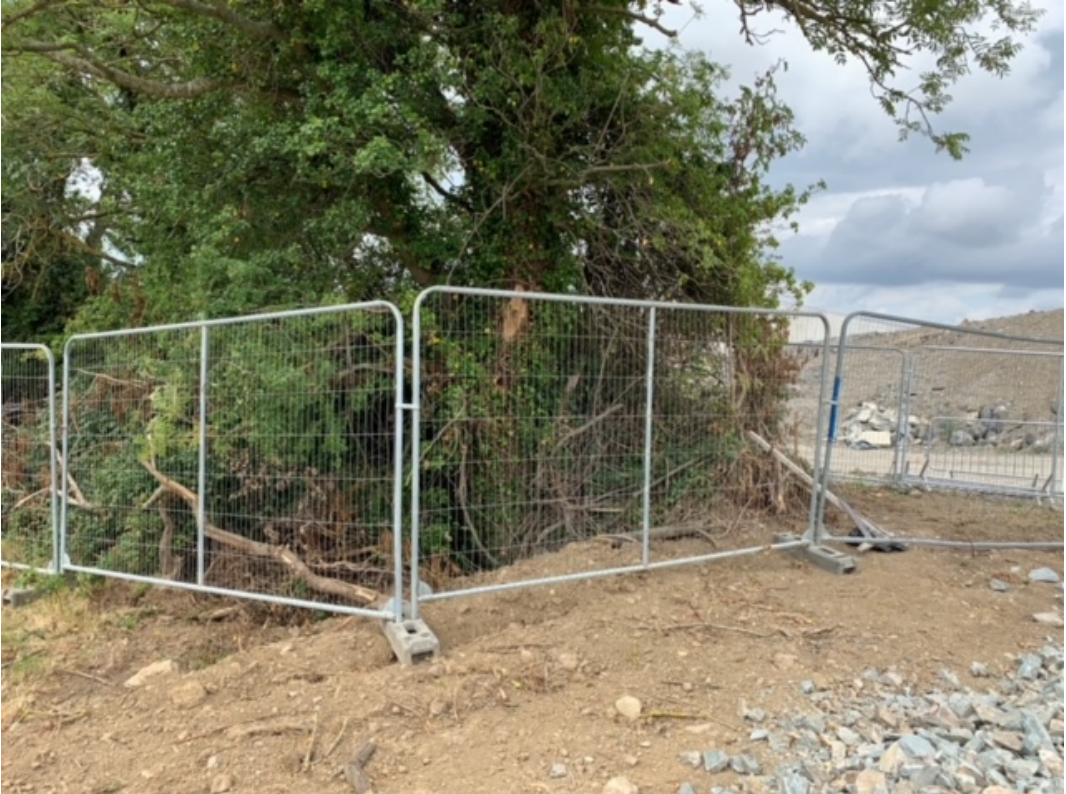
<p data-bbox="312 1935 1382 2000">Tree protection fencing at the entrance. Free standing and braced (site side)</p>

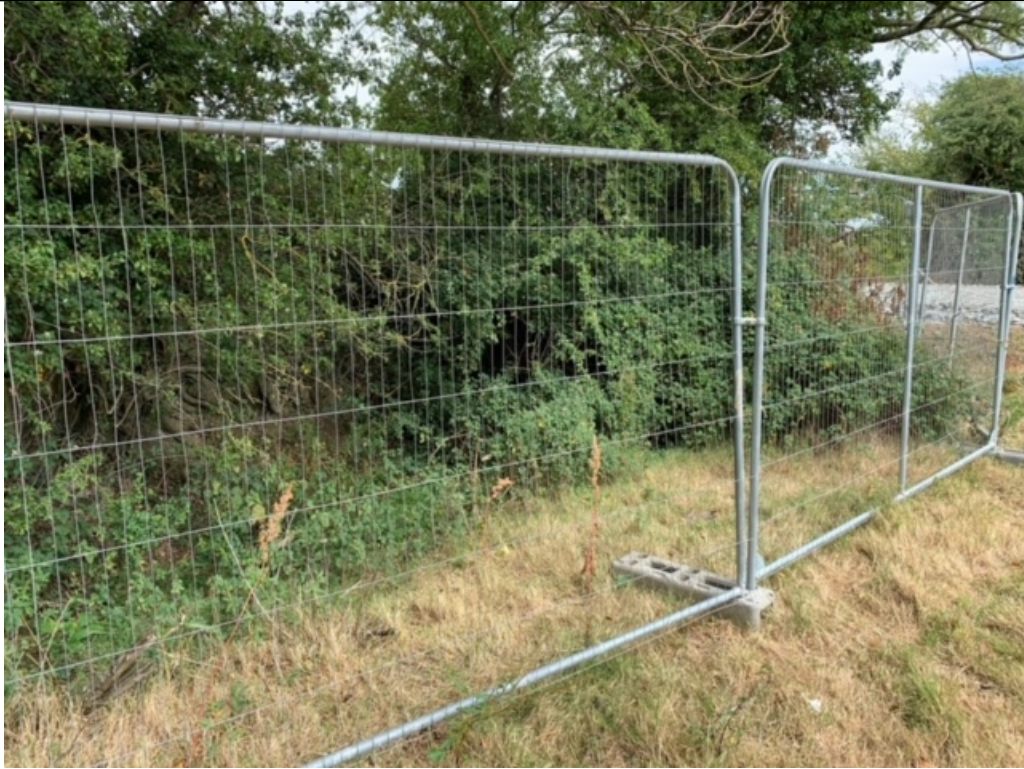
3

Tree protection fencing at site entrance (site side)

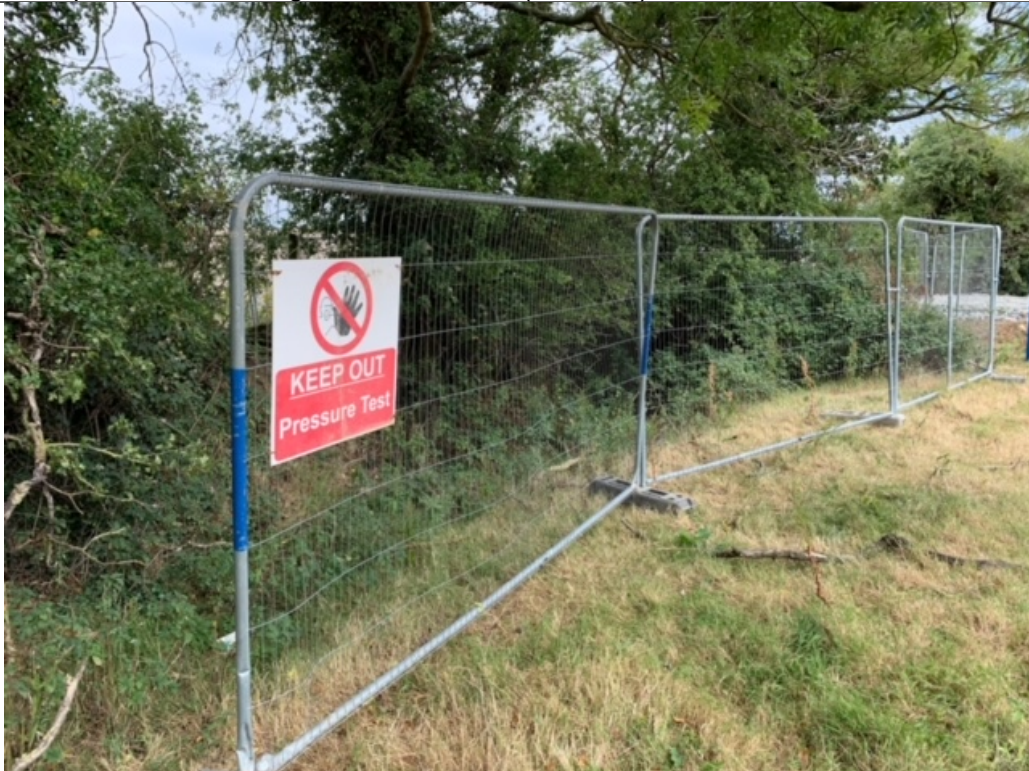
4

Tree fencing inspected and present at the site entrance area, the access side and the site side of the tree line. The site boundaries on all sides were demarked with pegs. No entry sign present on two areas of fencing at points on the site exterior tree fencing. Additional signage was recommended. The site boundary paint margining was suggested to be refreshed on a regular basis so clear to all.

Site fencing and No Entry signage Site side

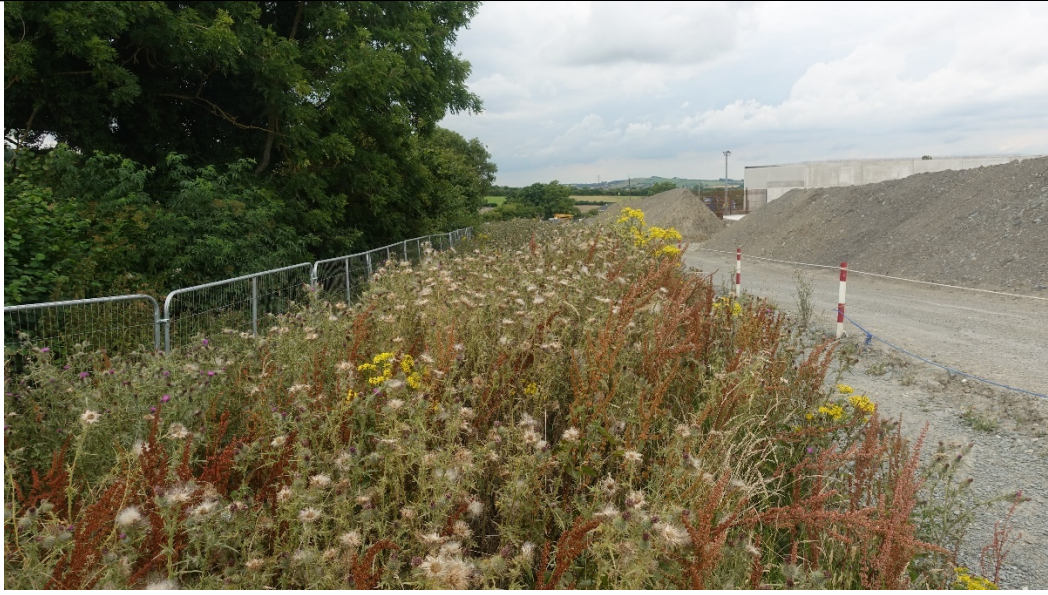
5

Fencing along length of hedgerow at access side.

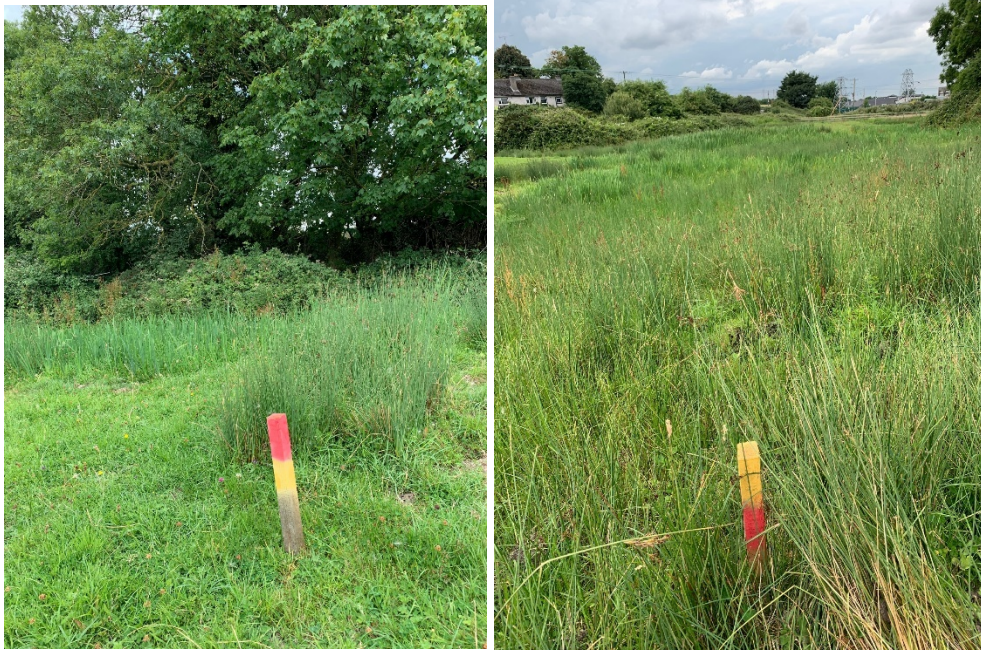
6

RPA Demarcation is through paint and coloured pegs around the entire site. Boundaries were checked around the site and clearly marked. The spray paint has been requested to be refreshed and maybe required regularly. Site Environmental manager will check boundaries and pegs on a regular basis, as well as fencing and replace as required. Suggested some additional no entry signage added within the site.

RPA and site boundary markers.

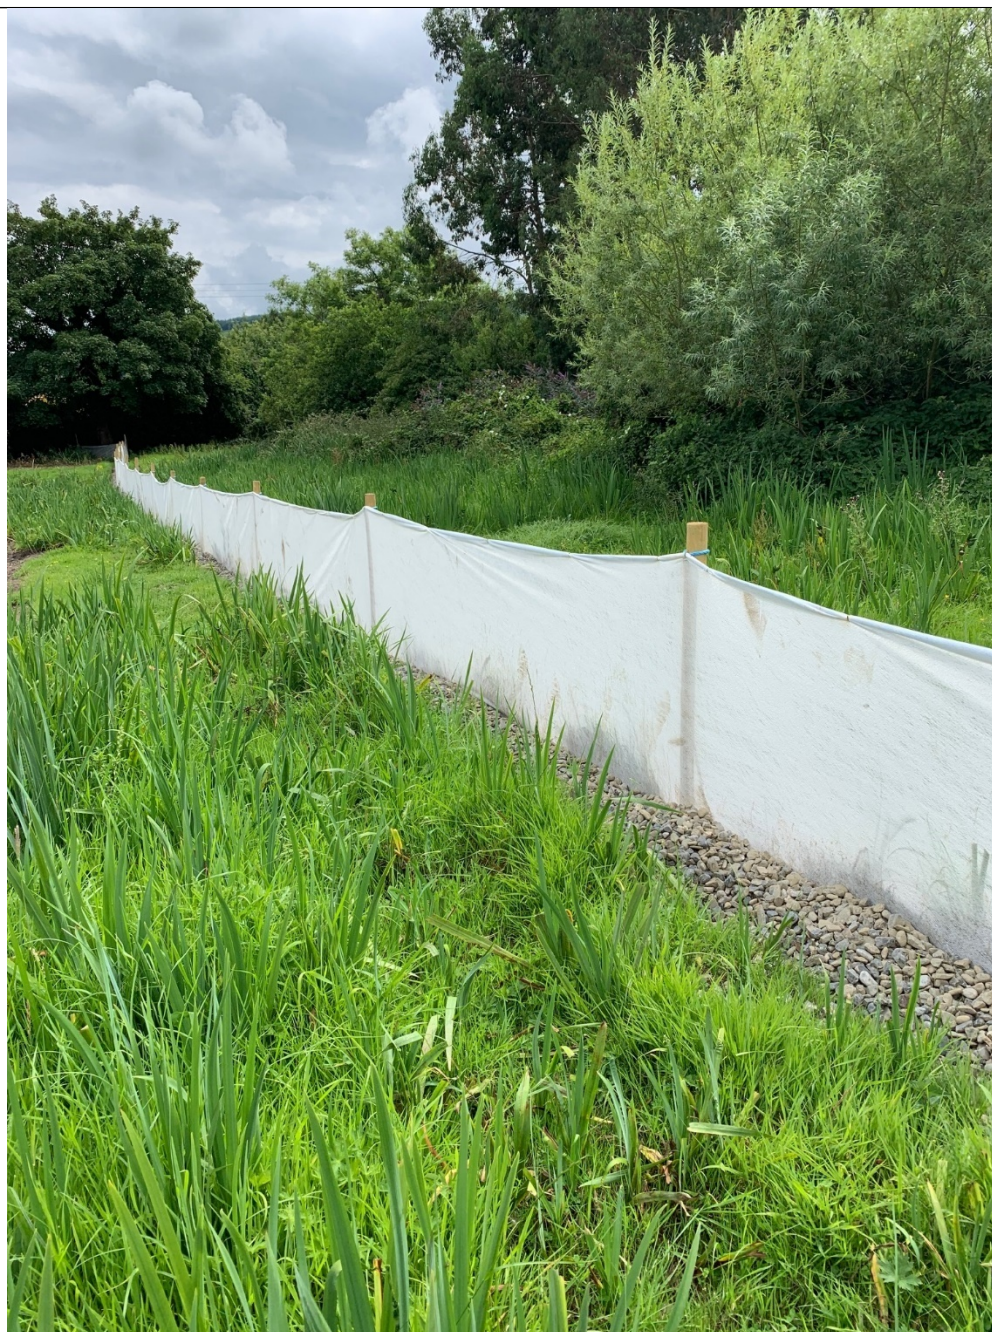
7

Silt fence has been correctly installed along the agreed length of the site from the boundary (including protection through the disused drain at the site boundary, to the extent of the proposed infilling activities. Inspection of geotextile and construction is compliant with EIAR mitigation and site conditions.

Silt fencing installed at a set back from the river. Trench and gravel correctly laid as per the specification

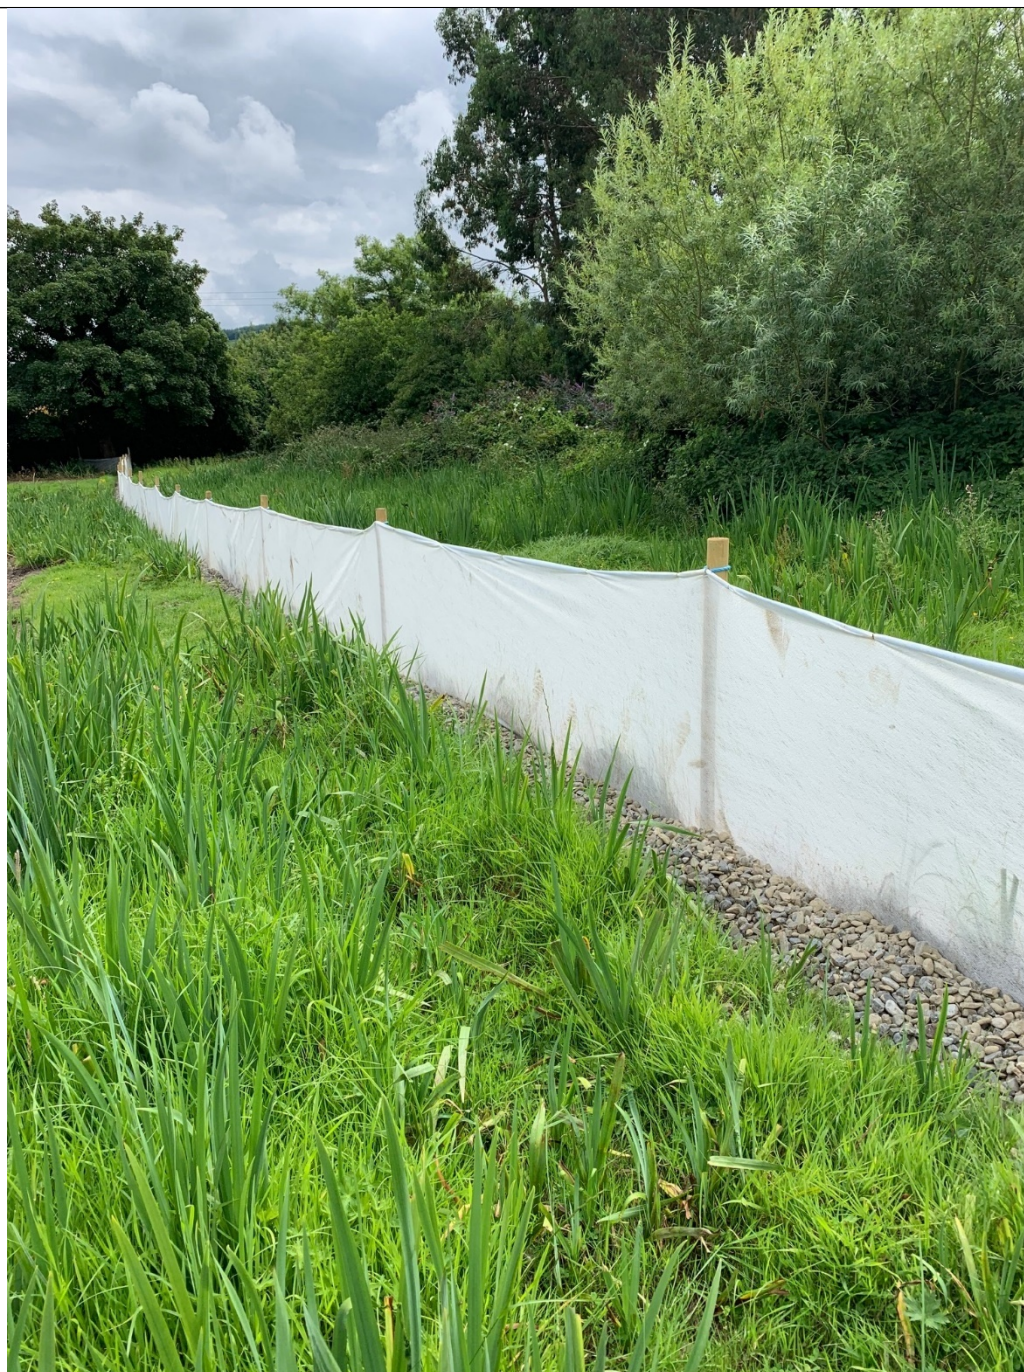
Silt fencing, continuous and complete to the site boundary and including the field edge drain,

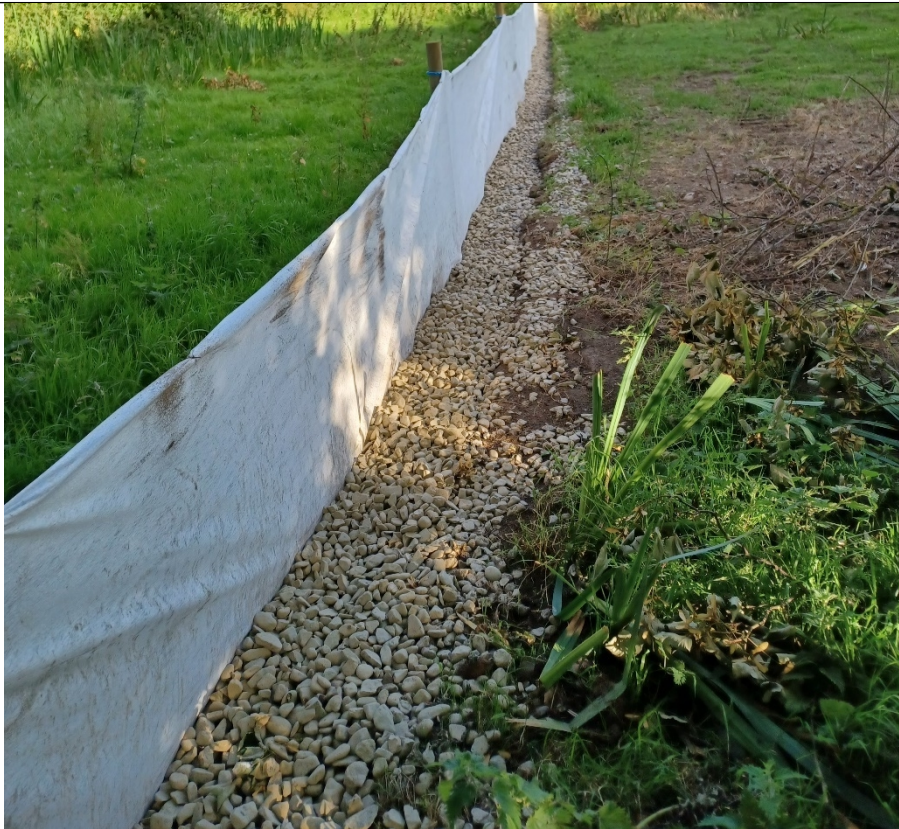
Silt fencing installation

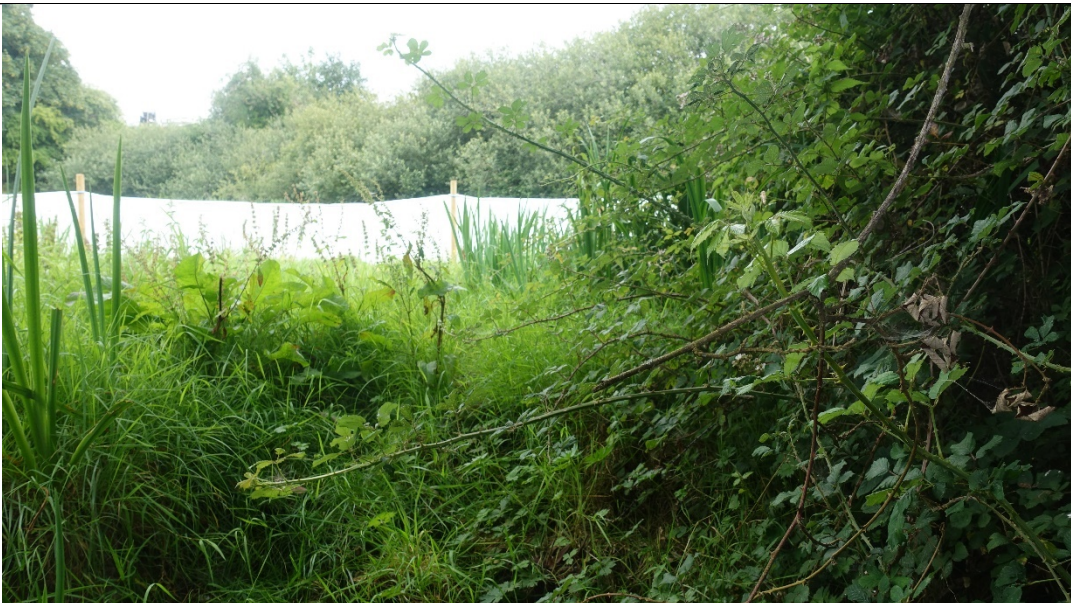
Silt fencing viewed from river

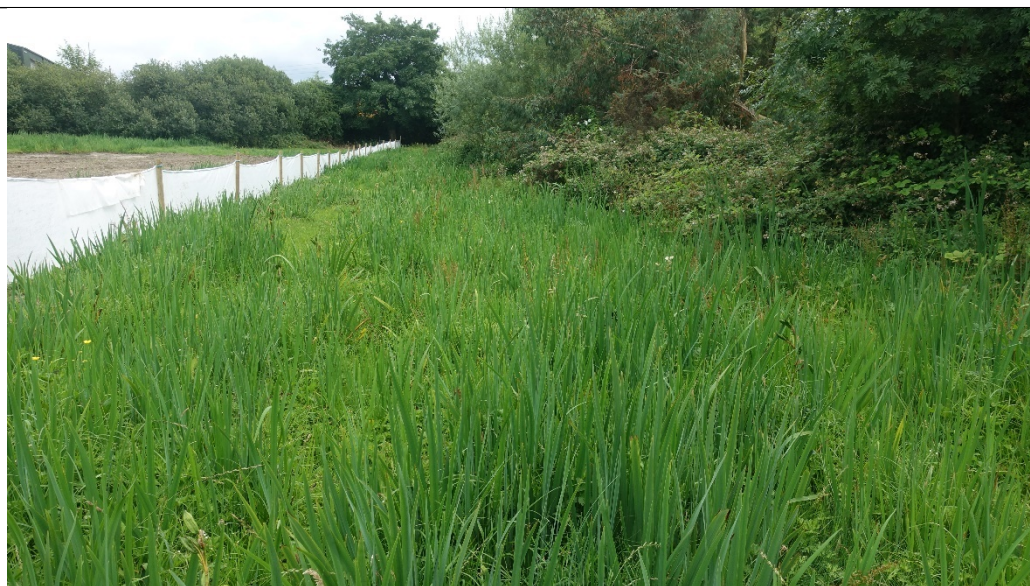
Silt fence from the river showing correct set backs.
