Title: Stage 1 Road Safety Audit

**Link Road to Clonlara Road, Baldonnell Business Park,
Dublin 22.**

Client: PUNCH Consulting Engineers

Report reference: 1462R01

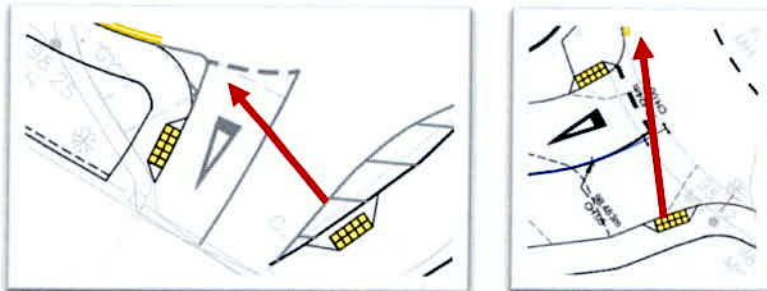
The tactile paving at the uncontrolled crossings do not align on either side of the carriageways. This could lead to blind or partially sighted pedestrians being directed incorrectly as they attempt to cross the carriageway. This could lead to collisions with passing vehicles.

It is recommended that the tactile paving be aligned.

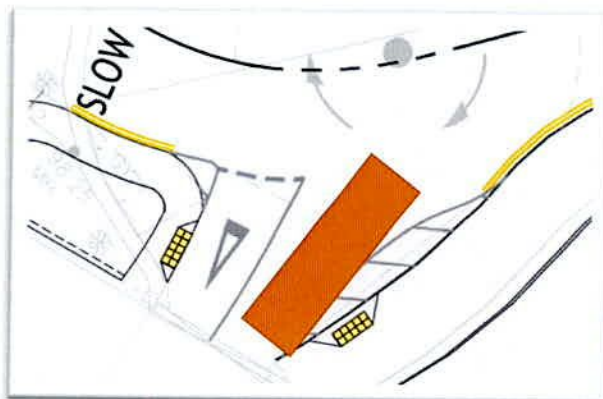
It is unclear if a HGV can park outside the Caulfield Transport gated entrance without overhanging the through road. If the trailer overhangs this could lead to side-swipe or rear-end collisions.

It is recommended that the gate be far enough back so that a HGV driver can pull clear of the carriageway when looking to speak through the intercom to gain access.
