# **Arborist Associates Ltd.**

## **An Arboricultural Assessment of the Site Area on 'Clonburris SDZ Lands', Cappagh, Dublin 22.**

**Prepared for: Kelland Homes Ltd. (Planning Applicant)**

**Date: 31<sup>st</sup> May 2022**

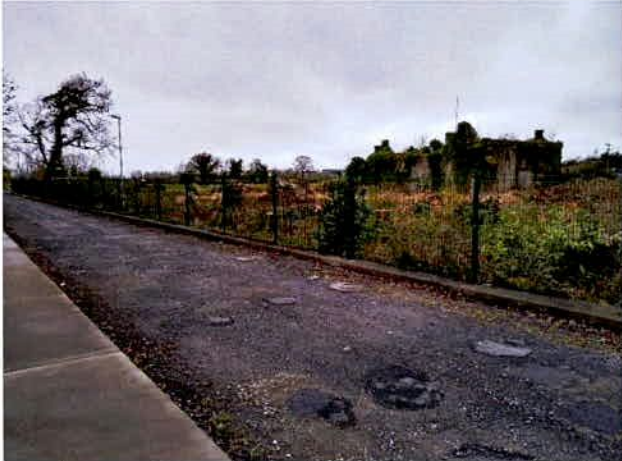
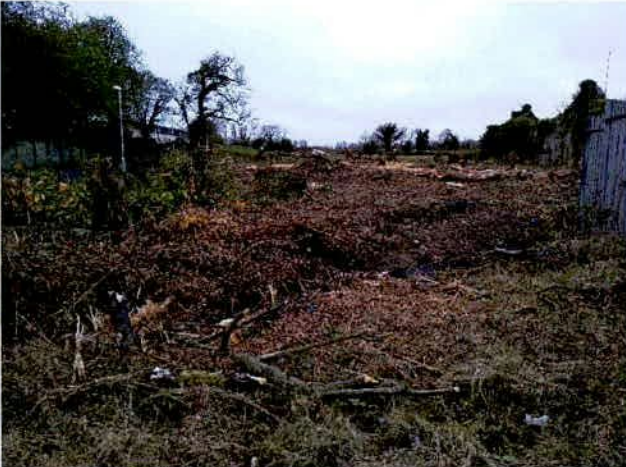
Tree No.	Tree Species	Ht. (m)	Stem Dia. (mm)	Branch Spread (m)				C-Ht. (m)	Age Class	Phys Con.	Structural Condition Other Comments	Preliminary Recommendation	Remain Contribute in years	Cat. Grade	
				N	S	E	W								
				N	S	E	W				N=North S=South E=East W= West Phys Con. = Physiological Condition.	A= Average C-Ht= Crown Height			
<p>A Condition Assessment of the tree and hedge vegetation within the Site Area on 'Clonburris SDZ Lands', Cappagh, Dublin 22.</p> <p>The survey commences on the southern boundary adjacent to 'Whitton Avenue' and proceeds in a broadly east to west direction following the hedge lines.</p>															
<p>Recent clearing works have removed all but one of the trees along this boundary. Associated hedgerow material has also been removed. The single remaining tree, Tree No. 1975, has been left isolated. Trees and hedge lines have also been removed around the remains of the old building.</p>

1795	Oak <i>Quercus robur</i>	17	820	7	4	4	4	5	Mature	Fair	Fair/ Poor Originally it formed part of tree and hedge line located along the southern boundary with Whitton Avenue. The rest of the tree and hedge line has been removed leaving this tree in isolation. It leans out to the north before straightening up. It	Cut Ivy at ground level.  Remove dead/ unstable growth and carry out pruning to help address imbalance and exposure	10-20	C2

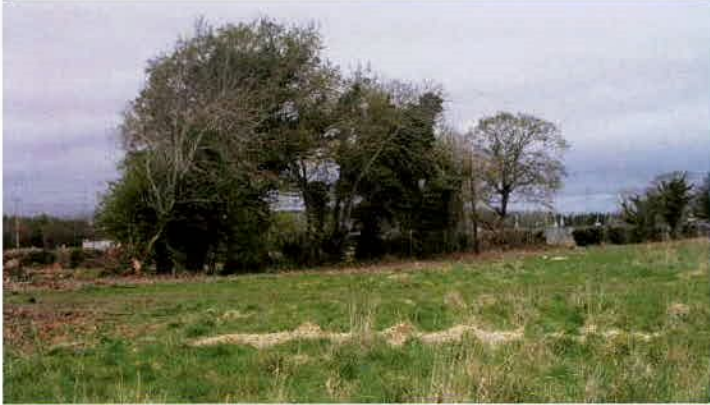
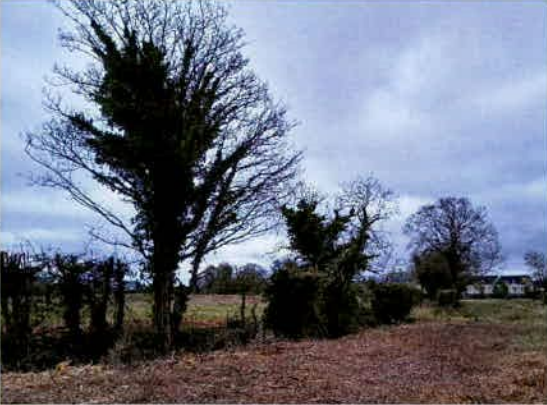
Tree No.	Tree Species	Ht. (m)	Stem Dia. (mm)	Branch Spread (m)				C-Ht. (m)	Age Class	Phys Con.	Structural Condition Other Comments	Preliminary Recommendation	Remain Contribute in years	Cat. Grade
				N	S	E	W							
				N	S	E	W				N=North S=South E=East W= West Phys Con. = Physiological Condition.	A= Average C-Ht= Crown Height		
	<i>Prunus spinosa</i> <b>Ash</b> <i>Fraxinus excelsior</i> <b>Sycamore</b> <i>Acer pseudoplatanus</i> <b>Bramble</b> <i>Rubus fruticosus</i>	immediately to the west. It is mostly continuous along its length with a field gap located at the north end. Hawthorn and Blackthorn dominate with Bramble present along the line. It has recently been mechanically reduced to current height and spread.

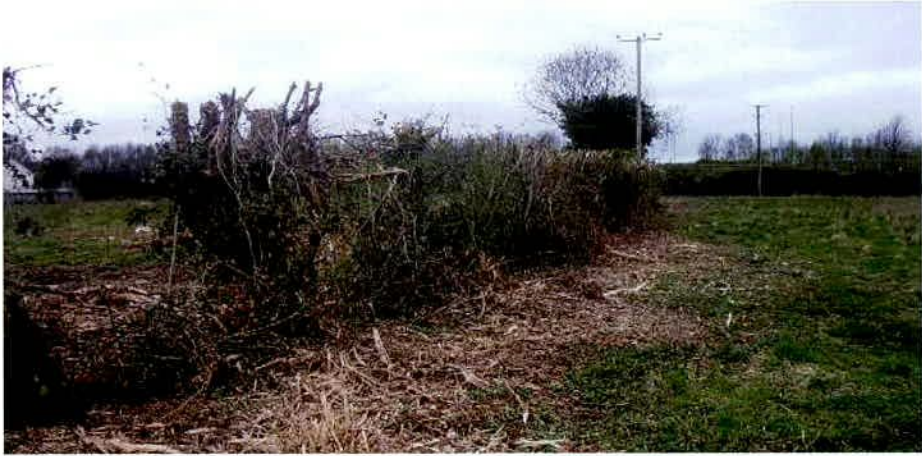
A2.0		A2N, A2S				-

Tree No.	Tree Species	Ht. (m)	Stem Dia. (mm)	Branch Spread (m)				C-Ht. (m)	Age Class	Phys Con.	Structural Condition Other Comments	Preliminary Recommendation	Remain Contribute in years	Cat. Grade
				N	S	E	W							
										N=North S=South E=East W= West Phys Con. = Physiological Condition.	A= Average C-Ht= Crown Height			
										damage in lower branches which has left stubs. Ivy growth extends high into the crown increasing the wind sail.	pruning points.			
Hedge No. 3	<b>Hawthorn</b> <i>Crataegus monogyna</i> <b>Elder</b> <i>Sambucus nigra</i> <b>Ash</b> <i>Fraxinus excelsior</i> <b>Bramble</b> <i>Rubus fruticosus</i> <b>Goat Willow</b> <i>Salix caprea</i> <b>Blackthorn</b> <i>Prunus spinosa</i>	<p>It extends at ninety degrees from Hedge No. 1 in a broadly east to west direction across the site forming an internal boundary between fields.</p> <p>It is of a mature age class in fair condition physiologically and structurally. It is not continuous, with gaps along the line to allow passage between fields and also due to the overhead utility lines. It is located on the northern side of a derelict drainage ditch. It has recently been mechanically reduced to current height and spread. There is one mature Ash tree located along the line which extends above the general hedge height.</p>										<p>Carry out further general tidying works to improve appearance and structure.</p> <p>It would benefit from infill planting with hedgerow species.</p>	C2

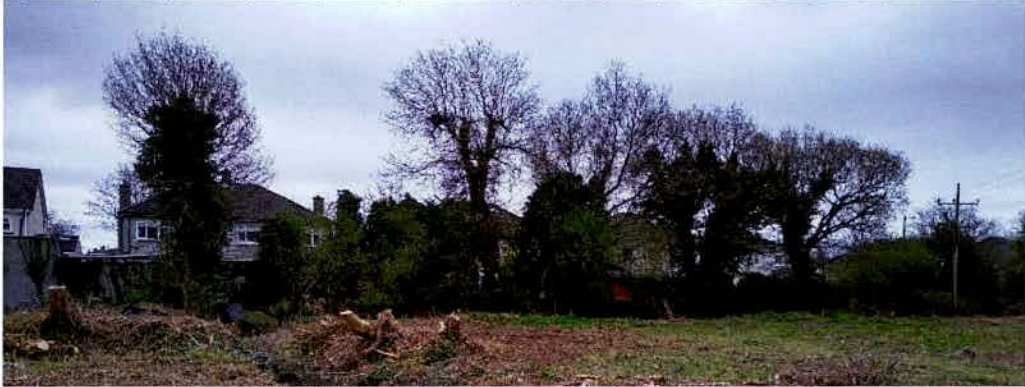
It is of a mature age class in fair condition both physiologically and structurally. There is a deep, water filled, ditch located immediately to the west of this hedge, which prevents access from the site side. It is mostly continuous along its length and has been allowed to grow unmanaged for some time. It forms part of a longer hedge line and contains a number larger trees along its length. It consists mainly of clumps of Hawthorn and Elder with Bramble colonizing.										
				A4.0			A2E, A2W		-
