Lidl Development, Main Street (R405), Newcastle
Stage 1 Road Safety Audit

Lidl Ireland GmbH

July 2022

Stage 1 Road Safety Audit

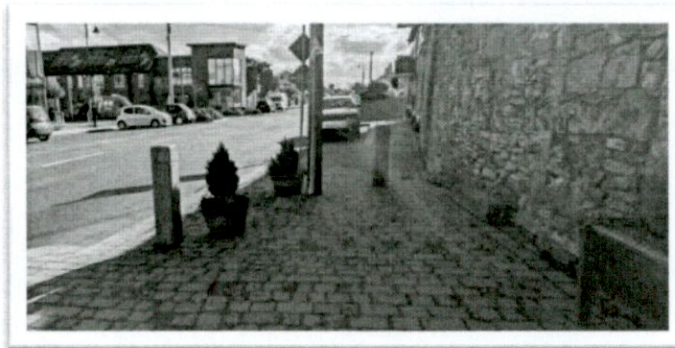
Figure 2.1 – Proliferation of Street Furniture on Footpath Near Access

2.1 Problem: Existing Street Furniture Blocking Footpath

Location: Public Footpath on R405 in Proximity to Site Access

The existing footpath was cluttered with street furniture in proximity to the site access. This could lead to progression issues on the footpath for mobility impaired road users and obstruction to junction visibility.

Recommendation

The street furniture in proximity to the store access should be rationalised to mitigate the risks described.

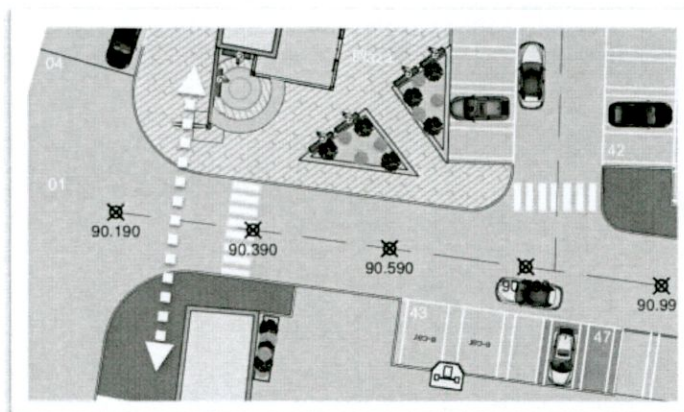
Figure 2.2 – Pedestrian Desire Line Which Will Cross the Access

2.2 Problem: Set Back of Pedestrian Crossing

Location: Public Footpath on R405 in Proximity to Site Access

The pedestrian crossing will be set back a significant distance from the pedestrian desire line which crosses the access. This could lead to the pedestrian crossing being ignored, resulting in vulnerable road users coming into conflict with vehicular traffic.

Recommendation

The pedestrian crossing should be aligned on, or closer to the pedestrian desire line on the public footpath which crosses the access.

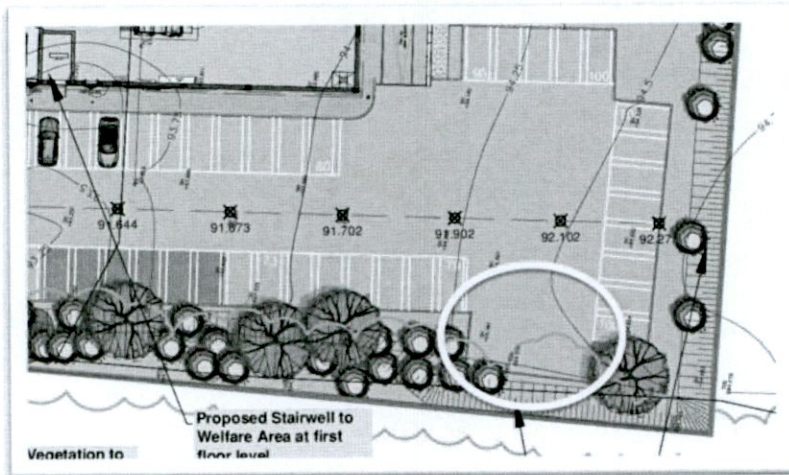
Figure 2.3 – Area where Errant Parking will Obstruct Service Vehicle Manoeuvring

2.3 Problem: Errant Parking in Service Vehicle Turning Area

Location: Southern Section of Carpark and Internal Circulation Road

An area of carpark has been set aside to assist turning and manoeuvring for service vehicles on approach to the dock loader. This area may attract errant parking which could lead to conflicts between service vehicles and store patrons.

Recommendation

Measures to deter errant parking in the area described should be implemented by the Designer.

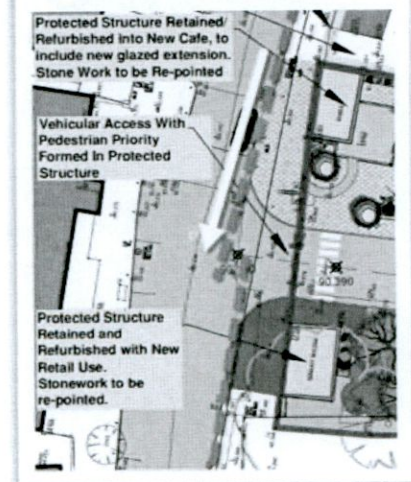
Figure 2.4 – Kerb Alignment Either Side of Site Access

2.4 Problem: Kerb Alignment Mis-Directing Westbound Traffic

Location: R405 in Proximity to Site Access

The re-alignment of the R405's southern kerb line either side of the store access could direct westbound drivers out of their lane and into the opposing traffic lane. This could lead to head-on type collisions.

Recommendation

The kerb alignment should be adjusted locally to provide a smooth and intuitive road alignment and to direct drivers to stay within their lane as they pass the store access.

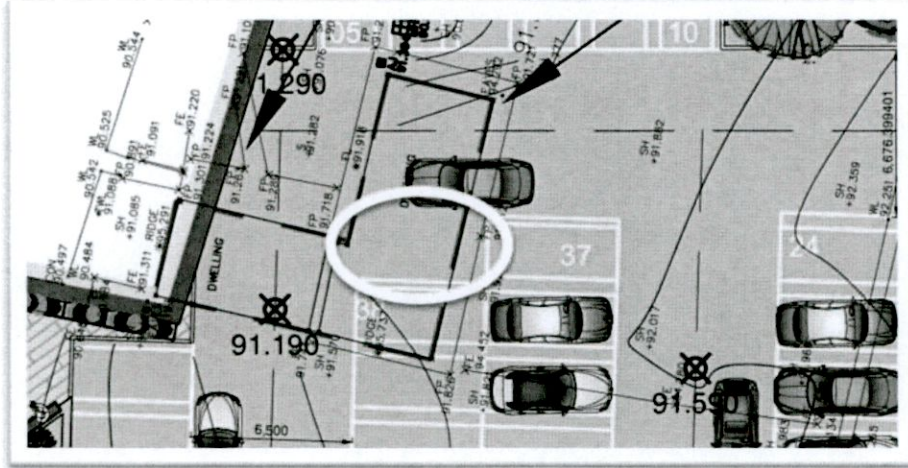
Figure 2.5 – Space Where Patrons Are Likely to Park

2.5 Problem: Errant Parking Leading to Obstruction in Car Park

Location: Section of Pavement at Corner Between Parking Spaces 37 & 38

Patrons are likely to park in this area, which could lead to driver frustration, delays and vehicle queues impacting upon the operation of the adjacent R405.

Recommendation

A traffic island should be placed at the location described to prevent inconsiderate parking.
