TREE SURVEY

Westpark Crescent, Gartars Lane, Saggart, Co. Dublin 24

PROJECT TITLE
 C.O.U of Residential Units at Westpark Crescent, Gartars Lane, Saggart, Co. Dublin 24

SHEET TITLE
 Tree survey

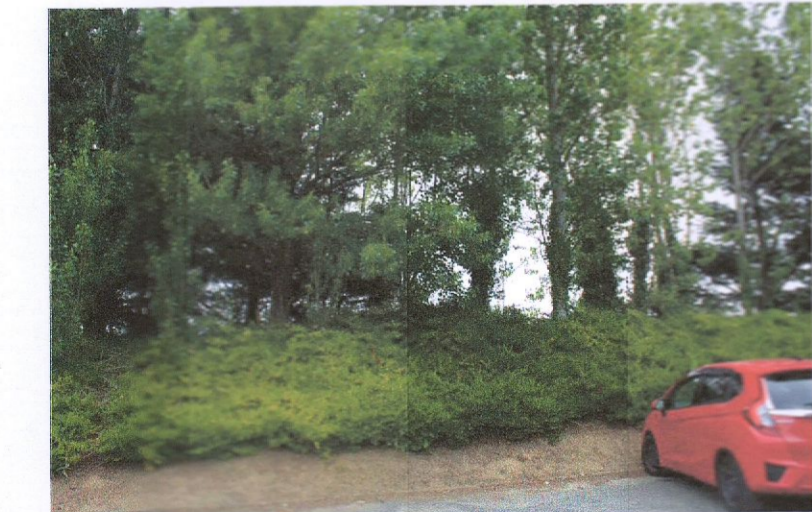
1 - *Populus nigra* / *Cupressus Leylandii* double hedgerow with *buxus sempervirens* groundcover

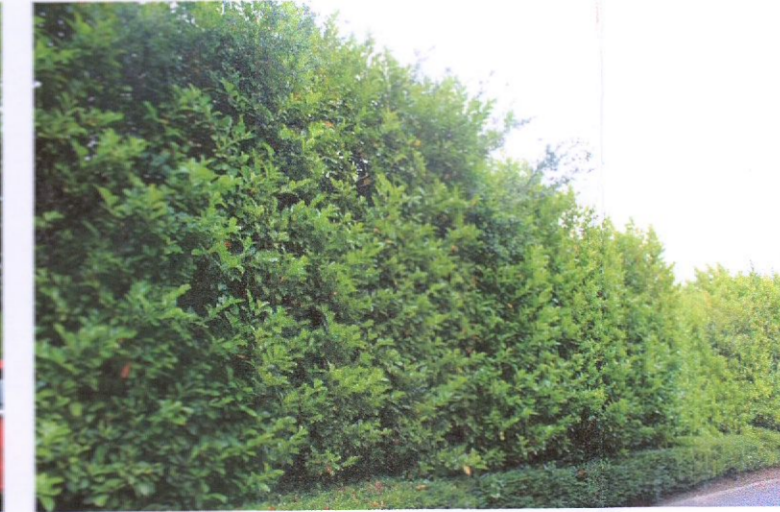
2 - *Prunus laurocerasus* hedge with *buxus sempervirens* hedge in front

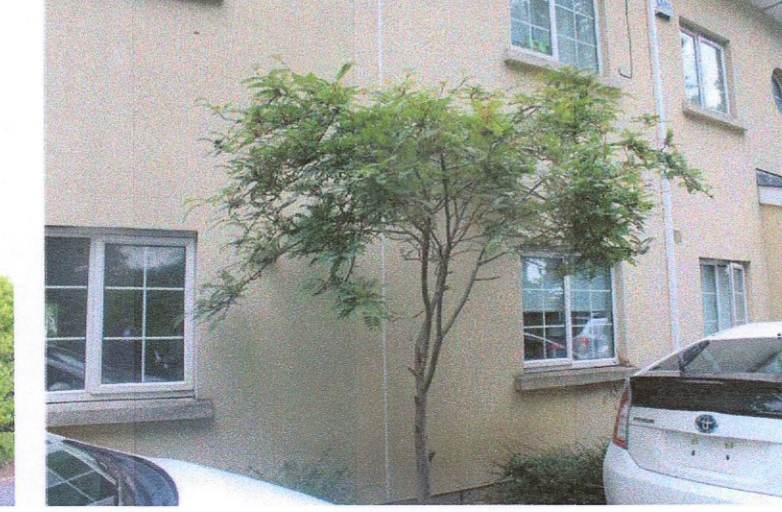
3 - Existing *Fraxinus excelsior*

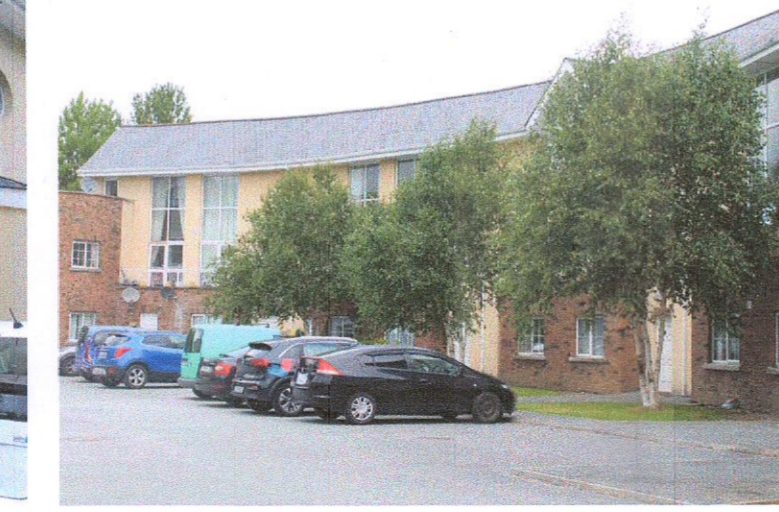
4 - Existing *Betula pubescens* at the front elevation

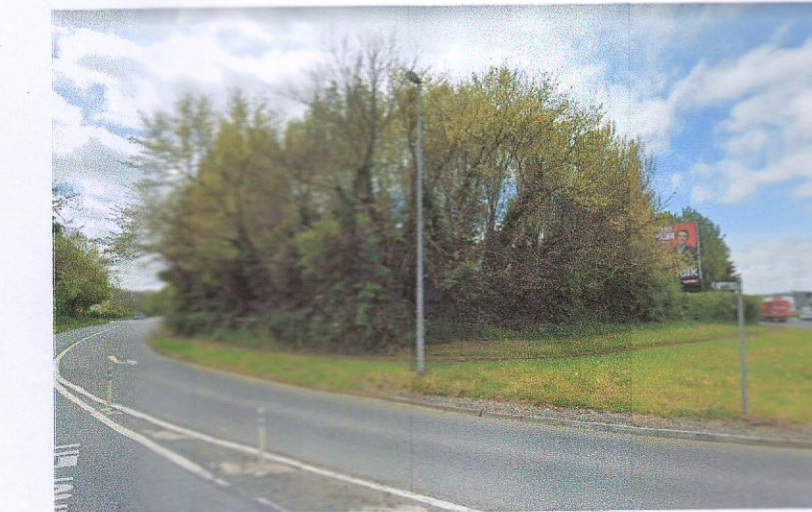
5 - Tree group 1 and 2, from Garter lane

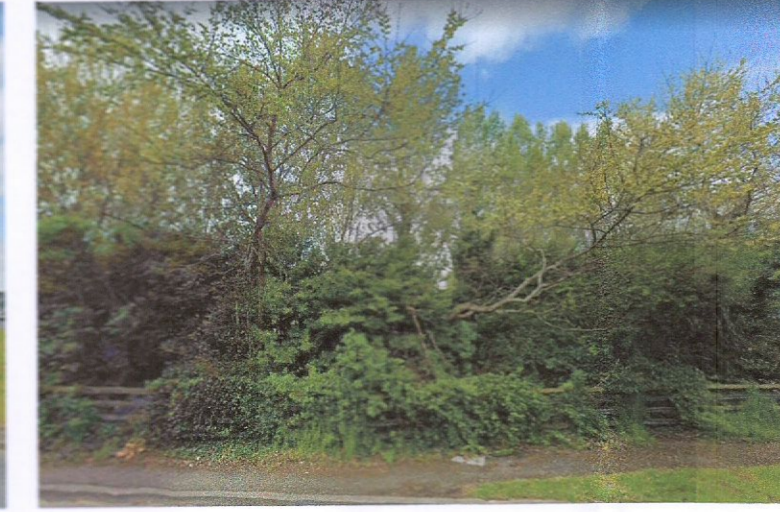
6 - Tree group 2, from Garter lane

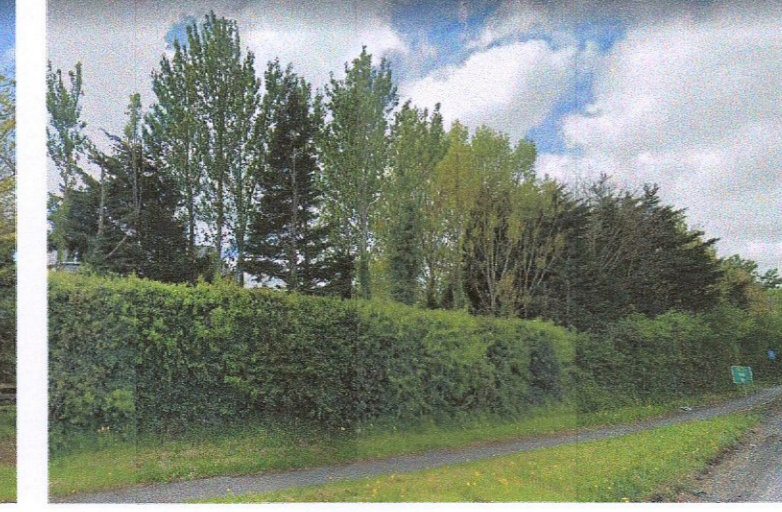
7 - Tree group 1 - *Populus nigra* / *Cupressus Leylandii* double hedgerow mix. View from N7 road.

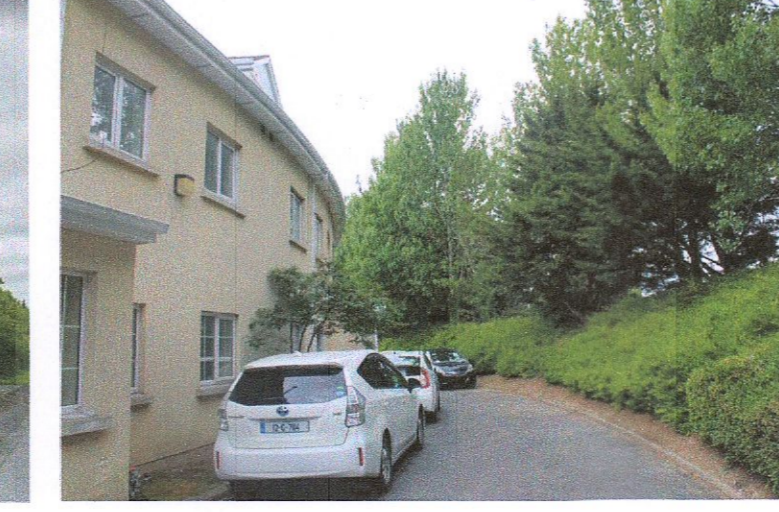
8 - Tree group 1 - *Populus nigra* / *Cupressus Leylandii* double hedgerow mix and *buxus sempervirens* groundcover.
