Title: **STAGE 1 ROAD SAFETY AUDIT**

Hillhouse, Lucan, Proposed Residential Development.

Client: **PMCE**

Report reference: **1495R01**

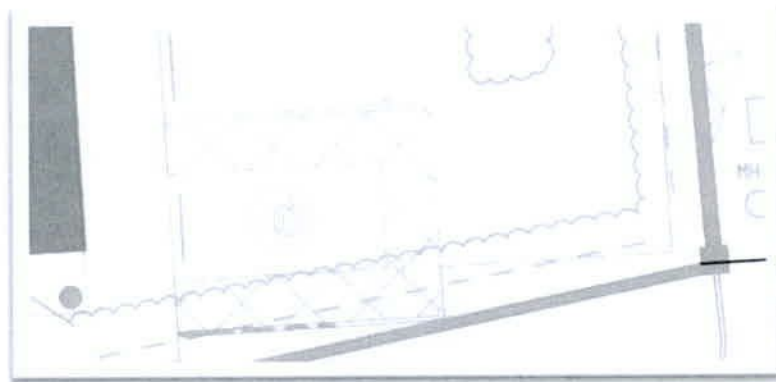
Drawing P22-026-DG-SP-001 S0, Rev 2.0 – Disabled Parking Space.

It is unclear if there is sufficient space for a user of the disabled parking space to easily enter/exit the parking space given the proximity of the boundary walls. A lack of space could lead to material damage of vehicles.

It is recommended that a swept path analysis be carried out to ensure that sufficient space is available.

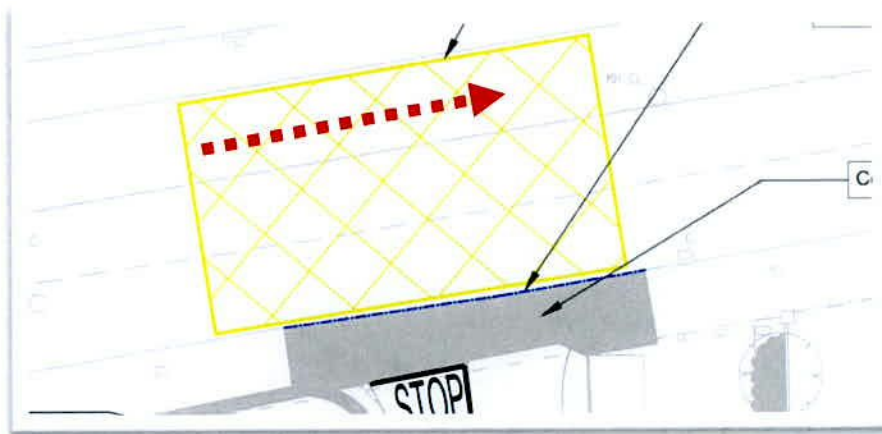
Drawing P22-026-DG-GA-001 S0, Rev 2.0 – Yellow Box.

It is unclear if the proposed yellow box is required on the outbound lane from Lucan on the Lucan Road. If queues of traffic do not form in that direction drivers exiting the development during peak periods of inbound traffic may mistakenly think that they can turn right without checking for oncoming outbound traffic resulting in side-impact or rear-end collisions.

It is recommended that the Design Team confirms if outbound queuing takes place and if not, that the yellow box only be provided on the two inbound lanes.

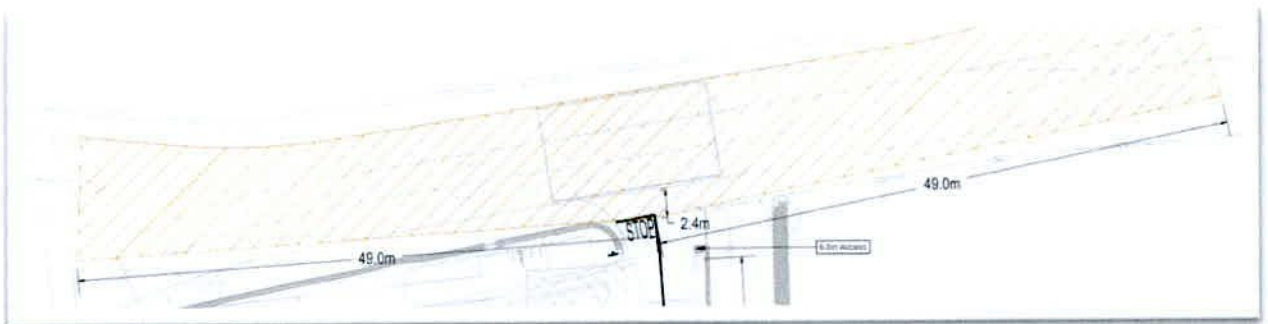
Drawing P22-026-DG-VE-001 S0, Rev 2.0 – Visibility Splays.

The proposed visibility splay lines cut through both existing and proposed obstacles (vegetation, walls etc.). These obstacles will obstruct visibility for drivers exiting the development and could lead to side-impact or rear-end collisions.

It is recommended that the visibility splays be kept clear of obstacles except for those that are momentary obstructions both individually and cumulatively.

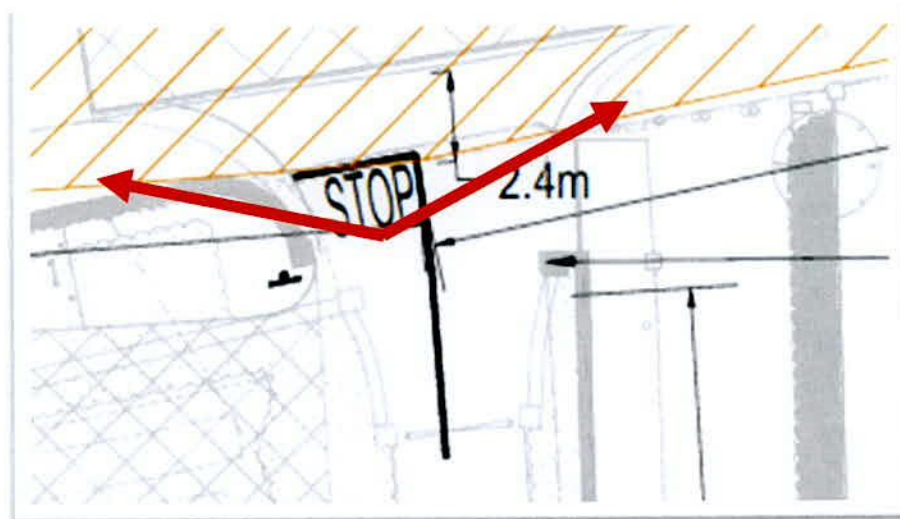
Drawing P22-026-DG-VE-001 S0, Rev 2.0 – Visibility Splays.

The proposed visibility for exiting drivers to crossing pedestrians on the footpath is not clear. The proposed boundary treatment may be high enough to block visibility to crossing children which could result in collisions with those pedestrians.

It is recommended that low boundary treatment be provided such that suitable inter-visibility is provided between exiting drivers and crossing pedestrians including small children.

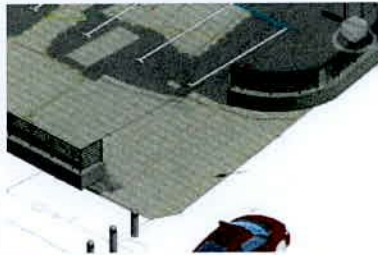
Paragraph No. in Quality Audit Report	Problem accepted (yes/no)	Recommended measure accepted (yes/no)	Alternative measures (describe)	Alternative measures accepted by Auditors (Yes/No)
3.1	Yes	Yes		
3.2	Yes	Yes		
3.3	Yes	Yes		
3.4	Yes	No	<p>Attached below is an image of the (horizontal) railings proposed at the entrance for increased visibility. The Design team believe this will maintain adequate inter-visibility at the access.</p>
