Drainage & Water Supply
Report

No. 1 Fonthill Park,
Rathfarnham,
Dublin 14

22736-Drainage & Water
Supply Report

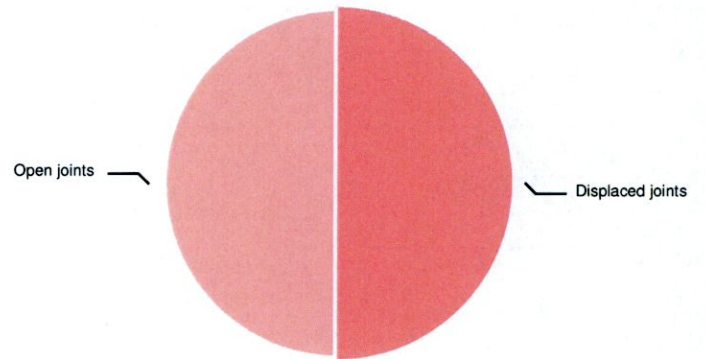
Structural Defect	Quantity
Open joints	1
Displaced joints	1

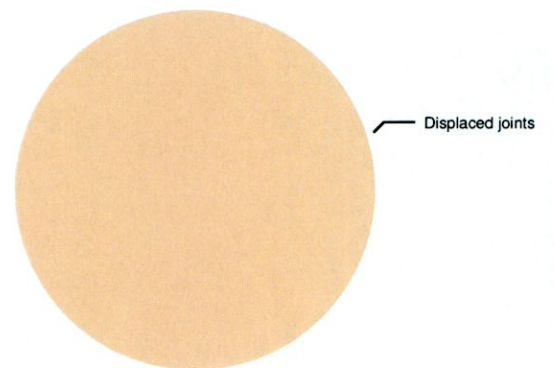
Service/Operational Defects	Quantity
Displaced joints	1

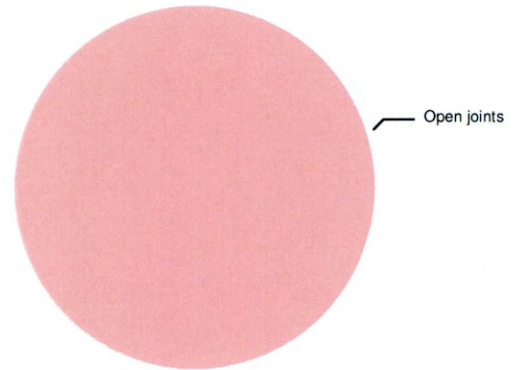
Structural Defect	Quantity
Open joints	1

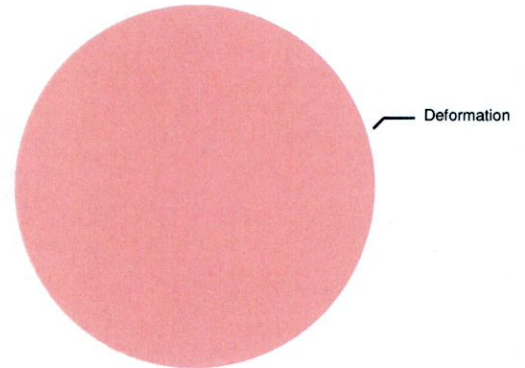
Structural Defect	Quantity
Deformation	3

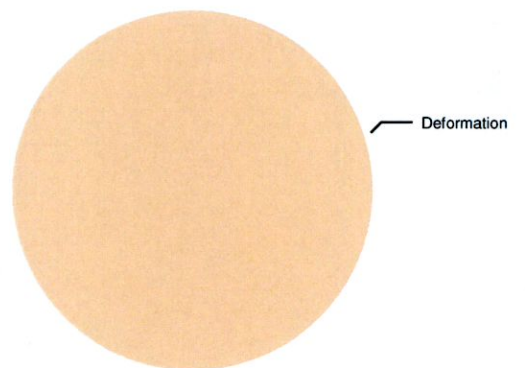
Service/Operational Defects	Quantity
Deformation	3

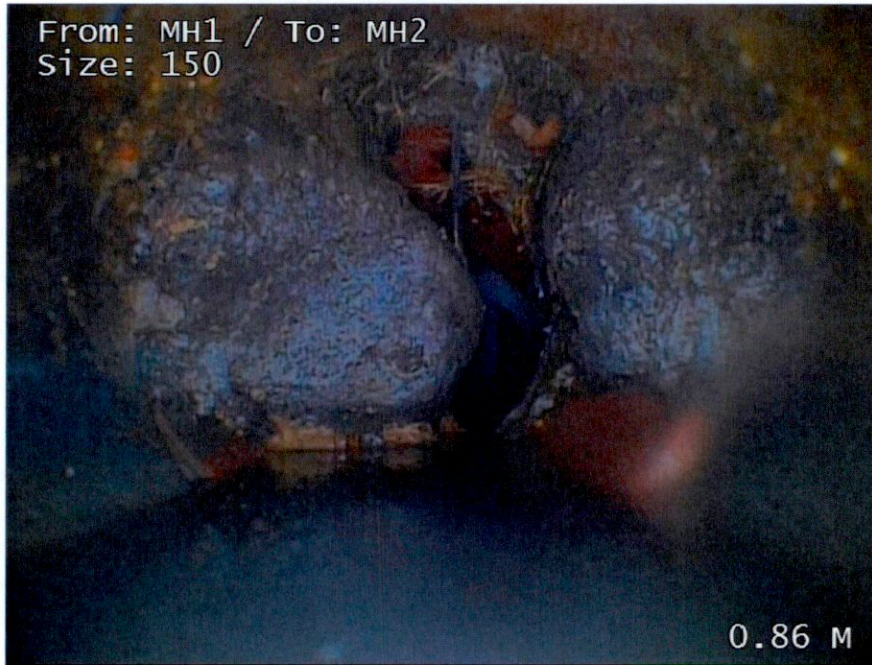
S6C8

00:00:33 - 0.86 m

Survey abandoned - Remark: CANNOT PASS

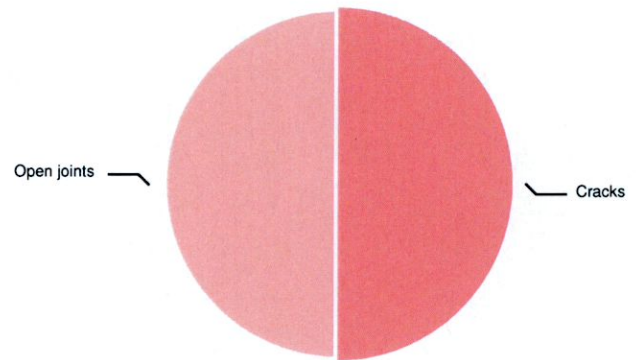
Structural Defect	Quantity
Open joints	1
Cracks	1

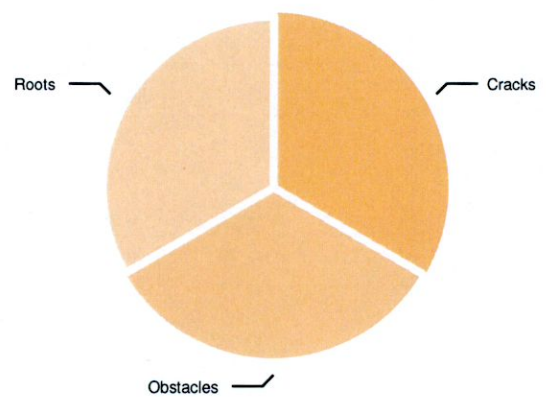
Service/Operational Defects	Quantity
Roots	1
Obstacles	1
Cracks	1

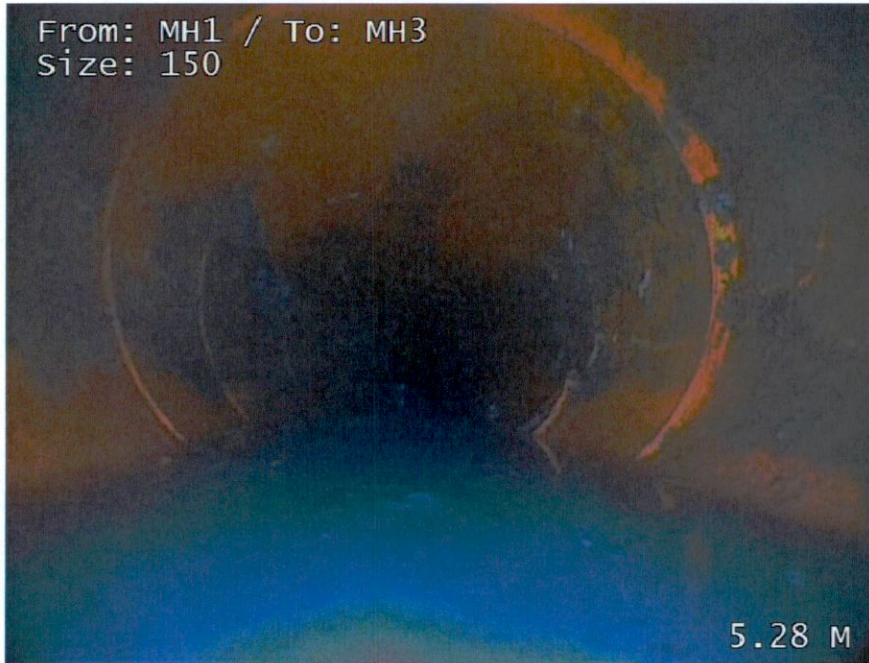
S7C9

00:01:08 - 5.31 m
Joint displaced medium

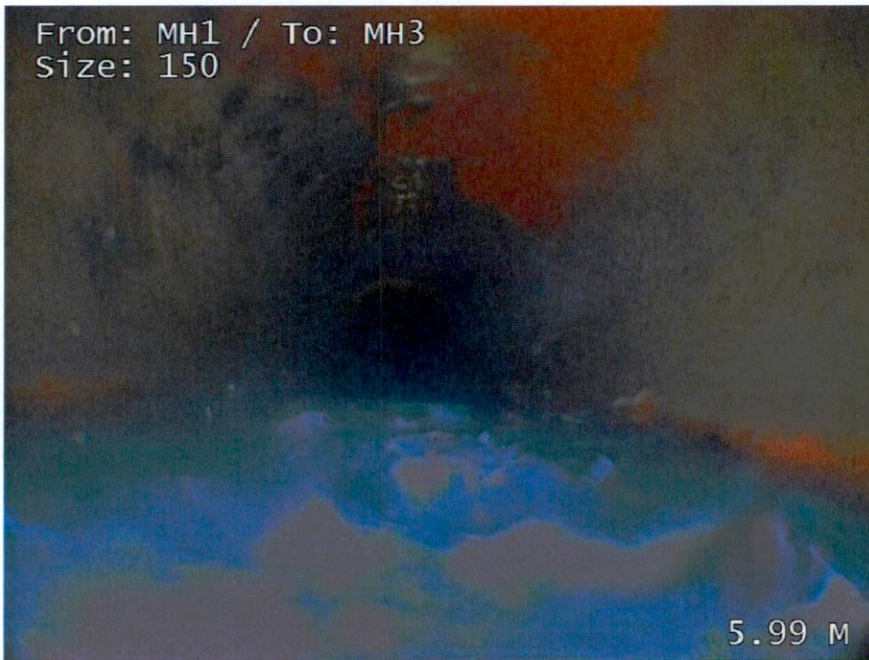
S7C10

00:01:23 - 6.01 m
Cracks multiple from 12 to 12 o'clock, Finished

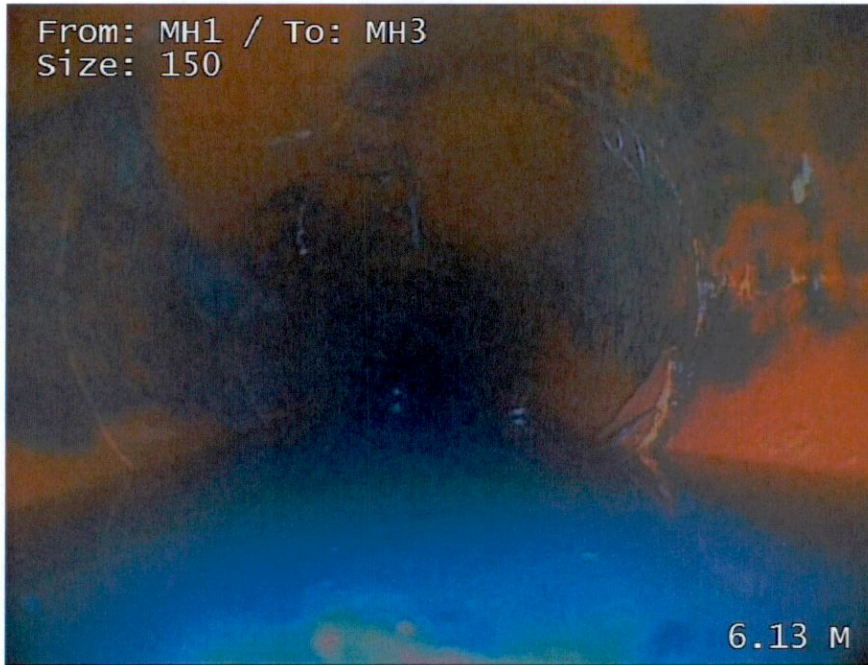
S7C11

00:01:14 - 6.13 m
Cracks multiple from 12 to 12 o'clock, Start

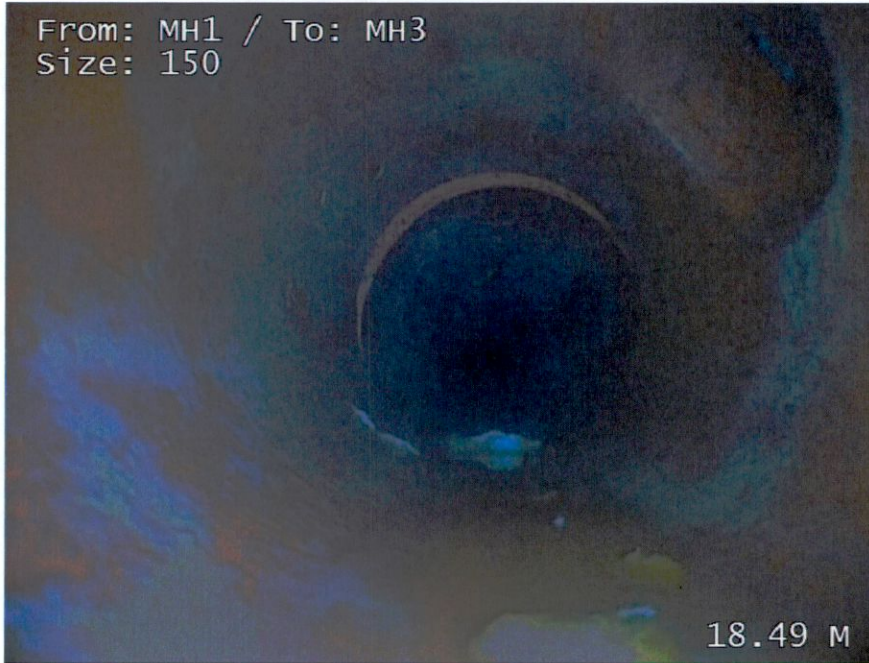
S7C17

00:04:00 - 18.50 m
Junction at 2 o'clock, diameter 100mm

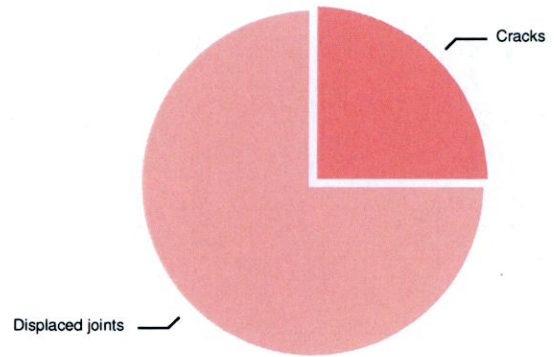
Structural Defect	Quantity
Displaced joints	6
Cracks	2

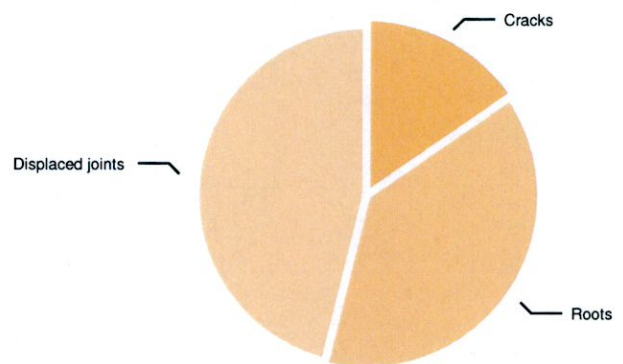
Service/Operational Defects	Quantity
Displaced joints	6
Roots	5
Cracks	2

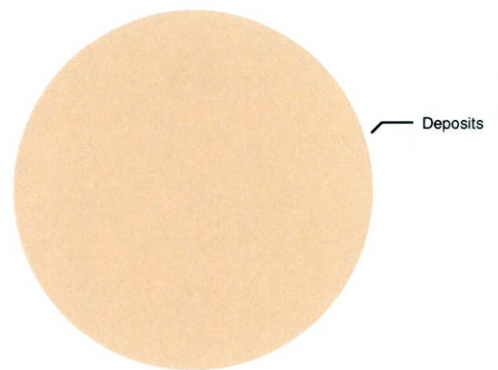
Service/Operational Defects	Quantity
Deposits	1

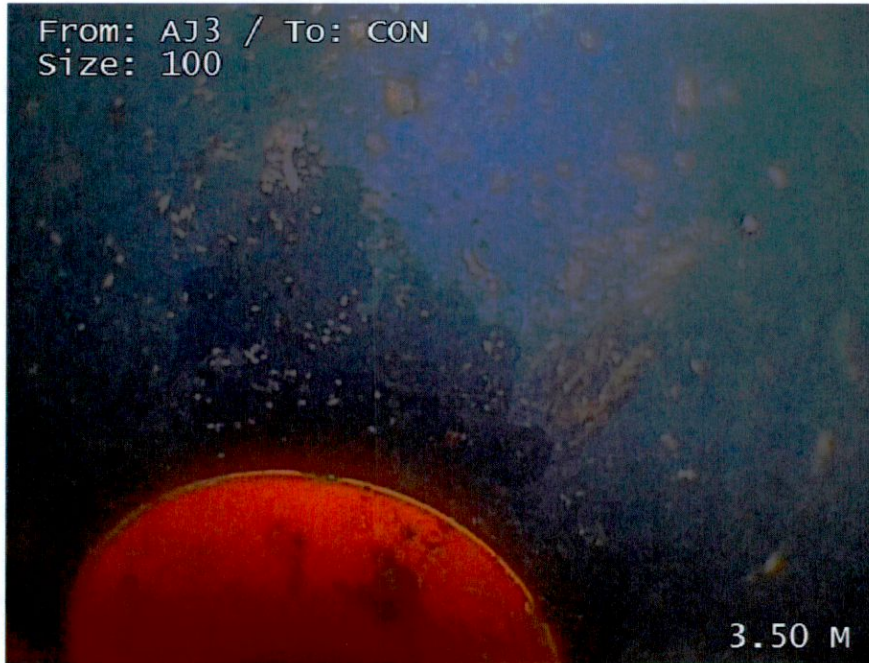
S10C3

00:00:15 - 3.50 m
Line of drain/sewer deviates down

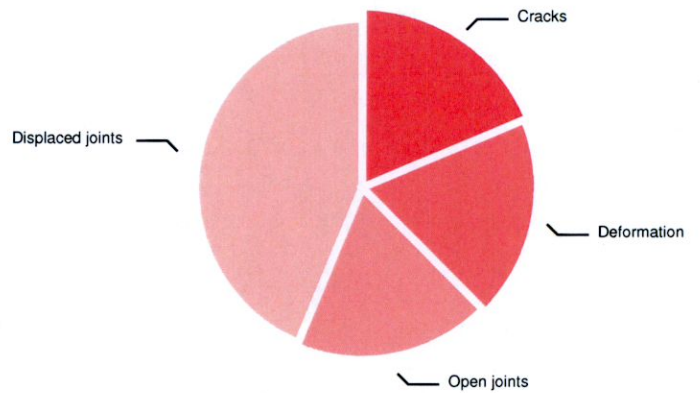
Structural Defect	Quantity
Displaced joints	7
Open joints	3
Deformation	3
Cracks	3

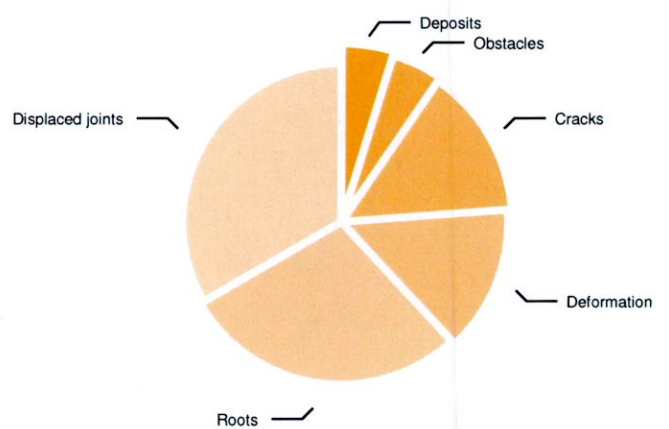
Service/Operational Defects	Quantity
Displaced joints	7
Roots	6
Deformation	3
Cracks	3
Obstacles	1
Deposits	1
