Tree & Hedgerow Survey, Assessment, Management, Mitigation & Protection Measures

**RATHCOOLE AGE-FRIENDLY DEVELOPMENT
TAY LANE, NEWCASTLE ROAD,
RATHCOOLE, DUBLIN 24**

Riverside Projects Limited

AUGUST 2022

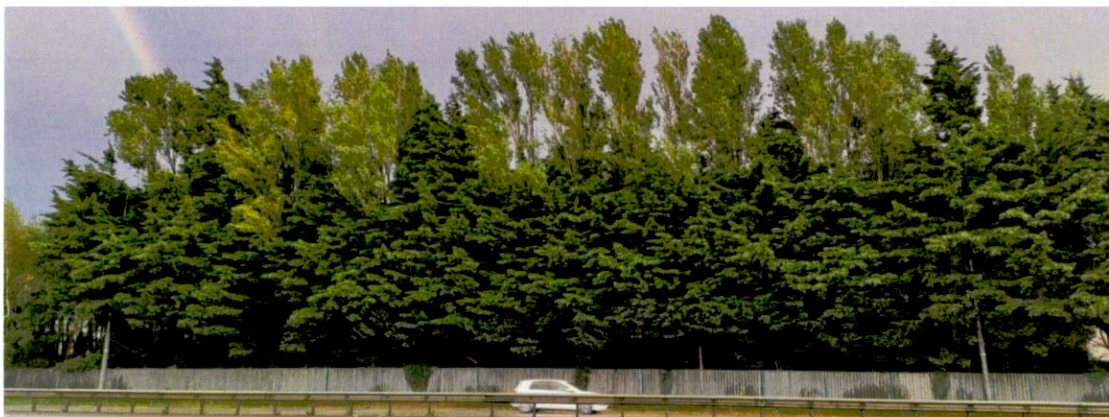
This group of trees is found along the sites northern boundary and presents an important visual screen to the N7 motorway behind. A densely planted tree boundary that consists of 25% *Populus alba* and 75% *Cupressus x Leylandii*. These trees are in relatively good condition a form this dense boundary reaching a total height of approx. 10 – 12m tall. The *Leylandii* trees are planted at approx. 1.5m spacing with the *Poplar* trees planted at approx. 4 metres spacing providing an interesting mix of deciduous and evergreen trees along this boundary.

Fig 4.0 – Photo of sites northern boundary taken from northern side of N7.

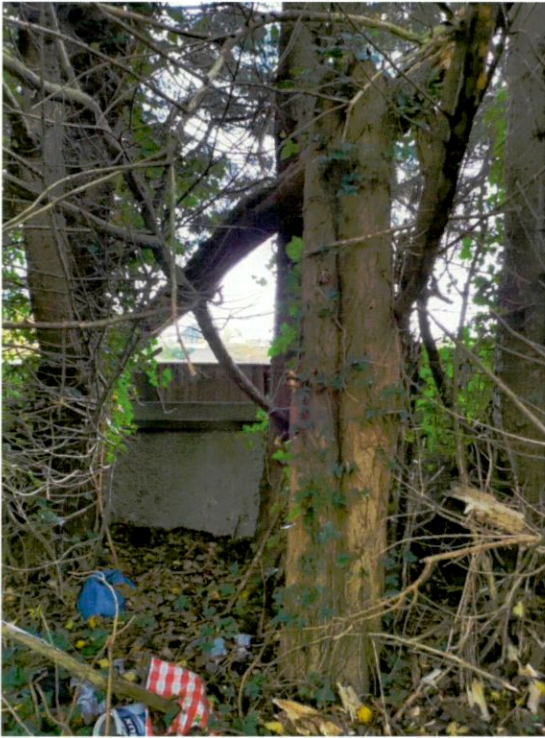
Fig 5.0 – Photo demonstrating Leylandii/Poplar mix.

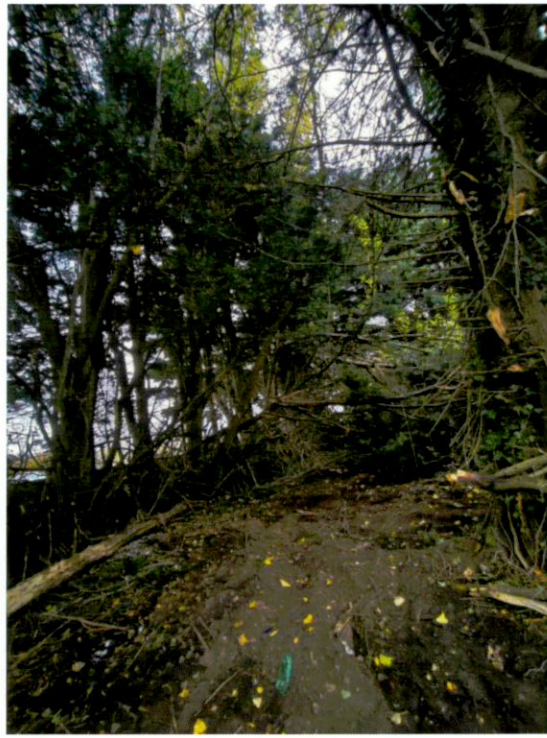
Fig 6.0 – Photo facing north of boundary.

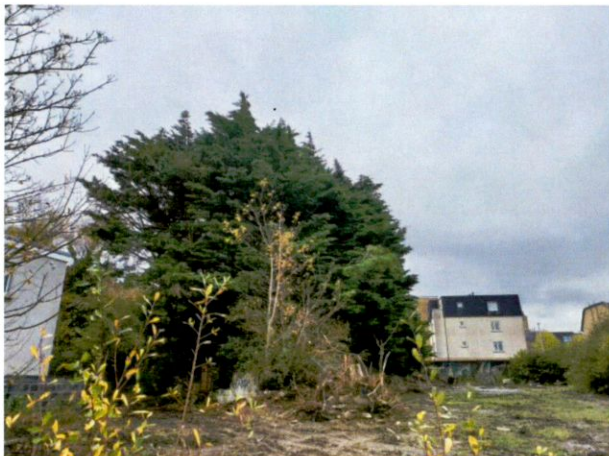
This group of trees is found within the site planted east to west in the middle of the site and consisting of only densely planted *Cupressus x Leylandii* trees planted. These trees have been tightly planted at approx. 1.5m spacing and there are approximately 17 trees in this boundary. These trees will be removed to facilitate construction.

Fig 7.0 – Photo of tree group 2 facing east.

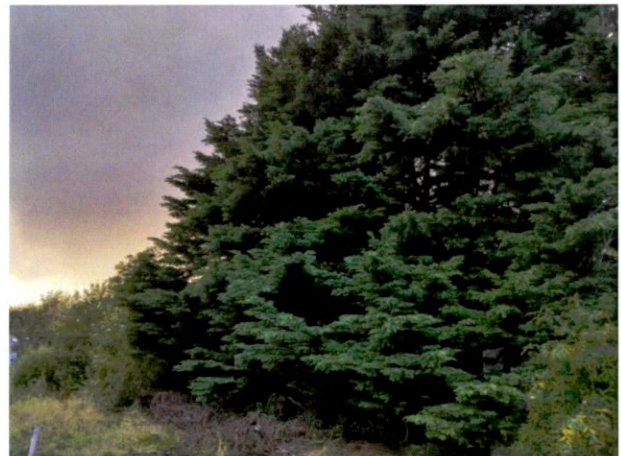
Fig 8.0 – Photo of tree group 2 facing west.

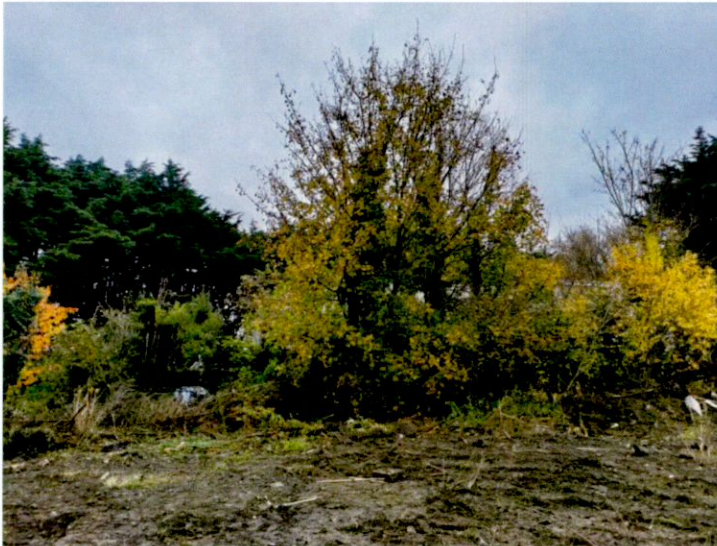
This group of trees is found along the sites northern boundary with the existing residential dwelling. A tightly packed group of 4 multi-stem *Acer pseudoplatanus* trees in relatively poor condition covers a small section of this boundary. These trees will be removed to facilitate the proposed construction.

Fig 9.0 – Photo of tree group 3 facing north.

Group 003	Sycamore, <i>Acer pseudoplatanus</i>	6-8m	200-40	2 north, 4.5 south forming continuous canopy east west	0	Y	Fair	Crowded group of multi-stem, self seeded Sycamore trees growing on part of the existing northern boundary of the site. Trees are suffering from over crowding and do not have the size or space to offer thorough growth.	10-20 yrs (trees to be REMOVED to facilitate proposed development)	C2
Group 004	Leylandii, <i>Cupressus x Leylandii</i> ,	10-12m	400-550	3 east, 33 west forming continuous canopy north-south	1	SM	Fair	These trees form a continuous canopy of 10 metres in length along the sites north eastern boundary. A total of 4 trees of the same maturity and quality are found in this stand. These trees are proposed to be retained to offer adequate screening to the boundary	10-20 (trees to be REMOVED to facilitate proposed development)	C2
Tree 005	Birch, <i>Betula pubescens</i>	8.5m	m/s 600 at base	5,4,6,4	0	M	Good	Prominent multi-stem Birch tree engulfed in Ivy with some wounds in lower leaders evident. Mature tree.	20-40 (trees to be REMOVED to facilitate proposed development)	B2

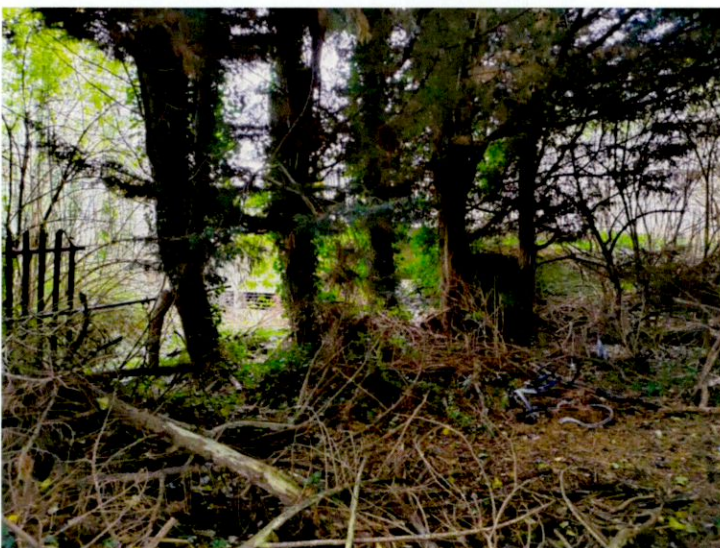
This group of trees is found along part of the sites north eastern boundary and consisting of only densely planted *Cupressus x Leylandii* trees planted. These trees have been tightly planted at approx. 1.5m spacing and there are approximately 4 trees in this boundary. These trees will be removed to facilitate the proposed construction.

Fig 10.0 – Photo of tree group 4 facing east.

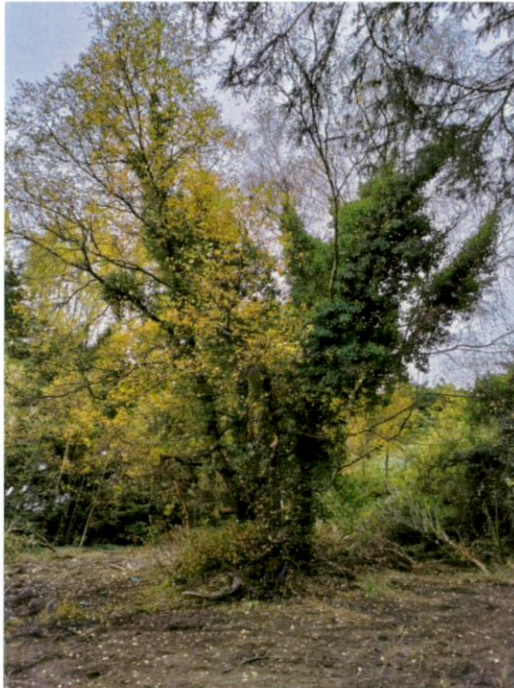
There are two specimen trees that have been recorded on site. One prominent ,mature, multi stemmed *Betula pubescens* that is located in the centre of the site and one semi-mature *Cupressus macrocarpa* that is found to the north east of the site. Both of these trees will be required to be removed to facilitate the proposed construction.

Fig 11.0 – Photo of T005 *Betula pubescens*

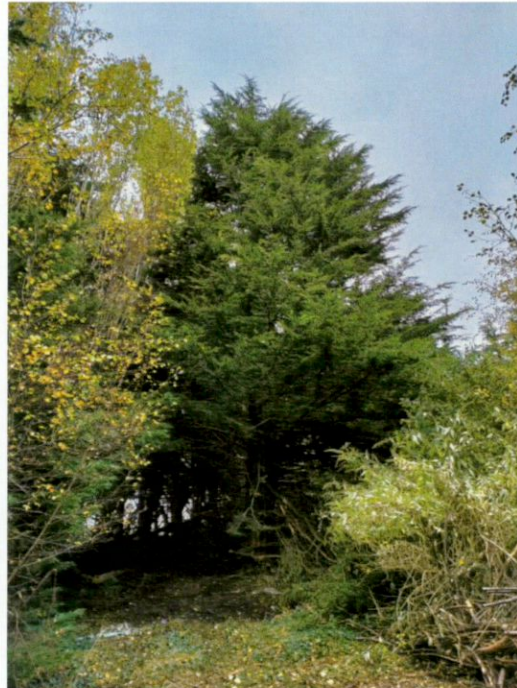
Fig 12.0 – Photo of *Cupressus macrocarpa*

Tree 006	Monterey cypress, <i>Cupressus macrocarpa</i>	12m	750	5,5,4,4	1	SM	Fair	Semi-mature specimen suffering from damaged lower leader with exposed wound and some lower canopy deadwood.	10-20 (trees to be REMOVED to facilitate proposed development)	C1
