**Report Title:** Arboricultural Tree Survey Report

**Project Title:** Residential Development at St Edmunds Phase 3

**Client(s):** Moykerr Limited

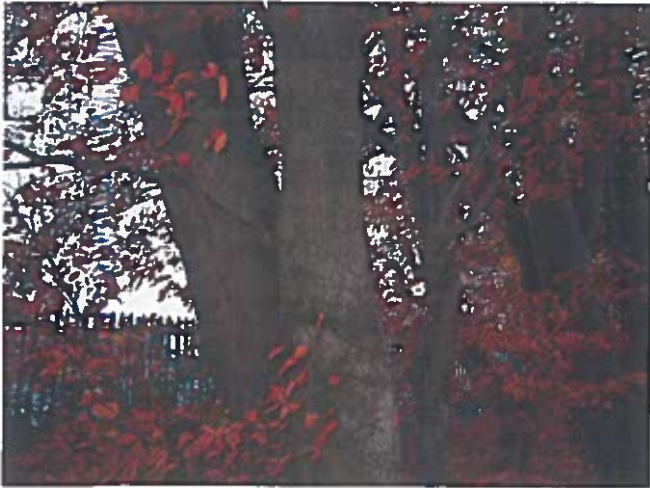
Photo 3: Views of Beech tree no. 624 with weak forking point.

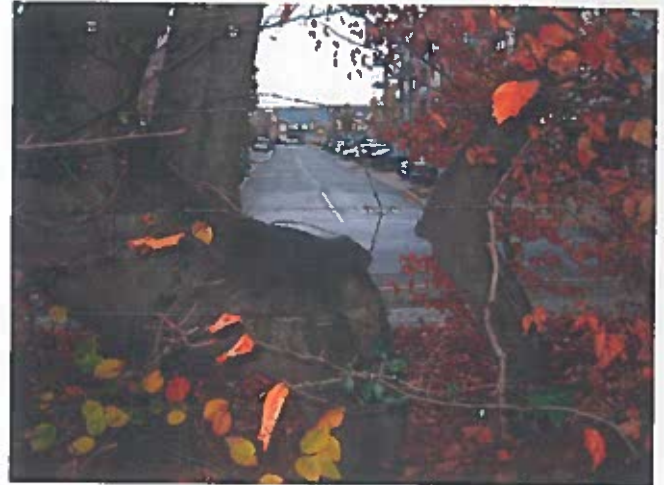
Photo 4: Tree nos. 626 and 627 with fused stems - Poor long-term potential.

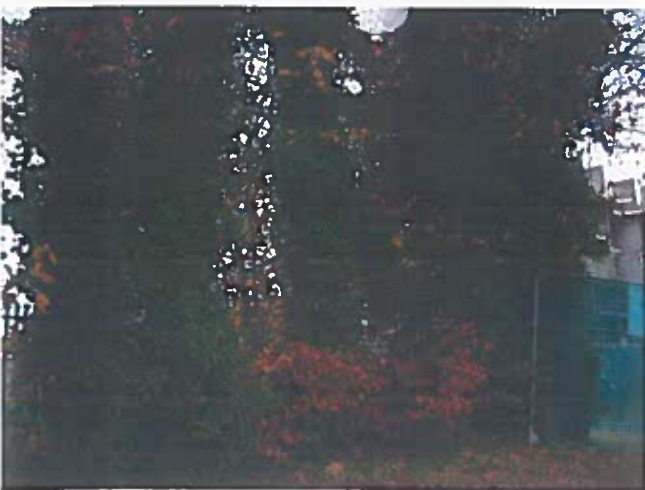
Photo 5: Views of Beech trees 642-646 - Note heavy ivy growth.

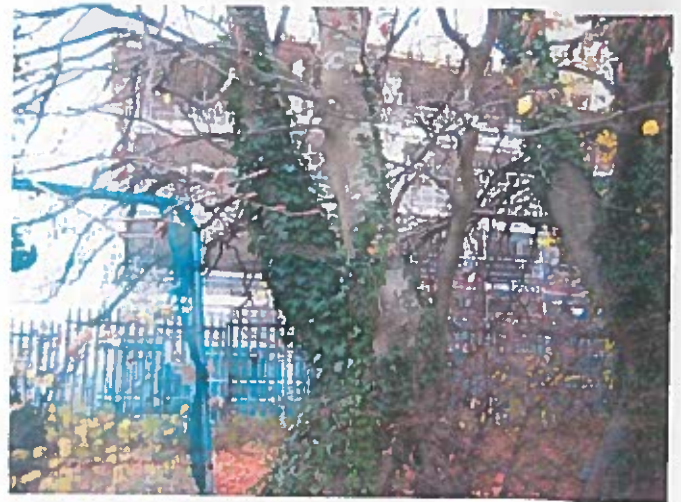
Photo 8: Tree no. 648 with weak stem union.

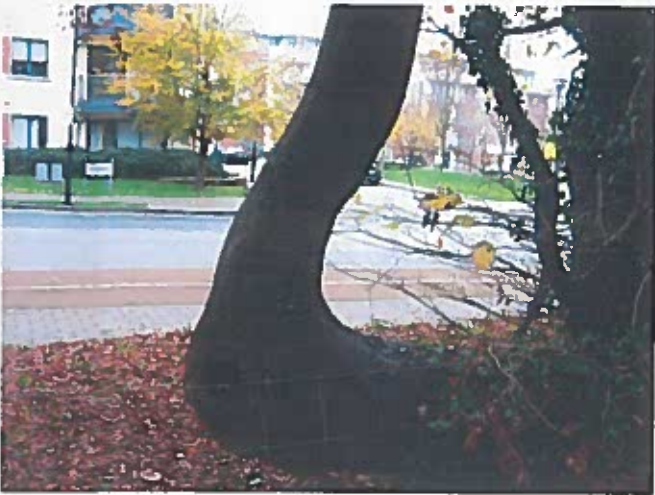
661	Common Beech	15.0	29	0N 0S 5E 0W	MA	Poor. Cavities along trunk. Crooked and deformed main stem. Cavity on main trunk at elbow. Could be prone to stem breakage. Leaning to east. Wire attached to main trunk east side.	Fell.	<10	U
662	Common Beech	16.0	53	1N 0S 3E 5W	MA	Fair. Forked at 1.7m. Wire attached to main trunk east side. Ivy growth to 14m. Leaning stems to west over path and cycle lane. Deformed and unbalanced crown.	Remove the tree - see paragraph 4.4	20-40	U
663	Common Beech	15.0	40	0N 2S 3E 3W	MA	Poor. Light ivy growth to 5m. Multiple forking points from 2m. Old pallet in crown. Wide-spreading crown. Leaning stem to west. Wire attached to main trunk east side.	Remove the tree - see paragraph 4.4	20-40	U
664	Common Beech	17.0	34	1N 0S 2E 1W	MA	Poor. Crooked stem. Self-corrected. Heavy ivy growth to 10m. Wire attached to main trunk east side. High crown.	Remove the tree - see paragraph 4.4	20-40	U

Photo 9: Views of Beech tree (no. 661) with crooked stem and cavity.

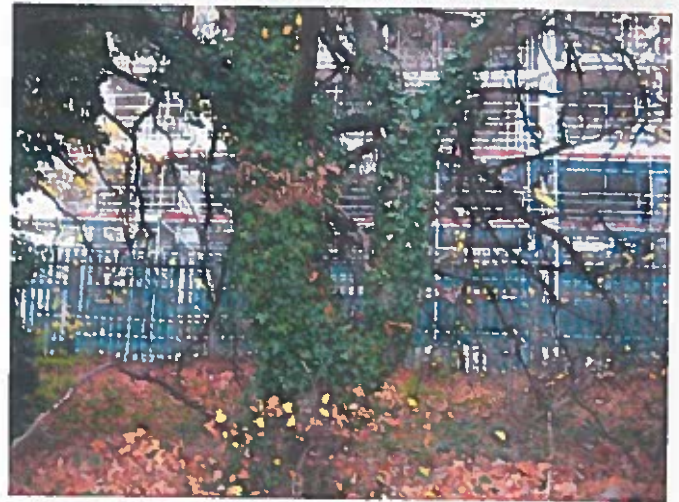
Photo 10: View of Beech tree with poor shape and form.

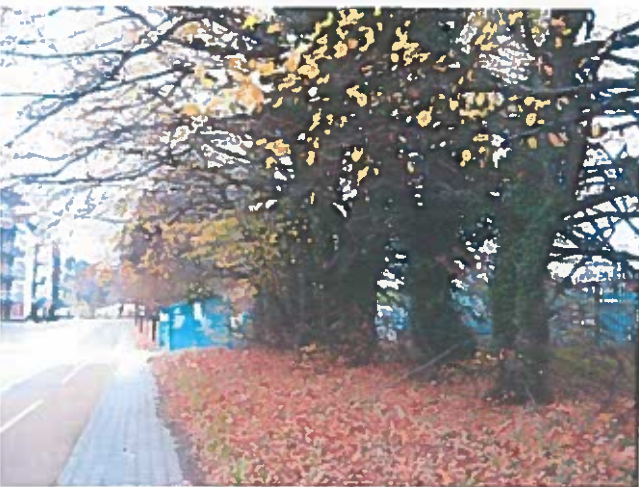
Photo 11: Views of row of Beech trees looking north - Note the overhanging limbs over path and cycle lane

cyclists, motorists, busy road, cycle lane, footpath and buildings) all combine to provide a high tree hazard evaluation with limited abatement options. Therefore our recommendation is to fell the row of Beech trees and to replant with a more sustainable and suitable species of avenue trees.

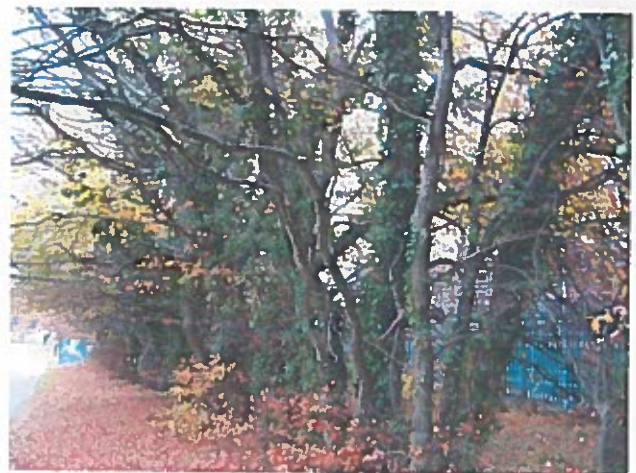
Photo 12: Close up views of Beech trees showing poor formation from overcrowding

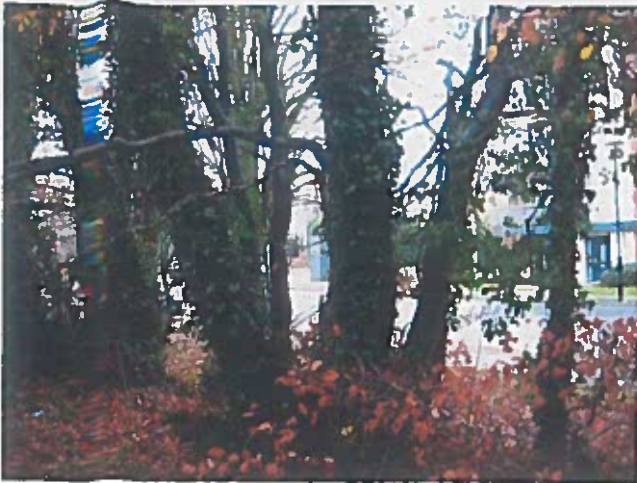
Photo 13: Beech trees with low forking points leading to weak stem unions.

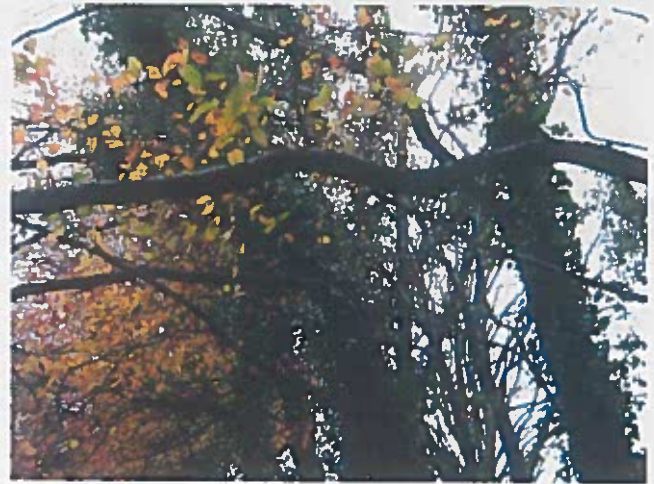
Photo 14: Upper canopy views of Beech tree with leaning stems to east.

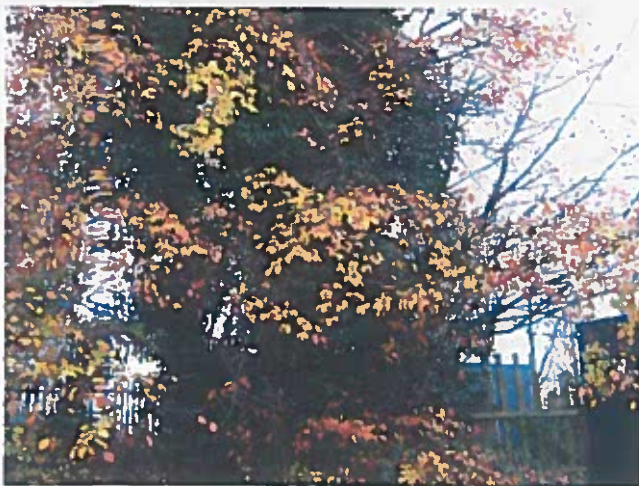
Photo 15: Beech trees nos. 685-688 - note heavy ivy growth.

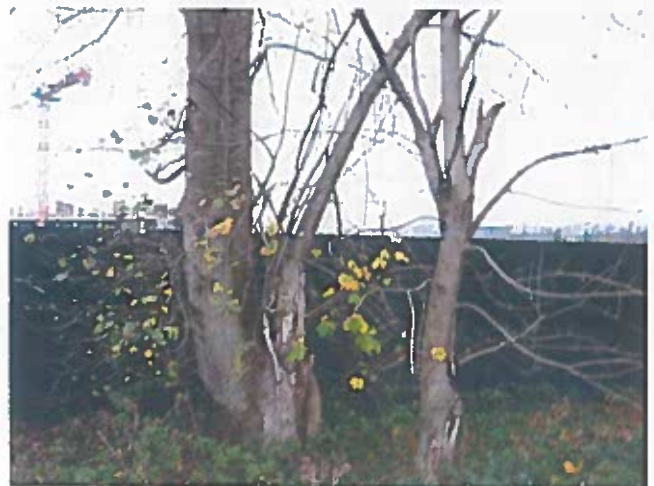
4.5 The group of Poplar and Maple growing on lands to the east of the site in the ownership of South Dublin County Council are in fair to poor condition. The trees are growing in an exposed part of the site. Many of the trees have suffered from storm damage in the past, resulting in broken and storm-damaged crowns. Some trees are displaying signs of storm damage, stem fractures, cavities, decay and broken and hung-up limbs. The tall poplar trees are close to or within falling distance of the adjoining slip road to the N4. In general, Poplar trees show a high propensity to form weak forks, a high propensity for fork failure and a high propensity to fail due to decay. Thus the species are not suitable for long-term retention on public lands close to a busy road. We have prescribed felling a number of the Poplar trees and recommend that consideration be given to the removal of the remaining Poplar trees in this location. Other works for trees to be retained includes crown cleaning, crown pruning and the removal or repair all leaning, storm-damaged and broken limbs.

Photo 18: Views of Poplar and Maple trees in poor condition.
