Arboricultural Assessment

Clondalkin Rugby Football Club

Kingswood Farm, Moneenalion Commons

20-June-2022

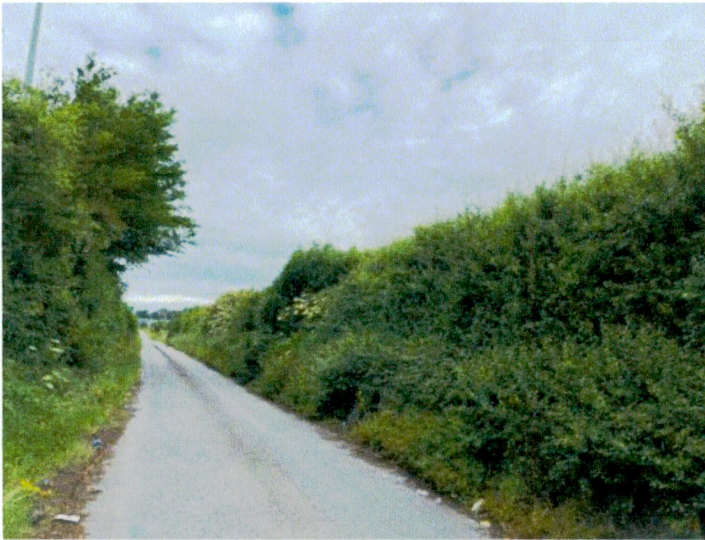
Hedge No. 1 extends east to west along the southern boundary of the site area and consists of species such as, hawthorn (*Crataegus monogyna*), dog-rose (*Rosa canina*), bramble (*Rubus fruticosus*), honeysuckle (*Lonicera periclymenum*) and elder (*Sambucus nigra*). It has received regular maintenance to contain its spread and there is a c.1m grass verge on the public roadside. Hedge No.1 has been divided into Hedge No.1A, B and C as there are gaps in the hedge and structural differences in it (see pics below). At the eastern end of Hedge No.1 there is a small group of early-mature ash (*Fraxinus excelsior*) and alder (*Alnus glutinosa*), the alder trees have potential for the long-term tree cover in this area, but the ash trees will likely succumb to 'ash dieback' (*Hymenoscyphus fraxineus*).

Above image shows Hedge 1A.

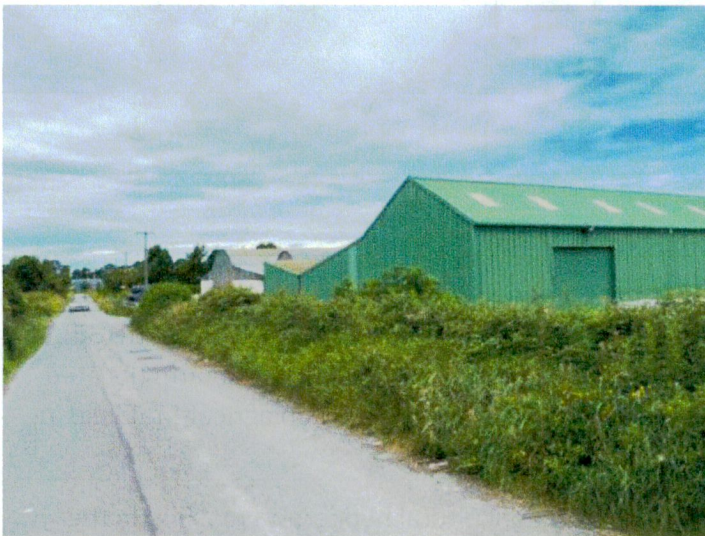
Above image shows Hedge 1B.

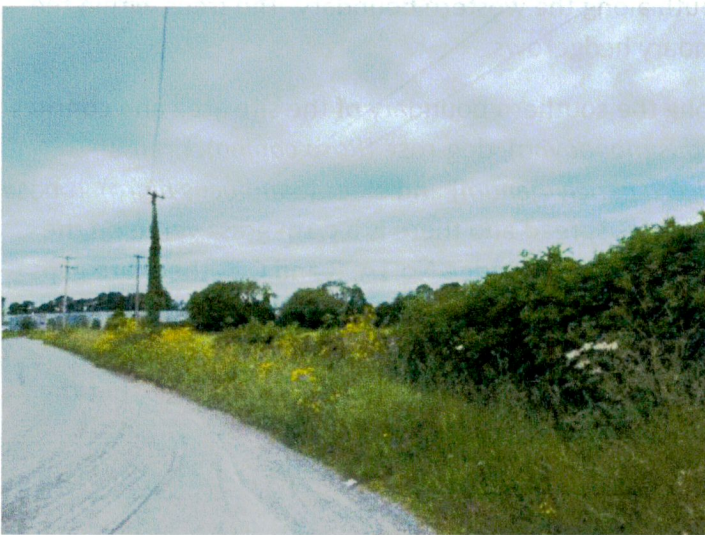
Above image shows Hedge 1C.

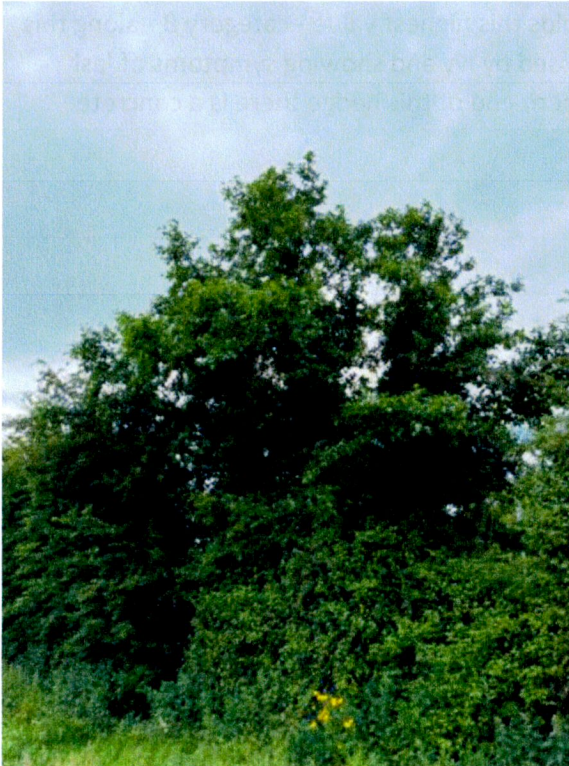
Above image shows a grey alder growing out of Hedge No.1A.

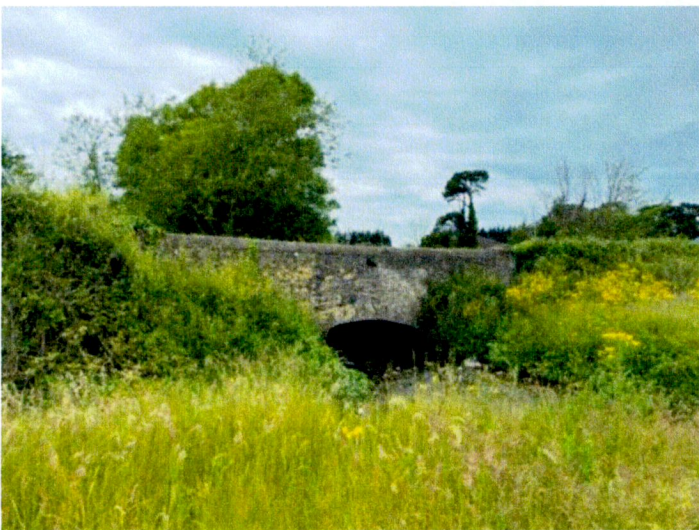
Above image shows the bridge that the stream and open drainage ditch pass under at the western end of Hedge No.1.

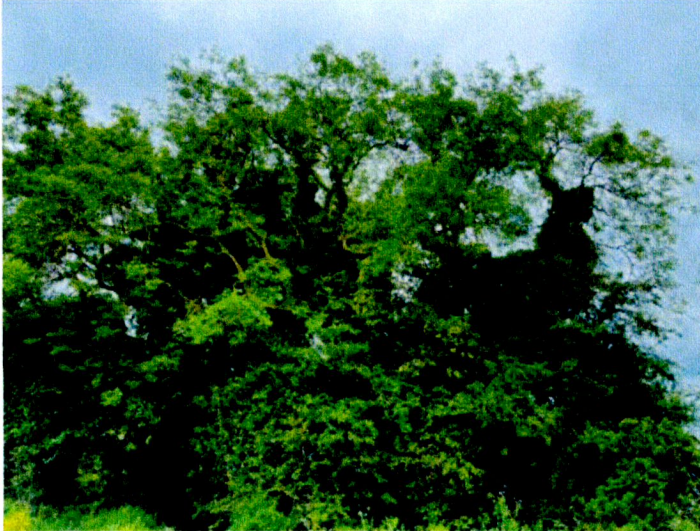
Above image shows Tree No.2 & 3 becoming suppressed by ivy and showing symptoms of 'ash dieback'. They are growing out of the southern end of Hedge No.2 on the adjoining landside of the stream, but their crowns overhang the site area.

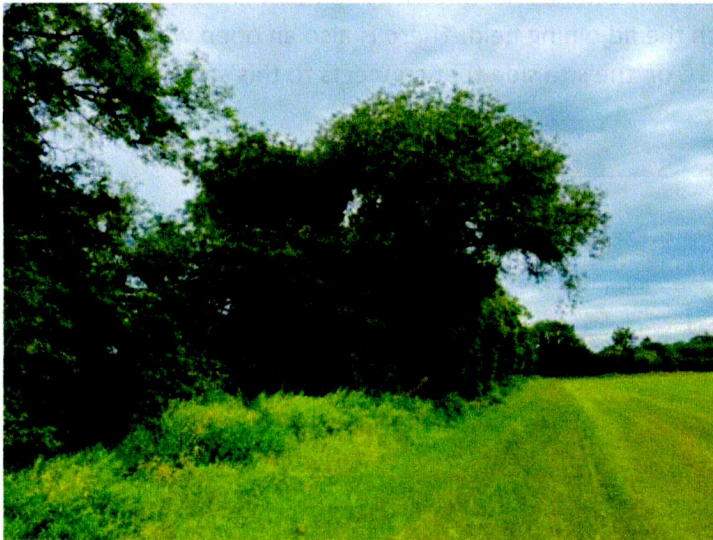
Above image shows Tree No.0393, a crack willow, growing out of the southern end Hedge No.2 on the adjoining landside of the stream with its crown overhanging the site area.

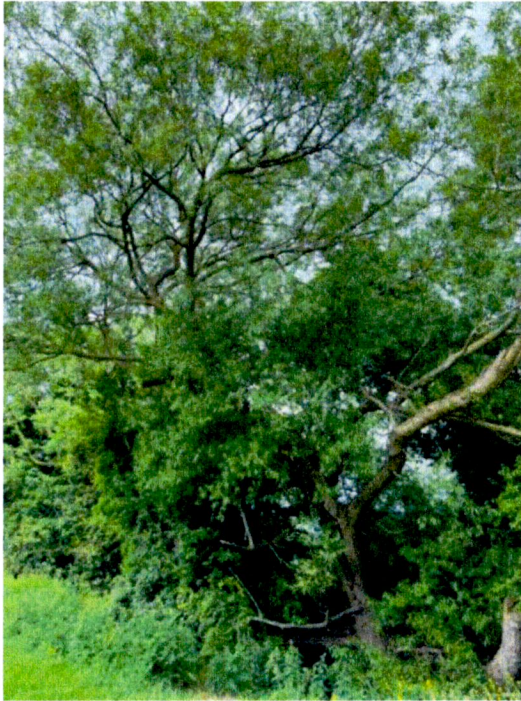
Above image shows a close-up of Tree No.0393, this tree has been cut back on the site side in the past and it has also suffered limb failure near its base; it is a poorly structured tree.

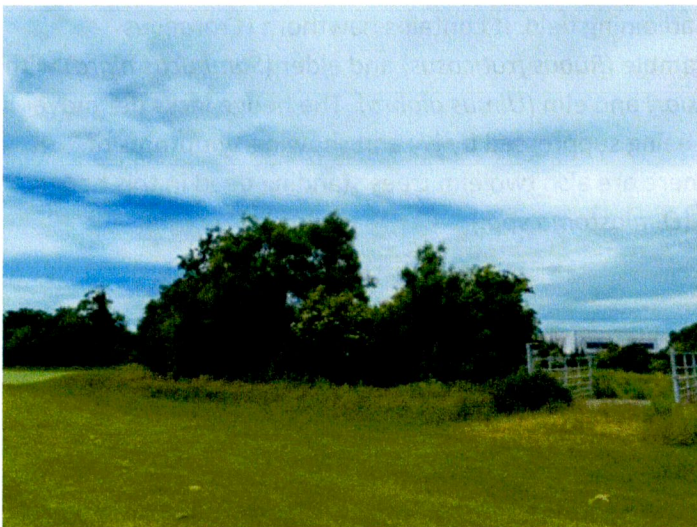
Above image shows the concrete bridge providing access to the adjoining field at the northern end of Hedge No.2.

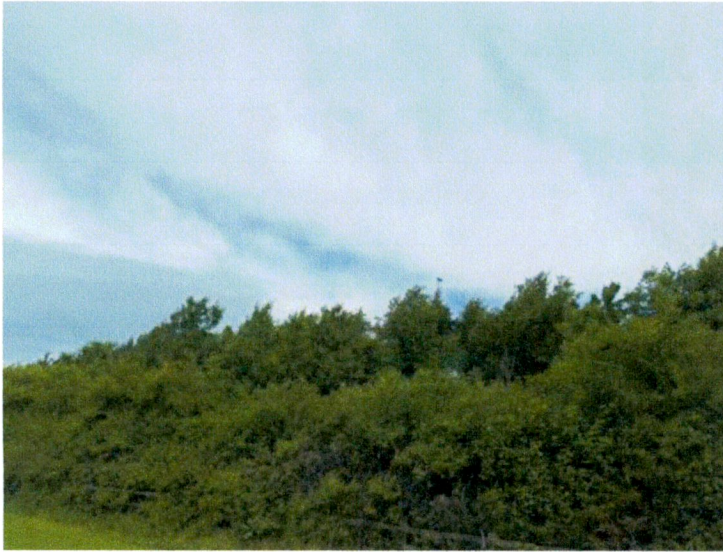
birch (*Betula pendula*). Hedge No.3 and Tree Belt No.1A provide valuable screening along this boundary with the public road (R136) and will provide the long-term tree cover in this area.

Above image shows Hedge No.3 with Tree Belt No.1A growing behind it.

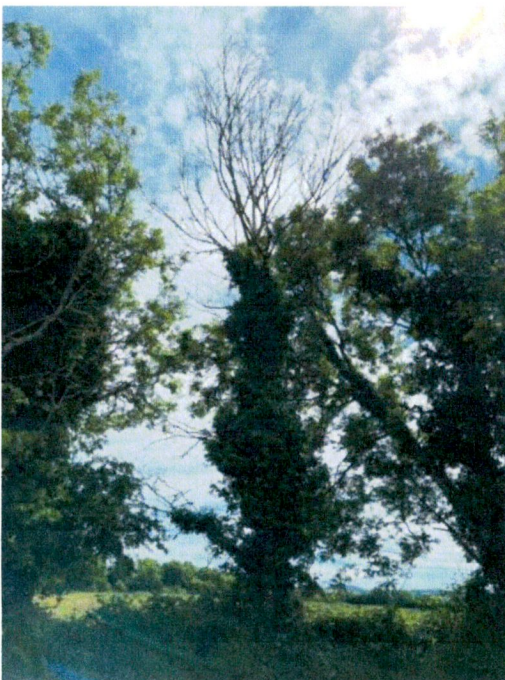
Hedge No.4 connects to Hedge No.3 at ninety degrees and extends north to south creating an internal boundary between two fields within the site area and there is a gap at the southern end of this hedge providing access into the adjoining field. It contains hawthorn (*Crataegus monogyna*), dog-rose (*Rosa canina*), bramble (*Rubus fruticosus*) and elder (*Sambucus nigra*) with an upper canopy of ash (*Fraxinus excelsior*) and elm (*Ulmus glabra*). The hedge lacks definitive structure and a lot of the ash trees are being suppressed by ivy and showing symptoms of 'ash dieback' (*Hymenoscyphus fraxineus*). There are also two elm trees standing dead in this hedge, death likely due to 'Dutch elm disease' (*Ophiostoma* spp.)

Above image shows Tree No.0395, a dead elm, in Hedge No.4

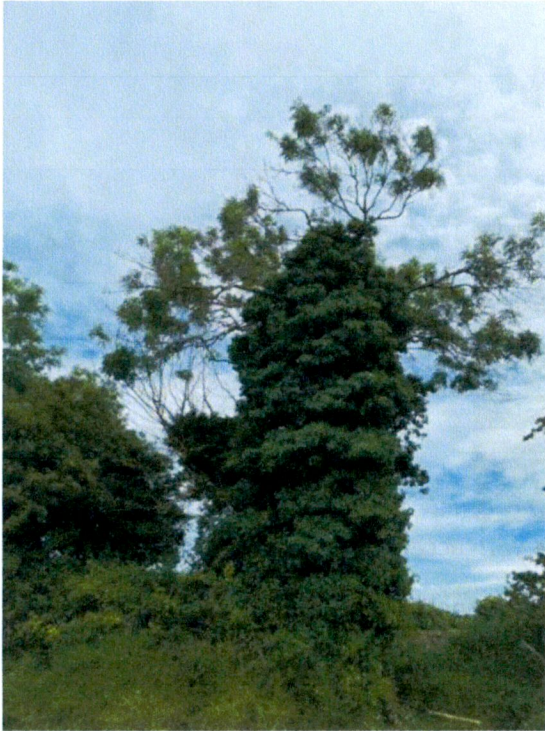
Above image shows Tree No.0396 in decline from 'ash dieback', with extensive basal decay present and ivy beginning to cause suppression. A dead elm tree can also be seen in the background.

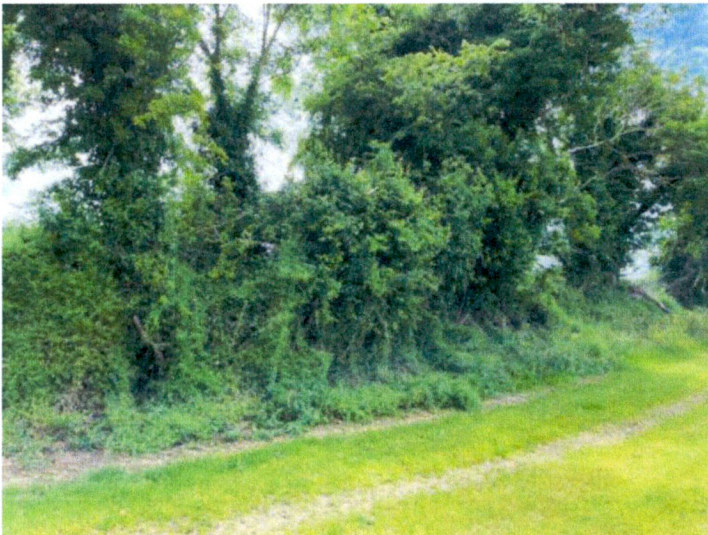
Above image shows Hedge No.4 with an upper-canopy of ash.

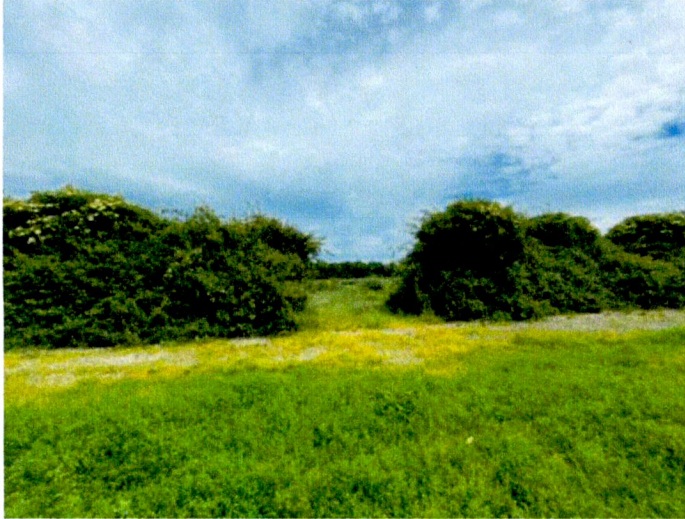
Above image shows the northern end of Hedge No.5 with access into the adjoining field.

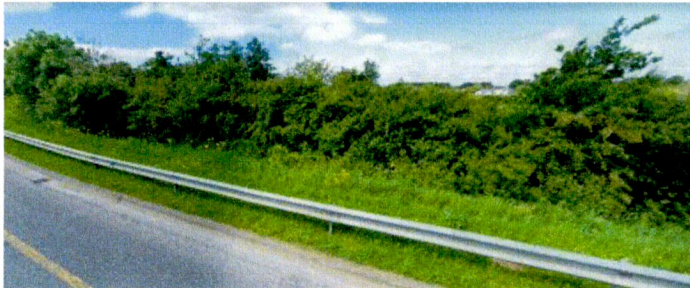
Above image shows Hedge No.6 from the off ramp of the public road (N7).

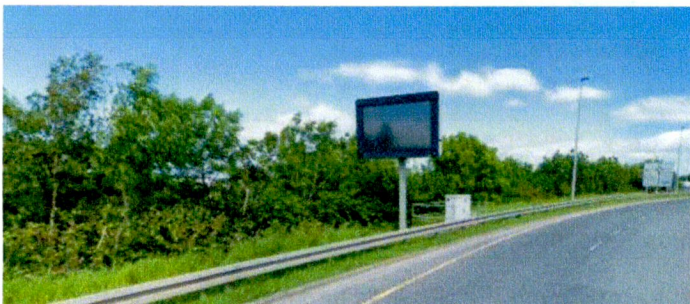
Above image shows Tree Belt No.1B from the off ramp of the public road (N7).
