# **Arborist Associates Ltd.**

## **An Arboricultural Assessment of the Tree and Hedge Vegetation on Lands for Development at 'Stoney Hill Road', Rathcoole, Co. Dublin.**

**Prepared for: Romeville Developments Ltd.**

**Date: 28<sup>th</sup> July 2022**

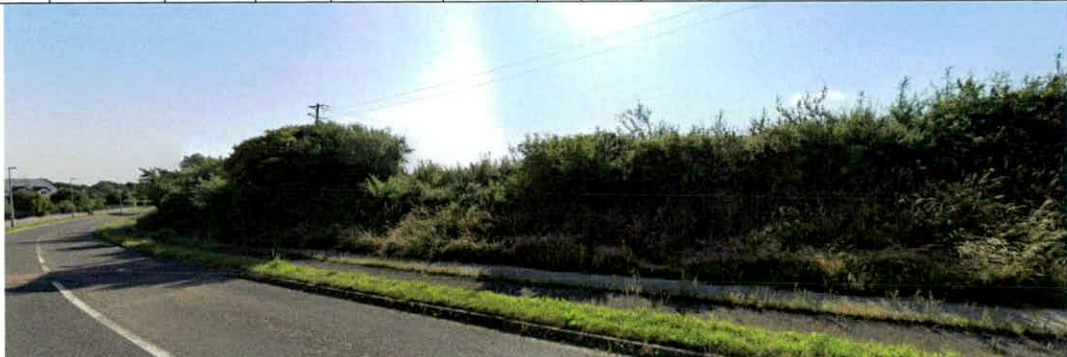
<p><b>Google Maps Street View</b></p>										
Hedge No.2A	<b>Hawthorn</b> <i>Crataegus monogyna</i> <b>Blackthorn</b> <i>Prunus spinosa</i> <b>Bramble</b> <i>Rubus fruticosus</i> <b>Dogrose</b> <i>Rosa canina</i> <b>Elder</b> <i>Sambucus nigra</i>	<p><b>It extends in a north to south direction and forms an internal boundary within the site area between a field on the west side and private gardens on the east side.</b></p> <p>It is a mature hedge in fair condition both physiologically and structurally. It consists of Hawthorn, Blackthorn, Elder, Bramble and Dogrose. Its height and side extending into the private property have been cut back previously and it has been allowed to grow more unmanaged on the field side with Bramble and other hedge species encroaching out in some places as a result. The overhead utility lines runs across the northern end of this hedge line. The previous cutting from the adjoining property side has helped to maintain a good stock proof quality, density and structure.</p>							Carry out general tidying and trimming works and trim in encroaching hedge species.	C2

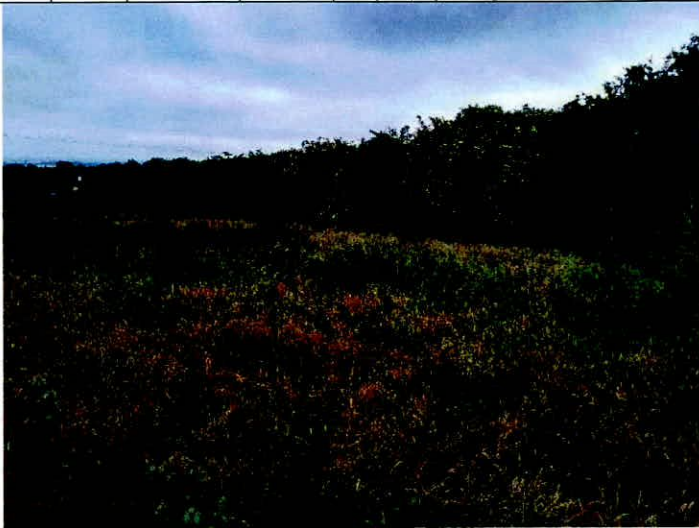
Hedge No.2B	<b>Hawthorn</b> <i>Crataegus monogyna</i> <b>Blackthorn</b> <i>Prunus spinosa</i> <b>Bramble</b> <i>Rubus fruticosus</i> <b>Dogrose</b> <i>Rosa canina</i> <b>Elder</b> <i>Sambucus nigra</i>	<p><b>It extends southwards from hedge No.2A and forms an internal boundary within the site area between two fields.</b></p> <p>It is a mature hedge in fair condition both physiologically and structurally. It consists of Hawthorn, Blackthorn, Elder, Bramble and Dogrose. It has in the past been cut, but has since been allowed to grow up from this to its current size and form with Bramble and other hedge species encroaching out in some places as a result. Lower vegetation has also been impacted by livestock sheltering/grazing in this hedge.</p> <table border="1" data-bbox="472 1241 898 1281"> <tr> <td>A4.5m</td> <td>-</td> <td>A2E/3.5W</td> <td>-</td> </tr> </table>					A4.5m	-	A2E/3.5W	-	Carry out general tidying and trimming works and trim in encroaching hedge species.	C2
A4.5m	-	A2E/3.5W	-

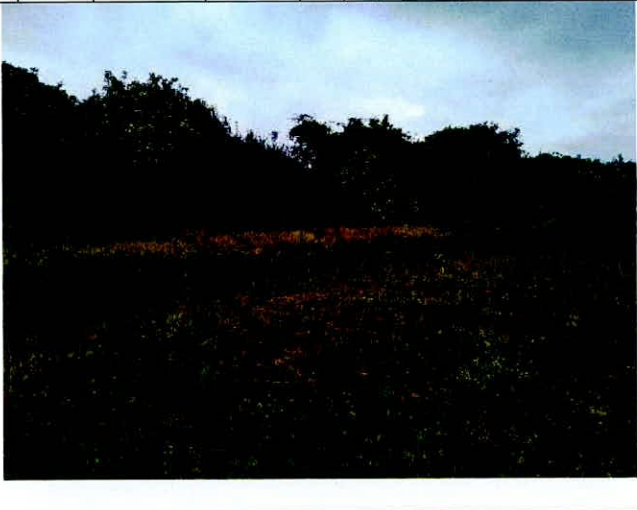
Hedge No.3	<b>Hawthorn</b> <i>Crataegus monogyna</i> <b>Blackthorn</b> <i>Prunus spinosa</i> <b>Bramble</b> <i>Rubus fruticosus</i> <b>Dogrose</b> <i>Rosa canina</i> <b>Elder</b> <i>Sambucus nigra</i>	<p><b>It runs in an east to west direction at ninety degrees to Hedge No.2 and forms the boundary between the field to the south and the private residential property to the north, and forms part of a longer hedgerow and extends eastwards outside the site area.</b></p>						<p>It would benefit from general tidying works. Trim in encroaching hedge species.</p>			C2				
		<p>It is of a mature age class in fair condition both physiologically and structurally. It consists of Hawthorn, Blackthorn and Elder with Bramble and Dogrose dominating the lower vegetation. A section of this hedge has been cut down to provide views. It has received some trimming from the adjoining private property side to the north in order to contain. Bramble is dominating some places, in particular at the western end.</p>													
		<table border="1" style="width: 100%; border-collapse: collapse;"> <tr> <td style="width: 25%;">A3m</td> <td style="width: 25%;">-</td> <td style="width: 25%;">A4m</td> <td style="width: 25%;">-</td> </tr> </table>						A3m	-	A4m	-				
A3m	-	A4m	-

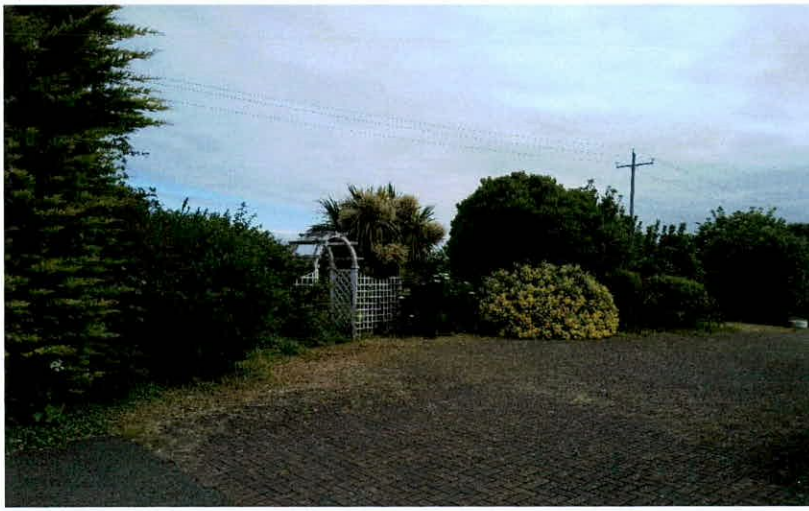
A2m	-	-	-	It is in need of further maintenance/ management in order to contain.		C2
A2m	-	-	-											
Shrub Border No.2	Mixed Ornamental Shrubs	<p><b>It cordons off the back lawn area from the front of the house.</b> It is becoming overgrown with the slower growing shrubs being suppressed out with scrub vegetation such as Bramble and weeds developing throughout. It is of some value for screening/ breaking up the view up the back garden and lawn area.</p> <table border="1"> <tr> <td>A5.5m</td> <td>-</td> <td>-</td> <td>-</td> </tr> </table>						A5.5m	-	-	-	It would benefit from general tidying works / trimming in order to contain.		C2

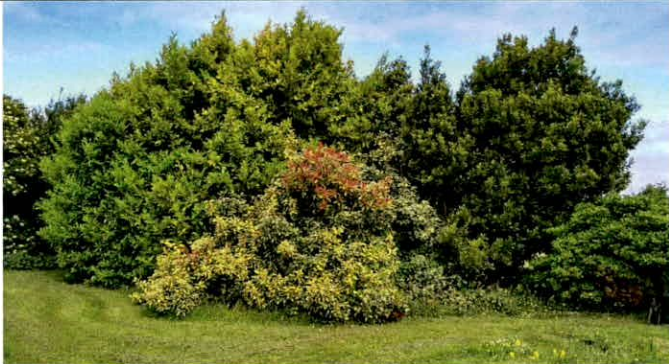
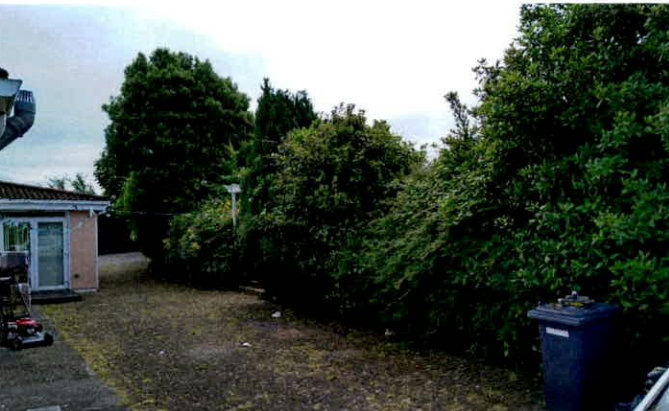
Shrub Border No.3	Mixed Ornamental Shrubs	<p><b>It extends along the back of the house and cordons off the lawn area from the back of the house.</b> It consists of a mixture of ornamental shrubs and was initially formally maintained, but has since been allowed to grow up more unmanaged in recent times. There are some scrub species, in particular Bramble, developing throughout.</p>						<table border="1"> <tr> <td data-bbox="454 948 568 987">A4m</td> <td data-bbox="568 948 685 987">-</td> <td data-bbox="685 948 801 987">-</td> <td data-bbox="801 948 857 987">-</td> </tr> </table>	A4m	-	-	-

It would benefit from further general management.	C2
A4m	-	-	-

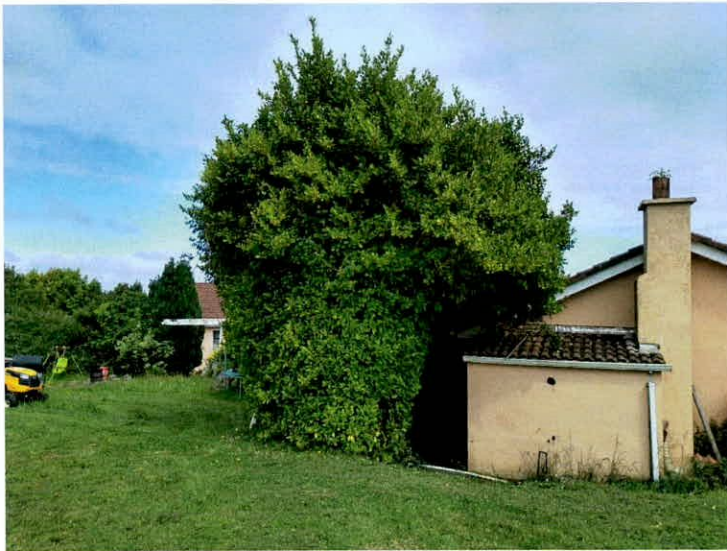
Tree No.	Tree Species	Ht. (m)	Stem Dia. (mm)	Branch Spread (m)	C-Ht. (m)	Age Class	Phys. Con.	Structural Condition Other Comments	Preliminary Recommendation	Remain Contribute in years	Cat. Grade					
								N-north S-south E-east W- west Phys.-physiological.	A- average,							
		<b>The following tree is located within shrub border No.3.</b>														
0863	<b>Pittosporum</b> <i>Pittosporum tenuifolium</i>	9	100 x 8 Stems	2.5N 2.5S 2.5E 2.5W	0	Early Mature	Fair/ Good	Fair Multiple-stemmed from base with a broad spreading crown. It forms part of the higher bulking within this shrub border.	Tidy up the area around its base.	10-20	C1					
<b>Hedge No. 5</b>	<b>Griselinia</b> <i>Griselinia littoralis</i>	<p><b>It runs at nightly degrees to Shrub Border No.3 and screens off the garage from the lawn area to the back of the house.</b></p> <p>It is of a mature age class in fair condition physiologically and structurally. Its sides have been trimmed to contain spread, but it has been allowed to grow up tall and is becoming top- heavy and unbalanced.</p> <table border="1" data-bbox="465 786 860 823"> <tr> <td>A5m</td> <td>-</td> <td>A3m</td> <td>-</td> </tr> </table>								A5m	-	A3m	-	It is in need of further maintenance/management in order to contain. It would benefit from a height reduction to improve its balance and stability.		C2
A5m	-	A3m	-

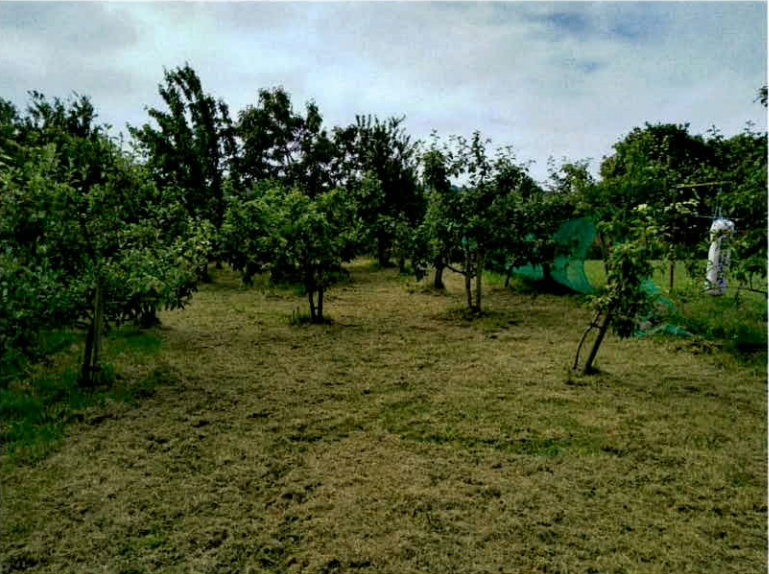
Tree No.	Tree Species	Ht. (m)	Stem Dia. (mm)	Branch Spread (m)	C-Ht. (m)	Age Class	Phys. Con.	Structural Condition Other Comments	Preliminary Recommendation	Remain Contribute in years	Cat. Grade
								N-north S-south E-east W- west Phys.-physiological.	A- average,		
<b>Fruit Orchard</b>	<b>Apple</b> <i>Malus domestica</i> <b>Pear</b> <i>Pyrus communis</i> <b>Plum</b> <i>Prunus domestica</i> <b>(c.17 trees)</b>	<b>It is located within the south-eastern corner of the garden area of the private residence in the corner of Hedge Nos.3 &amp; 4.</b> It is of a young age class in fair condition both physiologically and structurally. It consists of a mixture of Apples, Pears and Plums. They have been planted in recent times at c.3m between rows and at c.2.5m centres between each row and they are still attached to their tree ties and stakes.

They are in need of some maintenance in order to contain and to encourage fruiting.  Remove or adjust any tree ties and stakes still present.		C1
