CCTV Inspection Report

**DAVID WHITSON
5 LIMEKILN DRIVE,
D12 AP60.**

Job Number: 00037

Greenday Environmental

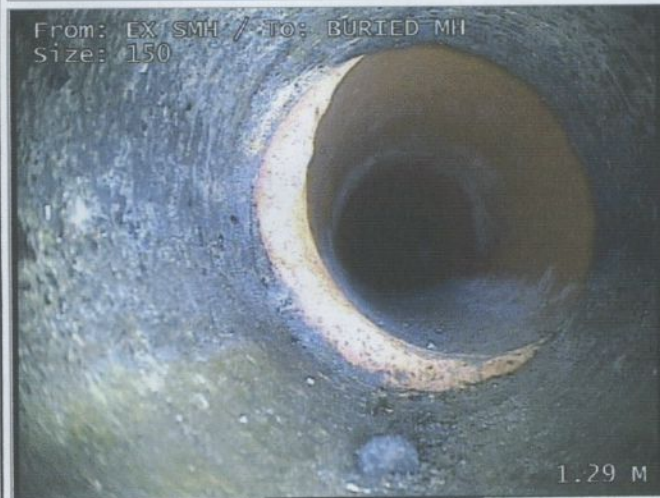
Joint displaced 15mm

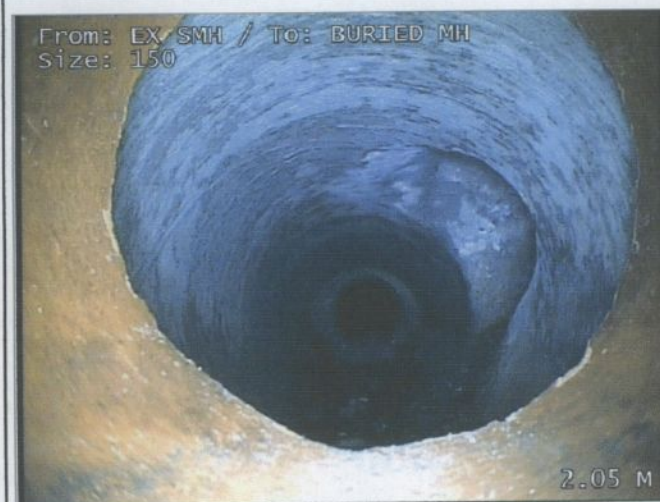
Joint displaced 15mm

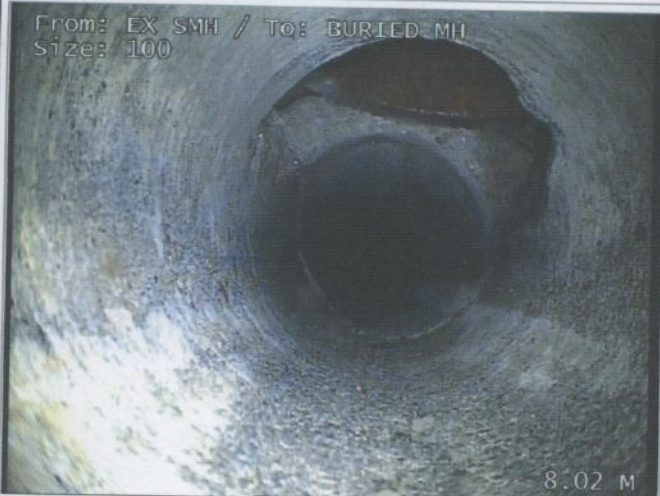
Connection defective at 12 o'clock, diameter 100mm

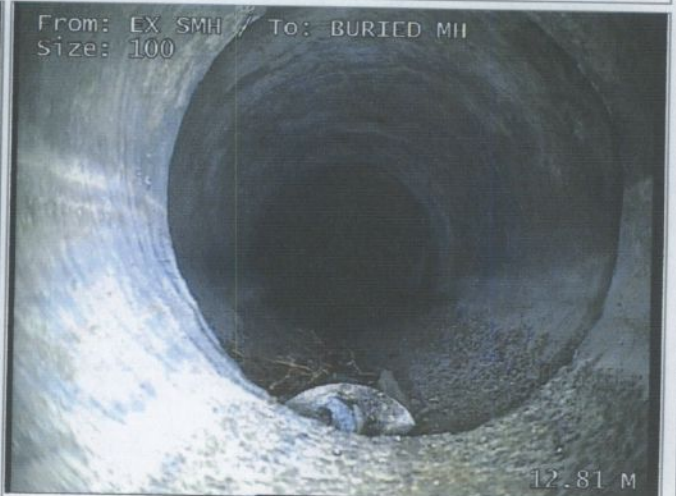
Joint displaced 10mm

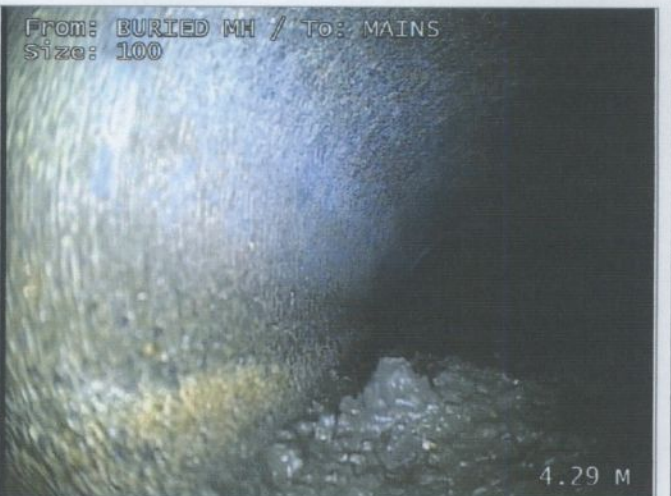
Other attached deposits from 4 to 7 o'clock 50% cross-sectional area loss
- Remark DEBRIS/CONCRETE

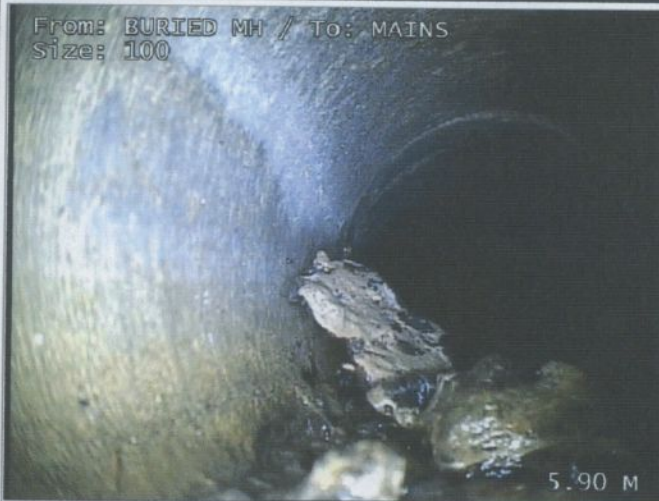
Settled deposits coarse 25% cross-sectional area loss - Remark: STONE IN LINE

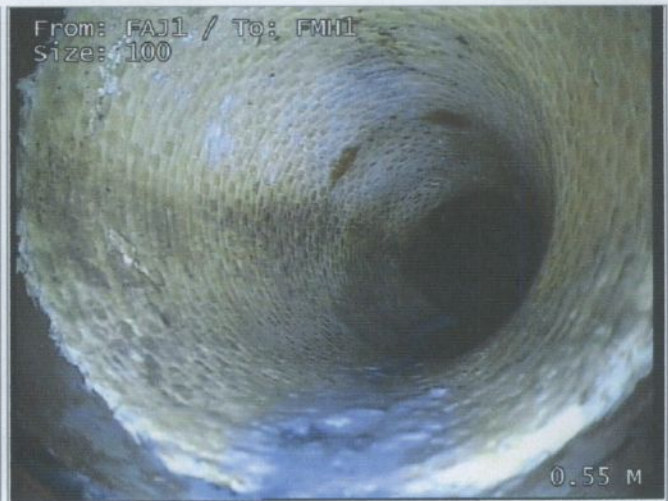
General photograph taken at this point - Remark: PART LINER INSTALLED

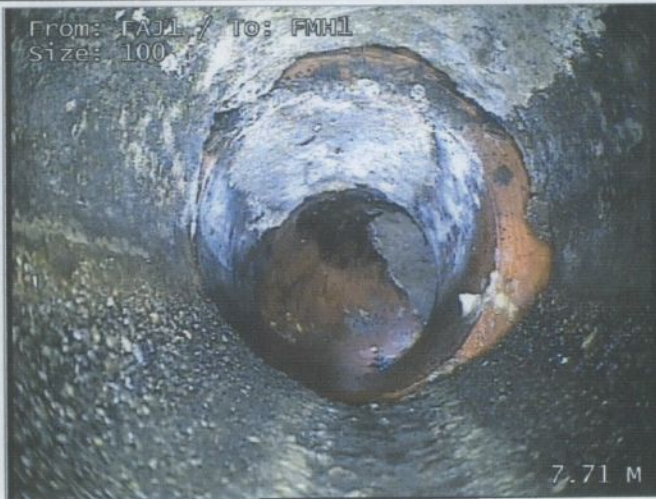
Joint displaced 15mm

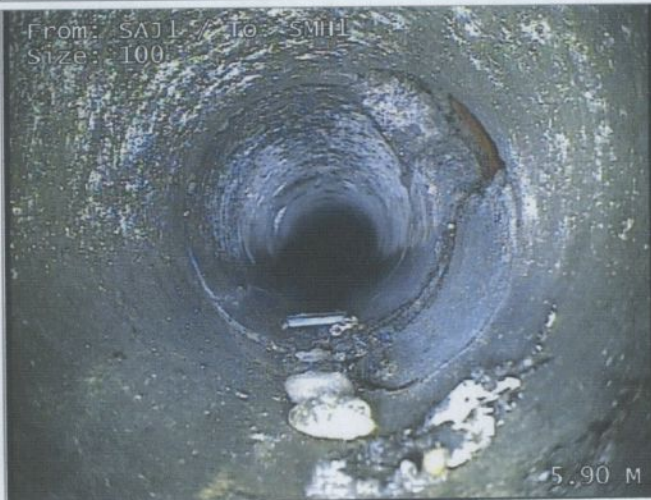
Connection defective at 1 o'clock, diameter 100mm

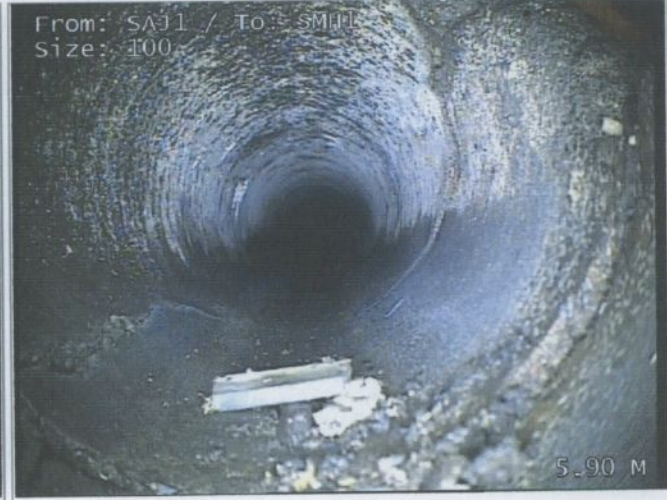
Fracture spiral from 8 to 1 o'clock

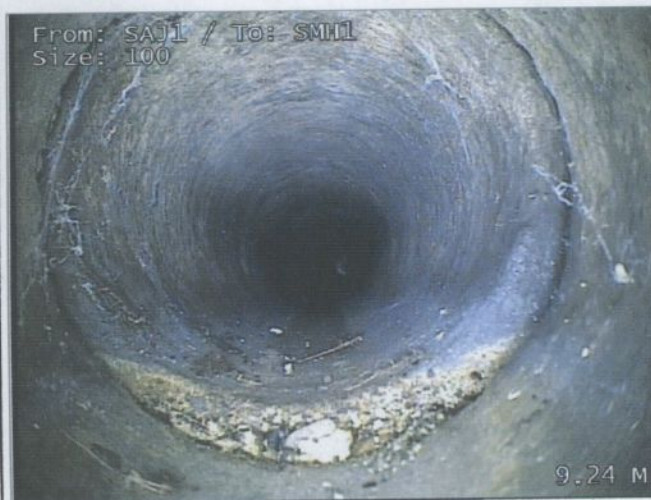
Joint displaced 10mm

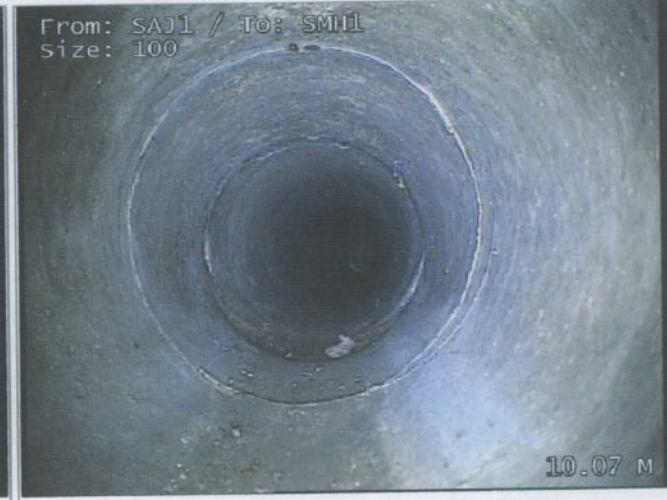
Crack circumferential from 12 to 12 o'clock

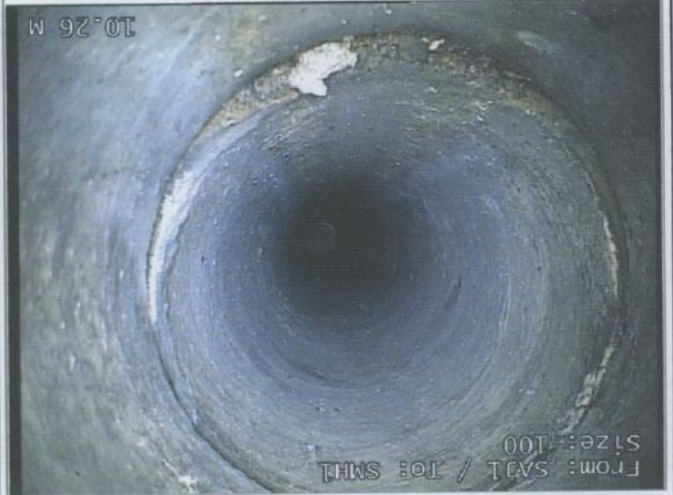
From: S4J1 / To: SMH1
 Size: 100

Joint displaced 10mm

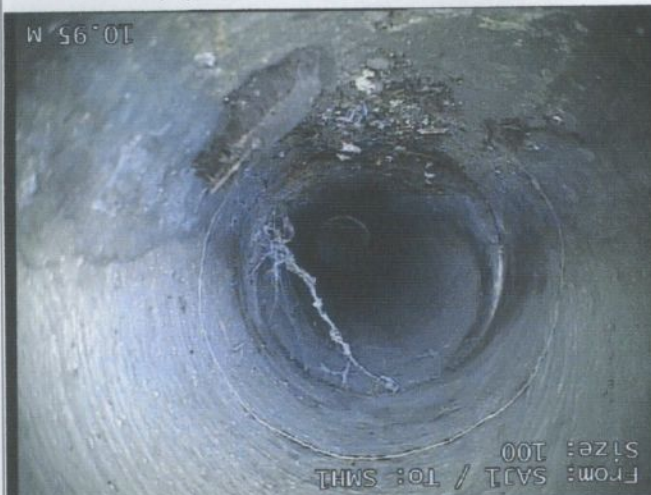
From: S4J1 / To: SMH1
 Size: 100

Crack circumferential from 7 to 4 o'clock

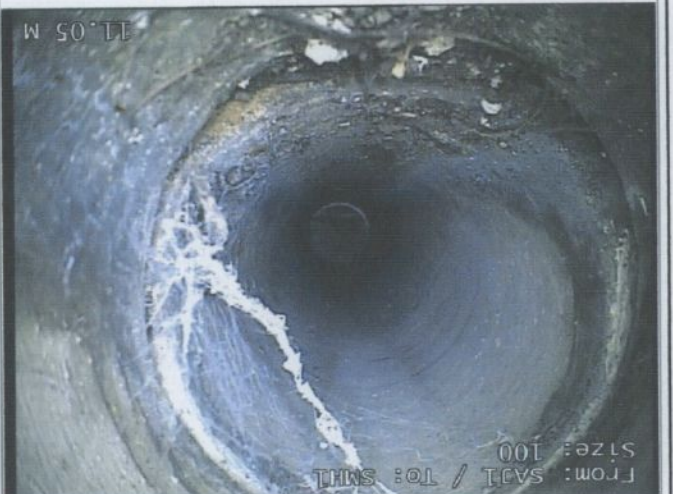
From: S4J1 / To: SMH1
 Size: 100

Open joint 10mm

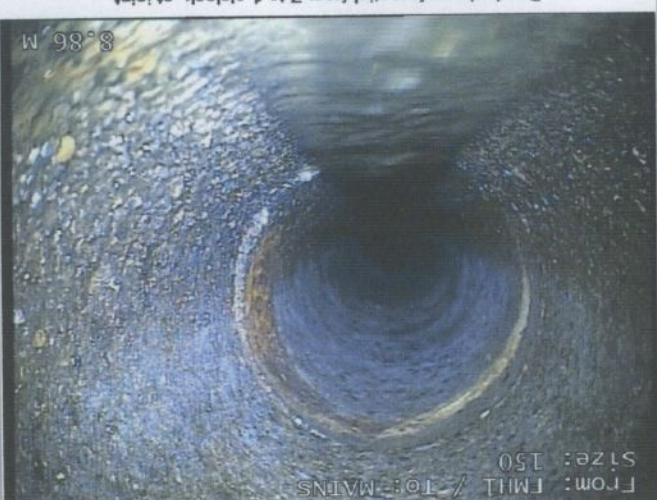
8.86 M

Crack circumferential from 7 to 1 o'clock, at joint

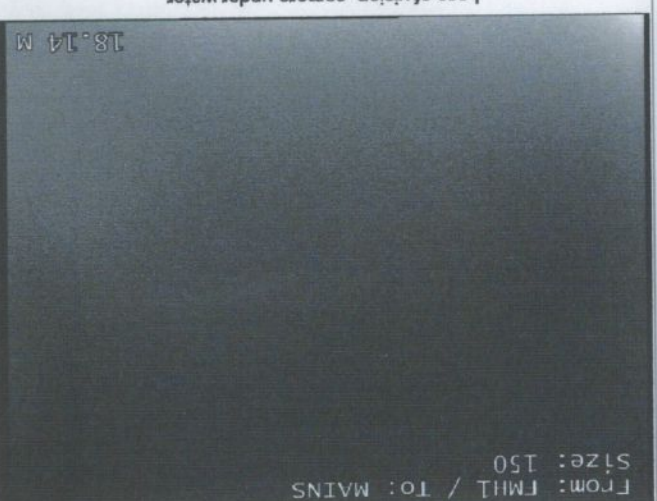
18.14 M

**FOUL LINE IS BLOCKED AT 19M DOWNSTREAM.
 STORM LINE IS FULL OF STONE.
 BOTH LINES NEED TO BE CLEANED AND RE-SURVEYED.**

Loss of vision, camera under water

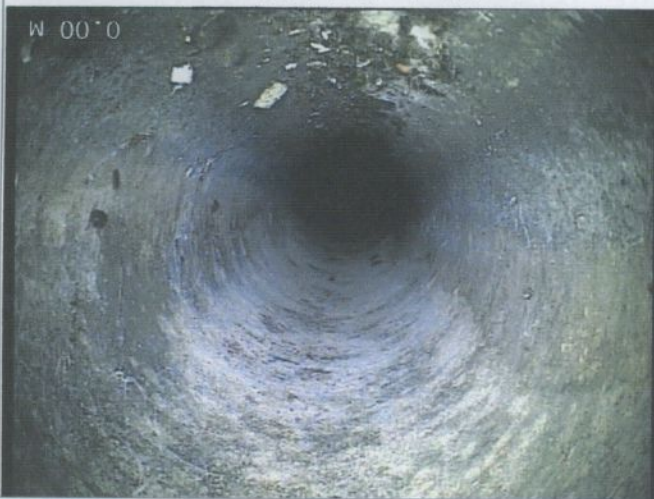
Settled deposits coarse 25% cross-sectional area loss

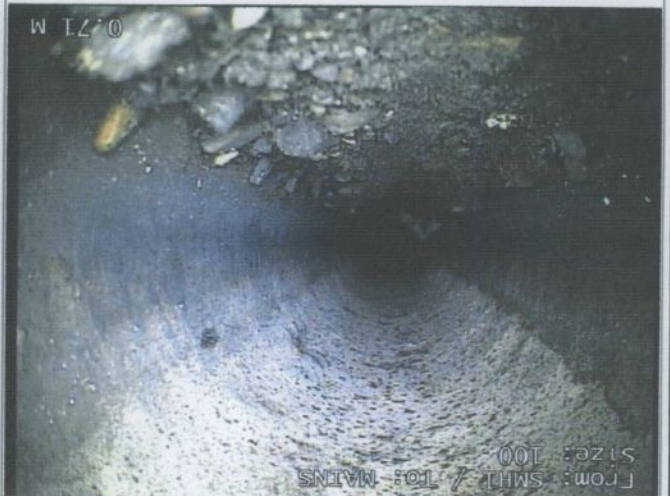
Joint displaced 15mm

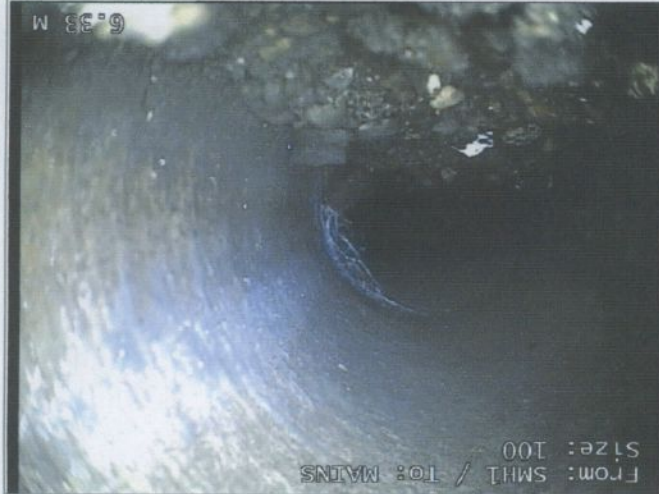
Settled deposits hard or compacted 40% cross-sectional area loss

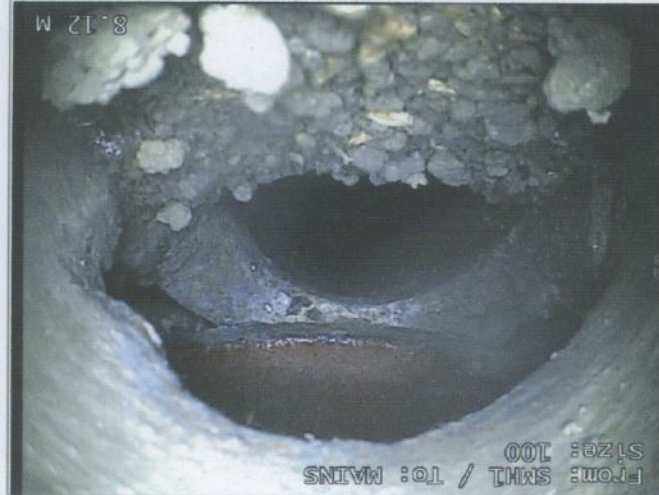
Connection defective at 12 o'clock, diameter 100mm

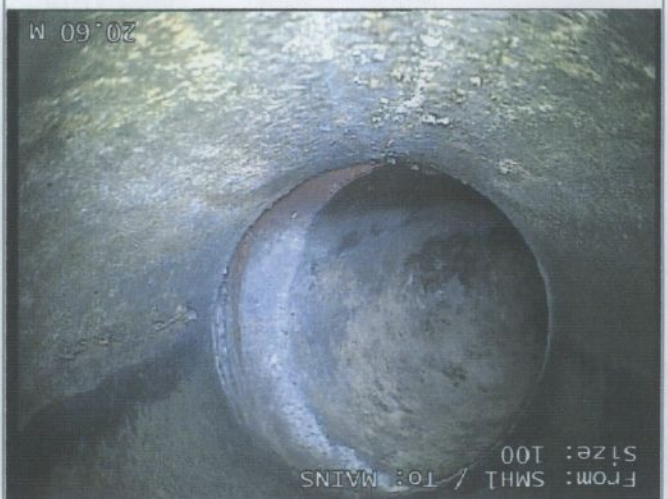
Joint displaced 25mm

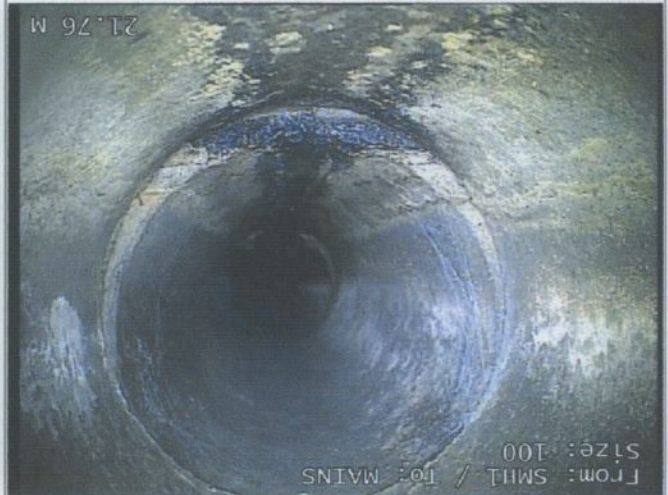
Joint displaced 10mm

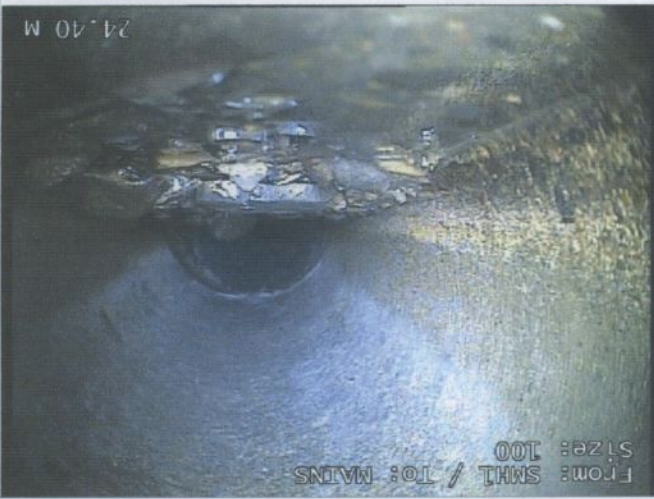
<p>From: SMHT / TO: MAINS Size: 100 24.40 M</p> <p>Survey abandoned - Remark: LINE FULL OF STONE</p>

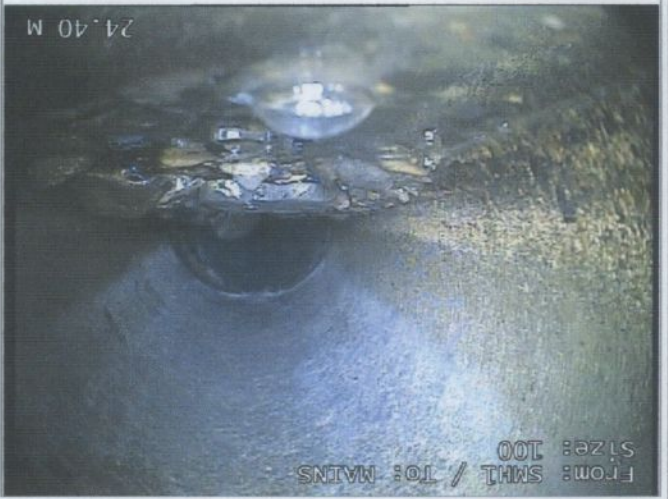
<p>From: SMHT / TO: MAINS Size: 100 24.40 M</p> <p>Settled deposits hard or compacted 75% cross-sectional area loss</p>
