Arboricultural Assessment

Clondalkin Rugby Football Club

Kingswood Farm, Moneenalion Commons Lower, Clondalkin, Dublin 22

20-June-2022

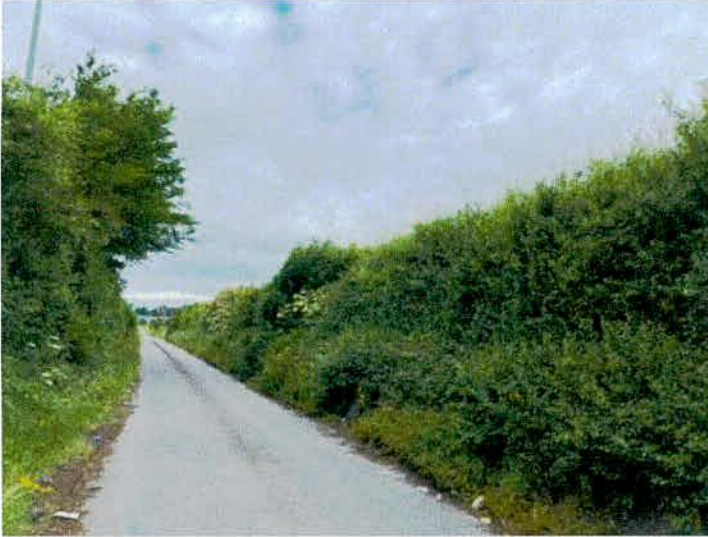
Above image shows Hedge 1A.

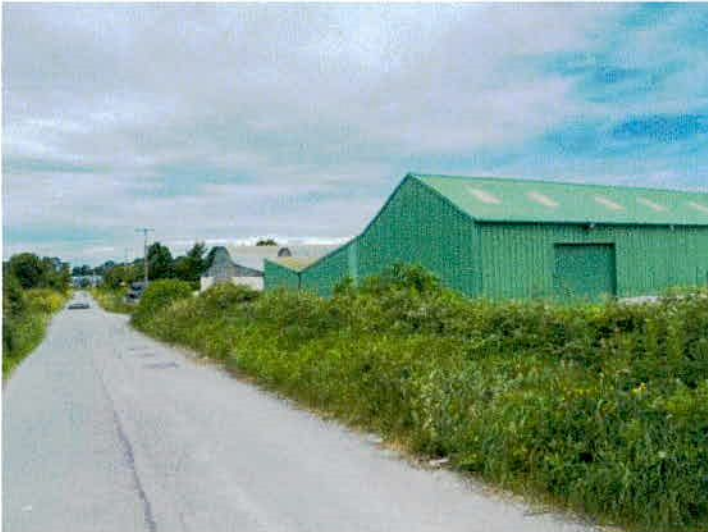
Above image shows Hedge 1B.

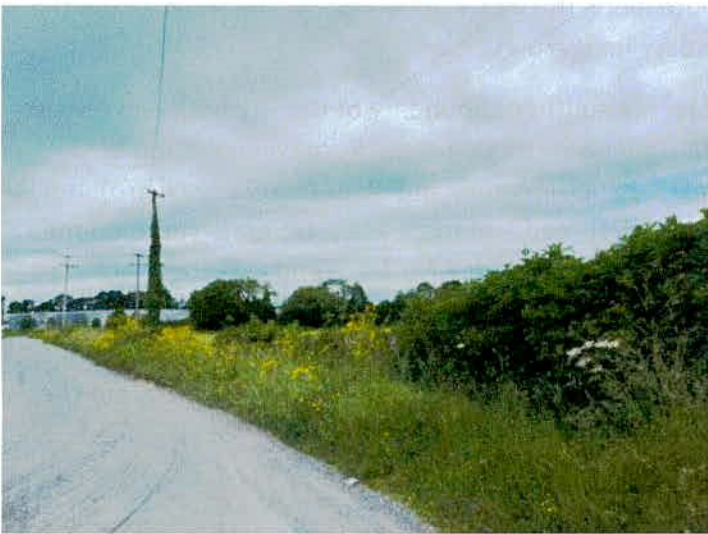
Above image shows Hedge 1C.

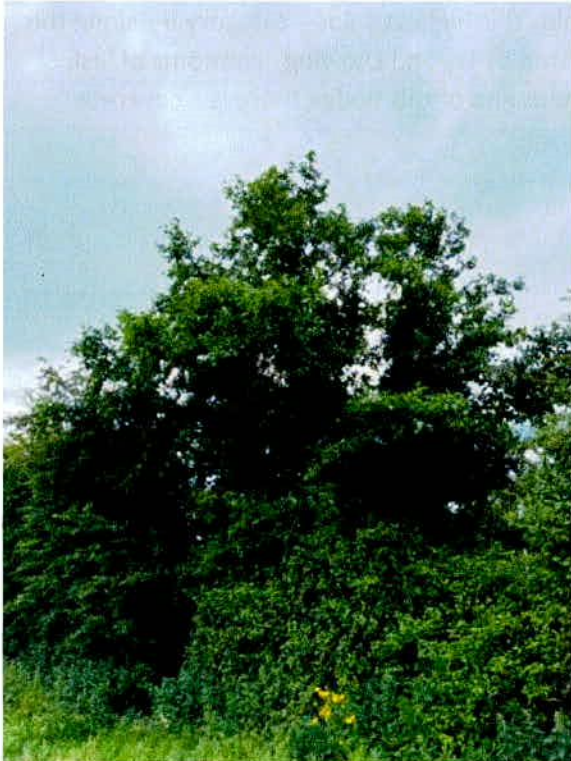
Above image shows a grey alder growing out of Hedge No.1A.

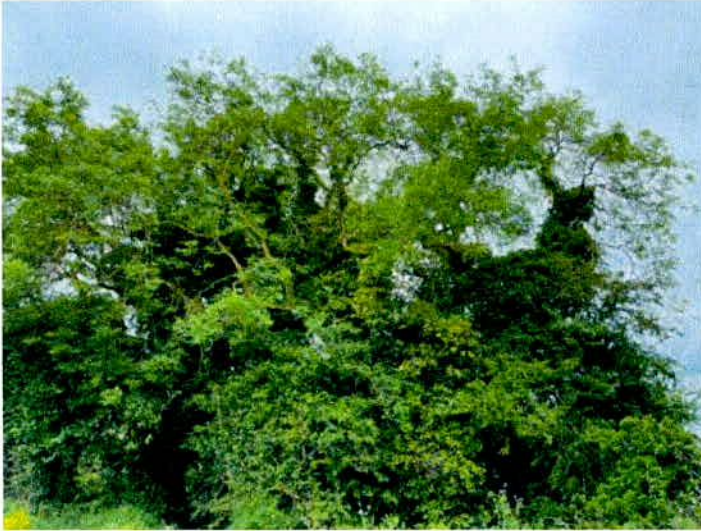
Above image shows Tree No.2 & 3 becoming suppressed by ivy and showing symptoms of 'ash dieback'. They are growing out of the southern end of Hedge No.2 on the adjoining landside of the stream, but their crowns overhang the site area.

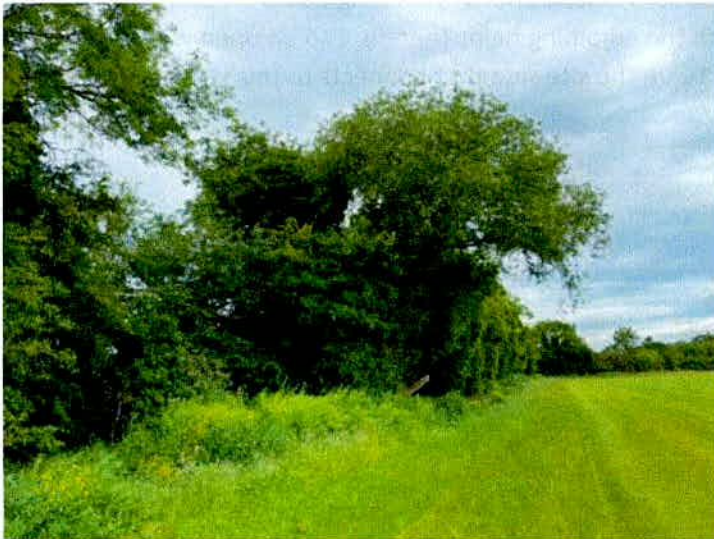
Above image shows Tree No.0393, a crack willow, growing out of the southern end Hedge No.2 on the adjoining landside of the stream with its crown overhanging the site area.

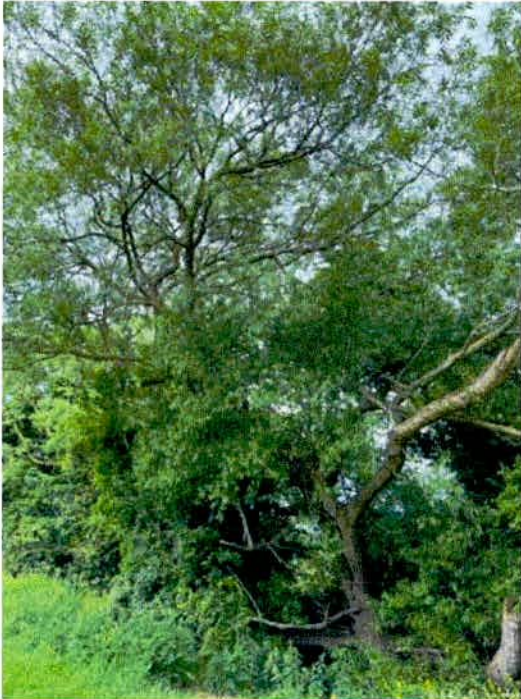
Above image shows a close-up of Tree No.0393, this tree has been cut back on the site side in the past and it has also suffered limb failure near its base; it is a poorly structured tree.

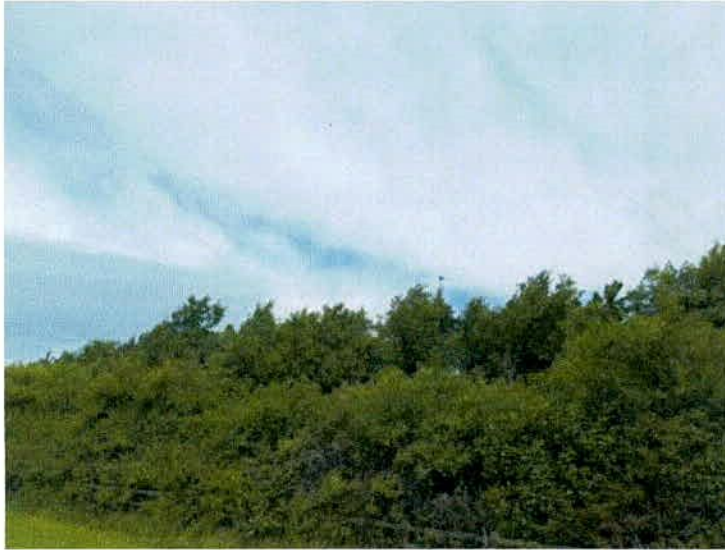
birch (*Betula pendula*). Hedge No.3 and Tree Belt No.1A provide valuable screening along this boundary with the public road (R136) and will provide the long-term tree cover in this area.

Above image shows Hedge No.3 with Tree Belt No.1A growing behind it.

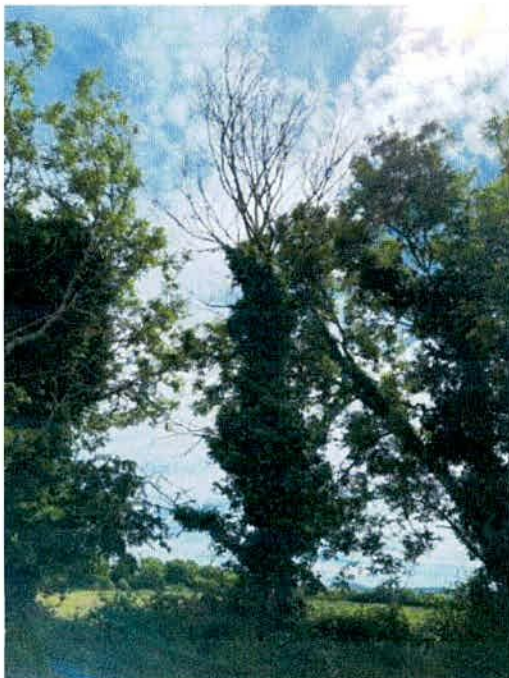
Above image shows Tree No.0395, a dead elm, in Hedge No.4

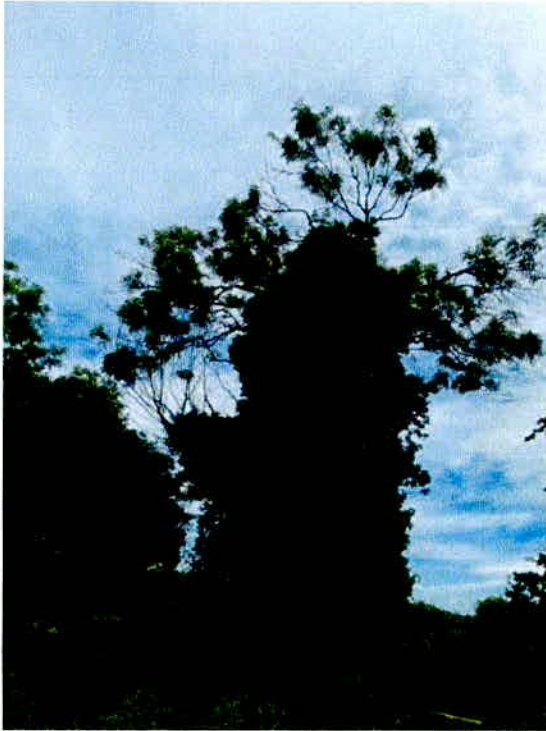
Above image shows Tree No.0396 in decline from 'ash dieback', with extensive basal decay present and ivy beginning to cause suppression. A dead elm tree can also be seen in the background.

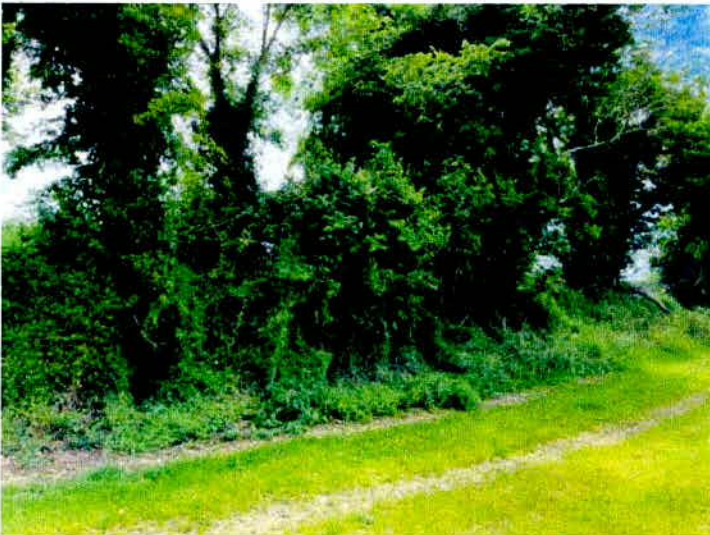
Above image shows Hedge No.4 with an upper-canopy of ash.

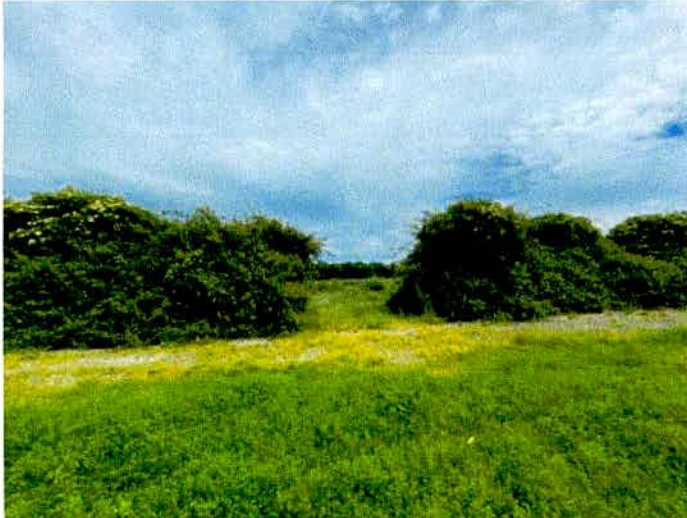
Above image shows the northern end of Hedge No.5 with access into the adjoining field.

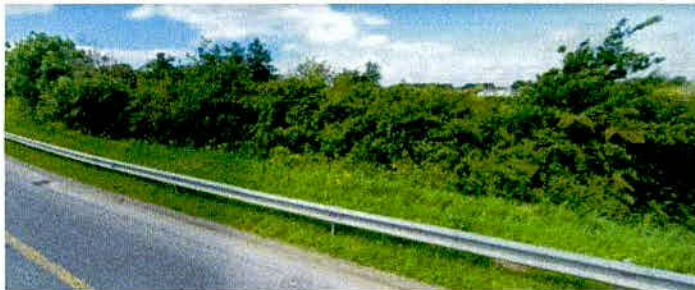
Above image shows Hedge No.6 from the off ramp of the public road (N7).

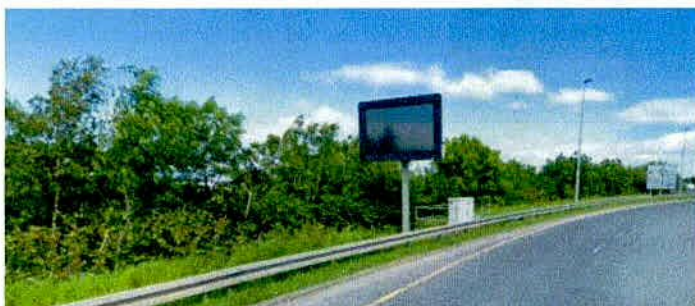
Above image shows Tree Belt No.1B from the off ramp of the public road (N7).

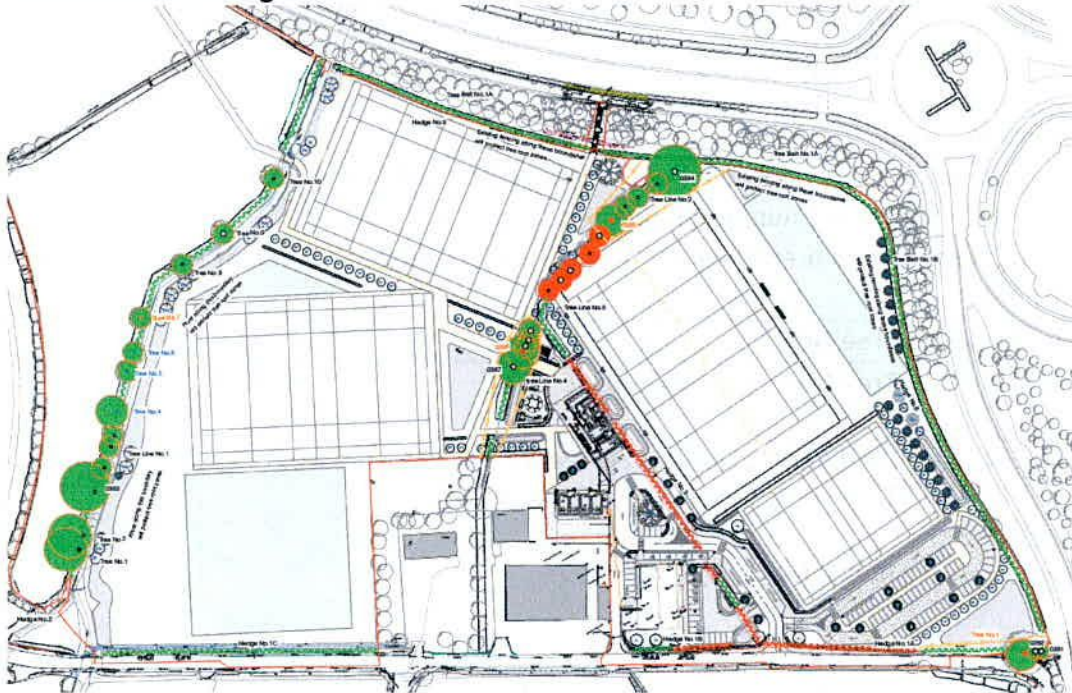
Proposed plan below shows the tree and hedge vegetation that will need to be removed in red and retained in green.

- c.115m (45%) of Hedge No.1 to allow for a vehicular and pedestrian entrance to the new car park and egress sightlines on the southern boundary.
- c.8m (7%) of Tree Belt No.1A and Hedge No.3 combined to allow for the pedestrian entrance on the northern boundary.
- c.45m (36%) of Hedge No.4 to allow for the sports field to the east.
- Tree Line No.3 (5 ash trees) to allow for the sports field to the east.
- c.145m (88%) of Hedge No.5 to allow for the two sports field to the east and access to the new clubhouse.
- C.5m of Hedge No.7 to allow for pedestrian access between the internal fields.

The loss of the above trees is to be mitigated by the landscaping of this completed development with the use of trees, shrubs, hedging, herbaceous perennial, and bulb planting. This planting will be in the new beds that surround the car parking spaces, along the internal paths, and the tree lines and hedging that will partition the playing fields. This planting will complement the development and its incorporation into the surrounding area. It will also help to provide good quality, sustainable, long-term tree cover and, as it establishes and grows, it will be continuously mitigating any negative impacts created with the loss of the existing tree and hedge vegetation. A mix of tree species, forms, and sizes, including the use of semi-mature trees, will form a strong and unifying element to the landscape areas, ideally with the use native species such as oak, birch, alder, and Scots pine in open spaces; whitebeam, hornbeam, and cherry bird in smaller spaces and near structures; and hazel, yew, holly as hedging plants.
