Independent Tree Surveys Ltd

Tree Survey & Planning Report 1 The Crescent Lucan Co. Dublin

July 2022

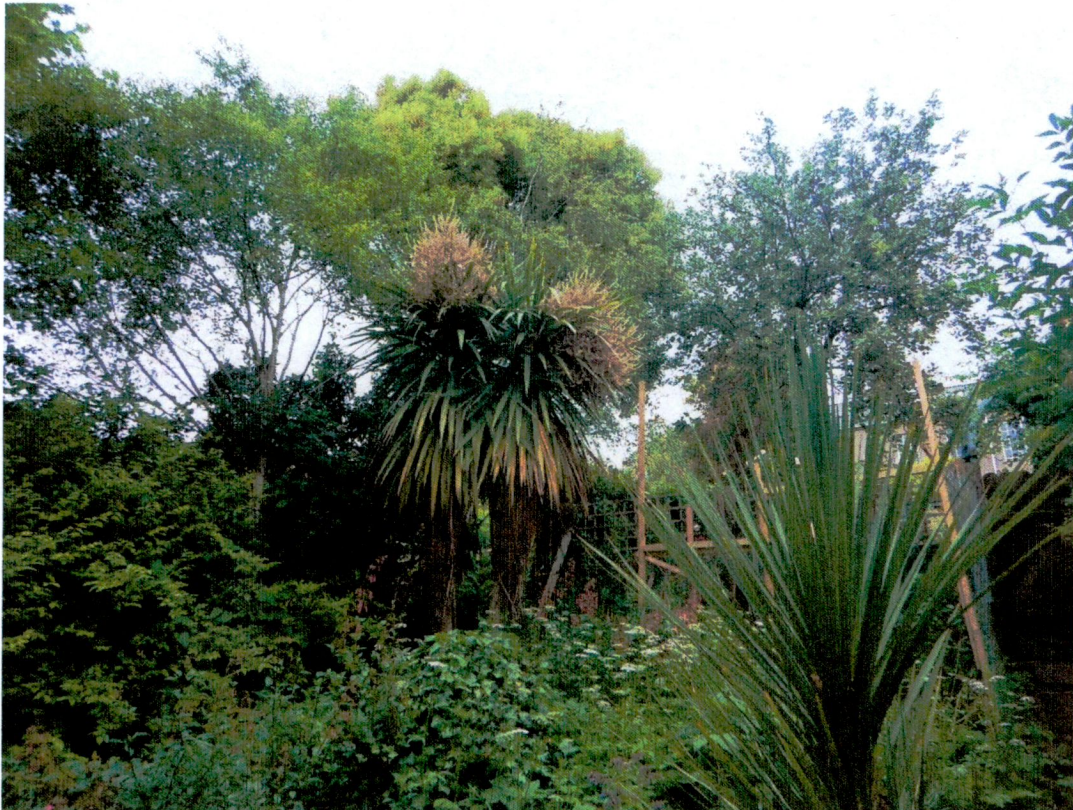
Photo 1 View from the centre of the proposed site looking north, with Cabbage Palm T464 in the centre and Whitebeam 467 to the right

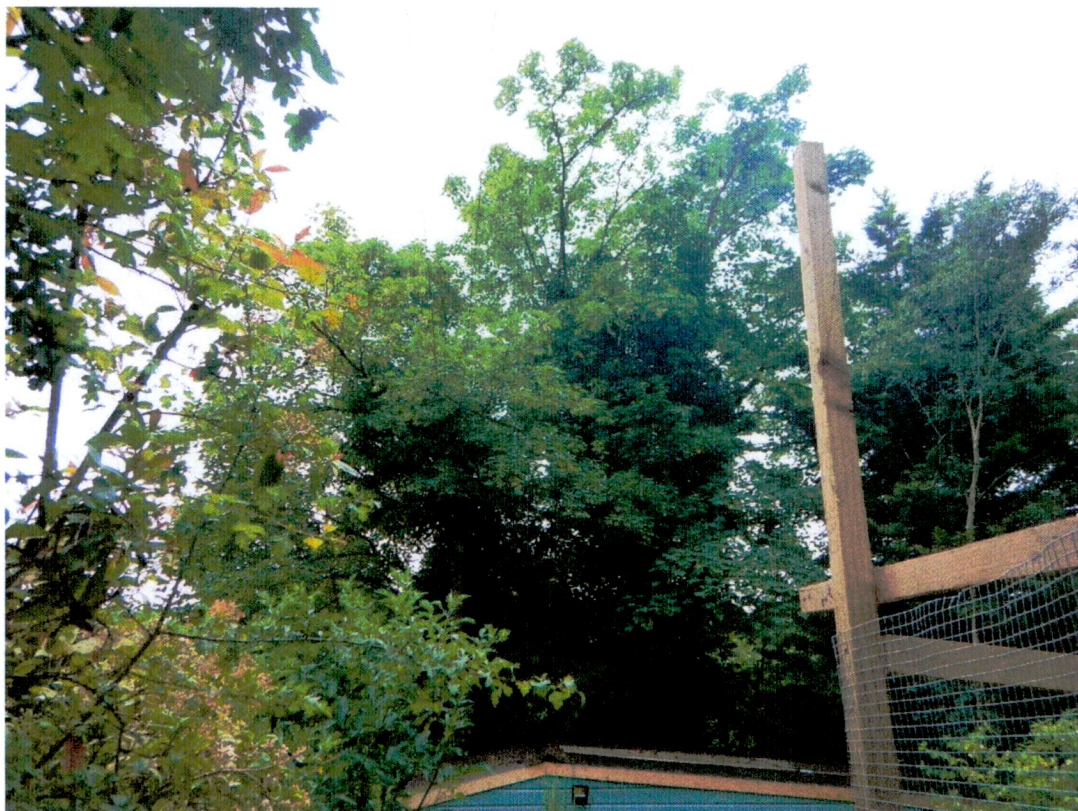
Photo 2 Trees (457-463) growing inside the southern boundary of the property, taller Sycamore 459 in the centre

The trees highlighted on the drawing will be felled and the resulting arisings removed to a licenced green waste facility or recycled as mulch on the site. The trees inside the site being felled are the eight tagged T459-T466, along with tree T467 just outside the northern boundary. The trees tagged T452, T457, and T458 in the neighbouring garden will also be removed as part of the development planned for the adjoining lands.

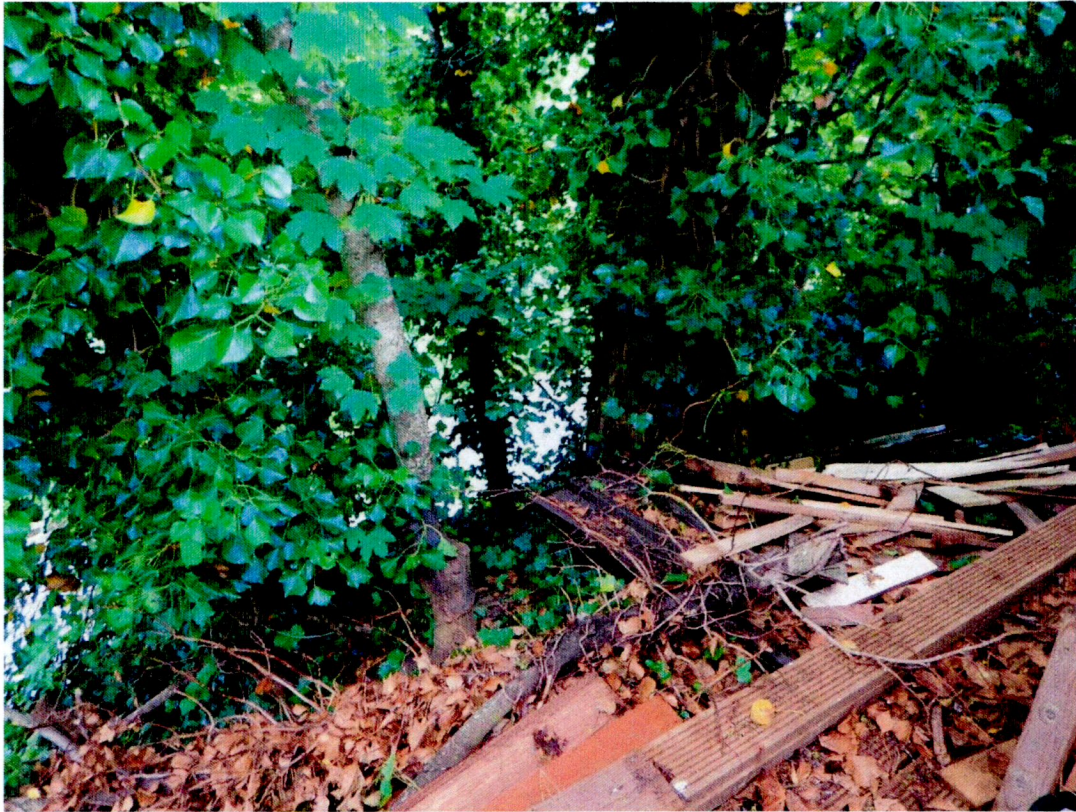
Photo 4. Sloping area around the stem bases of trees T459-462 close to the southern boundary wall
