ARBORICULTURAL ASSESSMENT & IMPACT REPORT

Transitional Care Facility,
Unit 21 First Avenue,
Cookstown Industrial Estate,
Dublin 24

Project No.	Project name	Date	Revision
T00002	Cookstown	13/09/22	-

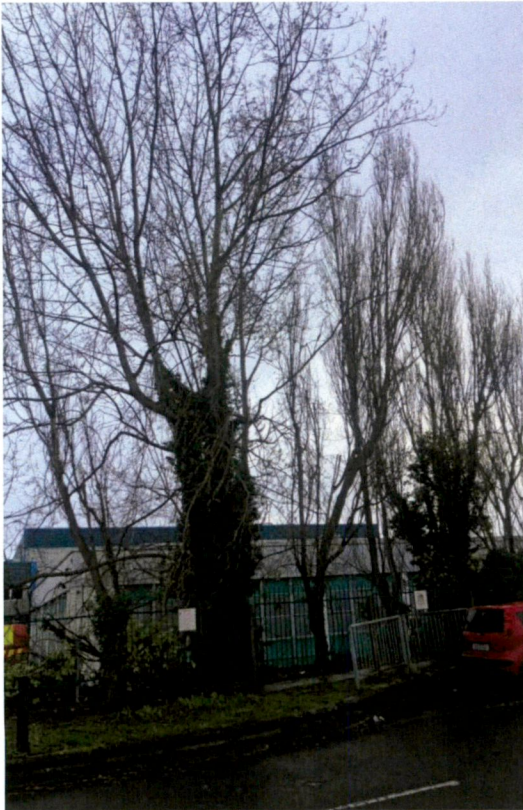
Image 2. Typical view of poplar trees on northern boundary. Note the poor quality of canopies and variable growth rates.

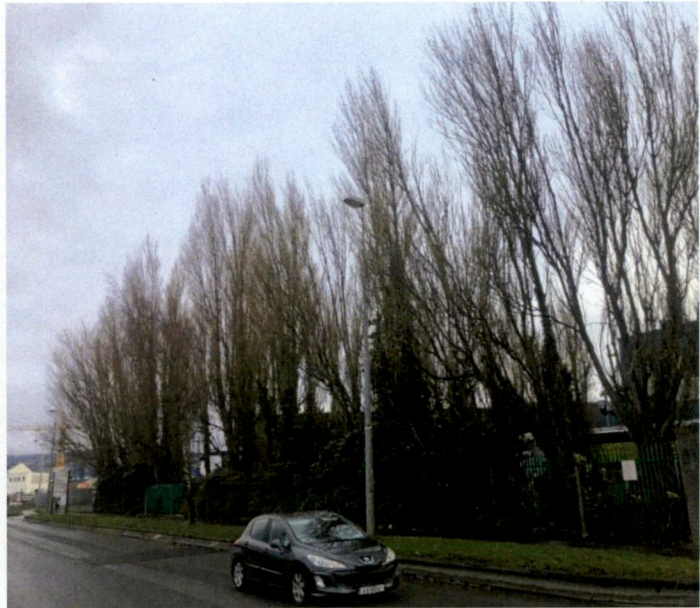
Image 3. Typical view of poplar trees on Cookstown Road boundary. Note partial collapse of some specimens

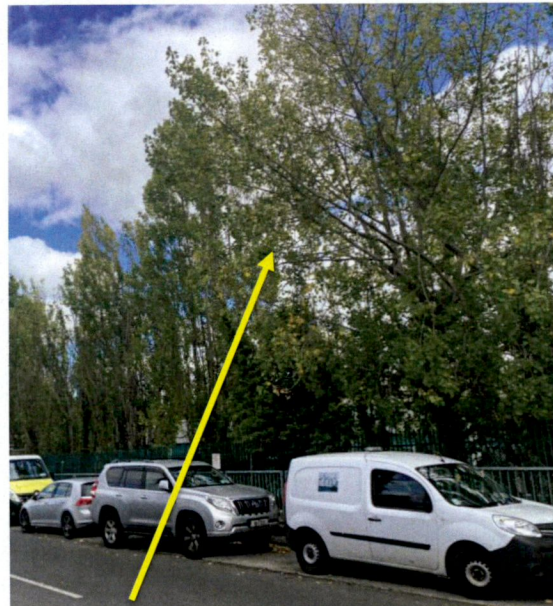
Image 4. Typical view of poplar trees on northern boundary. Opening of canopy and limb exposure arrowed.
