**Inspection Report
Paul Keogh Architects**

Coric House

Dated: 31/10/2018

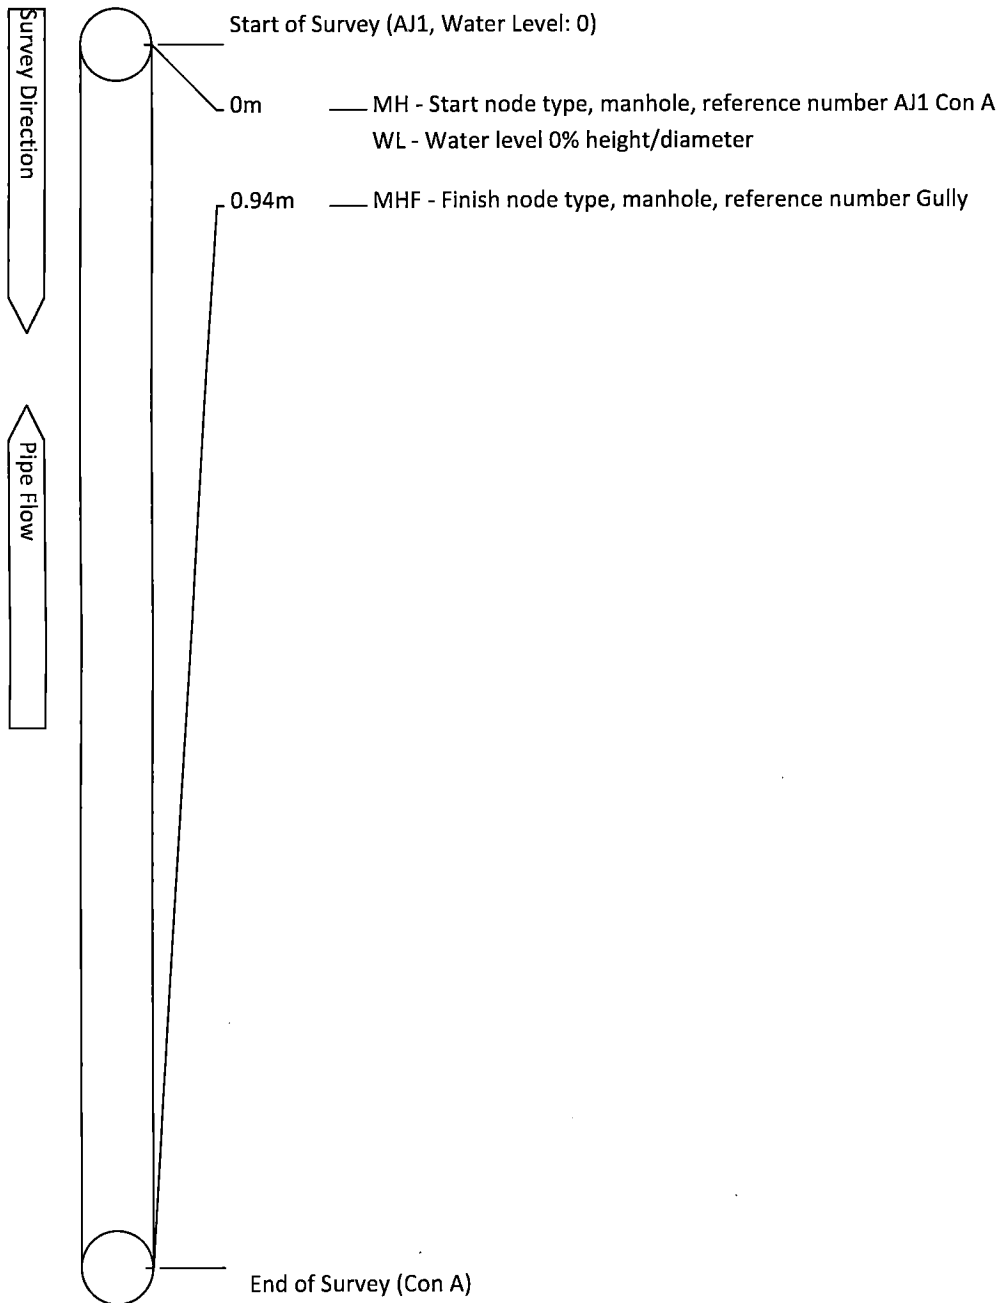
After our survey and jetting here we found this line is in good condition. It takes a gully which is buried under the stone.

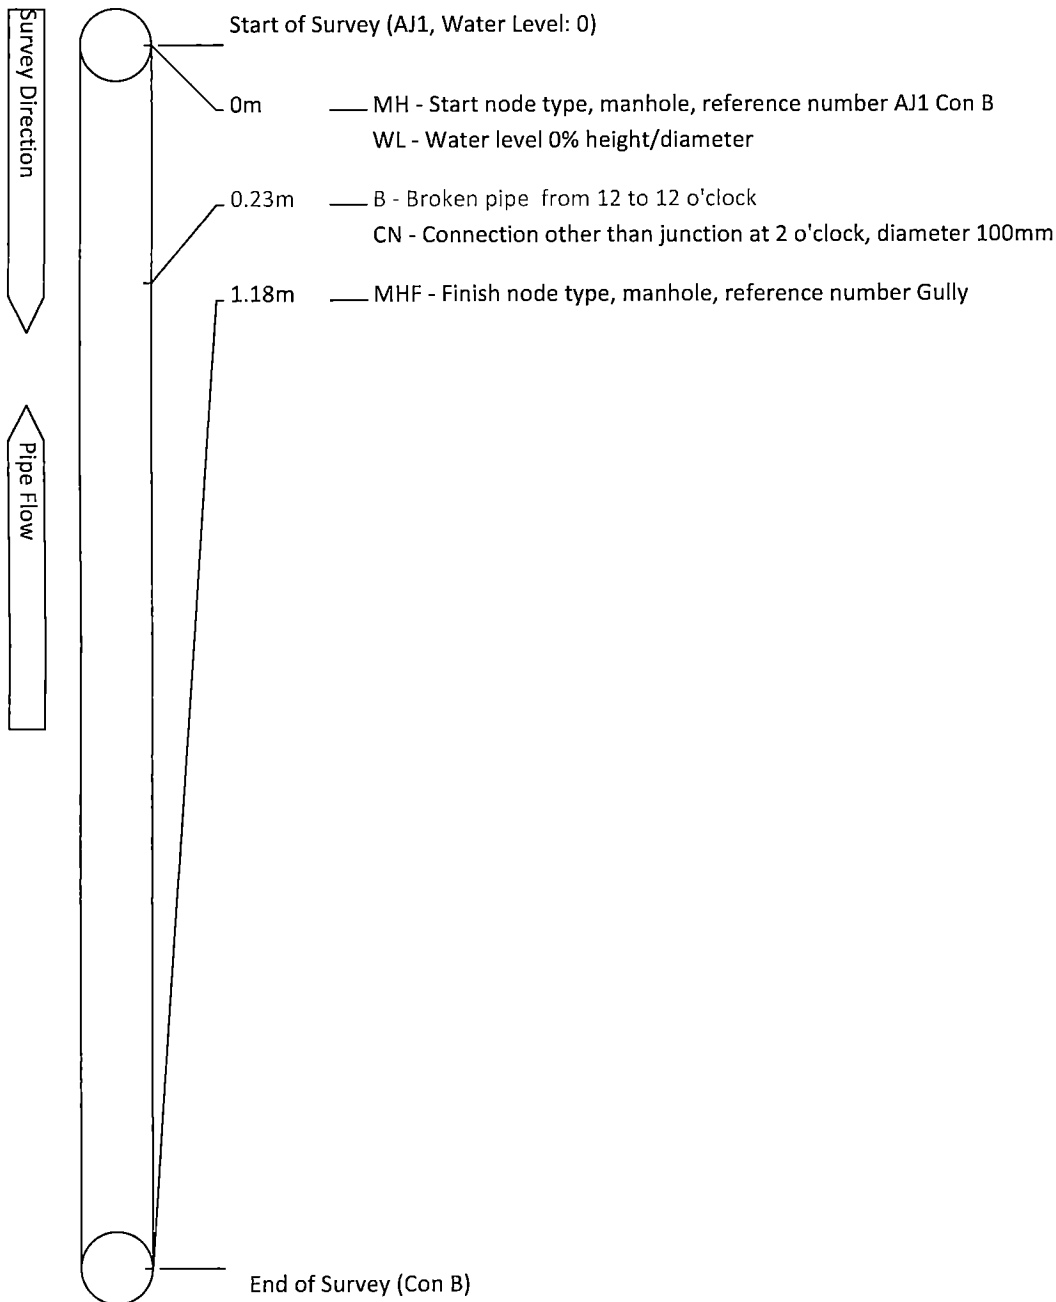
Position	Code	Description/Remarks	Grade	Photo
0m	MH	Start node type, manhole, reference number AJ1 Con B		
0m	WL	Water level 0% height/diameter.		
0.23m	B	Broken pipe from 12 to 12 o'clock. Hole	2

0.23m	CN	Connection other than junction at 2 o'clock, diameter 100mm.		
1.18m	MHF	Finish node type, manhole, reference number Gully

After jetting and surveying this line to remove lots of stone we found this line has a hole on the top of the pipe. There is no other problems to report here.

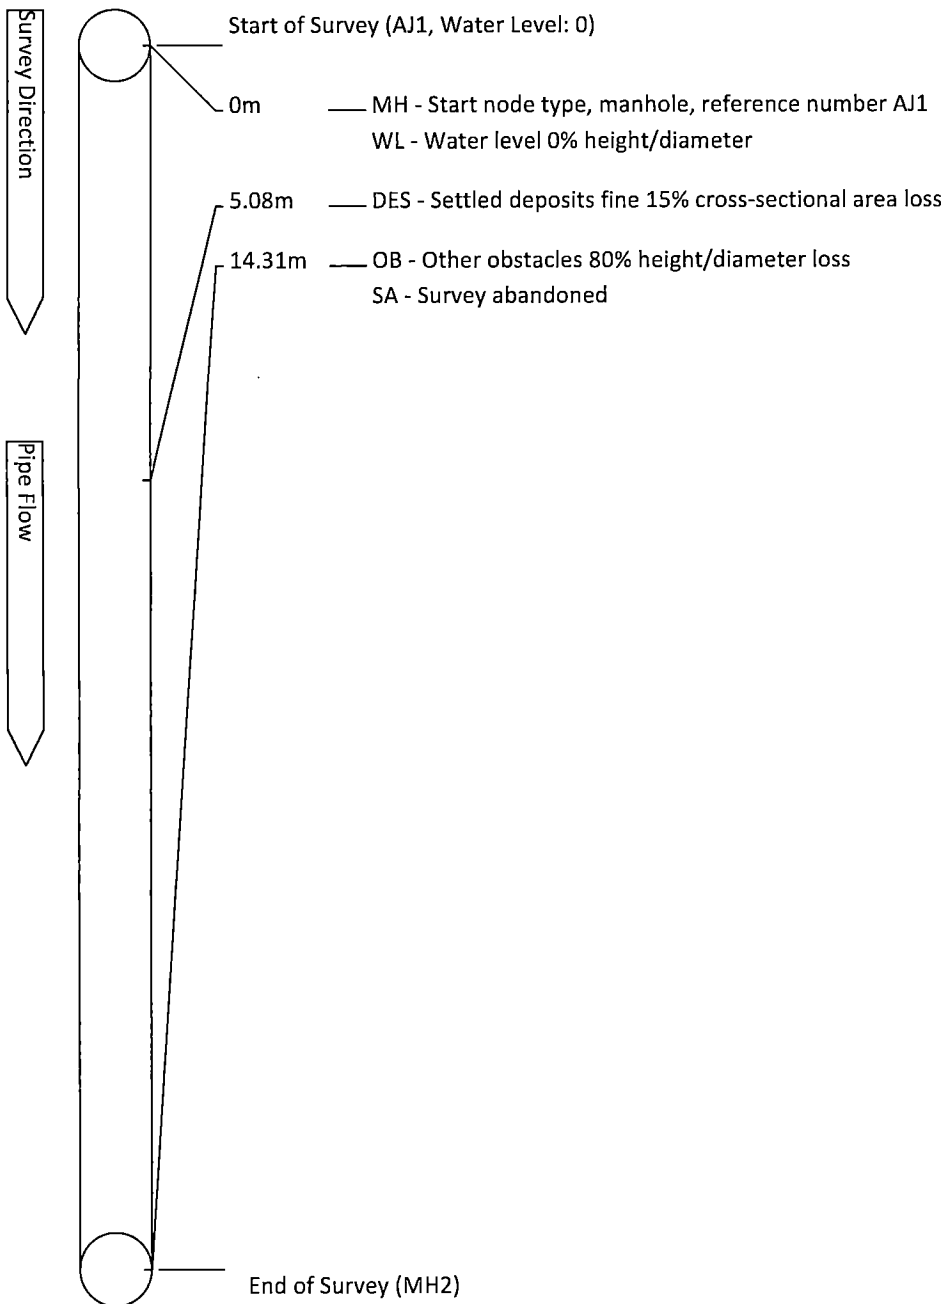
Position	Code	Description/Remarks	Grade	Photo
0m	MH	Start node type, manhole, reference number AJ1		
0m	WL	Water level 0% height/diameter.		
5.08m	DES	Settled deposits fine 15% cross-sectional area loss. Debris

<p>31Oct_001.MP4_002.JPG</p>
14.31m	OB	Other obstacles 80% height/diameter loss. Rubble

<p>31Oct_001.MP4_003.JPG</p>
14.31m	SA	Survey abandoned. Camera wont pass

After jetting this line we found that it flows down to a MH in the car park (MH2). There is a car parked on this but we could hear the jet in the MH. We could not fully clean the line back jetting from the AJ. We need access to the manhole that has a car parked on it in order to jet the line out from here. No other issues to report.

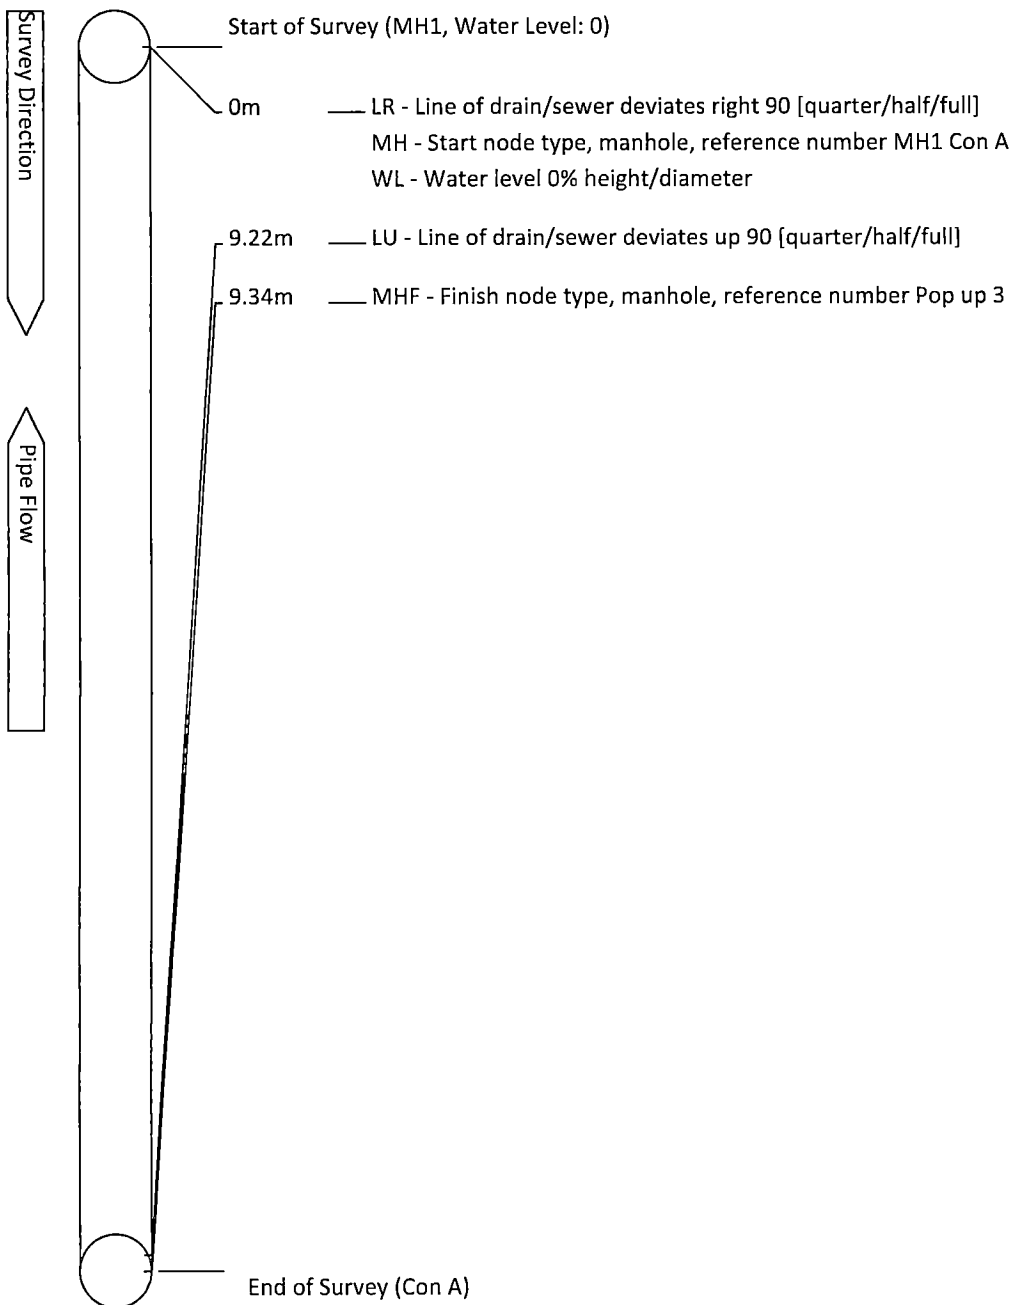
After our survey here we found the line is in good condition, no problems to report. This is the foul pop up (pop up 3) for unit2.

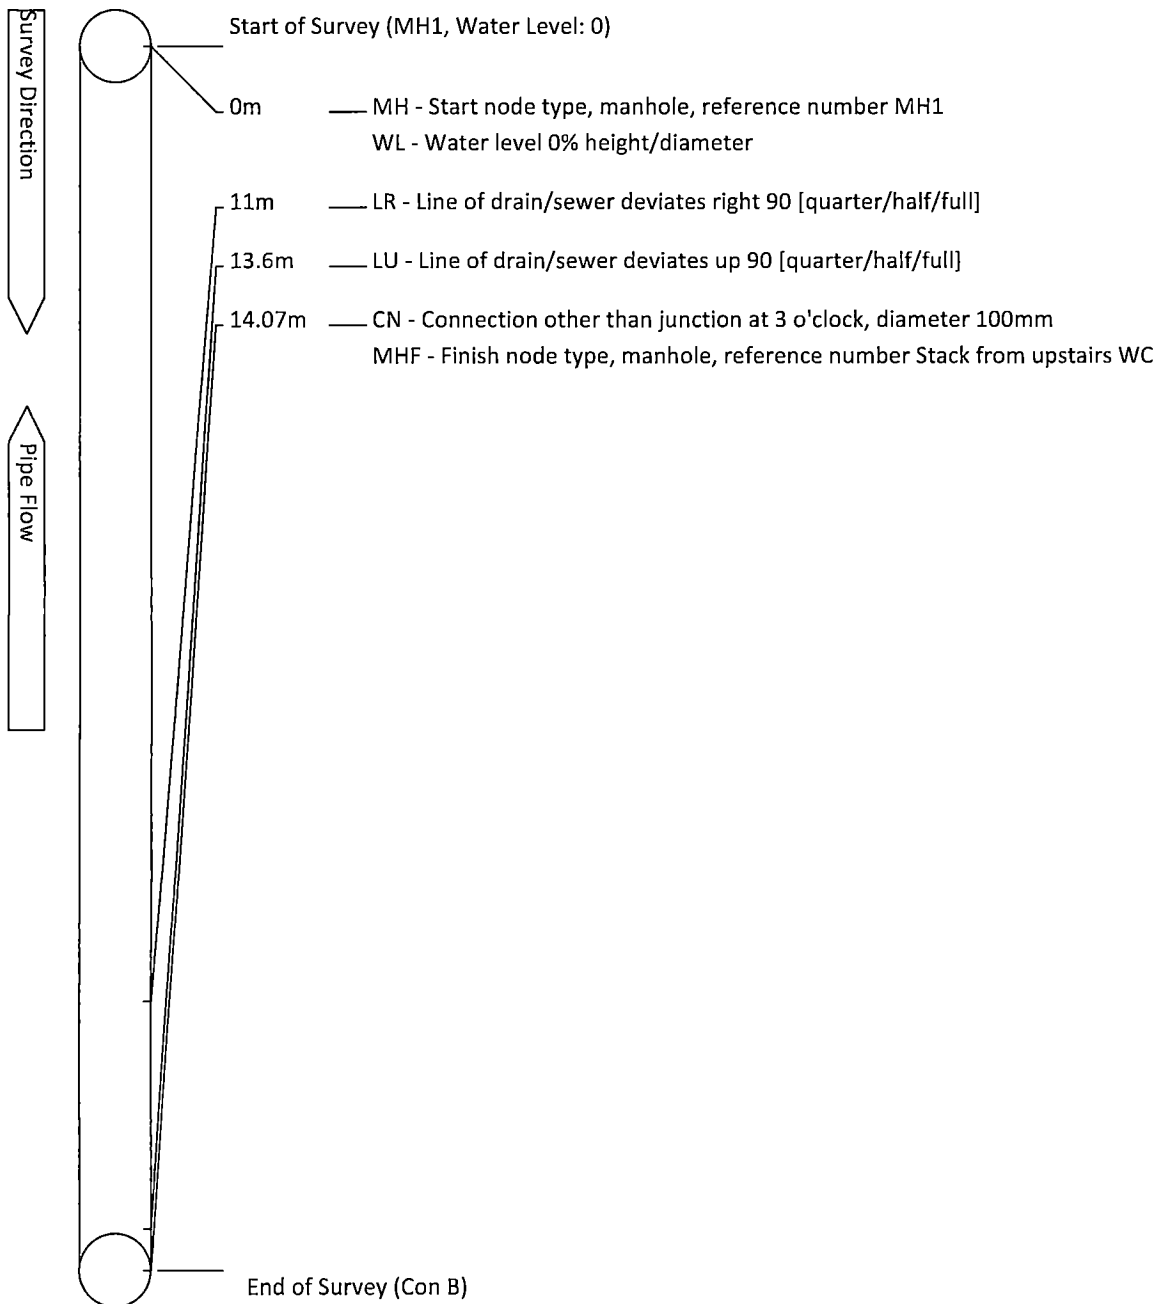
After our survey on this line we found it is in good condition. This takes the toilets from upstairs and downstairs in unit3. No problems to report.

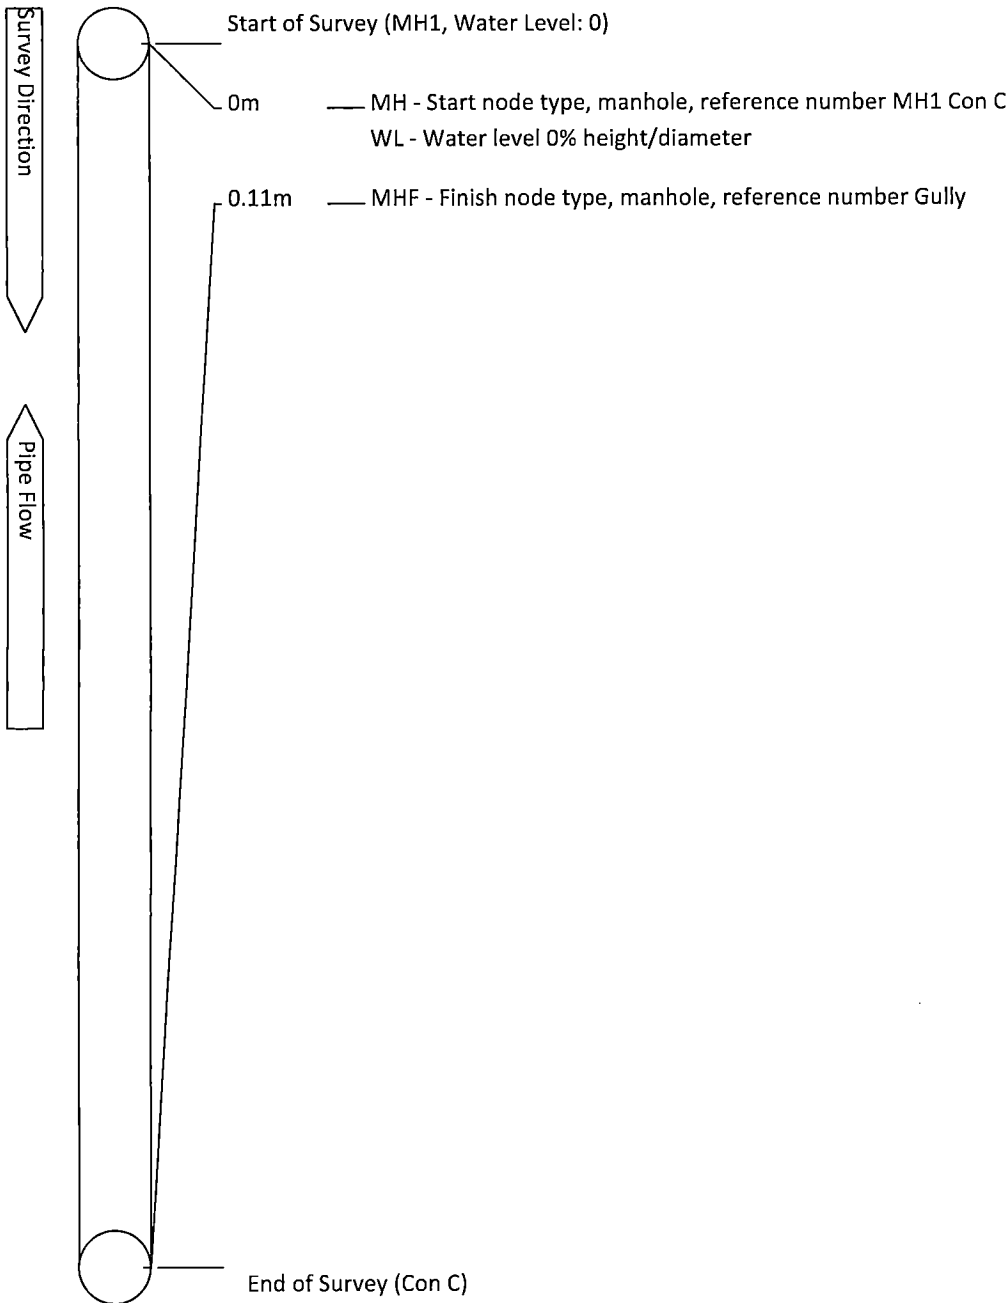
After our survey here we found this line is in good condition. This takes a gully in the courtyard area.

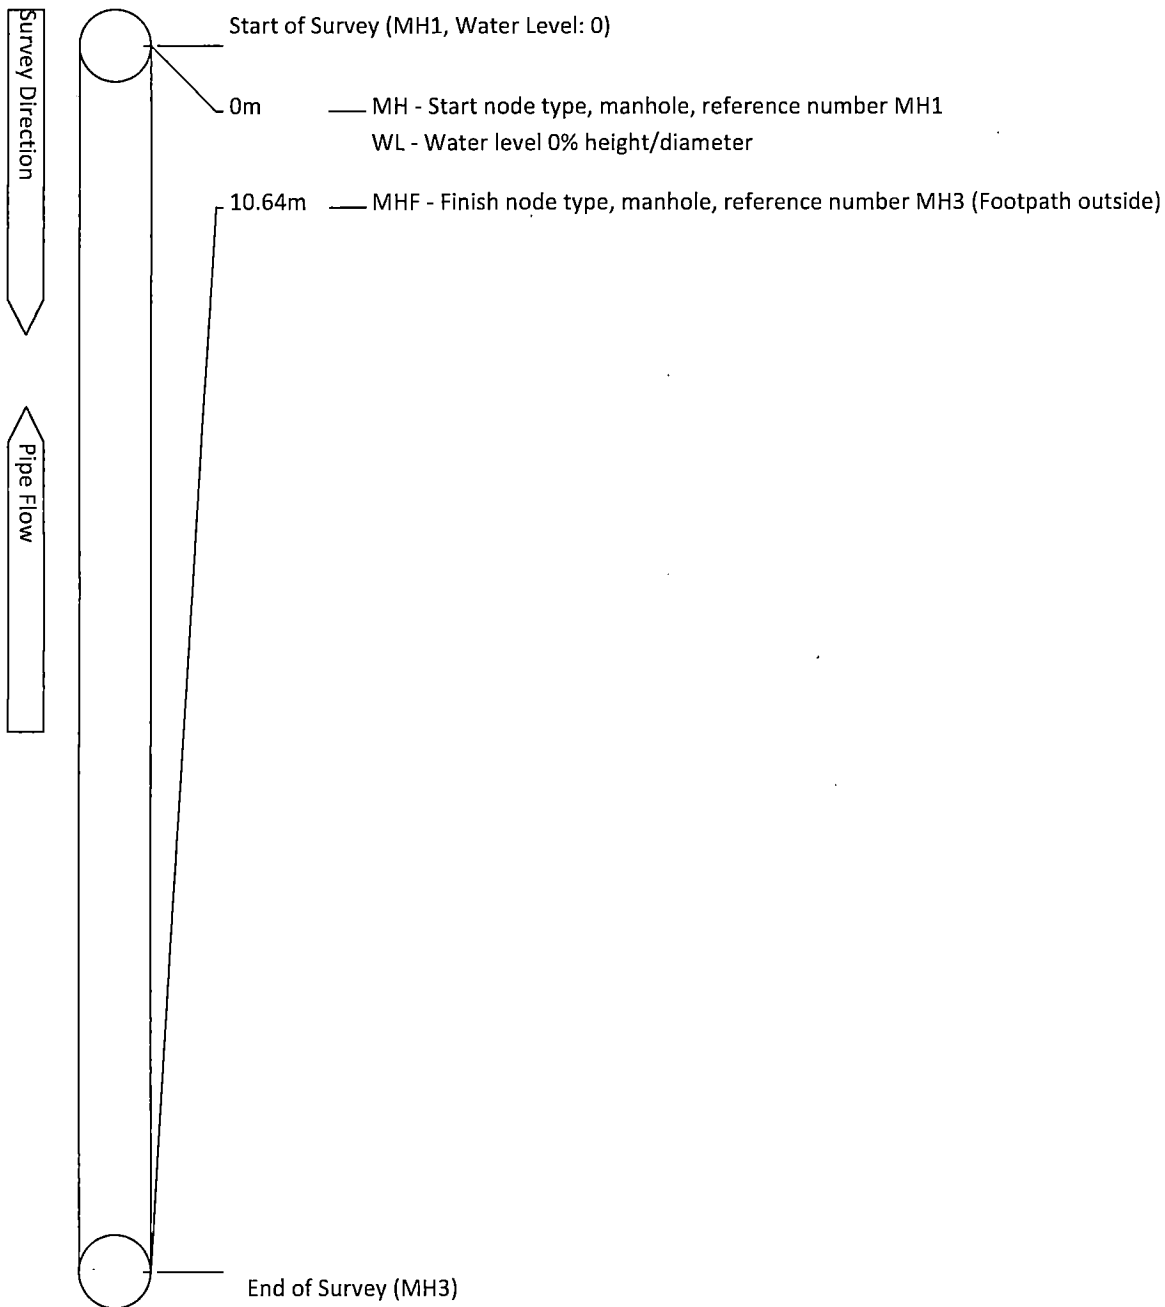
Line in good condition

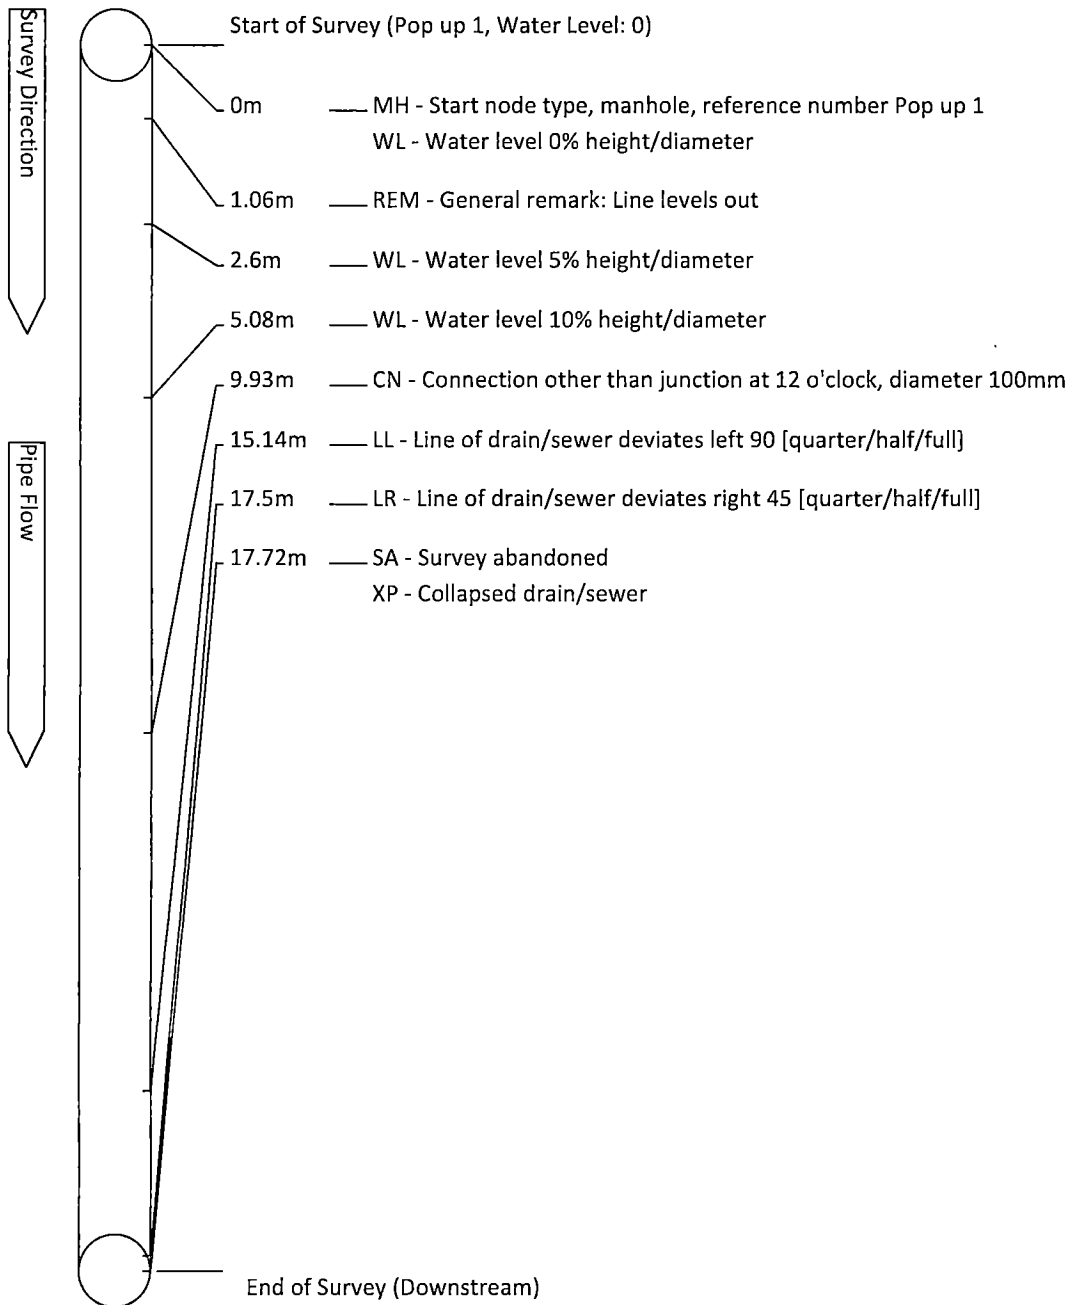
31Oct_001.MP4_003.JPG
9.93m	CN	Connection other than junction at 12 o'clock, diameter 100mm. Stack 1		
15.14m	LL	Line of drain/sewer deviates left 90 [quarter/half/full]		
17.5m	LR	Line of drain/sewer deviates right 45 [quarter/half/full]		
17.72m	SA	Survey abandoned. Camera wont pass obstruction		
17.72m	XP	Collapsed drain/sewer.	5

After our survey on Popup1 we found that the line is holding a WL for the majority of the run. We pulled the hose into the unit and jetted downstream, this dropped the levels a bit, but there is still a WL in the line. The line turns left at approx 15m and then turns right at approx 17.5m. There is damage after it turns right. We jetted numerous times but this did not move. This looks like the pipe is collapsed here.

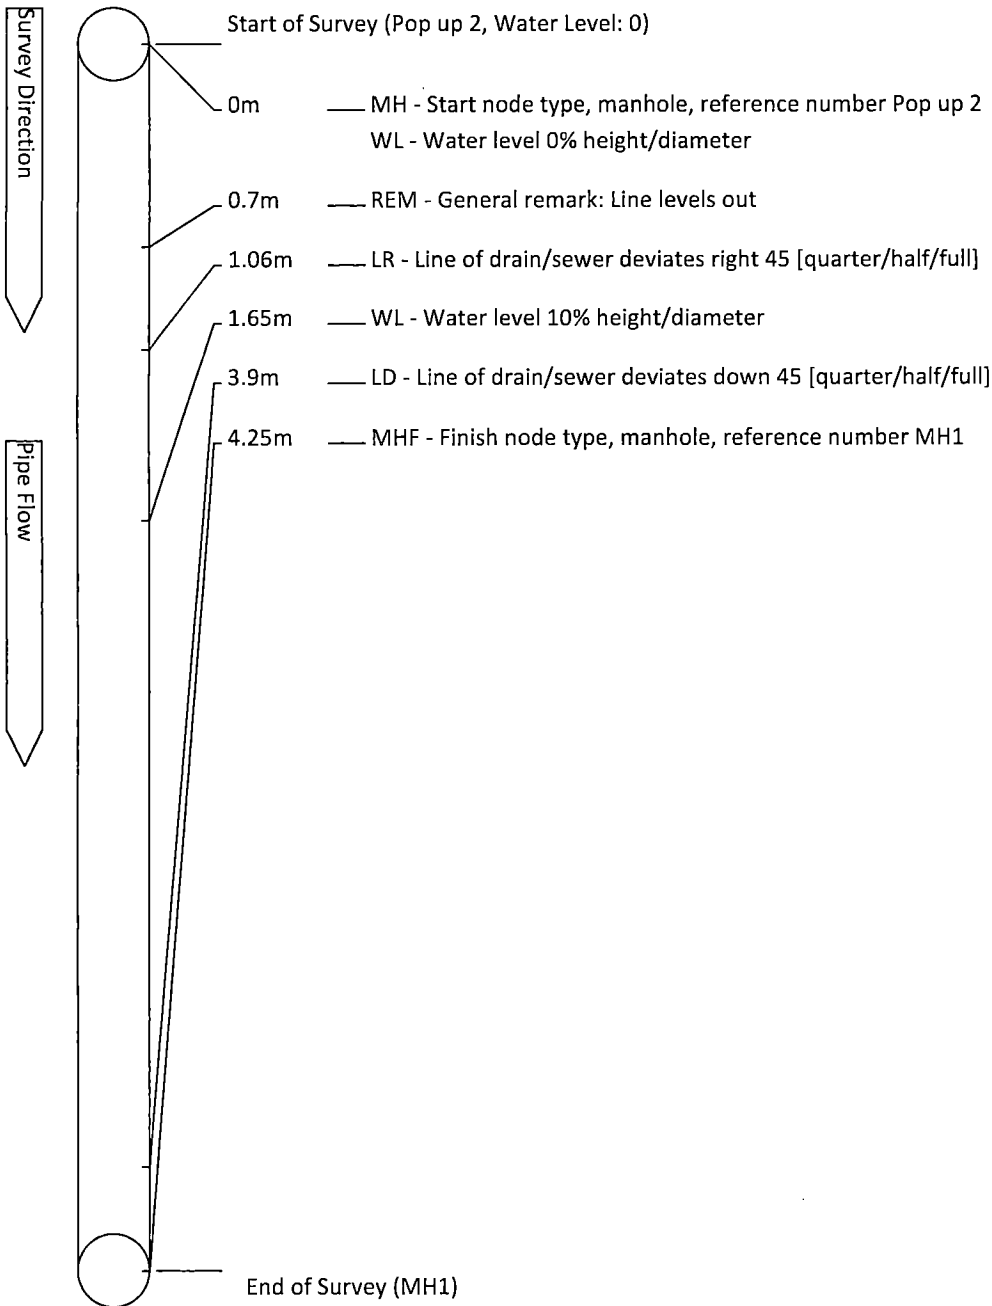
After our survey on this line we found that it has a WL of 5-10% in it, This line drops into MH1. No other problems to report. This was blocked on arrival so we pulled hose in and jetted to enable us to survey the line. This is the foul pop up (pop up 2) for unit1.

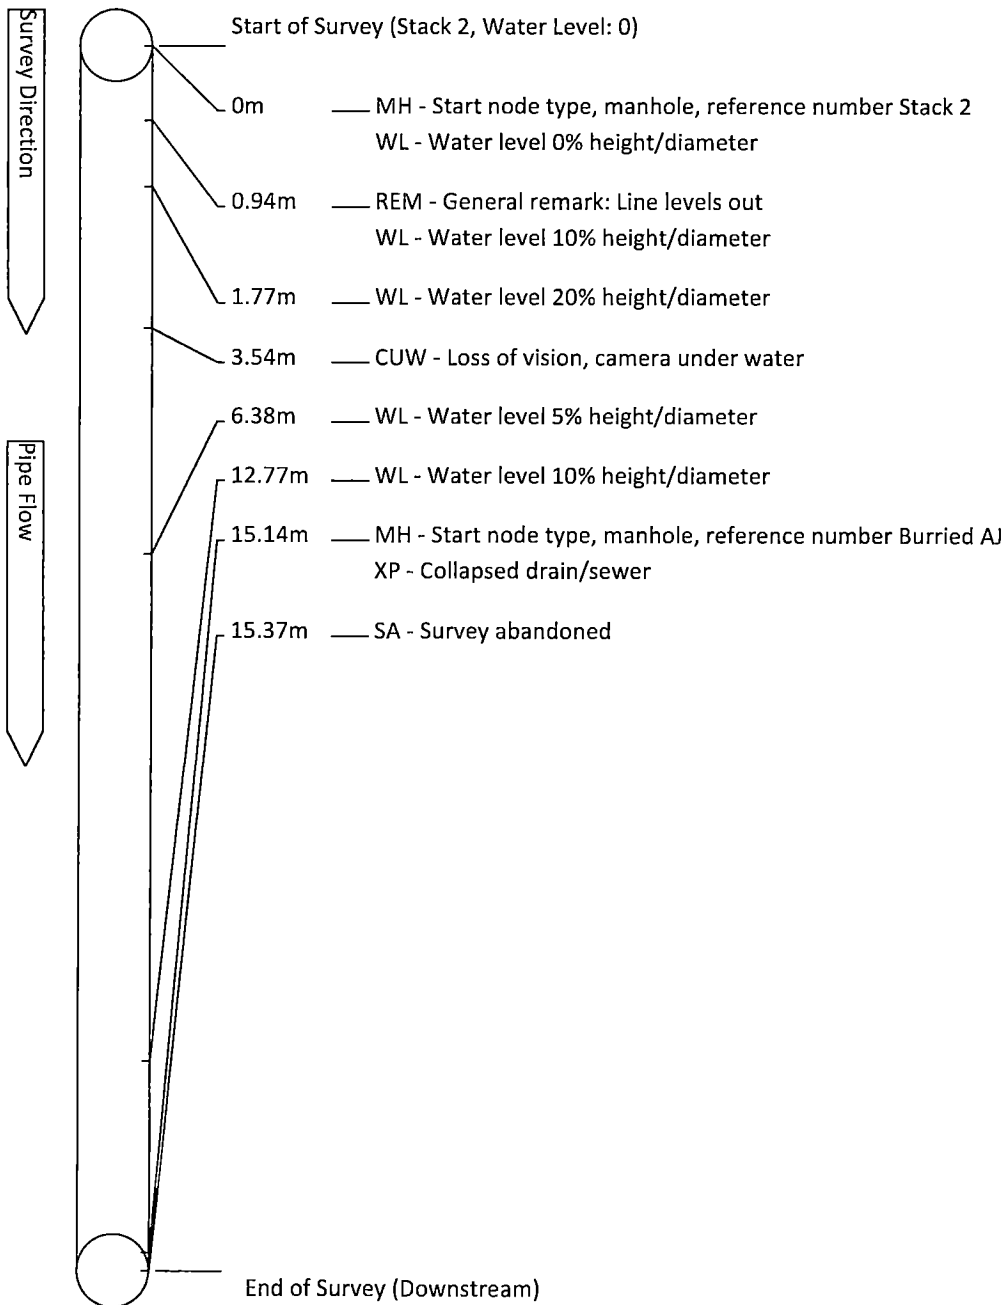
15.14m XP Collapsed drain/sewer. Broke in the AJ

After surveying this line we found that it is holding a WL for the majority of the run with the camera under water for parts of the run. We found that the line runs to a buried A outside the shop and this has a broken pipe in it. It may be collapsed. This is the same area where Popup1 is blocked.

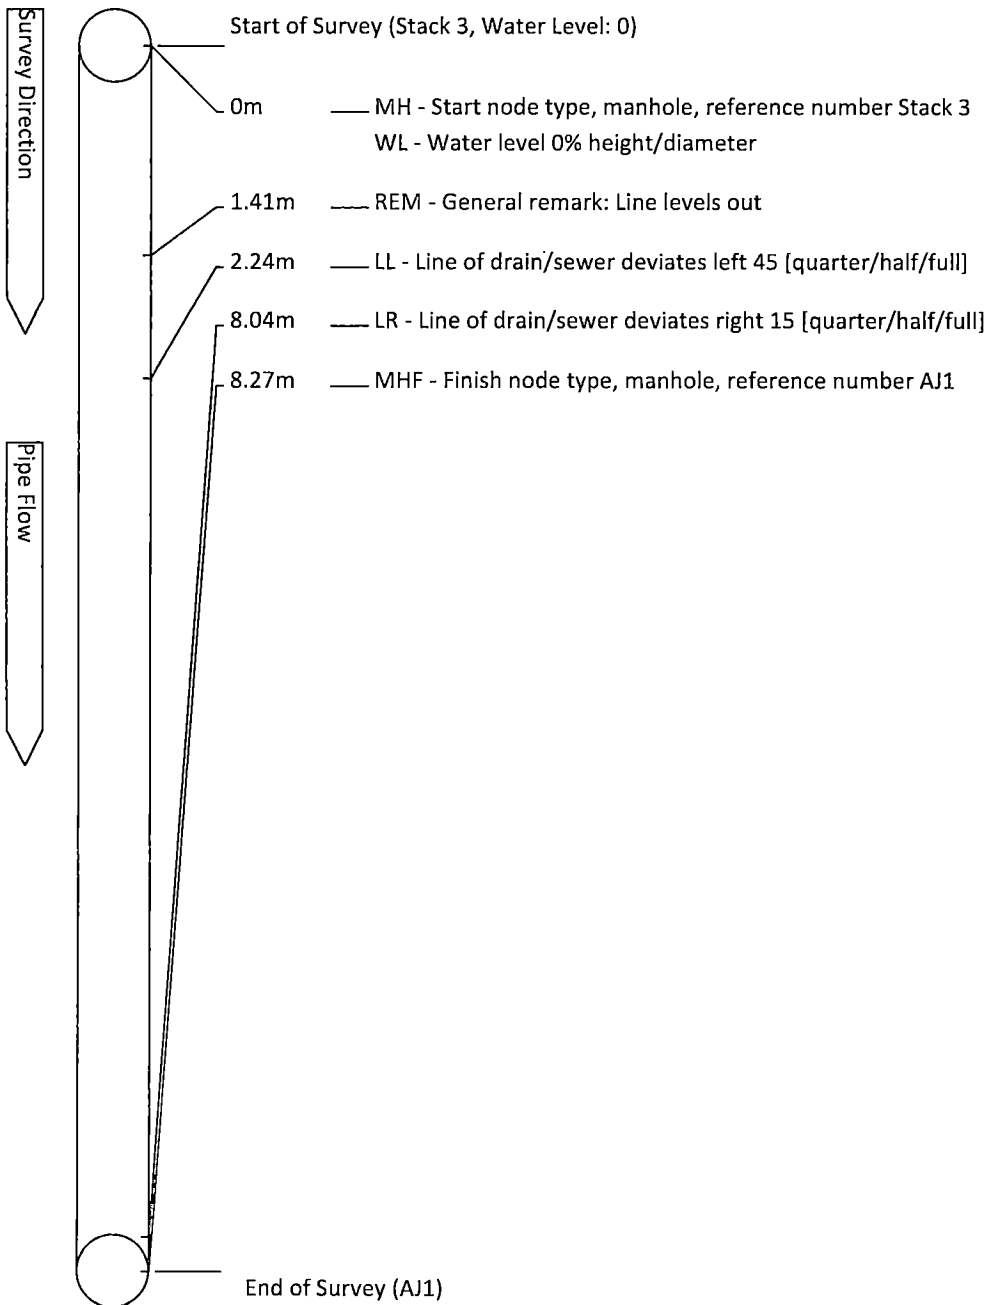
After jetting this line we found that it goes out to an AJ outside. (AJ1). The line is in good condition. No problems to report.
