An Arboricultural Assessment for the Site Area at 'Edmondstown Mill', Edmondstown Road, Rathfarnham, Dublin 16.

Prepared for: Ronan MacDiarmada & Associates Ltd.

Prepared by: Felim Sheridan F. Arbor. A, RFS Dip, Nat. Dip & NCH in
Arboriculture

Date: 25th July 2022

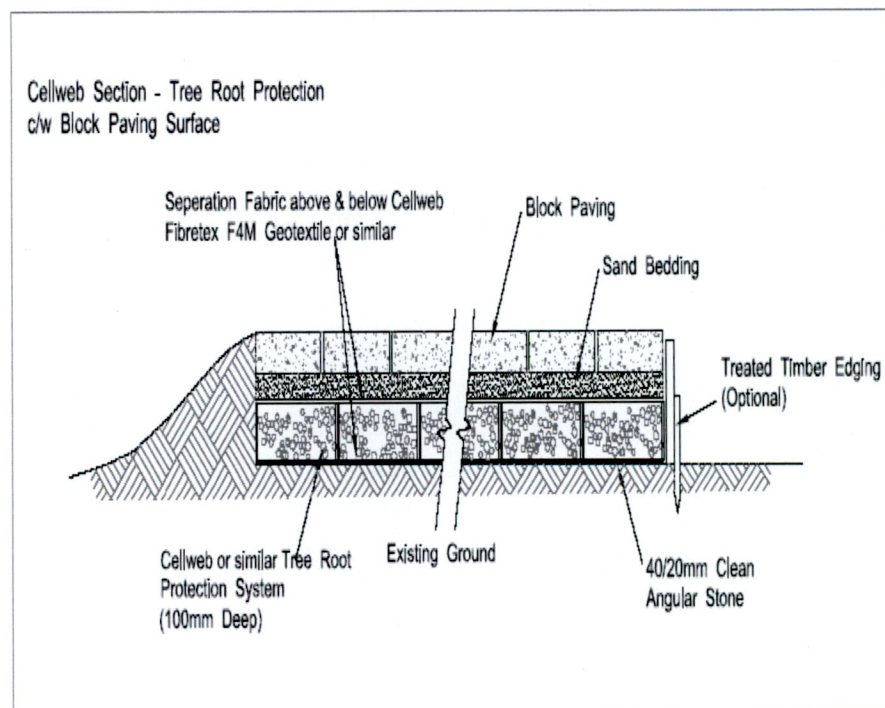
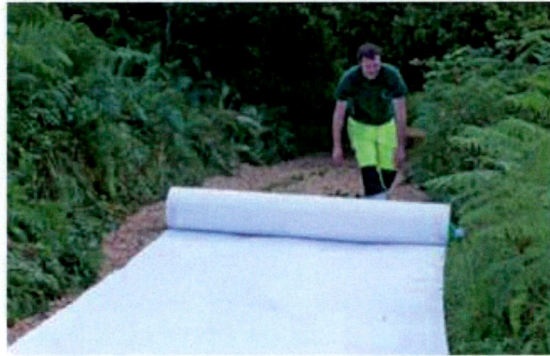
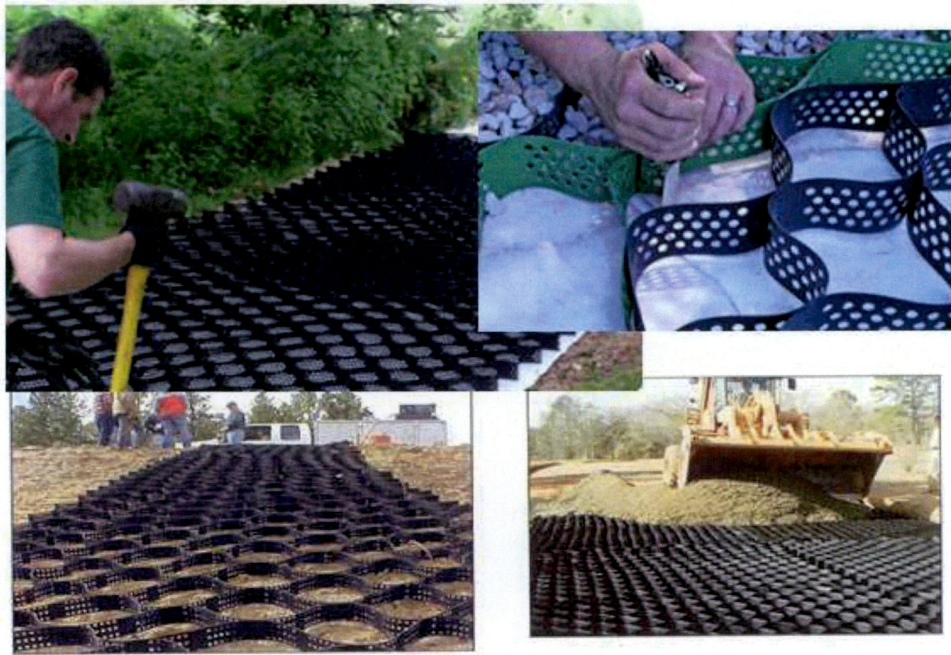
Pictures show the CellWeb being installed on the ground.

Step 6 – Slightly surcharge the Cell Web product with 25mm of 40/20mm clean angular stone and place the finished wearing course over this.

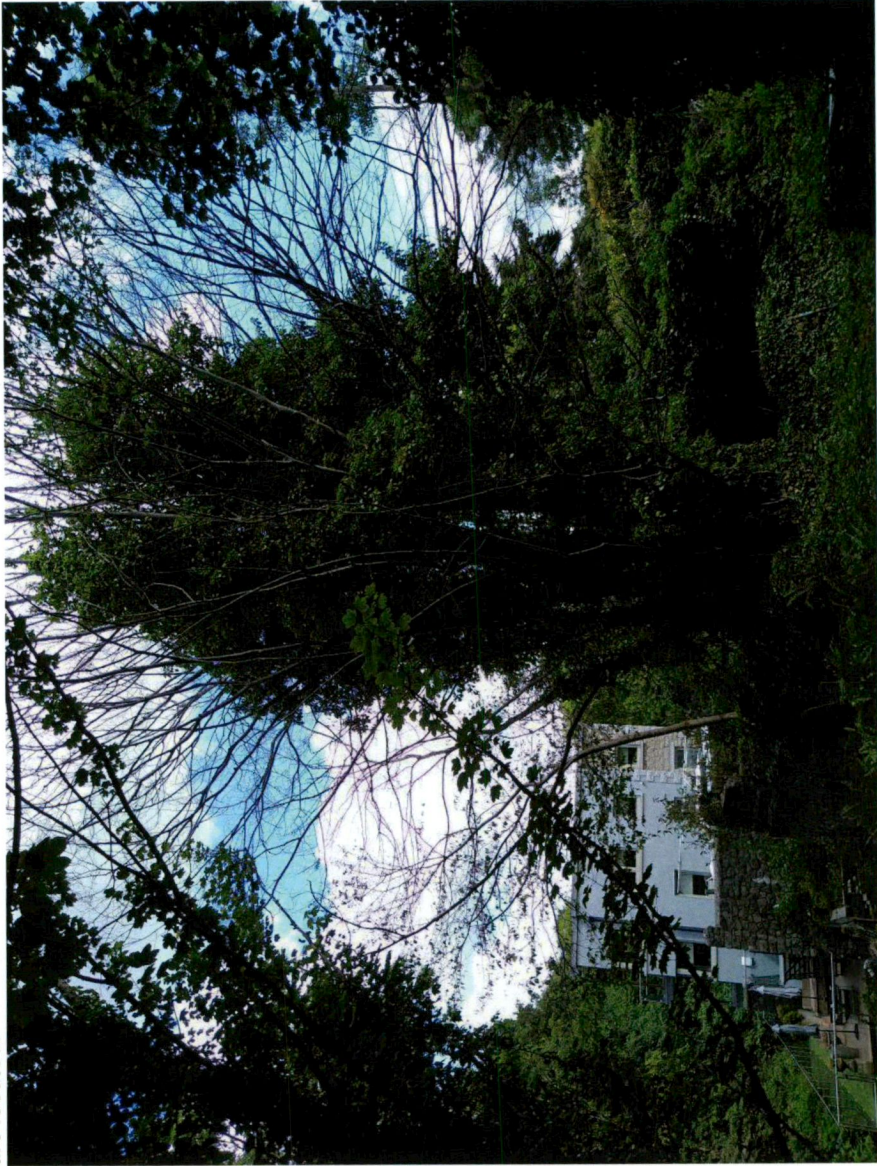
1433 – 1437	Elm <i>Ulmus sp</i>	A14	A	270	6N 6S	A3 A3	Early Mature	Poor A group of five self-sown trees growing up as a	I would recommend their removal as part of	<10	U

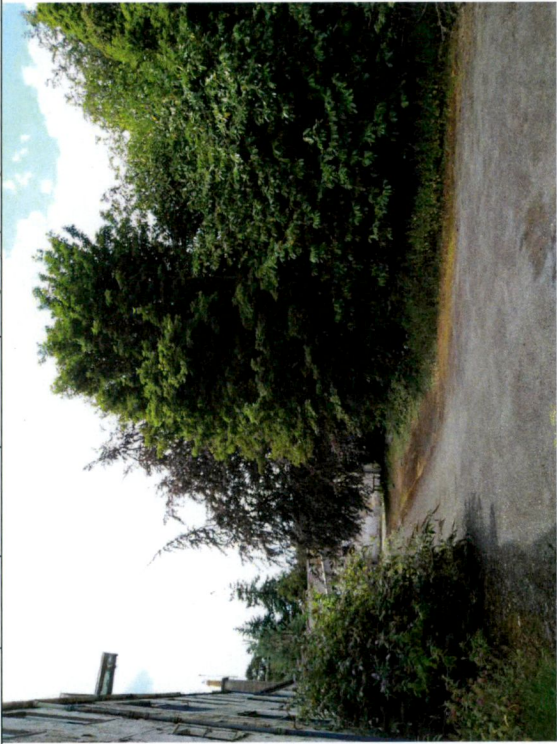
Tree Nos. 1450, 1451, 1452 and 1453 shown above.											
1450	Cherry Laurel <i>Prunus laurocerasus</i>	14	A.200 X 7 stems	9N 4S 5E 8W	1	Mature	Fair	Fair/Poor A multi -stem tree from near ground level growing on the side of the steep riverbank and its stability at this size on the bank is a concern. It has a large spreading crown which is suppressing neighbouring vegetation and it extends out over the river bank. Some stems have broken off / cracked opening up the crown leaving it more prone to wind damage.	Retain for now as part of the group bulking of this area. Reduce crown size by 3m and remove lower branches and open up the area and prune in side branches to contain width.	10+	C1

1451	Sycamore <i>Acer pseudoplatanus</i>	16	360/ 310/ 280	2N 6S 7E 1W	3	Early Mature	Fair	Fair/ Poor This tree divides at ground level into three stems growing parallel to each other with an acute union formation between some stems. It has been drawn	Retain for now as part of the bulking of this area. Prune back Cherry Laurel to open up its crown and prune lower	10+	C1

1453	Copper Beech <i>Fagus sylvatica purpurea</i>	16	430	5N 4S 6E 3W	1	Early Mature	Fair/ Good	Fair A single -stem tree, with a somewhat asymmetrical crown due to suppression from neighbouring trees that have been removed / failed in the past. The crown is weighed out to the east over the adjacent circulation area. It has potential to form part of the longer-term cover on the site.	It would benefit from some formative pruning on the eastern side to rebalance the crown and to improve ground clearance.	20+	B1
Tree No.1	Sycamore <i>Acer pseudoplatanus</i>	12	#320	2N 2S 2E 3W	10	Mature	Fair/ Poor	Poor. Growing on a steep river bank which will impact on its rooting ability. It was not possible to safely access this tree to fully inspect it due to its position on the embankment. It has been drawn up for light, due to competition from neighbouring trees which were removed in the past.	Retain for now as part of the bulking of this area. Prune in crown to improve its shape/ balance.	10+	C1

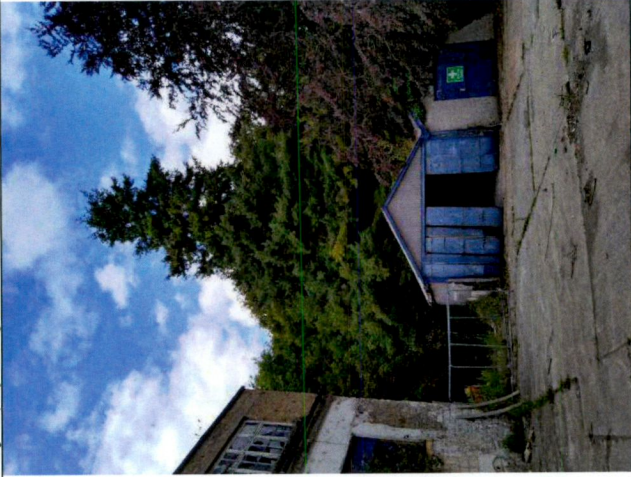
1459	Ash <i>Fraxinus excelsior</i>	12	260	3N 3S 4E 1W	4	Early Mature	Fair	Poor This tree is growing as a pair with Tree No. 1460 which arises at its base. It has been drawn up for light due to competition/ overcrowding from the surrounding trees. There is a lot of material stored around its base. It is growing on a steep bank with concern over its rooting ability and stability.	Remove debris from around its base. I would recommend its removal as part of management in short-term.	<10	U
1460	Horse Chestnut <i>Aesculus hippocastanum.</i>	9	230	2N 3S 7E 0W	1.8	Early Mature	Fair	Poor Growing out from the same base as Tree No. 1459, with a very pronounced lean to the east and this raises concerns over its rooting ability and stability. It extends out over adjacent buildings and	I would recommend its removal as part of management.	<10	U

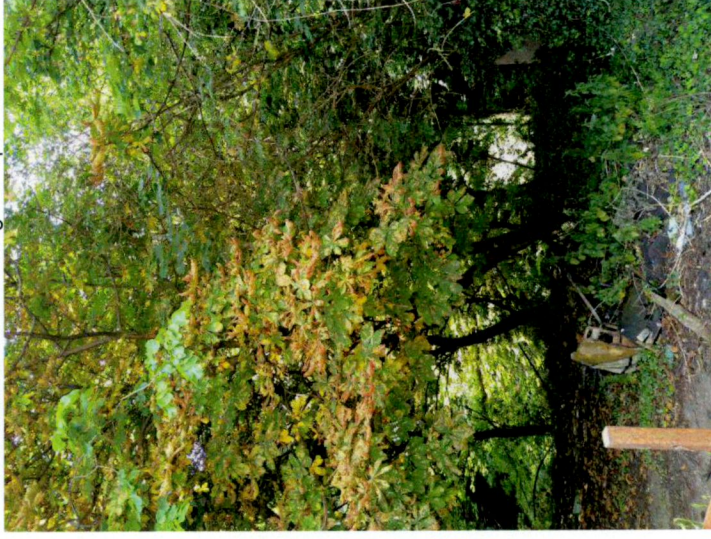
1461	Horse Chestnut <i>Aesculus hippocastanum</i>	15	300	4N 4S 7E 1W	6	Early Mature	Fair	Poor This tree is growing out of the river bank with a lean to the east towards nearby buildings raising concerns over its rooting ability and stability. It has been drawn up for light due to competition from the surrounding trees and it is quite suppressed on the western side as a result. The main stem divides at a height of c. 7m into two co-dominant stems. Ivy	I would recommend its removal as part of management.	<10	U
