## Refurbishment & Demolition Asbestos Survey

Site Address	<b>“St. Francis” Owendore Ave. Rathfarnham Dublin</b>
Site Location

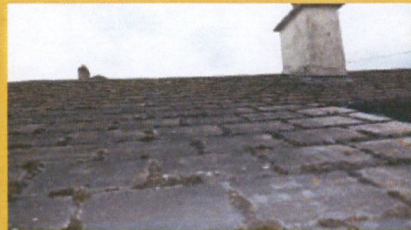
Ref:	<b>Confirmed Asbestos</b> [Requires removal and disposal as asbestos waste by a competent asbestos contractor prior to demolition.]
1	Asbestos containing slates to main roof. Circa 75/80 square meters.
2	Asbestos cement sheeting to canopy ceiling on porch. Circa 2 square meters.
6, 7, 10, 13, 16	Asbestos cement sheeting lining internal walls and partitions in the living room, kitchen, lower corridor and two bedrooms. Circa 90/95 square meters.

Ref No.	Building or Area of Site	Location or Functional Space	Sample No.	Material Description, surface treatment and condition	Extent	Asbestos identified (presumed, strongly presumed or identified)	Product type	Condition	Surface treatment	Asbestos type	Material assessment score	Recommendations	Photo
1.	St. Francis Owendore Ave.	Roof	2224401	Slates	Circa 75/80 SM	Chrysotile						Removal and disposal as asbestos was by a competent asbestos contractor prior to demolition.

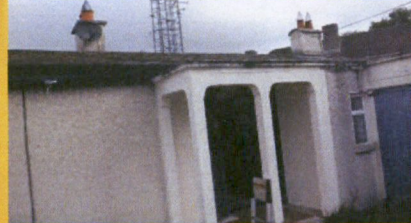
2.	St. Francis Owendore Ave.	Porch canopy Ceiling	2224402	AC sheeting	Circa 2 SM	Chrysotile						Removal and disposal as asbestos was by a competent asbestos contractor prior to demolition.

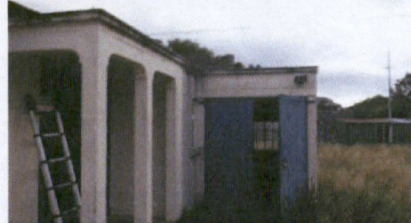
3.	St. Francis Owendore Ave.	Porch canopy		Bitumen asphalt to roof		NAD

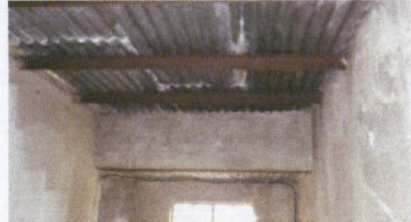
4.	St. Francis Owendore Ave.	Garage		Galvanized sheeting to roof. New mineral felt to back.		NAD

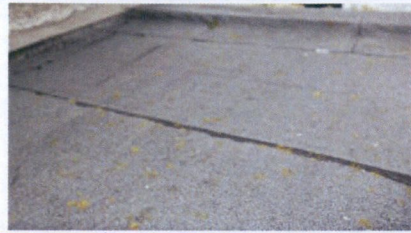
5.	St. Francis Owendore Ave.	Outhouse	2224405	Mineral felt over plywood		NAD

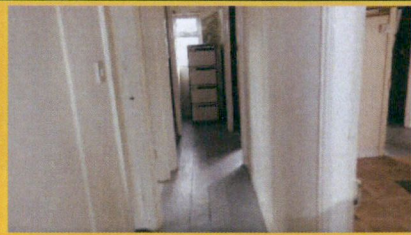
6.	St. Francis Owendore Ave.	Hallway to bathroom		AC sheeting to partition walls	Circa 10 SM	Chrysotile						Removal and disposal as asbestos was by a competent asbestos contractor prior to demolition.

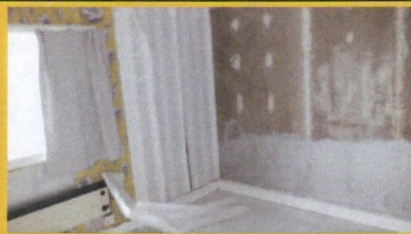
7.	St. Francis Owendore Ave.	Bedroom 1		AC sheeting internal linings	Circa 25 SM	Chrysotile						Removal and disposal as asbestos was by a competent asbestos contractor prior to demolition.

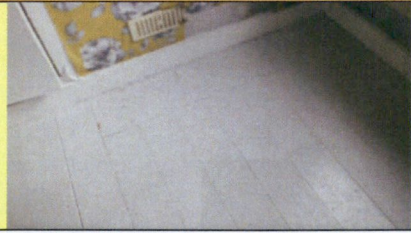
Ref:	<b>Presumed/Strongly Presumed Asbestos</b> [Requires dismantling and/or investigation by the competent asbestos contractor prior to work likely to demolition.]
8, 9, 18	The concrete hearths to the 3 fireplaces are presumed to contain asbestos cement shutters. Monitor during the demolition phase.
15	Immersion and brass instantor fittings on the copper cylinder are presumed asbestos.

8.	St. Francis Owendore Ave.	Bedroom 1		Old concrete hearth may have AC shutter		Chrysotile						Investigate during demolition

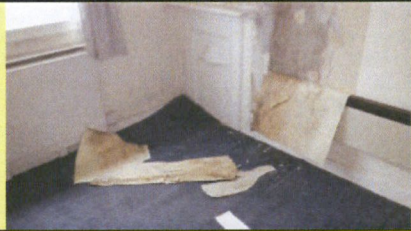
Ref No.	Building or Area of Site	Location or Functional Space	Sample No.	Material Description , surface treatment and condition	Extent	Asbestos identified (presumed, strongly presumed or identified)	Product type	Condition	Surface treatment	Asbestos type	Material assessment score	Recommendations	Photo
9.	St. Francis Owendore Ave.	Bedroom 2		Old concrete hearth in corner may have AC shutter		Chrysotile						Investigate during demolition

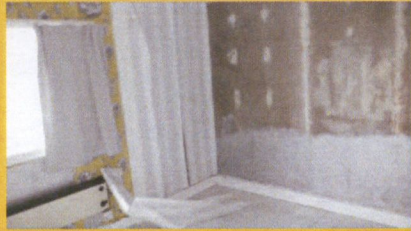
10.	St. Francis Owendore Ave.	Bedroom 2		AC sheeting internal linings	Circa 24 SM	Chrysotile						Removal and disposal as asbestos was by a competent asbestos contractor prior to demolition.

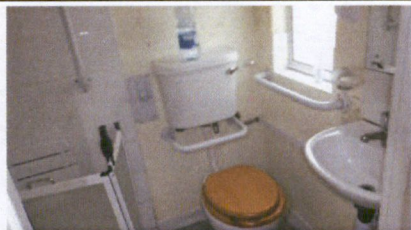
11.	St. Francis Owendore Ave.	Bathroom and bedroom 3		Plasterboard internal linings		NAD

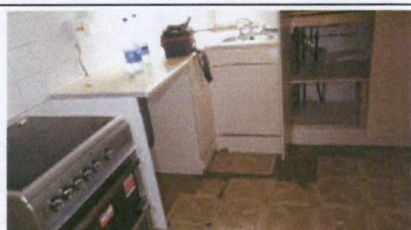
12.	St. Francis Owendore Ave.	Kitchen	2224404	Vinyl tiles and evode		NAD

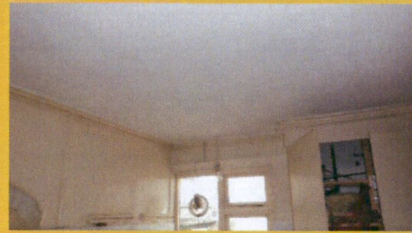
13.	St. Francis Owendore Ave.	Kitchen		AC sheeting internal linings	Circa 20 SM	Chrysotile						Removal and disposal as asbestos was by a competent asbestos contractor prior to demolition.

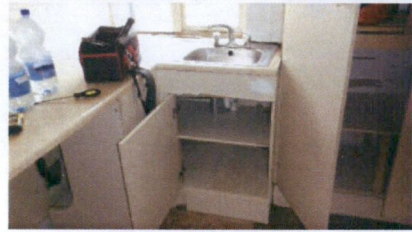
14.	St. Francis Owendore Ave.	Kitchen	2224403	Heat pads to sink unit		NAD

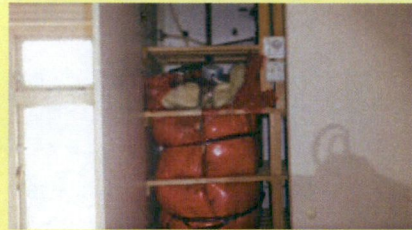
15.	St. Francis Owendore Ave.	Kitchen Hotpress		Flange gaskets to Immersion and brass instantor fittings on copper cylinder		Presumed asbestos						Investigate during demolition.

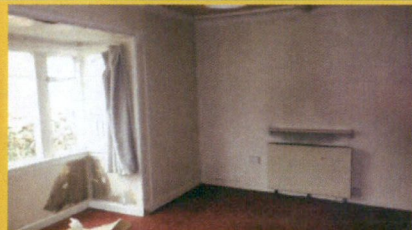
16.	St. Francis Owendore Ave.	Living room		AC sheeting internal linings	Circa 32 SM	Chrysotile						Removal and disposal as asbestos was by a competent asbestos contractor prior to demolition.

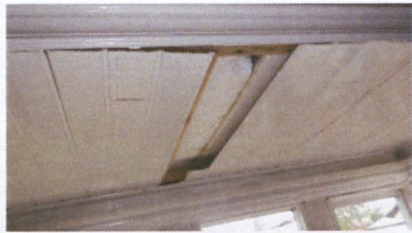
Ref No.	Building or Area of Site	Location or Functional Space	Sample No.	Material Description, surface treatment and condition	Extent	Asbestos identified (presumed, strongly presumed or identified)	Product type	Condition	Surface treatment	Asbestos type	Material assessment score	Recommendations	Photo
17.	St. Francis Owendore Ave.	Living room Bay window		Polystyrene insulation over timber cladding.		NAD

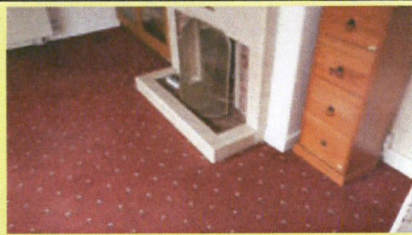
18.	St. Francis Owendore Ave.	Living room		Old concrete hearth may have AC shutter		Chrysotile						Investigate during demolition

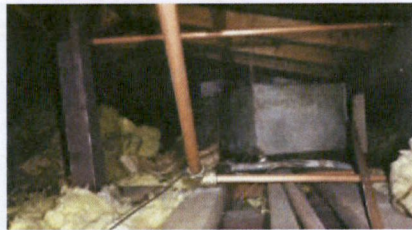
19.	St. Francis Owendore Ave.	Attic		Old galvanized water tank. MMMF between joists over hardboard ceilings.		NAD

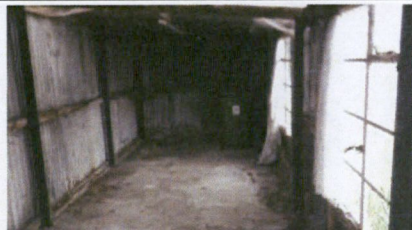
20.	St. Francis Owendore Ave.	Garden Shed				NAD
