SOIL CHARACTERISATION AND SITE SUITABILITY ASSESSMENT REPORT TE REF: 22/206 TE

NICOLA LYNCH & BRIAN DUNNE & CIARA
LYNCH & RICHARD O'FARRELL
LYNBROOK
WHITECHURCH RD
RATHFARNHAM
DUBLIN 16
D16T2P7

SITE CHARACTERISATION FORM FOR AN ON-SITE WASTEWATER TREATMENT SYSTEM

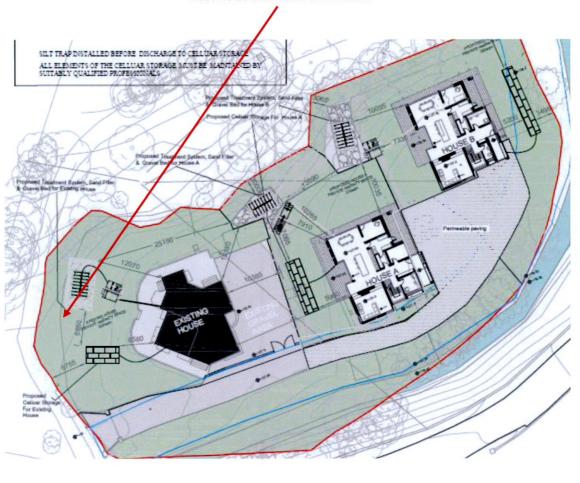
SITE LAYOUT DRAWING SHOWING TEST HOLE LOCATIONS

Approximate Location of Trial Hole & Percolation Test Holes Examined on 24.03.22

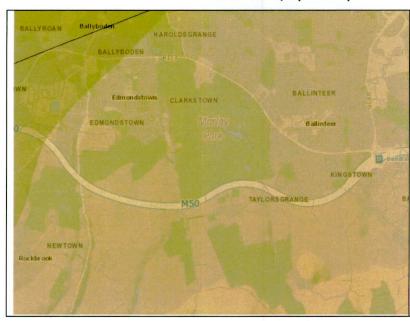
Groundwater/Aquifer Map

From the GSI Groundwater Aquifer Map Site is classified as PI- Poor Aquifer - Bedrock which is Generally Unproductive except for Local Zones

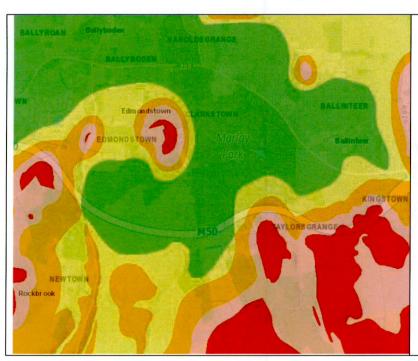
From the GSI Vulnerability Map Site is classified as Low

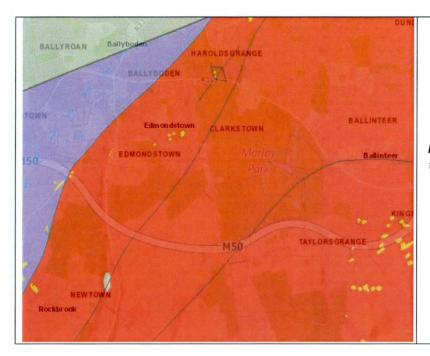
From the GSI Bedrock Map the Site is classified as GII-Granites & other Igneous Intrusive rocks

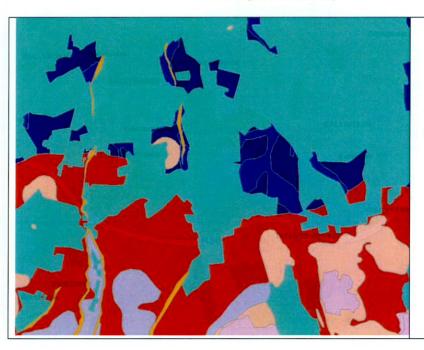
From the GSI Teagasc Subsoil Map Site is classified as Fine loamy drift with siliceous stones
