An Arboricultural Assessment of the Site Area on 'Clonburris SDZ Lands', Cappagh, Dublin 22.

Prepared for: Kelland Homes Ltd. (Planning Applicant)

Date: 4th November 2022

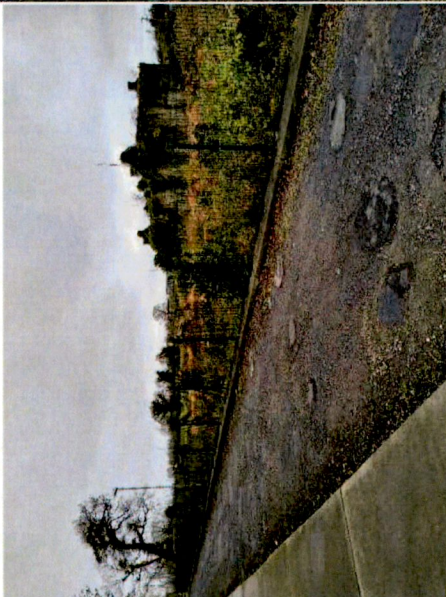
<p>Fair/Poor Originally it formed part of tree and hedge line located along the southern boundary with Whitton Avenue. The rest of the tree and hedge line has been removed leaving this tree in isolation. It leans out to the north before straightening up. It</p>	Cut Ivy at ground level. Remove dead/ unstable growth and carry out pruning to help address imbalance and exposure	10-20	C2

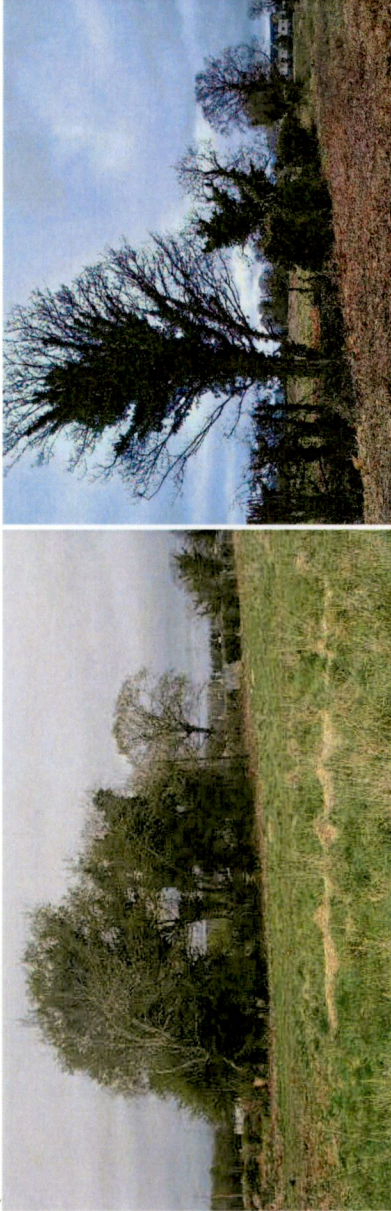
A= Average C-Ht= Crown Height					
1813	Sycamore <i>Acer pseudoplatanus</i>	8	190/ 210	2	3	3	2	2	Semi Mature	Fair / Good	Prune branch stubs back to target pruning points.	20+	C1			
<p>It contains the following trees.</p> <table border="1"> <tr> <td>A2.0</td> <td></td> <td>A1E, A1W</td> <td>-</td> </tr> </table>													A2.0		A1E, A1W	-
A2.0		A1E, A1W	-													
<p>Fair It is growing slightly to the east of the main hedge line and has self-seeded into this location. A twin stem tree from the base with an acute union formation between the stems. The stems are growing in a co-dominant manner and light Ivy growth is extending up the main stems. Lower branches have recently been cut back, leaving stubs.</p>

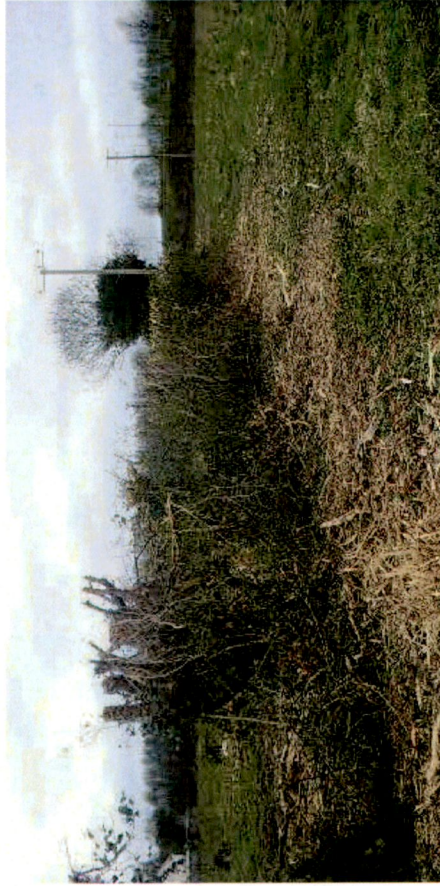
Tree No.	Tree Species	Ht. (m)	Stem Dia. (mm)	Branch Spread (m)					C-Ht. (m)	Age Class	Phys Con.	Structural Condition Other Comments	Preliminary Recommendation	Remain Contribute in years	Cat. Grade			
				N	S	E	W											
1818	Ash <i>Fraxinus excelsior</i>	11	1180	5	5	4	3	2	Mature	Fair	<p>N=North S=South E=East W= West Phys Con. = Physiological Condition.</p> <p>Fair / Poor</p> <p>Growing above the general hedge line and is a single stem tree to c.3m where it divides into two co-dominant stems. It has been topped in the past to clear the adjacent overhead power line to the north east, affecting its structure. It is re-growing from the cut points and will require ongoing management to maintain clearance. Very heavy lvy growth extends high into the crown increasing the wind sail. There is recent mechanical damage to the base of the tree on the south east side.</p>	<p>A= Average C-Ht= Crown Height</p> <p>Cut lvy at ground level.</p> <p>Cut broken stems back to proper target pruning points.</p> <p>It will require further management to maintain clearance with the overhead utility lines.</p>	10+	C1

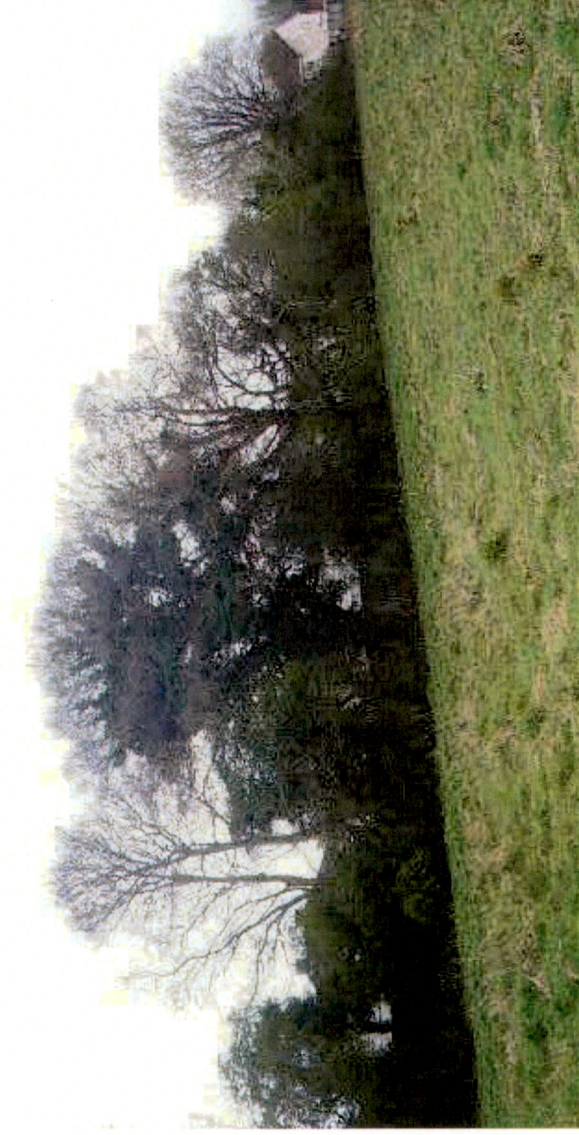
1819	Ash <i>Fraxinus excelsior</i>	19	1100	8	9	10	7	6	Mature	Fair	Fair	Remove dead/ unstable growth and prune in heavy end loaded side limbs/ branches by 1-2m	10-20	C2														
		<p>assessment. There is a dead Elm tree at the base. Cut Ivy at ground level.</p>

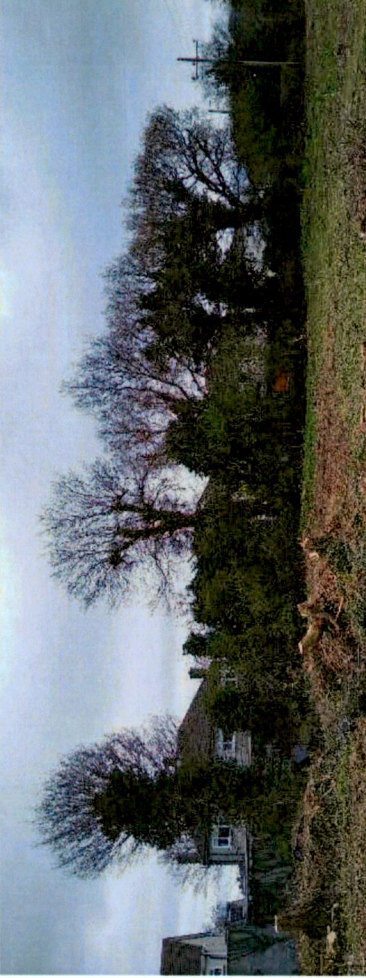
<p>It is of a mature age class in fair condition both physiologically and structurally. There is a deep, water filled, ditch located immediately to the west of this hedge, which prevents access from the site side. It is mostly continuous along its length and has been allowed to grow unmanaged for some time. It forms part of a longer hedge line and contains a number larger trees along its length. It consists mainly of clumps of Hawthorn and Elder with Bramble colonizing.</p>										
	Bramble <i>Rubus fruticosus</i>													
		A4.0		A2E, A2W			-
