TREE & VEGETATION SURVEY, ASSESSMENT, MANAGEMENT & PROTECTION
MEASURES
FOR

Lidl Newcastle

CLIENT: Lidl Ireland GmbH

November 2022

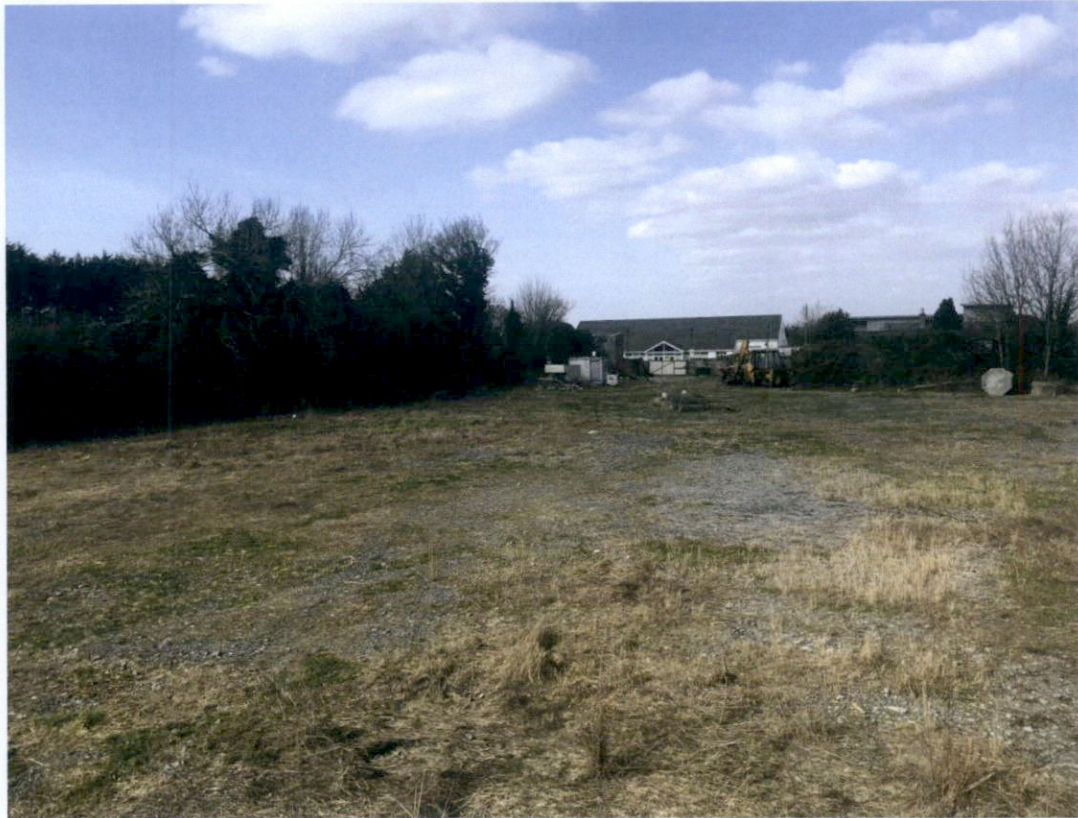
Figure 1: northern part of the site looking north across the yard, the western hedgerow, hedgerow 03 is visible to the right-hand side of the image

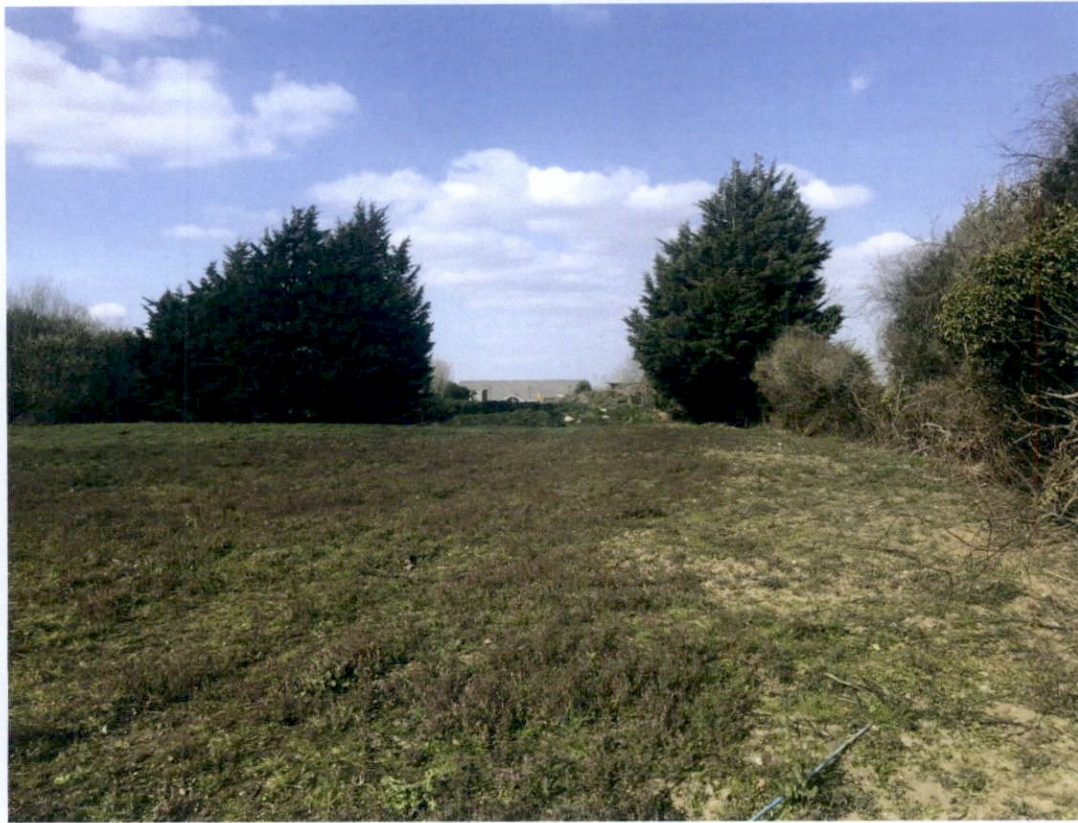
Figure 2: Southern part of the site looking north, Leyland Cypress X Cuprocyparis visibly, mound partially visible between the Leyland Cypress X Cuprocyparis leylandii

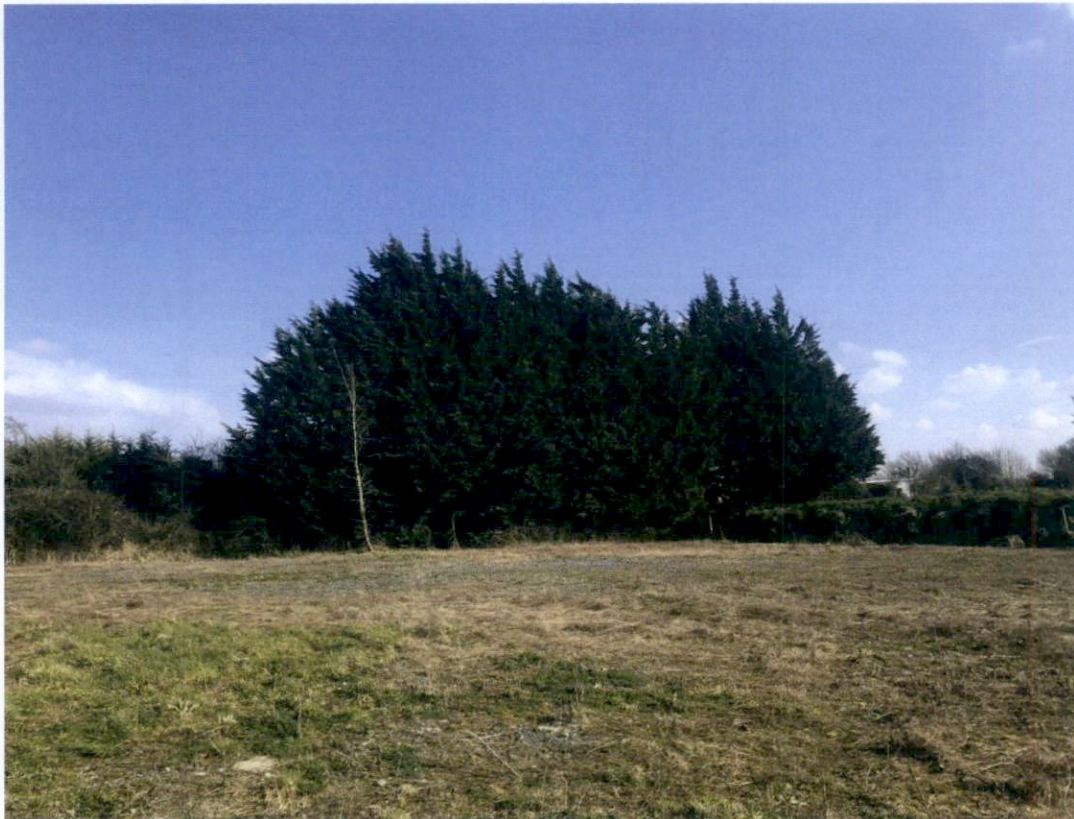
Figure 3: Leyland Cypress X Cuprocyparis Tree Group 01 on the eastern boundary

Tree Group 01 is a linear group of large spreading Leyland Cypress *X Cuprocyparis leylandii*. The group is growing east to west.

Impact of the development: The Lidl building and car parking access road will be located within the root protection area of these trees.

Action: Remove

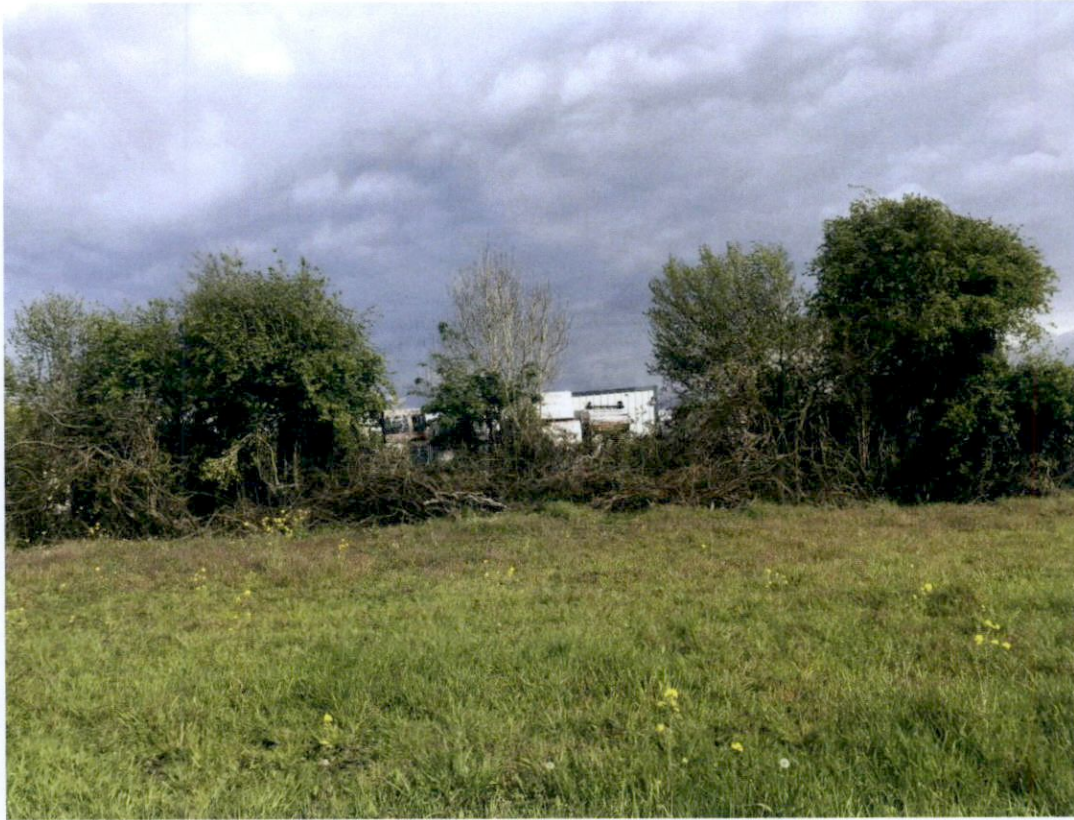
Figure 4: Eastern boundary, southern part, hedgerow 02, this hedgerow is somewhat scraggy with cut brush in the hedgerow, it needs to be cleaned out and augmented with supplementary native planting

Hedgerow 03 is located on the Southern part of the Eastern boundary. Species are *Fraxinus excelsior* Ash and *Crataegus monogyna* Hawthorn and Blackthorn *Prunus spinosa*. The hedge is quite sparse in places and needs augmentation.

- Tree protective fencing will be placed to prohibit access within the RPA of the hedgerow and protect the above and below ground parts of the hedgerow.
- The excavations for building foundations and building construction will be supervised on site by the project Arborist.
- Any local removal of hedging will be supervised by the project Arborist and suitable replacement planting will be planted.

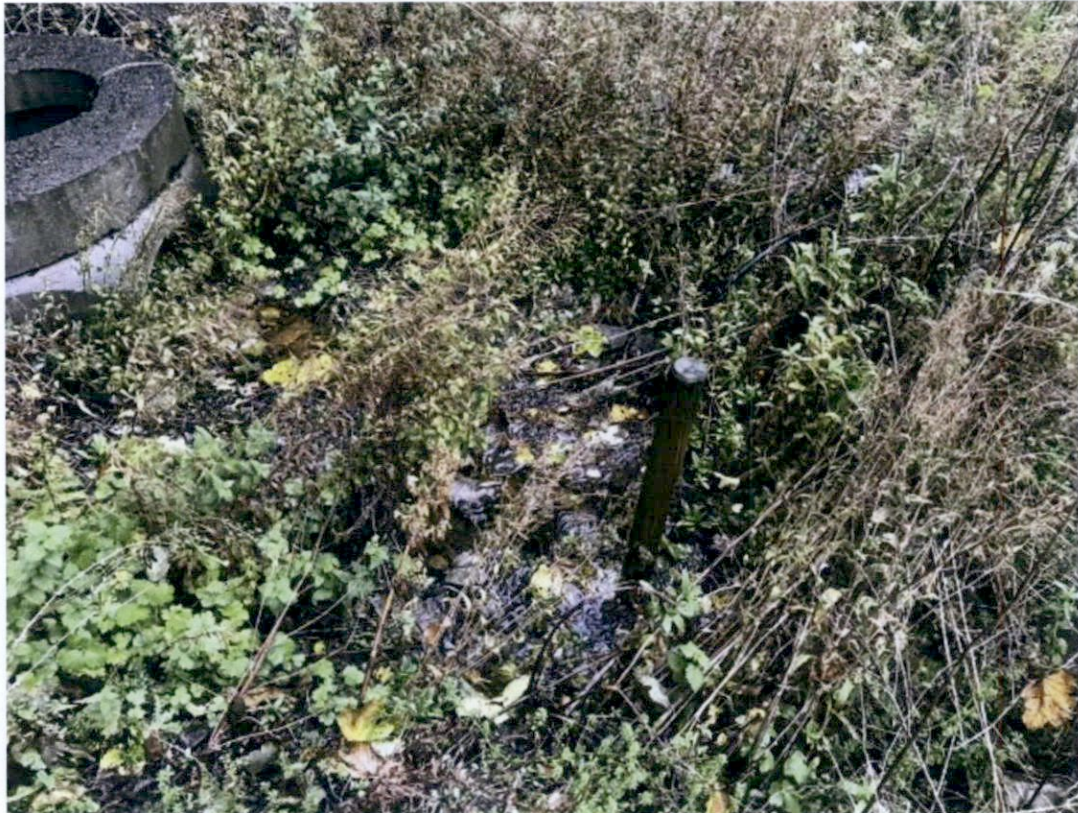
The Spring is currently open with a concrete ring and culvert. See figure 1 and figure 2 below. It is now proposed that this spring area be left open and planted with riparian perennial species. Please refer to the landscape plan 077622_LP_01 for further details.

The culverted area cannot be daylighted without risking damage to the nearby Burgage Plot hedgerow. The Culverted watercourse is within the root protection area of hedgerow 02 and the opening up of the culvert would damage the roots of this hedgerow. This damage to the roots would see degradation to the above ground parts of the hedgerow and would be detrimental to the Burgage Plot hedgerow.

The location of the existing culvert is well within the RPA of the hedgerow, up to 6.0 m within the RPA of the large Sycamore, tree no. 1794. Daylighting of

Figure 5: Open spring with concrete ring and culvert to left of image

the culvert would require excavation well within the RPA of the trees and hedgerow. It would not be good arboricultural practice to damage this root growth by daylighting the culvert. Therefore, the design team does not consider this approach appropriate.

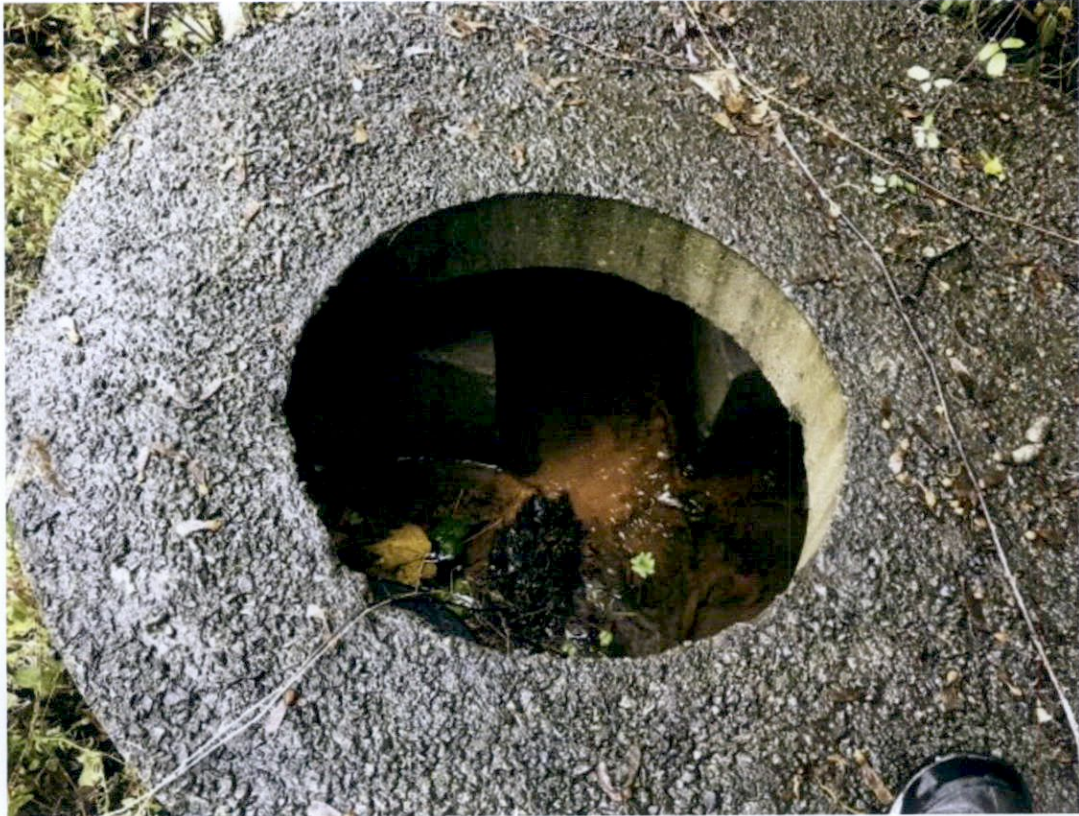
Figure 6: Concrete ring and culvert
