ARBORICULTURAL METHOD STATEMENT

TREE PROTECTION PLAN

Church of Scientology & Community Centre of Dublin, Firhouse Road, Tallaght, Dublin 24

20th January 2023

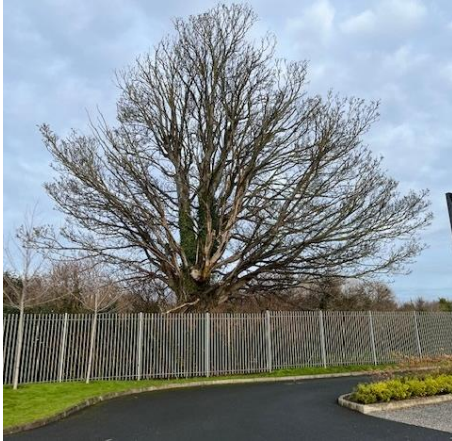
2.4 Tag No.0805 has a large bark wound at base on its western side that equates to c.40% of the trunk circumference and to a height of c.3m. The wound is infected by brittle cinder fungus (*Kretzschmaria deusta*), with extensive decay developing into the underlying timbers and large size dead wood in the crown, some of which has already fallen into the adjoining car park.

Tree No.0805 from the car park

I would recommend that this tree be reduced to a 2.5m tall stump and retained for its ecological value whilst addressing the apparent risk towards the car park and proposed new entrance.

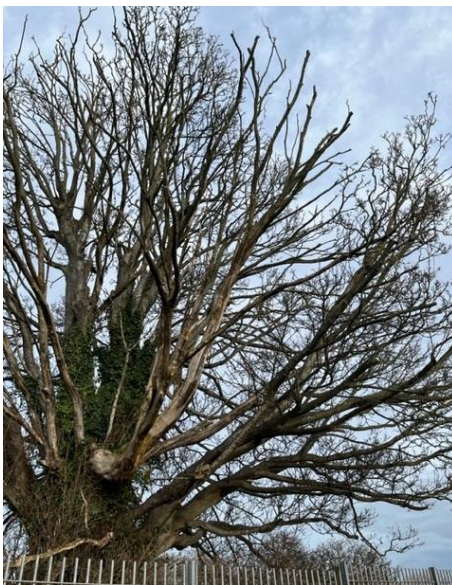
Large dead wood in Tag No.0805 overhanging the car park

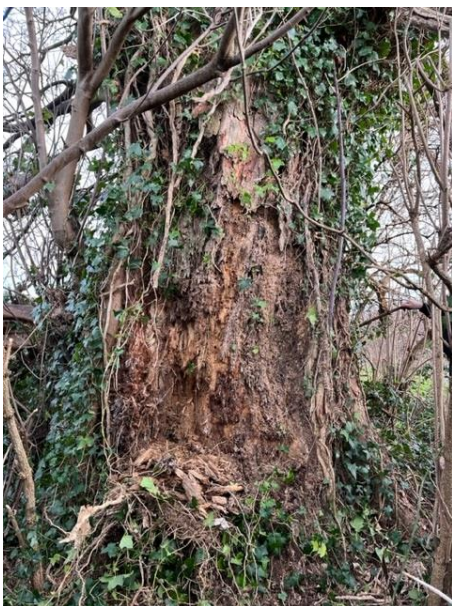
Extensive basal decay in Tag No.0805
