# Arboricultural Report

Tree Survey  
Arboricultural Impact Assessment &  
Arboricultural Method Statement

**Glenside House**  
**Glassamucky**  
**Bohernabreena**  
**Dublin 24**

**220822-PD-11**

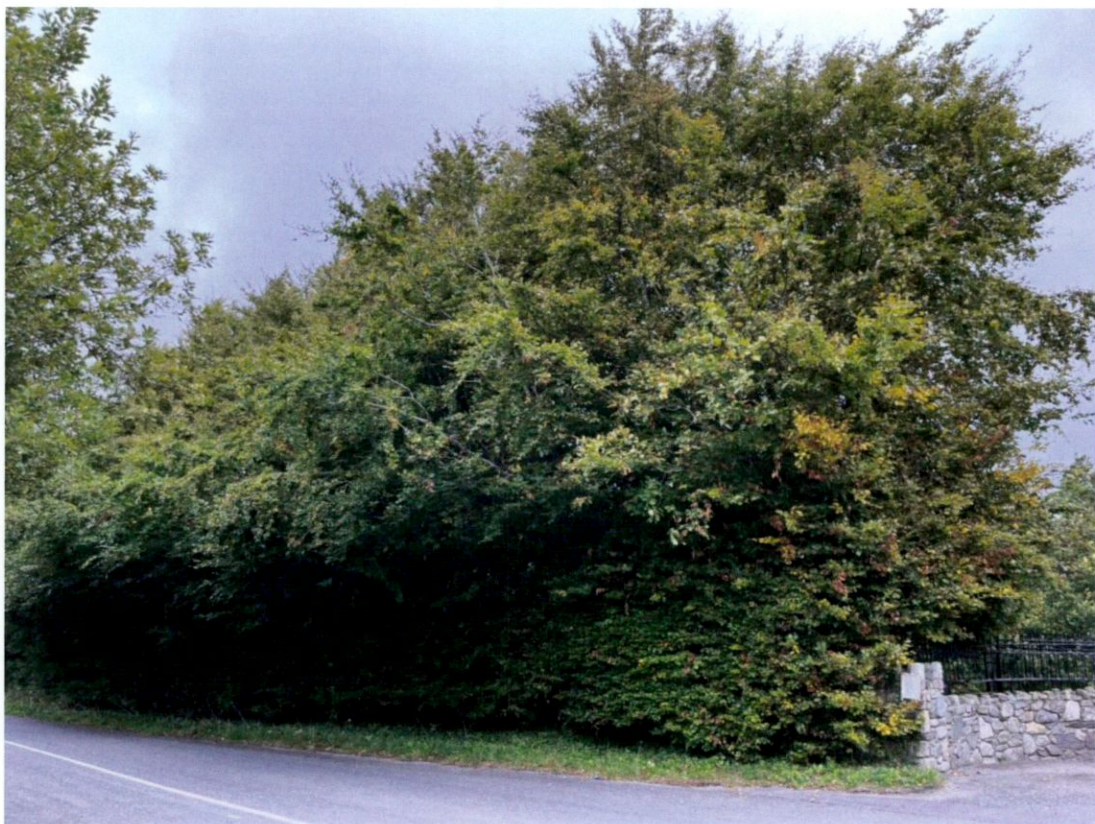
**Image 1:** View of the early-mature beech trees (G1) located along the western boundary of the site, adjacent to the road.

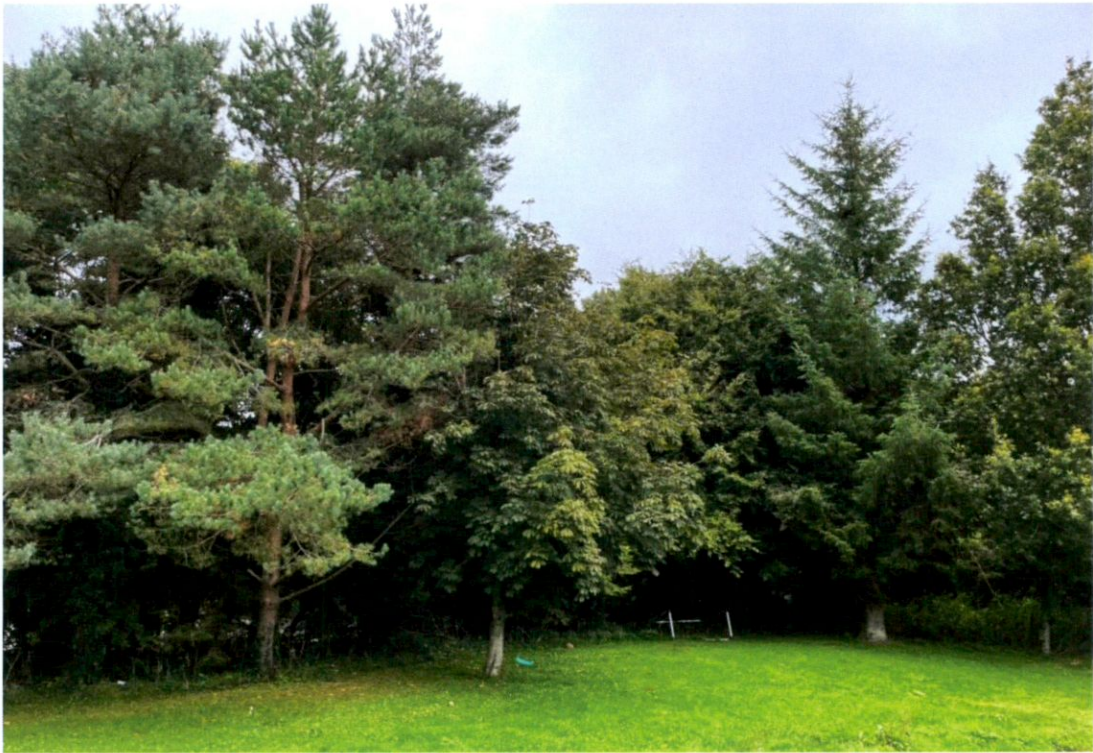
**Image 2:** View of the moderate-quality mixed woodland group (G2) located along the site's northern boundary.

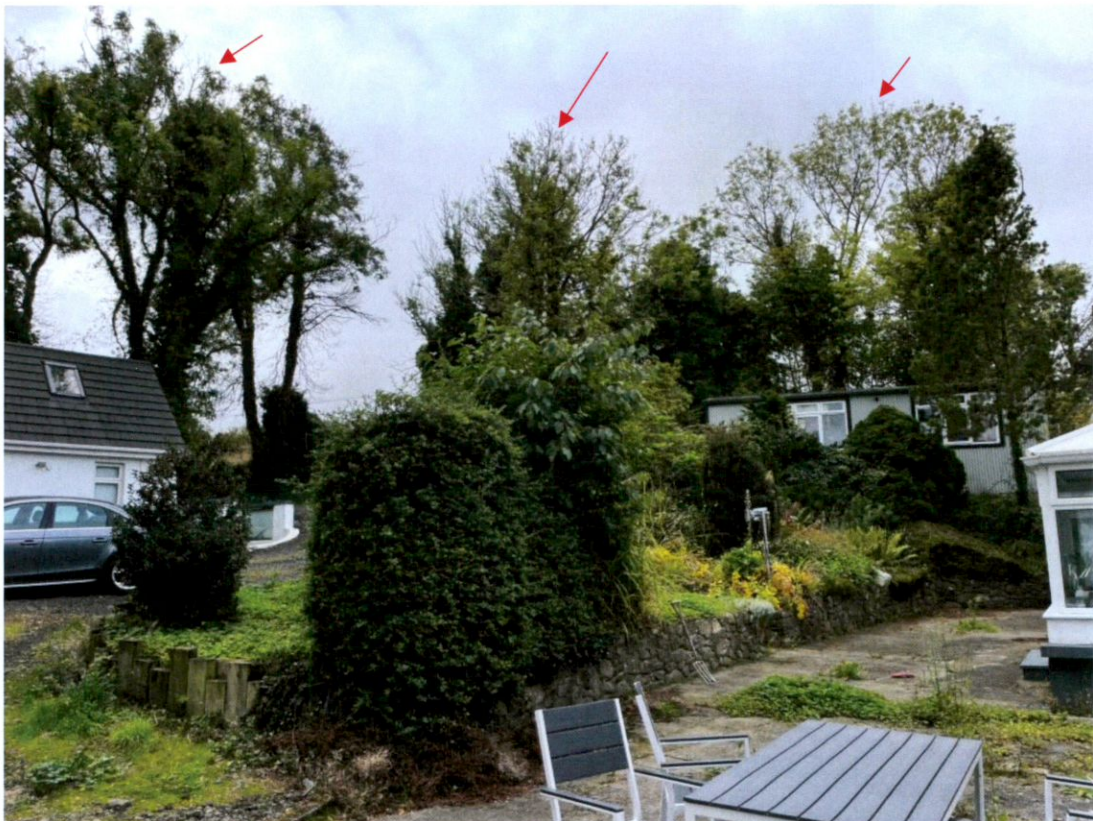
**Image 3:** View showing the rear garden of the site with the surrounding ash trees that are in poor condition and infected with ash dieback. The red arrows indicate the dieback observed in the upper canopies of the trees.

- 3.5 **Arboricultural management works** – Several of the trees on the site are in poor condition and require remedial works to be carried out for health and safety purposes. Two trees, a dead ash (T10) and a horse chestnut (T809) in poor condition, have been recommended for removal, while crown reduction works have been recommended for several of the declining ash trees that are located adjacent to existing buildings and the public road.

- 3.6 Given the poor condition of trees on this site, it is recommended that they are monitored by a suitable professional on an annual basis.
- 3.7 All proposed tree management works have been specified within the Tree Schedule at Appendix A. Their location within the site is shown on the Tree Protection Plan at Appendix B.

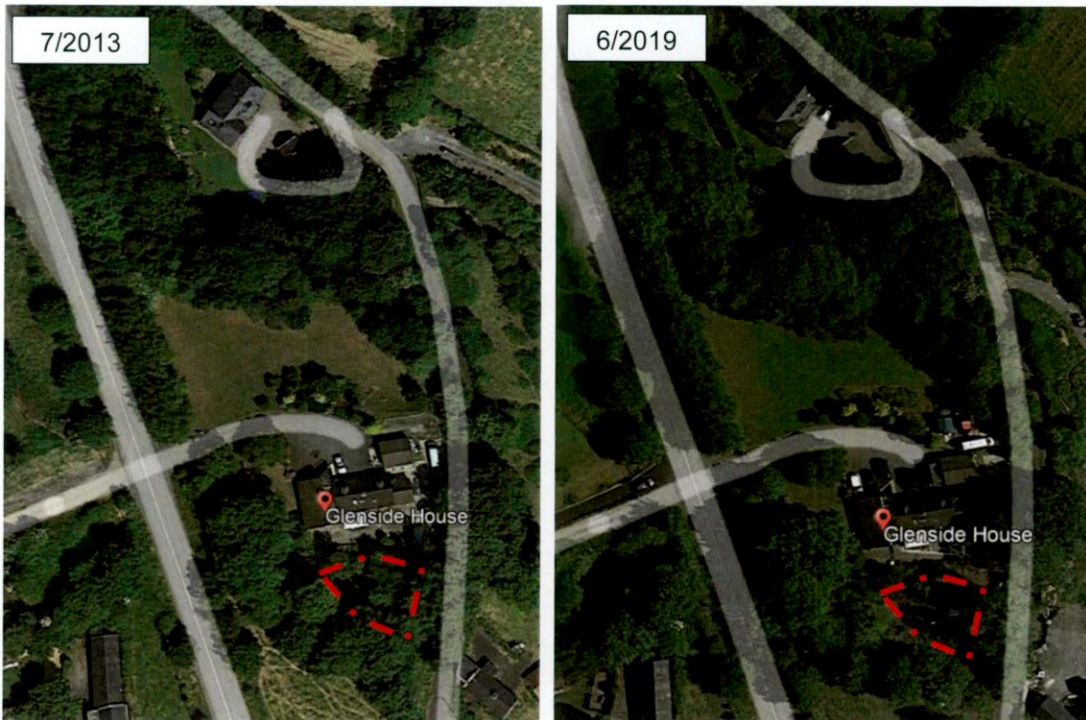
- 2.10 The extent of trees removed in the last 7 years accounts for approximately 165m<sup>2</sup> of canopy cover. The exact number of trees removed or their species type and age could not be determined during the site visit as no stumps were remaining.
- 2.11 This assessment has been made by comparing the difference in canopy cover between aerial images available on Google Earth (Images 4 & 5).
- 2.12 Considering the existing tree cover within this area of the site, the species most likely removed are ash and possibly some hawthorn.

**Images 4 & 5:** Comparison of Google images from the summer of 2013 and 2019. The dashed red line indicates the approximate area that trees were removed from.

- 3.3 **Arboricultural mitigation** – To mitigate the loss of these trees, a detailed landscape proposal, that includes new high-quality tree planting, has been prepared by Landscape Architects Landmark Design & Consultancy Ltd.

- 3.4 The proposal includes the planting of 15 semi-mature trees. As these trees mature, they will replace the canopy cover that was lost within the last 7 years. The species choice will also improve the diversity of tree cover on the site.
