Independent Tree Surveys Ltd

Tree Survey & Planning Report  
SDZ Residential Development  
Clonburris  
Newcastle Road  
Adamstown  
Dublin

January 2023

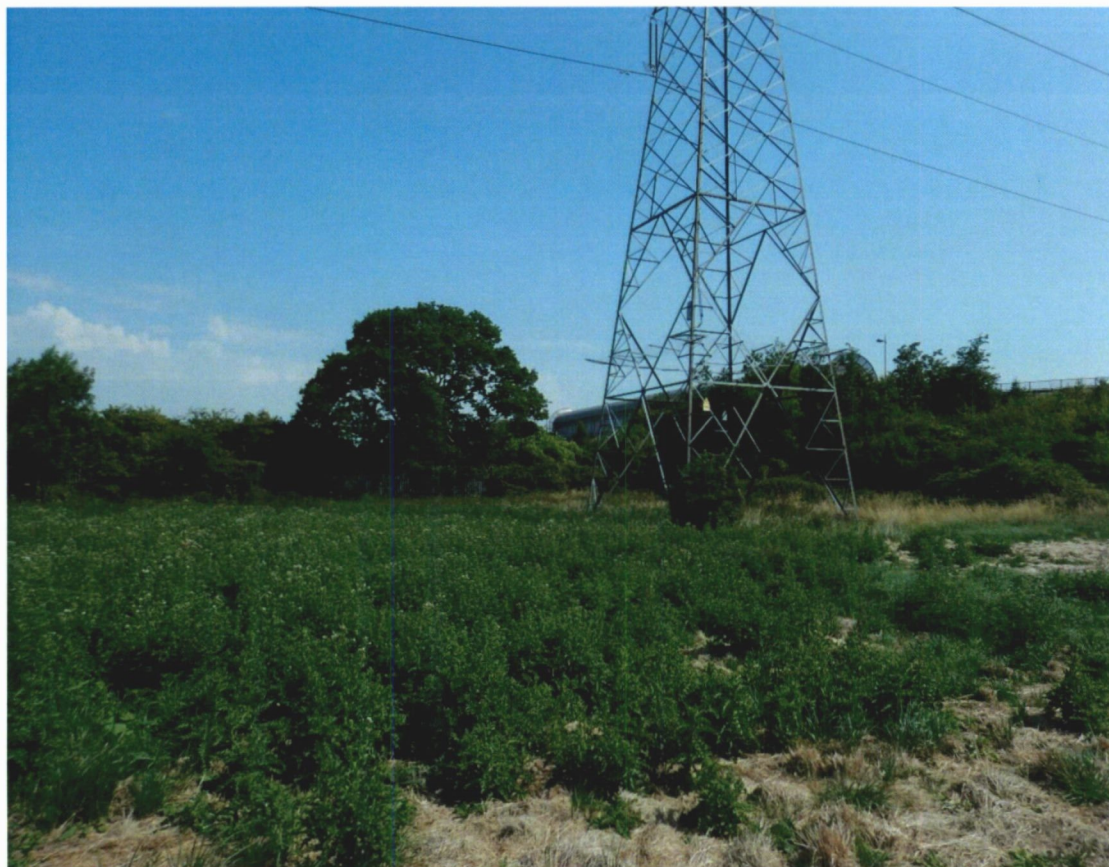
1. Mature Oak T1 next to the railway fence in the north eastern corner of the site

Type	No.	Species	Age	Ht m	Dbh mm	St	Cr	N	S	E	W	ERC	Phys Cond	Structural Condition/Comments	Preliminary Recommendations	RPA m	Cat
T	1	Quercus robur (Common Oak)	M	12	781	2	1.5	5	8.5	7	9	20+	Fair	Fair. Mature Oak tree growing out of bank approx. 3m north of railway fence. Tree not accessible so stem diameters estimated. Spreading form with some long extended limbs. Some deadwood in crown. Crown health and density seems fair for species and age class.	No need urgent works seen, however a closer inspection of stem base to check for any obvious structural defects is advised.	9.37	B2
T	2	Ulmus glabra (Wych Elm)	EM	10.5	350	1	1	4	3.5	3.5	3	10	Fair	Fair. Elm tree in hedge surrounded by dense undergrowth. Upright form. Thick Ivy growth on tree stem. Possible early signs of Dutch Elm disease (DED), with slight discolouration of some foliage.	Monitor foliage density and colour to check for signs of Dutch Elm disease; coppice if disease confirmed.	4.2	C2

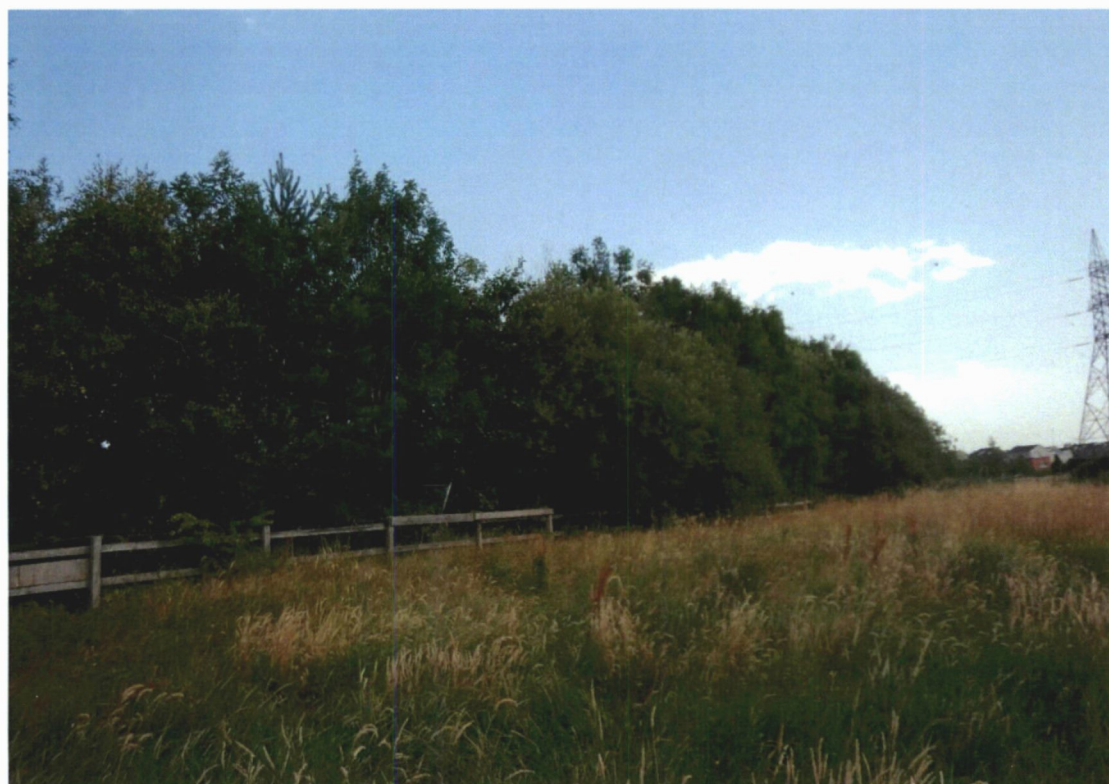
Extensive tree planting (forming woodland W1) was undertaken along the road frontage with Newcastle Road along the north-western boundary of the site; these young trees are now well-established but are overstocked and crowded.

2. Young plantation W1 along the road frontage with Newcastle Road; viewed from the south, inside the site

W	1	Betula pendula (Silver Birch) Fraxinus excelsior (Ash) Salix caprea (Goat Willow) Pinus sylvestris (Scots Pine) Alnus glutinosa (Common Alder)	SM	10	<100 to 200	1	1	2.5	2.5	2.5	2.5	10+	Fair/Poor	Fair. Young mixed species plantation along the road frontage of the site to the north of Hayden's Lane. Densely stocked plantation with the young trees at 1-2m spacing. No evidence of any thinning or re-spacing having been done. Crown dieback due to ADB amongst Ash stems. Some tree ties still around tree stems in plantation.	Carry out selective thinning of plantation to remove weaker and poor quality stems. Remove remaining tree ties.	2.4	C2 U

The bulk of the roadside plantation W1 will also be removed, with the northern part being retained within the new layout. The 5 semi mature Ash trees belonging to group G1 along Newcastle Road will be removed as the road layout is altered.

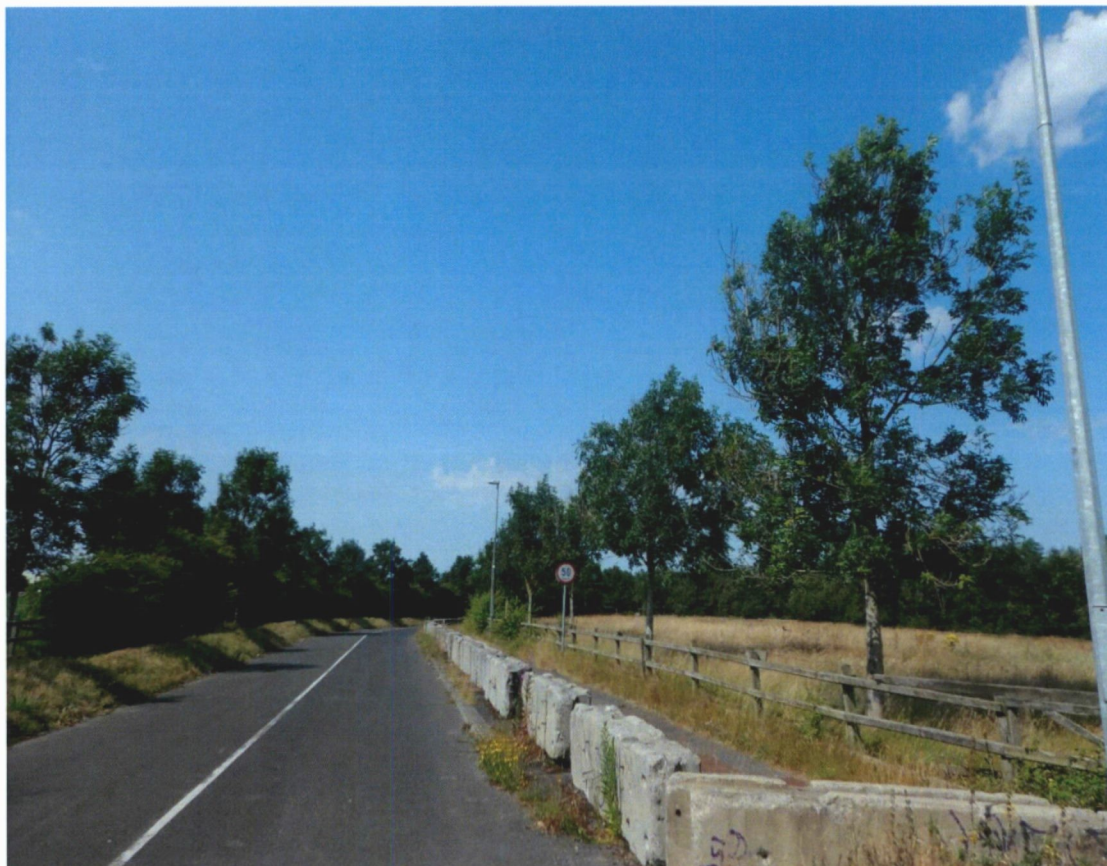
The avenue of young Ash trees (group G1) and Hawthorn understorey planted along Hayden's Lane is also now well established, however a number of the Ash trees along the western part of the avenue are showing clear signs of Ash Dieback disease (ADB). Interestingly, the trees making up the eastern part of the avenue are showing far fewer signs of the disease at the present time.

3. Avenue of young Ash trees along Hayden's Lane (G1), with signs of crown dieback caused by Ash Dieback disease

Type	No.	Species	Age	Ht m	Dbh mm	St	Cr	N	S	E	W	ERC	Phys Cond	Structural Condition/Comments	Preliminary Recommendations	RPA m	Cat
G	1	Fraxinus excelsior (Ash)	SM	6 to 9	200	1	2	2.5	2.5	2.5	2.5	10	Poor/Fair	Fair. Linear group planting of young Ash trees along either side of Hayden's Lane. The trees are mostly of good shape/form and would have been sourced as uniform nursery stock. Some trees have bark wounds to their lower stems, especially towards the western end of the group. Many of the trees along the western end of Hayden's Lane and those along the R120 are showing signs of crown dieback as result of ADB disease, some these trees are now in very poor condition. The double row of trees east of the old gateways of haydens Lane seemed much less affected by ADB at the time of the survey, with only minor dieback and epicormic growth in the crowns.	Fell worst affected trees and replace with alternative species. Monitor condition of remaining trees.	2.4	C2 U

The Hawthorn hedging (H4) and semi-mature Ash trees (G1) along Hayden's Lane will be removed as part of the SDZ 20A-0021.

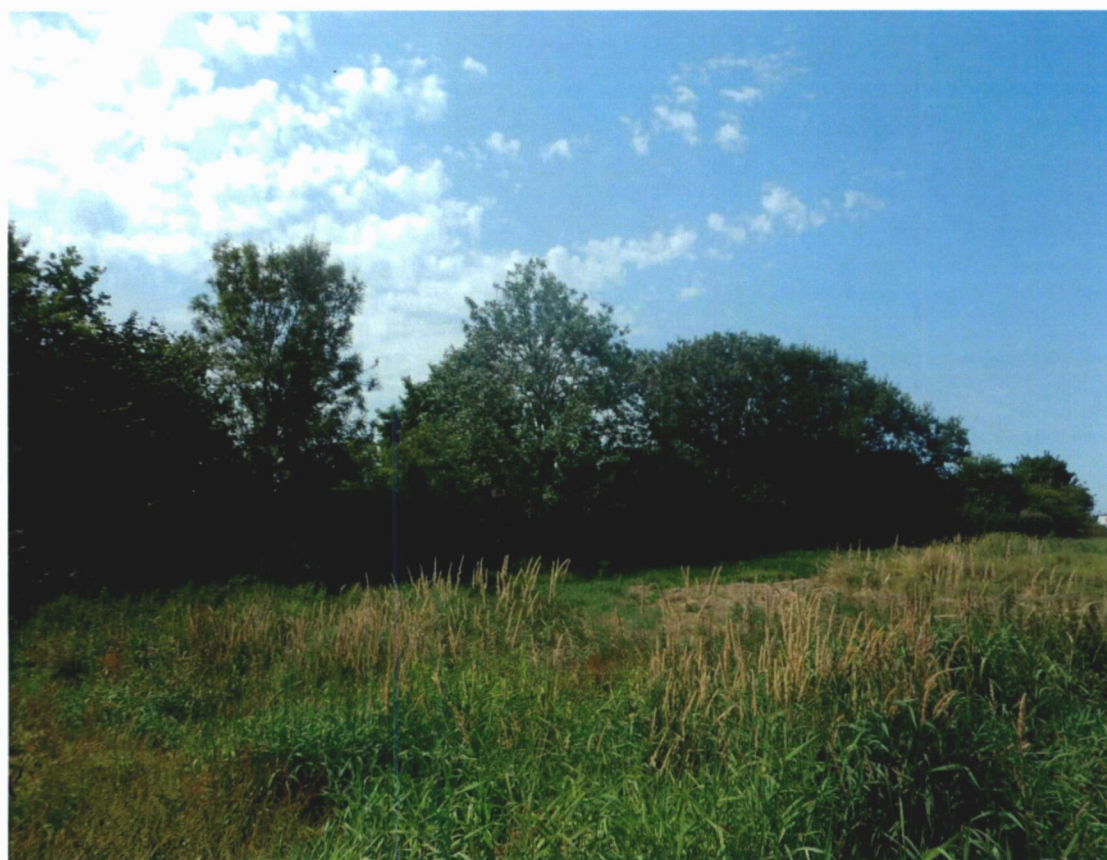
The southwestern part of the site borders the pitch and putt course, with the boundary marked by a tree-line/hedge (H3) of mixed species. This hedge is variable in width, density, height and species composition, with the central area being relatively narrow/thin in places. The eastern end of the hedge is taller and denser, with a series of multi-stemmed Ash trees (T6-T11) being the dominant feature. Unfortunately, these trees are suffering from infection by ADB disease and are likely to decline in health and condition.

4. Ash trees (T6-T11) along the eastern part of hedge H3

G	2	Acer pseudoplatanus (Sycamore)	SM	9	300	1	1	4	4.5	3.5	4.5	20+	Good	Fair. Three young Sycamore trees in hedge. Thick Ivy growth on tree stems and dense undergrowth.	No urgent works needed.	3.6	C2
T	6	Fraxinus excelsior (Ash)	EM	7.5	391	2	1	4	4	3.5	3.5	<10	Poor	Fair. Ash tree growing in hedgerow. ADB disease causing significant dieback and epicormic shoots on branching throughout crown. Thick Ivy growth restricts view of main stem and branch unions. Excessive Ivy growth in crown. Unable to inspect stem due to undergrowth.	Monitor tree condition to check progress of disease. Be prepared to fell tree if dieback becomes severe.	4.69	U
T	7	Fraxinus excelsior (Ash)	M	14	691	4	1	6	5	5	6	10	Poor	Fair. Multi-stem coppice stool growing on edge of ditch. Previously topped. Early signs of Ash Dieback disease, with wilting foliage and widespread epicormic growth. Tree on south side of ditch and not directly accessed.	Monitor tree condition to check progress of disease.	8.29	C2

T	8	Fraxinus excelsior (Ash)	M	14	691	4	1	6	5	5	6	10	Poor	Fair. Multi-stem coppice stool growing on edge of ditch. Previously topped. Early signs of Ash Dieback disease, with wilting foliage and widespread epicormic growth. Tree on south side of ditch and not directly accessed.	Monitor tree condition to check progress of disease.	8.29	C2
T	9	Fraxinus excelsior (Ash)	M	14	691	4	1	6	5	5	6	10	Poor	Fair. Multi-stem coppice stool growing on edge of ditch. Previously topped. Early signs of Ash Dieback disease, with wilting foliage and widespread epicormic growth. Tree on south side of ditch and not directly accessed.	Monitor tree condition to check progress of disease.	8.29	C2

Type	No.	Species	Age	Ht m	Dbh mm	St	Cr	N	S	E	W	ERC	Phys Cond	Structural Condition/Comments	Preliminary Recommendations	RPA m	Cat	
T	10	Fraxinus excelsior (Ash)	M	15	781	3	2	7	8	6	7.5	<10	Poor	Fair/Poor. Larger Ash tree in hedge. Multiple stems below 1.5m. Significant dieback in crown due to ADB. Unable to inspect stem due to undergrowth. Unlikely to recover from disease.	Monitor tree condition to check progress of disease. Be prepared to fell tree if dieback becomes severe.	9.37	U	
T	11	Fraxinus excelsior (Ash)	EM	11	300	1	1.5	4	3.5	3.5	4	10	Poor	Fair. Medium sized tree. Upright form. Thick Ivy growth on tree stem. Unable to inspect stem due to undergrowth. Some dieback in crown. Epicormic shoots on branching throughout crown.	Monitor tree condition to check progress of disease.	3.6	C2	
G	3	Fraxinus excelsior (Ash)	SM	6	250	2	1	3	3	3	3	10	Poor	Fair. Series of smaller Ash trees along fence-line. Early signs of Ash Dieback disease visible in most trees.	Monitor tree condition to check progress of disease.	3	C2 U

The hedgerow following the boundary with the pitch and putt club to the southwest will be removed and replaced with a new mixed native hedge to be planted to the south of the existing hedge. The removal of this hedge will include the 7 constituent trees labelled T5-T11 and 3 trees making up group G2. The semi-mature trees on the fence line along the south-eastern boundary will be removed; this includes the 5 members of group G3 and T12.

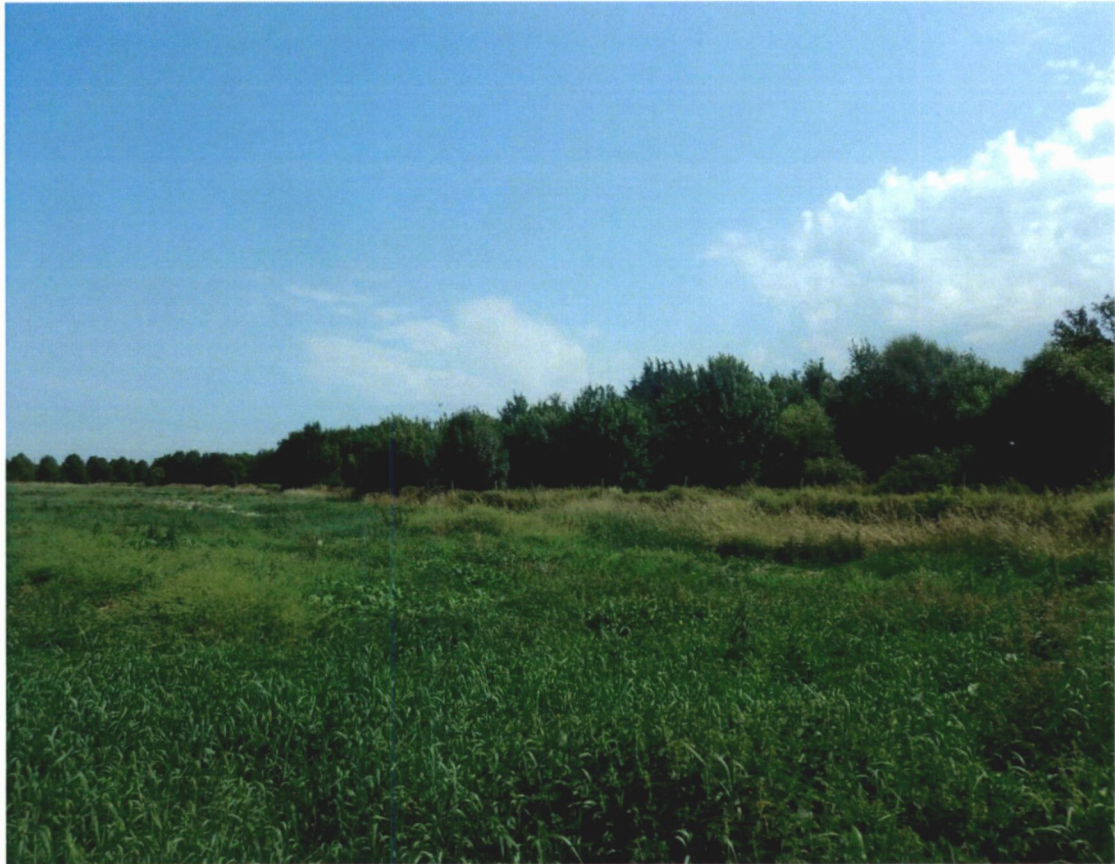
The south-eastern boundary area includes a swathe of young woodland (W2) to the southeast of the field boundary fence and linear bund. The origin of the woodland is unclear (planted or self-sown), but it is likely to include some naturally regenerated riparian growth along the small watercourse.

5. Wooded area W2 between the fence-line and south-eastern boundary of the site

T	12	Acer pseudoplatanus (Sycamore)	SM	8.5	343	5	1	4	3.5	3	3	10+	Good	Fair. Good vitality. Self-sown young tree on the fence-line. Multiple stems at ground level.	No urgent works needed.	4.12	C2	
W	2	Fraxinus excelsior (Ash) Salix spp. (Willow) Acer pseudoplatanus (Sycamore)	SM	6 to 9	250	2	1	3	3	3	3	10+	Fair	Fair. Dense wooded area to the south-east of the fence-line with poor access into interior of woodland due to undergrowth. Comprised of mixed young broad-leaved trees, mostly between a linear mound and stream. Some squirrel damage to branches of Acer spp. trees. Dieback due to ADB amongst young Ash trees.	Carry out selective thinning of woodland to remove weaker and poor quality stems.	3	C2 U	
G	4	Alnus glutinosa (Alder) Sambucus nigra (Elder) Fraxinus excelsior (Ash) Crataegus monogyna (Hawthorn) Acer pseudoplatanus (Sycamore)	SM	3 to 6	200								10+	Fair	Fair/Good. Dense thicket of scrub growth along bank between site boundary and public path. Includes numerous young Alder trees that may have been planted onto the slope.	No urgent works needed.	2.4	C2
