# **ARCHITECTURAL HERITAGE IMPACT ASSESSMENT**

**Muldowney's Pub,  
Main Street,  
Rathcoole,  
Co. Dublin**

**Additional Information Stage: Reg. Ref. SD22A/0096**

**March 2023**

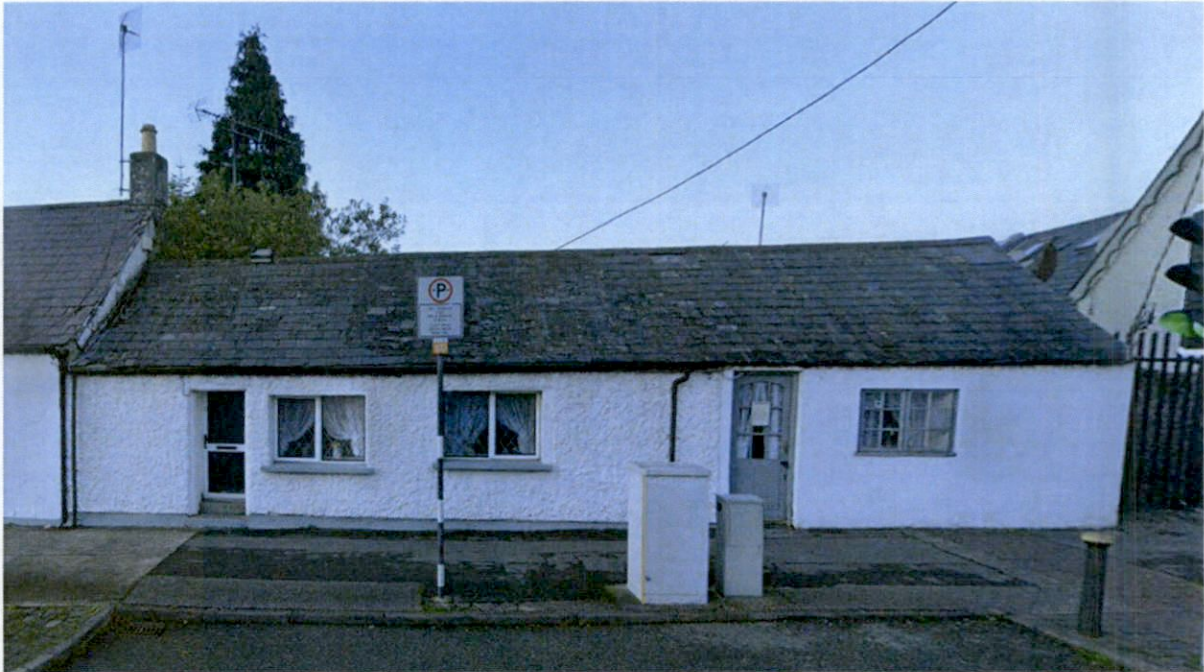
**Figure 6: South (Front) Elevation**

Cottage No.1 is a semi-detached, three-bay single-storey house, constructed c.1820. The external walls are painted rubble walls with smooth rendered base course. The original windows have been replaced with white uPVC framed windows. The roof is pitched with a natural slate finish rising from the ridge at each gable. It is noted that some slates are missing which is contributing to the deterioration in the condition of the house. There is a small, enclosed yard at the rear of the house.

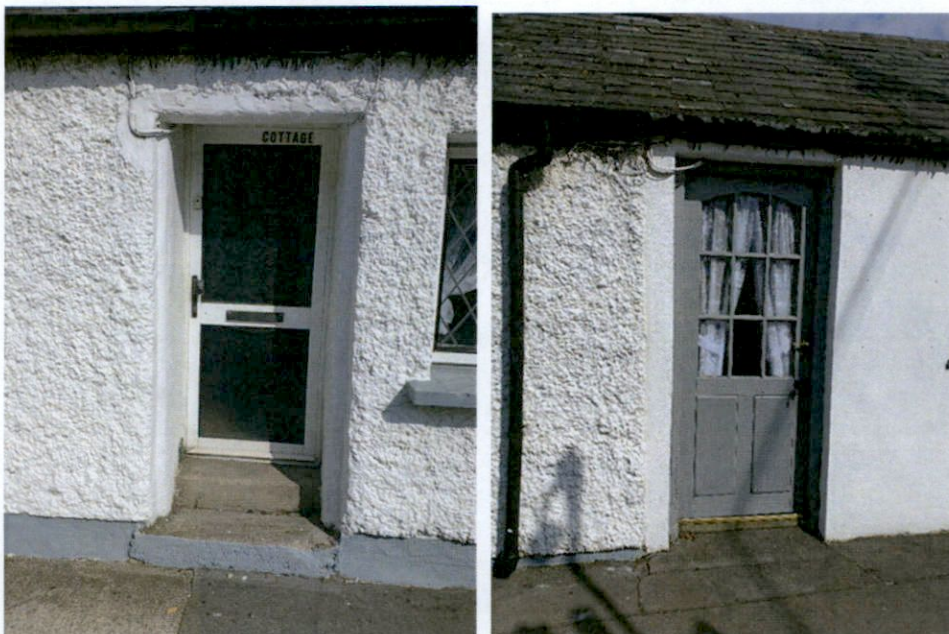
**Figure 7: South (Front) Elevation Entrance Doors Detail**

There are two front doors suggesting that this house was originally constructed as two houses which were subsequently joined together.

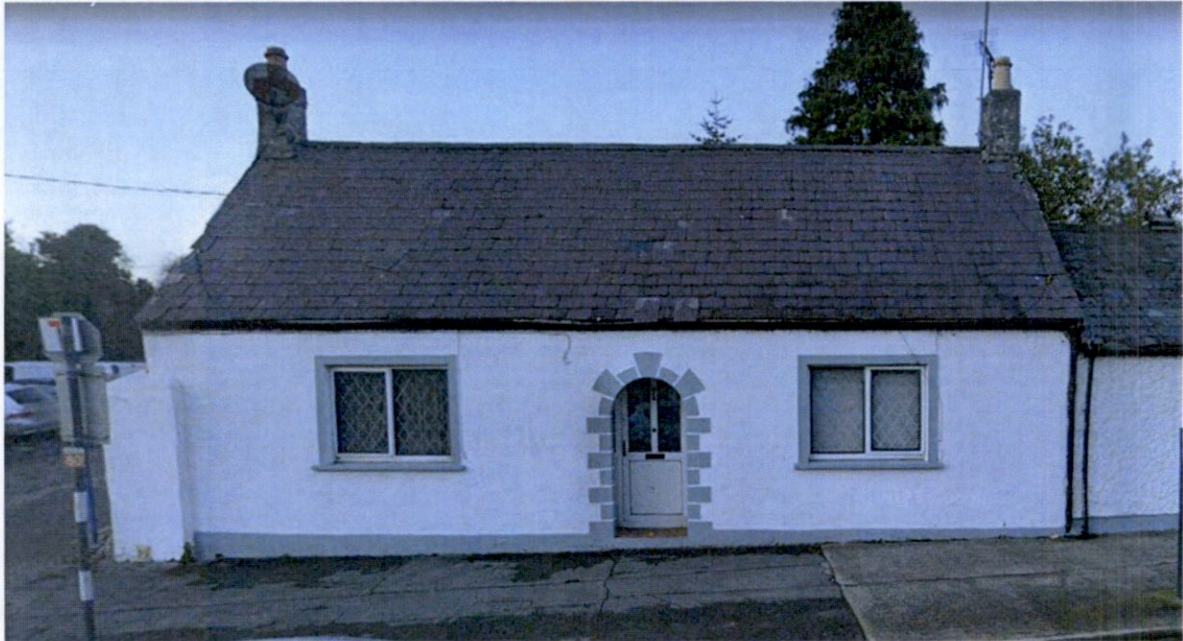
**Figure 10: South (Front) Elevation**

Cottage No.2 is a semi-detached, three-bay single-storey house, constructed c.1820. The external walls are painted rubble walls with smooth rendered base course.

The original windows have been replaced with white uPVC framed windows with leaded glass affect. The original door has been replaced with a white uPVC door which has been set back from the main façade. The pitched roof has a slate finish. The roof is pitched with a natural slate finish and there are two chimneystacks rising from the ridge at each gable. There is a small, enclosed yard at the rear of the house.

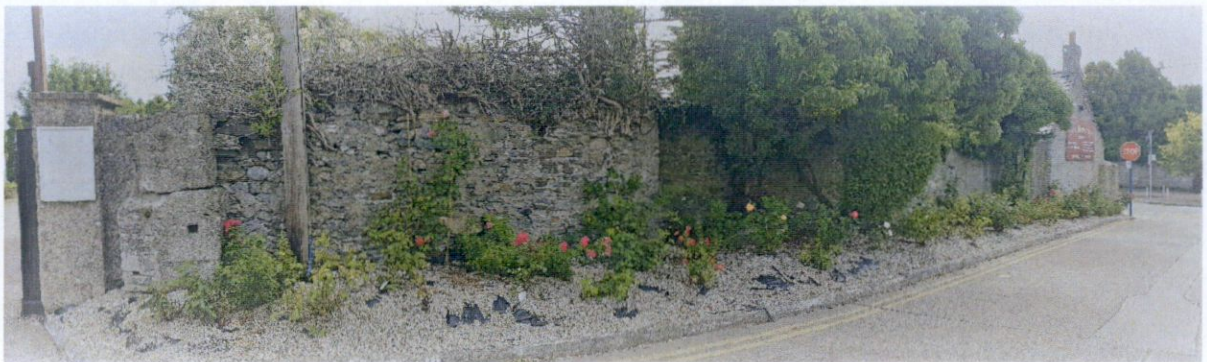
**Figure 13: Western Boundary Wall**

The wall extending along the western boundary of Cottage 2 is of early nineteenth century origin and consists of a 1.7metre high dry-stone wall extending for 21 metres from the rear façade of Cottage 2 and terminating in a modern concrete block pier with a render finish and precast concrete capping.

The proposed site entrance reuses an existing entrance to the site which allows the existing stone wall to be retained and made good as necessary.
